Bridge #03253(Routine)

SH 115-02-LM 16.14 over STRAWBERRY RIVER

Location: 4.0 MI S OF SMITHVILLE

Team Lead: James Adams Inspection Date: May 22, 2019

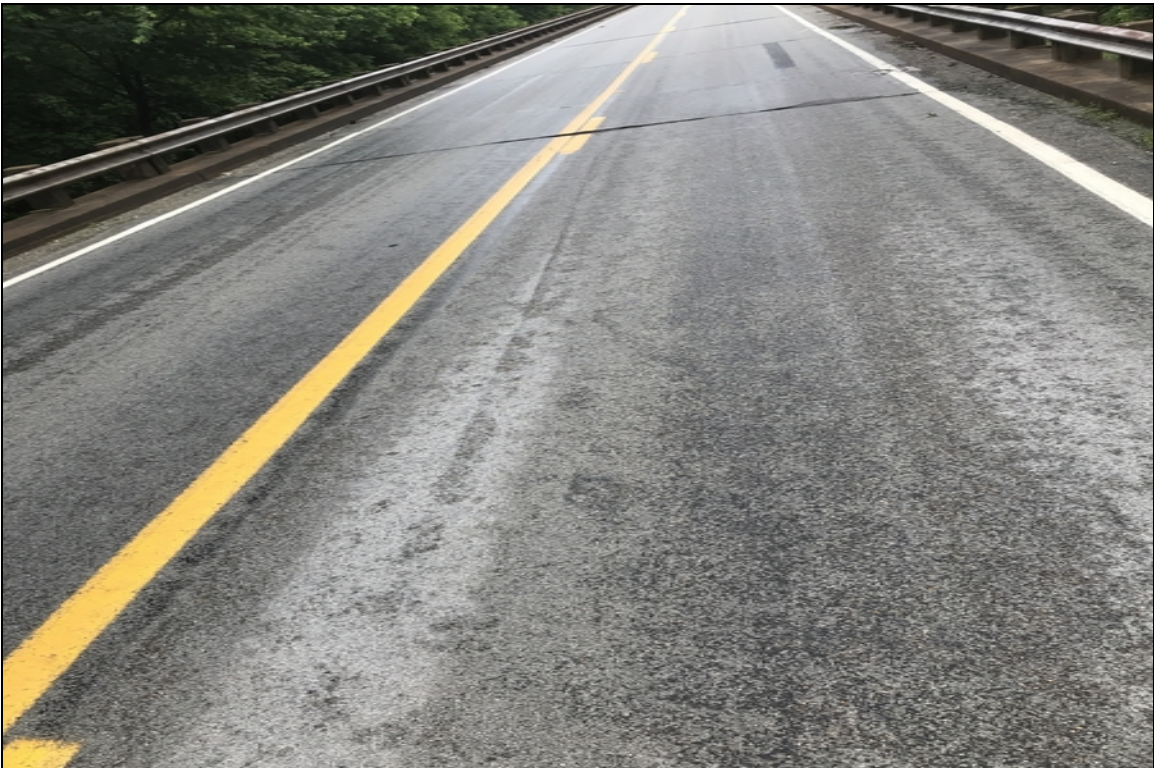
Deck

Inspected with snooper Underwater type 2 inspection performed late to optimize schedule. Spans 12,13 & 14 have several spalled areas with some exposed rebar. Wearing surface has several spalls and asphalt patches, especially spans 12,13 & 14. Soffit has several efflorescent cracks at left and right overhangs. Overhangs have a few minor spalls, some with exposed rebar. Bridge rail posts have a few cracks and spalls with exposed rebar.

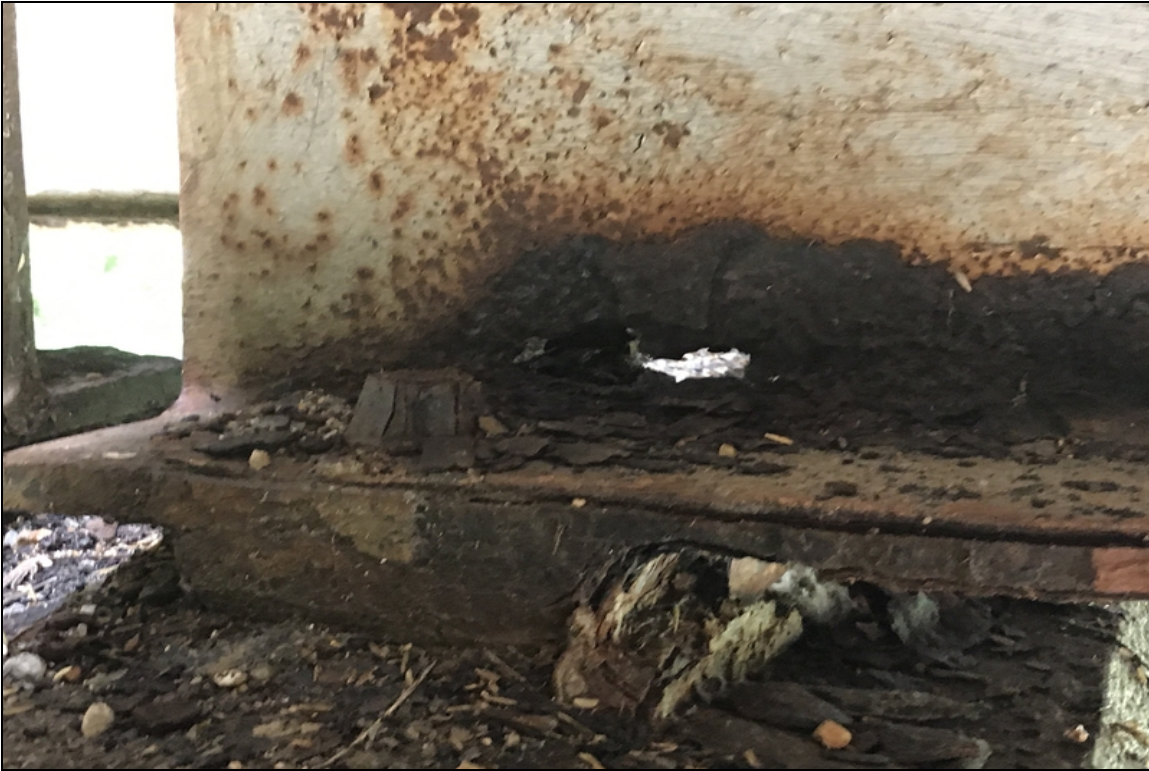
Span 9 bent 10 girder 2 2019

has a 1 in. diameter hole in web below haunch.Span 8 girder 2 bent 9
has plates welded over hole in web below haunch.Span 8 girder 3 bent 9
has a 2 in. diameter hole in web below haunch.Span 9 girders 2-4
bent 9 have plates welded over holes in web below haunch.Span 9 girder 5 bent 9
has section loss on bottom flange and bottom of web near utility connection.Span 9 girder 1 bent
10 has 4 ft. of section loss along bottom of web.Span 9 girder 2 bent
10 has plates welded over hole in web below haunch. Bottom of web has heavy
section loss with a 5 in. x 1 in. along bottom of web 4 in. from the end of
girder. See
2019 photo.Span 9 girder 3 bent
10 has a 1 in. diameter hole in web below haunch.Span 9 girder 5 bent
10 has a 7 in. x 1 in. hole in web below haunch.Span 10 girder 1 bent
10 has a 2 in. x 1 in. hole in web below haunch.Span 10 girder 2 bent
10 has a 3.5 in. x 1 in. hole in web below haunch.Span 10 girder 5 bent

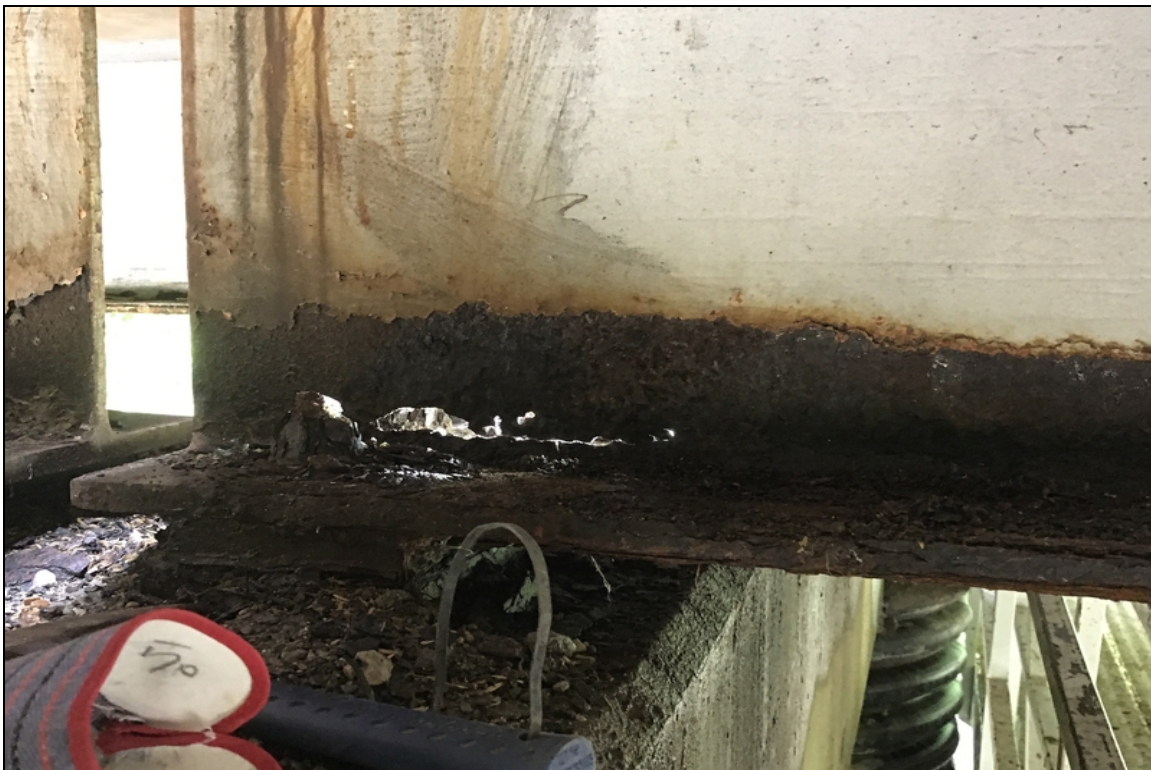
Span 5 bent 6 girder 2 2019

Ends of girders have rust with areas of section loss (1/8 in. - 1/4 in.), especially near concrete haunch, several have holes rusted through. Exterior girders have areas of section loss below drains. Exterior girder on right side of bridge has rust and areas of section loss at utility connections. Span 1 bent 1 girders 2 - 4 were T spliced in 2014. Span 1 girder 1 bent 1 has approximately 10 ft. of moderate to heavy section loss along bottom of web. Span 1 girder 2 bent 1 has a 3.5 in. x 1 in. hole in web below haunch. Span 1 girder 3 bent 1 has a 5 in. x 1 in. hole in web below haunch. Span 1 girder 4 bent 1 has 3 in. x 1 in. hole in web below haunch. Span 1 bent 1 girder 5 has 1 ft. on end with 1/8 in. section loss. Span 1 girders 2 & 4 bent 2 were T spliced in 2014. Span 1 girder 3 bent 2 has a 1.5 in. x 1 in. hole in web below haunch. Bottom of web has been T spliced. Span 1 girder 5 bent 2 has heavy section loss on end with a 9 in. x 4 in. hole in web below haunch. Span 2 girder 1 bent 2 has a 1 in. diameter hole 6 in. from end near haunch. Span 2 girder 3 bent 2 has a 2 ft. x up to 3 in. area of moderate section loss to bottom of web. Bottom flange has heavy section loss. Span 2 bent 2 girder 4 has a 5.5 in. x 1 in. hole in web below haunch. Span 2 girder 1 at bent 3 has a 1 in. diameter hole in web near haunch. Span 2 girder 3 bent 3 has a 3 in. x 1 in. hole in web below haunch. Span 3 girder 3 bent 3 has a 2 in. x 1/2 in. hole in web below haunch. Span 3 girder 1 bent 4 has a 2 in. x 1 in. hole in web below haunch. Span 3 girder 2 bent 4 has a 5 in. x 1 in. hole in web below haunch. Span 3 girder 2 bent 4 is floating, 1/8 in. gap between bearing plates. Span 3 bent 4 bearings 2 and 4 are each missing 1 anchor bolt. Span 3 girder 3 bent 4 has a 1.5 in. x 1/2 in. hole in web below haunch. Span 4 girder 2 bent 5 has a 1/2 in. diameter hole in web below haunch. Bottom of web has a 1/2 in. hole 5 in. from end of girder. Span 4 girder 3 bent 5 has a 2 in. x 1/2 in. hole in web below haunch. Span 4 girder 4 bent 5 has 1 ft. of moderate section loss along bottom of web. Bottom flange has heavy section loss. Span 5 girder 2 bent 5 has a 1/2 in. hole in web below haunch. Span 5 girder 2 bent 6 has a 7 in. x 1 in. hole in bottom of web 4.5 in. from end of girder, see 2019 photo. Span 6 girder 1 bent 6 has a 1/2 in. diameter hole in web below haunch. Span 6 girder 3 bent 6

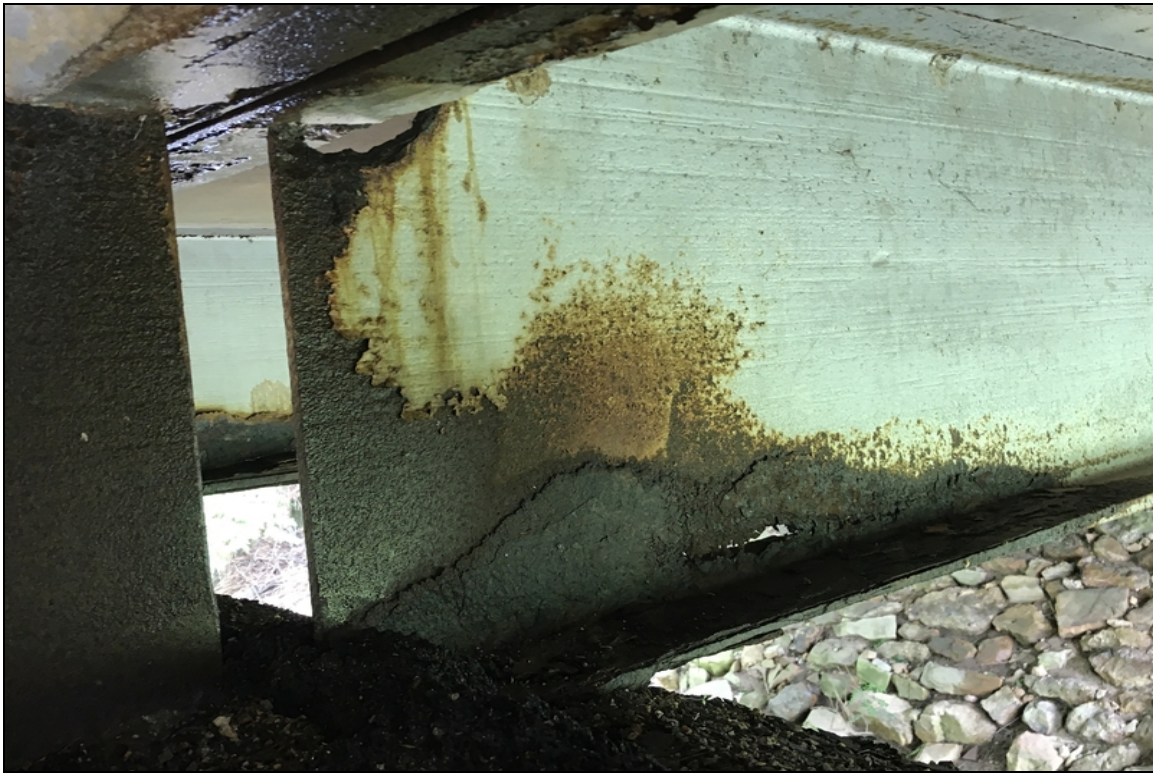
Span 17 bent 17 girder 4 2019

15 has a 3 in. x 1 in. hole in web below haunch.Span 15 girder 5 bent
15 has a 2 in. x 1 in. hole in web below haunch.Span 15 girder 3 bent
16 has a 4 in. x 1 in. hole in web below haunch.Span 15 girder 4 bent
16 has a ½ in. diameter hole in web near haunch. Span 16 girder 1 bent
16 has a 5 in. x 1 in. hole in web below haunch.Span 16 girder 4 bent
has a 5 in. x 1 in. hole in web below haunch.Span 16 girders 2 thru
5 bent 17 have approximately 6 ft. of advanced section loss at bottom flange
and bottom 6 in. of web. Bottom flanges have some beginning to knife edge.Span 16 girder 3 bent
17 has a 5.5 in. x 1 in. hole in web below haunch.Span 16 girder 4 bent
17 has a 4 in. x 1 in. hole in web below haunch. Bearing has 1 anchor bolt
missing.Span 16 girder 5 bent
17 has a 8 in. x 2 in. hole in web below haunch, web is beginning to buckle, see 2019 photo.Span 17 girder 4 bent
17 has a 6 in. x 1 in. hole in web below haunch and a 19 in. x 2 in. hole in

bottom of web 12 in. from end of girder. Bearing has 1 anchor bolt missing.Span 17 girder 5 bent
17 has a 8 in. x 1 in. hole in web below haunch.Span 17 girders 2-4
bent 18 were T spliced in 2014.

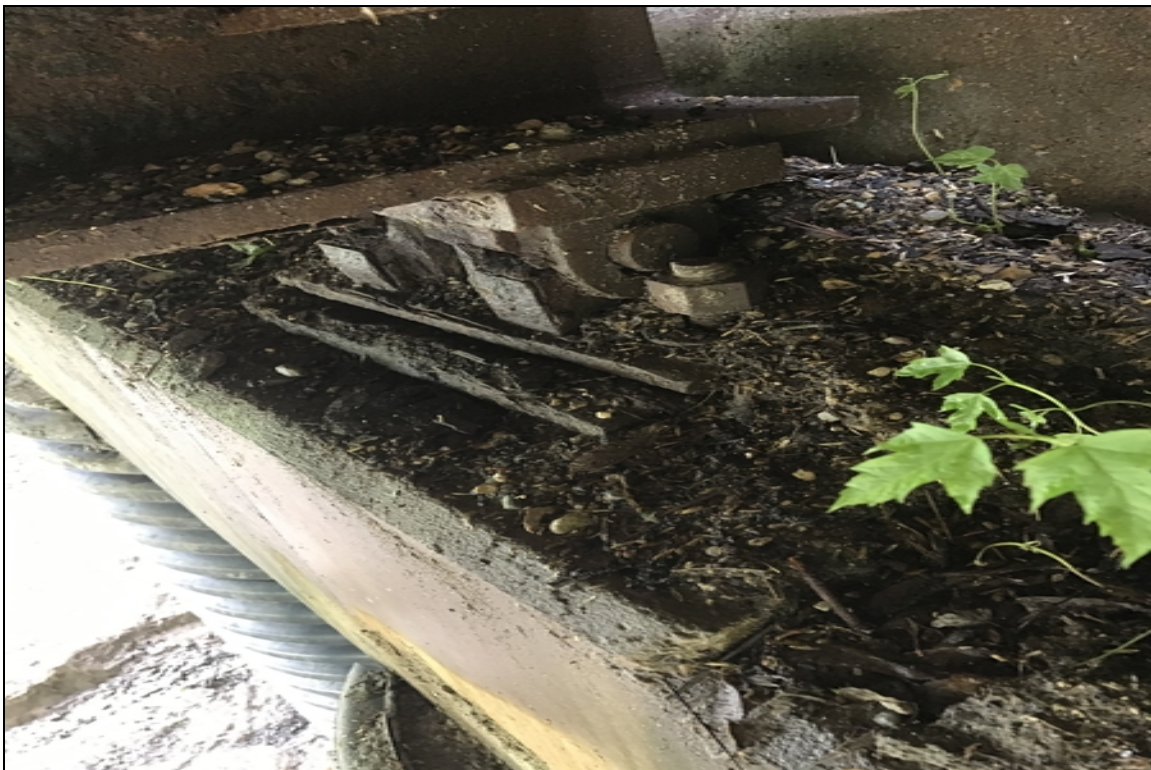
Span 12 bent 12 bearing 2 2019

10 has a 2.5 in. x 1 in. hole in web below haunch.Span 10 girder 2 bent
11 has a 3 in. x 1 in. hole in web below haunch.Span 10 girder 4 bent
11 has plates welded over hole in web below haunch.Span 11 girders 2-4
bent 11 have plates welded over holes in web below haunch.Span 11 girder 4 bent
11 has section loss along bottom of web. Bottom flange has heavy section loss
for 6 in. near bearing on both sides.Span 11 girder 1 bent
12 has a 2 in. x 1 in. hole in web below haunch.Span 11 girder 3 bent
12 has plates welded over hole in web below haunch.Span 11 girder 4 bent
12 has a 4 in. x 1 in. hole in web below haunch.Span 12 girder 2 bent
12 has a 2 in. x 1 in. hole in web below haunch.Span 12 girder 4 bent
12 has a 2.5 in. x 1 in. hole in web below haunch.
Span 12 girder 5 bent 12 has 8 ft. of
advanced section loss on bottom flange and bottom ¼ of web.Span 12 bent 12
bearings have advanced section loss and are frozen from corrosion. Rocker pins

have some lateral movement. Bearings are bouncing under traffic. Span 12 is a
1/2" lower at the road iron than Span 11.See 2019 photo.Span 13 girder 2 bent
13 has a 3.5 in. x 1 in. hole in web below haunch.Span 13 girder 3 bent
13 has a 2 in. x 1 in. hole in web below haunch.Span 13 bent 13
bearing 3 has cotter key rusted off or missing and sleeve on center of pin has
complete section loss.Span 13 bent 13 bearing
4 has 2 anchor bolts missing.Span 13 girder 5 bent
13 has 5 in. hole in web below haunch. End of web has section loss with some
beginning to knife edge and out of plane bending. Bottom flange has section
loss and is beginning to knife edge.Span 14 girder 2 bent
14 has a 5 in. x 1.5 in. diameter hole in web below haunch. Bearing has 1
anchor bolt missing.Span 14 bearings 3
& 4 bent 14 have cotter keys rusted off or missing and sleeve on center of
pin has complete section loss.Span 14 girder 4 bent
