Bridge #03467(Routine)

SH 117-01- LM 1.40 over REEDS CREEK

Team Lead: James Adams Inspection Date: October 16, 2019

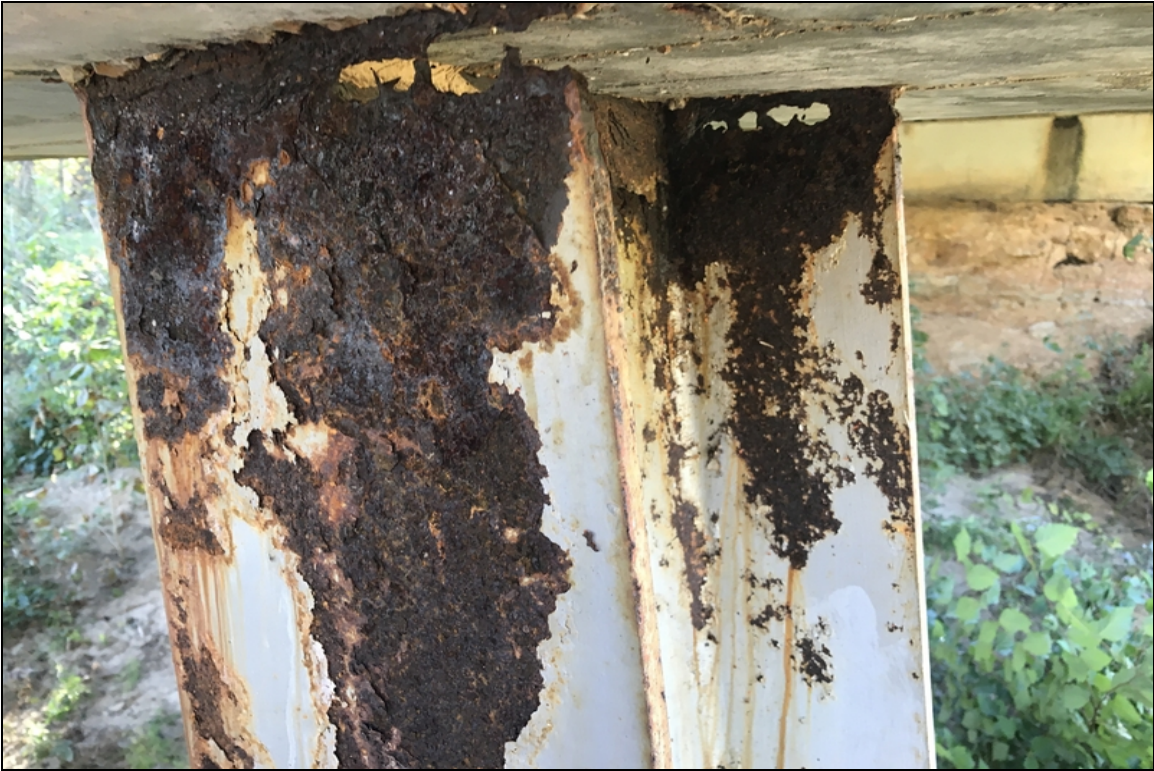
Bent 2 pile 1 2019

Bent 2 pile 1 has a 1 x 3 in. hole in left flange span 1 side & a 1 in. x 5 in. hole in left flange in span 2 side near bottom of cap. See 2019 photo.

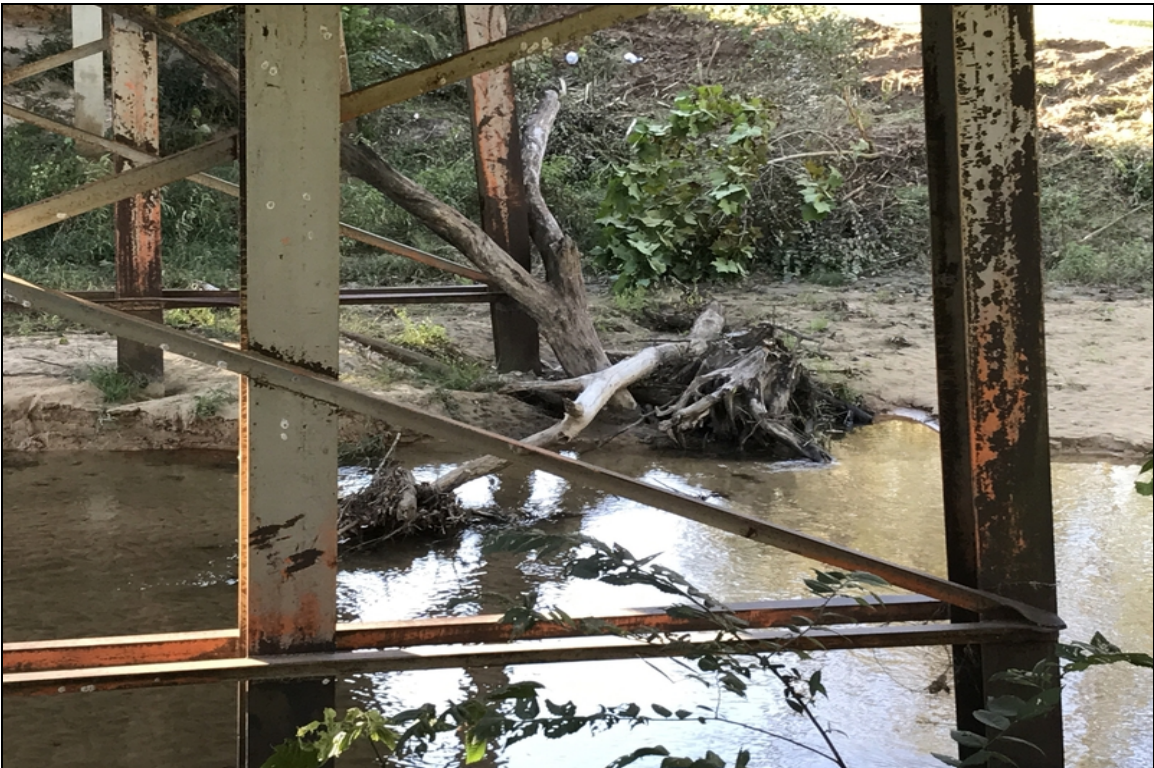
Bent 3 drift 2019

Trees & drift lodged on bents 3 & 4 piling, see 2019 photo.

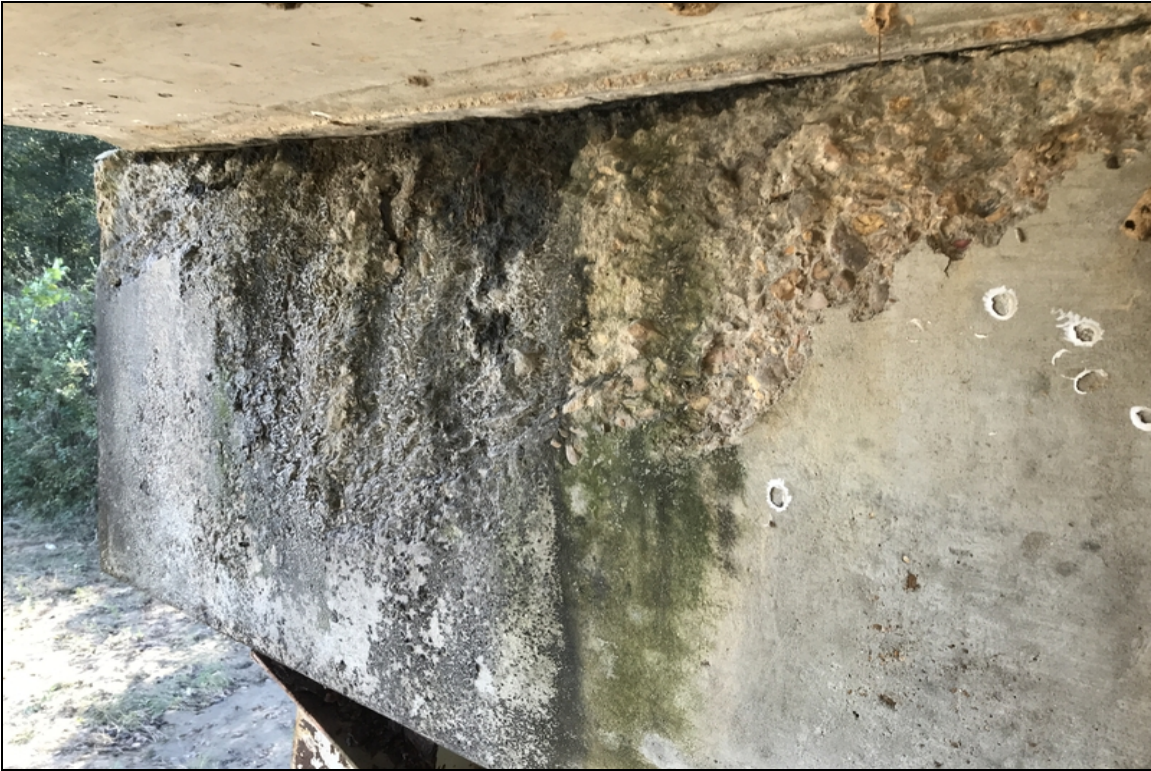
Span 3 bent 3 cap RT END 2019

Bent 3 cap has a spall with exposed rebar on span 2 side over pile 2. Cap has a 6 in. x 2 ft. spall on left end of span 3 side. Right end of cap on span 3 side has a 1.5 ft. x 5 ft. x 1 1/2 in. deep spall with exposed rebar, see 2019 photo.

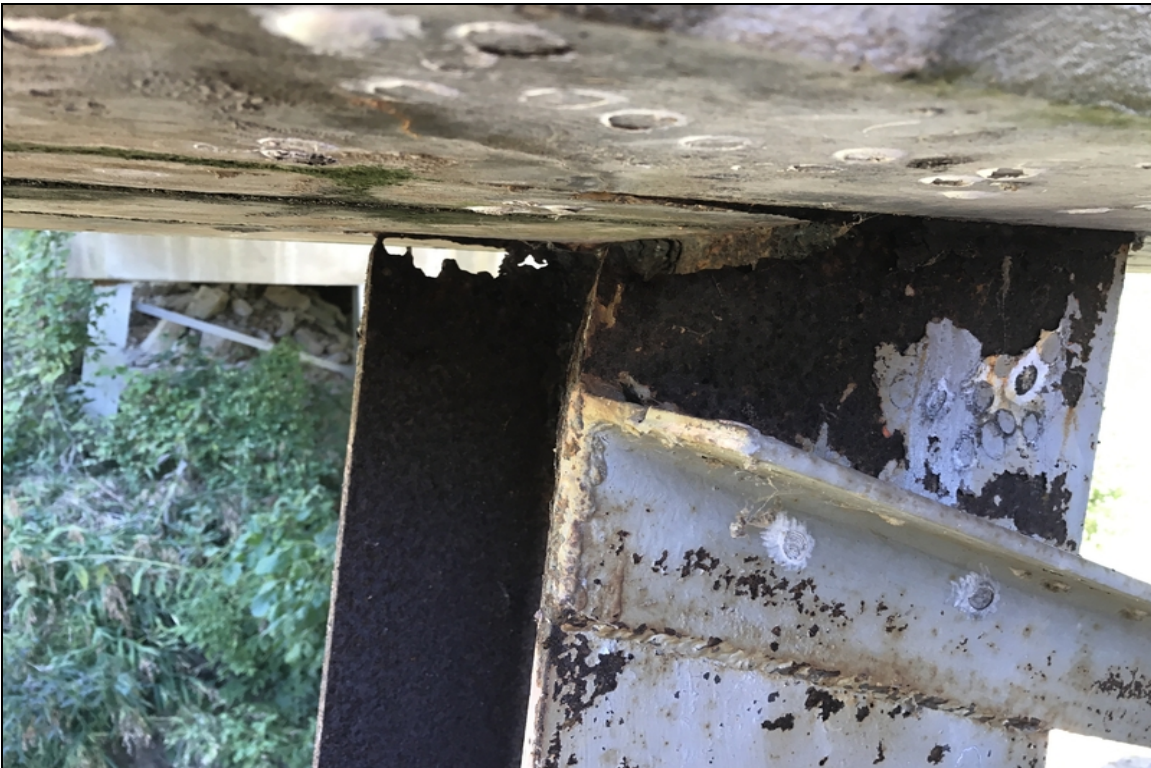
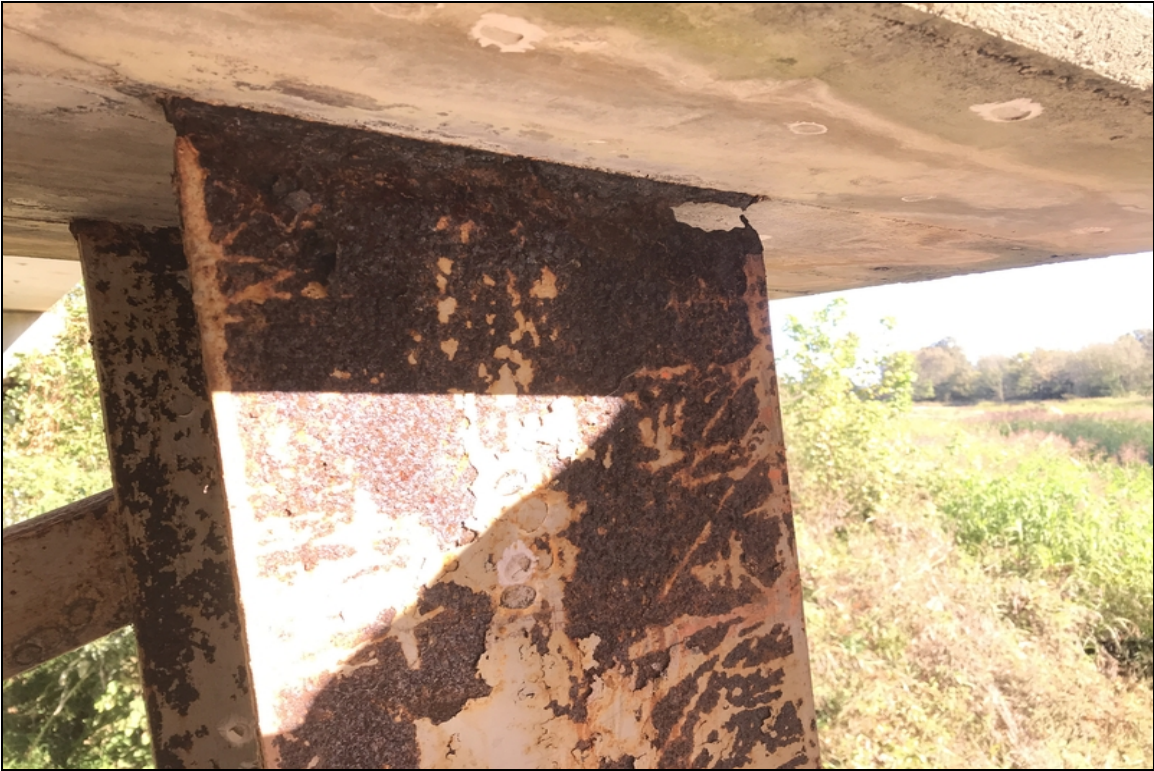
Bent 4 pile 4 2019

Bent 4 pile 1 left flange span 3 side has a 5 in. x 1 in. hole in flange near bottom of cap, right flange span 4 side has a 1 in. x 5 in. hole in flange, see 2019 photo. Bent 4 pile 4 span 3 side right flange has a 2 ½ in x 1 in. hole in flange, see 2019 photo.

Bent 4 pile 4 has 1/8 in. section loss to flanges near groundline.

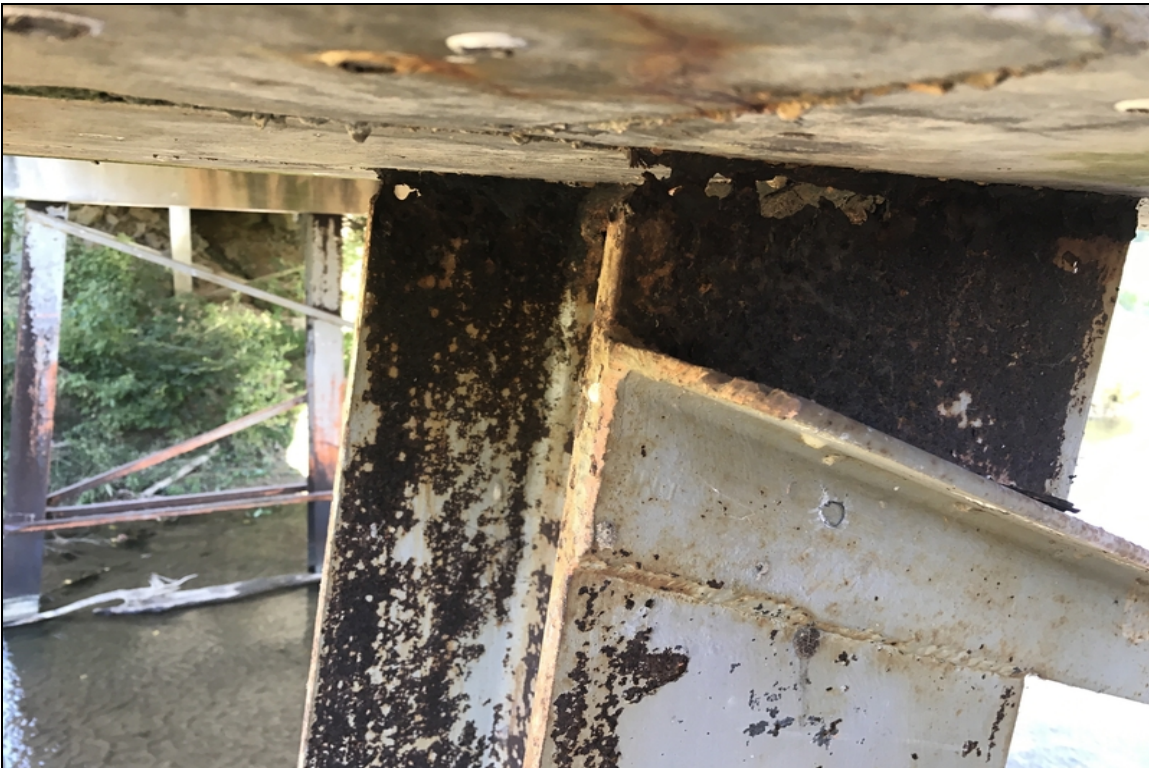
Bent 3 pile 1 2019

Bent 3 pile 1 has several minor bows in flange near bottom of pile.

Bent 3 pile 1 left flange span 2 side has a 5 in. x 1 in. hole in flange near bottom of cap. Span 3 side left flange has a 1 in. diameter hole, see 2019 photo.

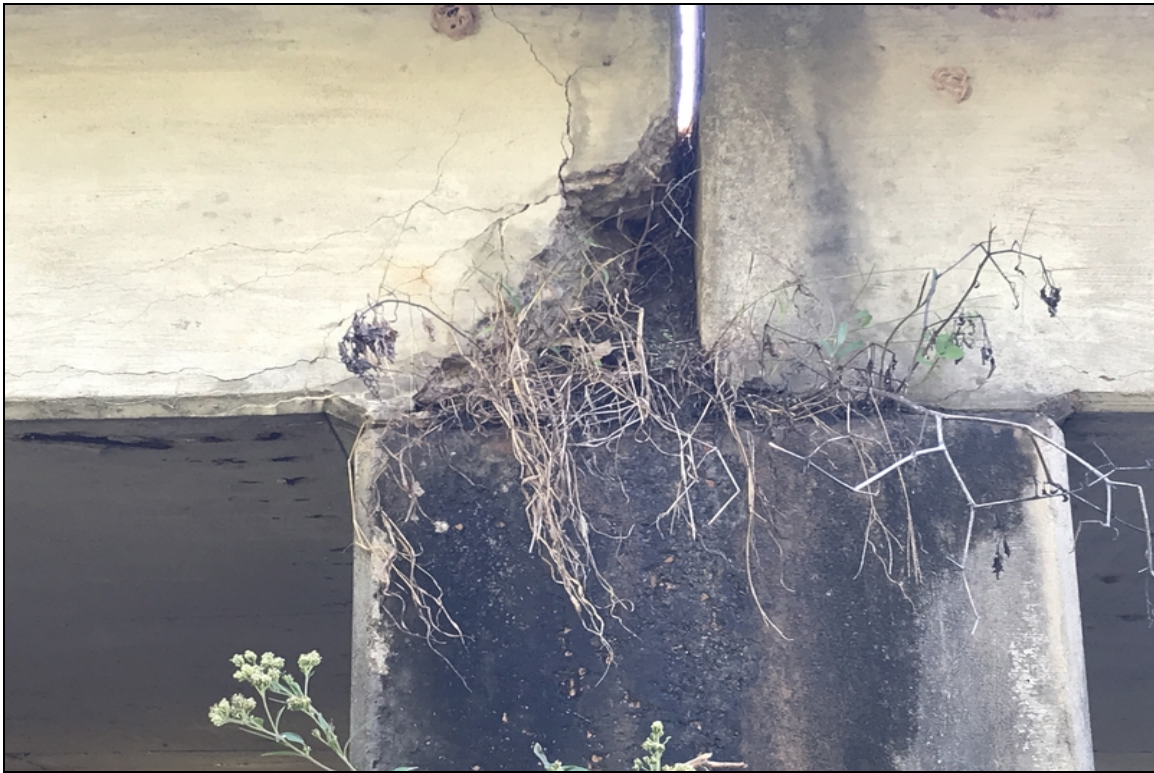
Span 5 LT SIDE over bent 5 2019

Span 5 left and right corners of slab are spalled over bent 5 cap. Left side is spalled with exposed rebar, see 2019 photo. Outside edge of slabs have horizontal cracking at all drain locations.

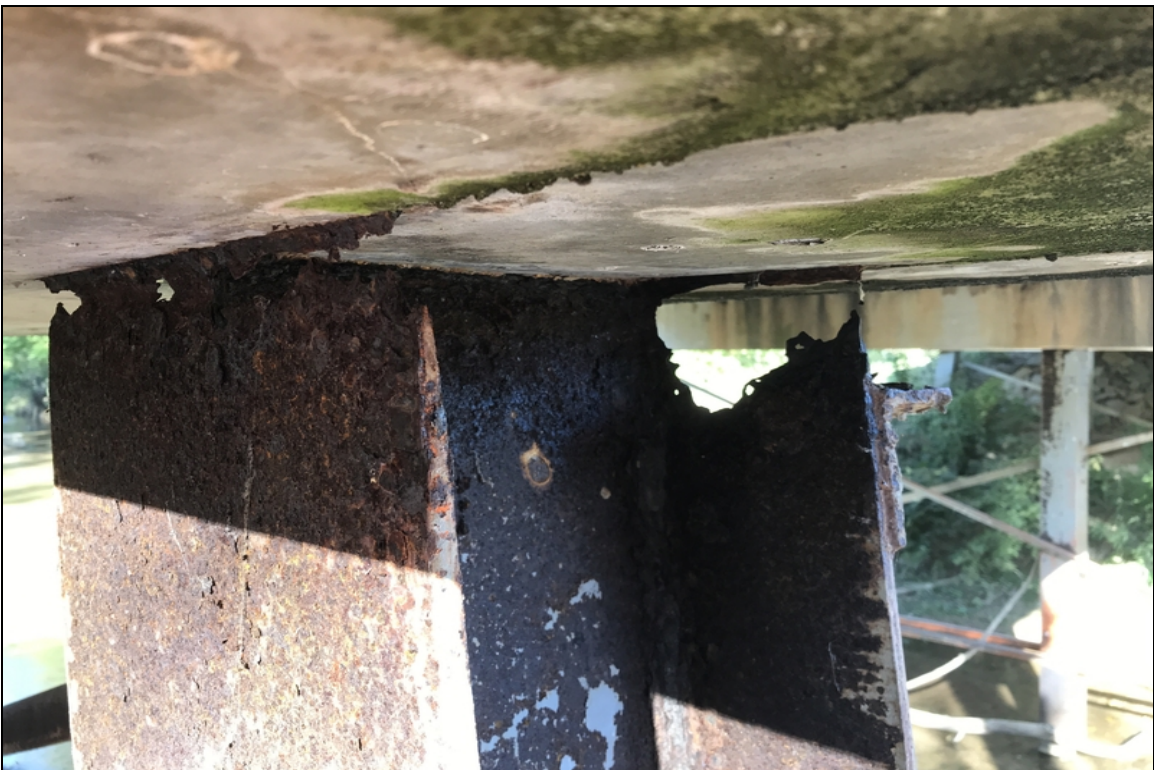
Span 3 bent 3 pile 4 2019

Bent 3

pile 4 span 3 side left flange has a 1 in. x 5 in. hole in flange. Span 3 side right flange has a 5 in x 3 ½ in hole in flange. See 2019 photo.

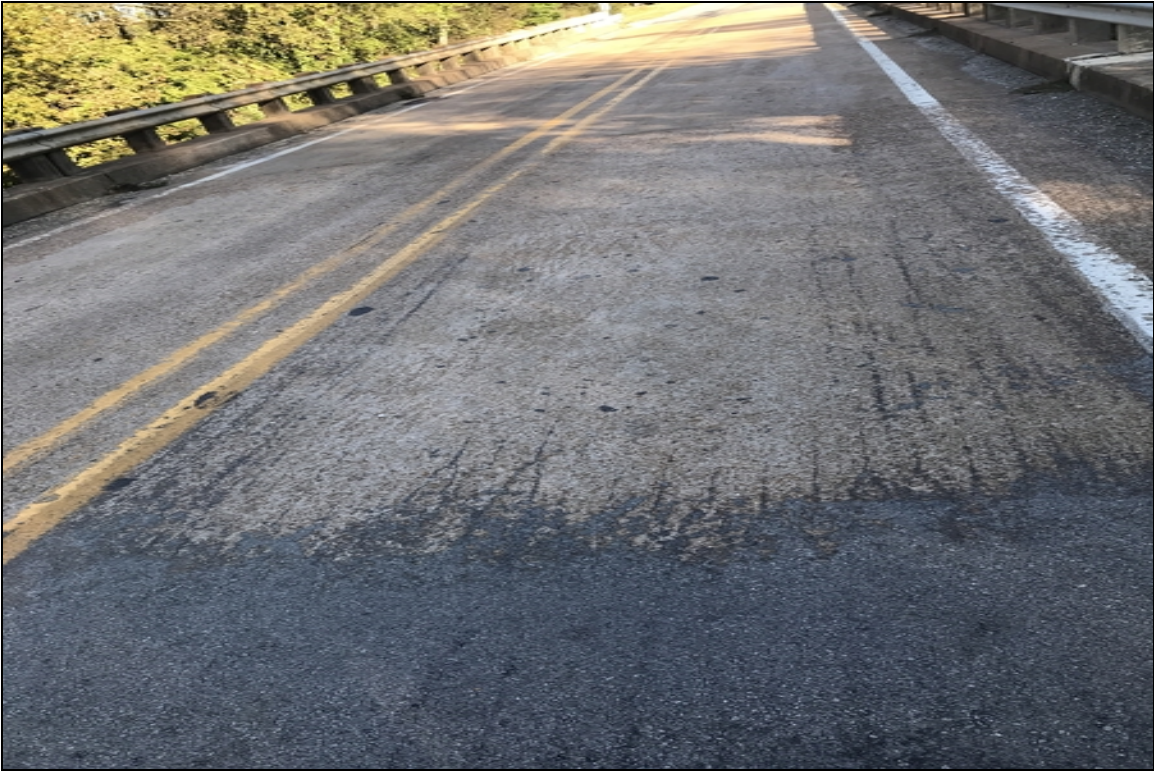
Deck

Top of slab has areas of abrasion, especially at spans 1 and 5. Slab has several longitudinal unsealed cracks, some with leakage thru deck.

Poured joints are torn or separated.

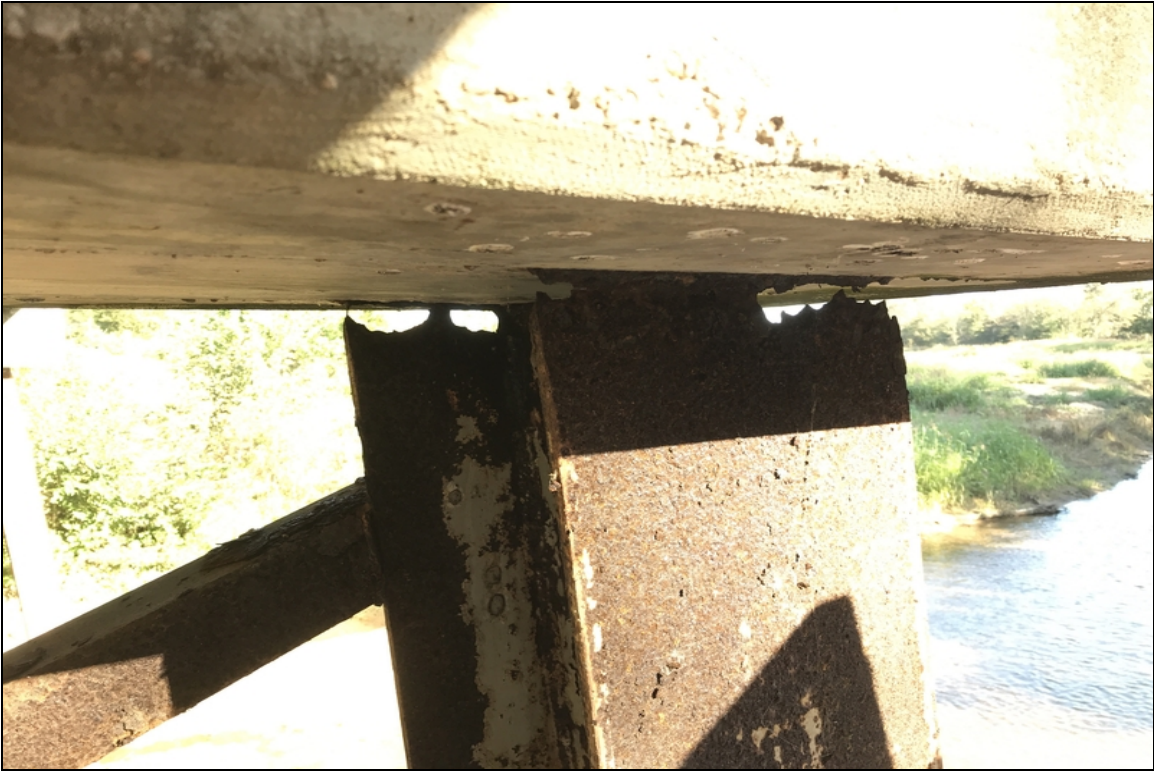
Span 2 Bent 3 pile 4 2019

Bent 3 pile 4 span 2 side left flange has (2) 1 in. diameter holes, right flange has a 5 in. x 1 in. hole in flange near

bottom of cap. See 2019 photo.
