Bridge #03468(Routine)

SH 117-01- LM 3.99 over BIG CREEK

Location: .22 MI S JCT SH 115 & 117

Team Lead: James Adams Inspection Date: October 16, 2019

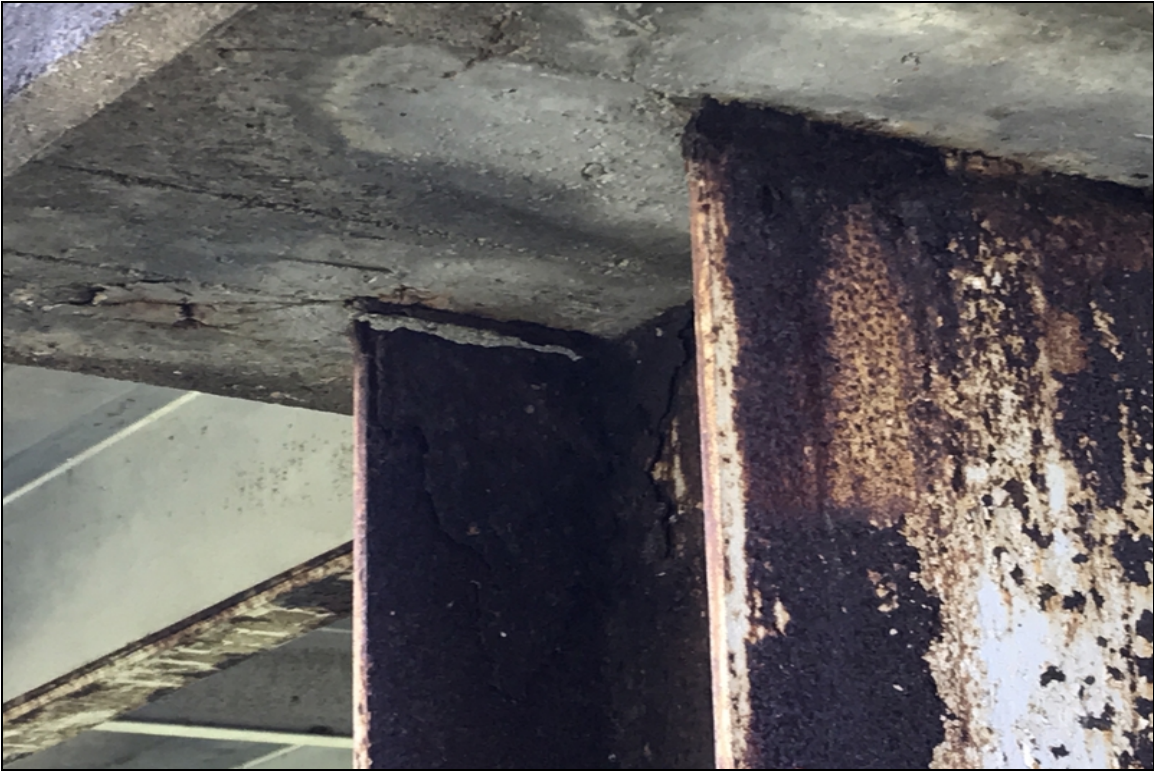
Span 5 bent 5 pile 1 2019

Steel H pile at bents 5  
and 6 are rust covered. Piles have heavy section loss at bottom of cap. Several  
have holes rusted through flange.

Bent 5 pile 1 has a 5.5  
in. x 1 in. hole rusted through flange. See 2019 photo.

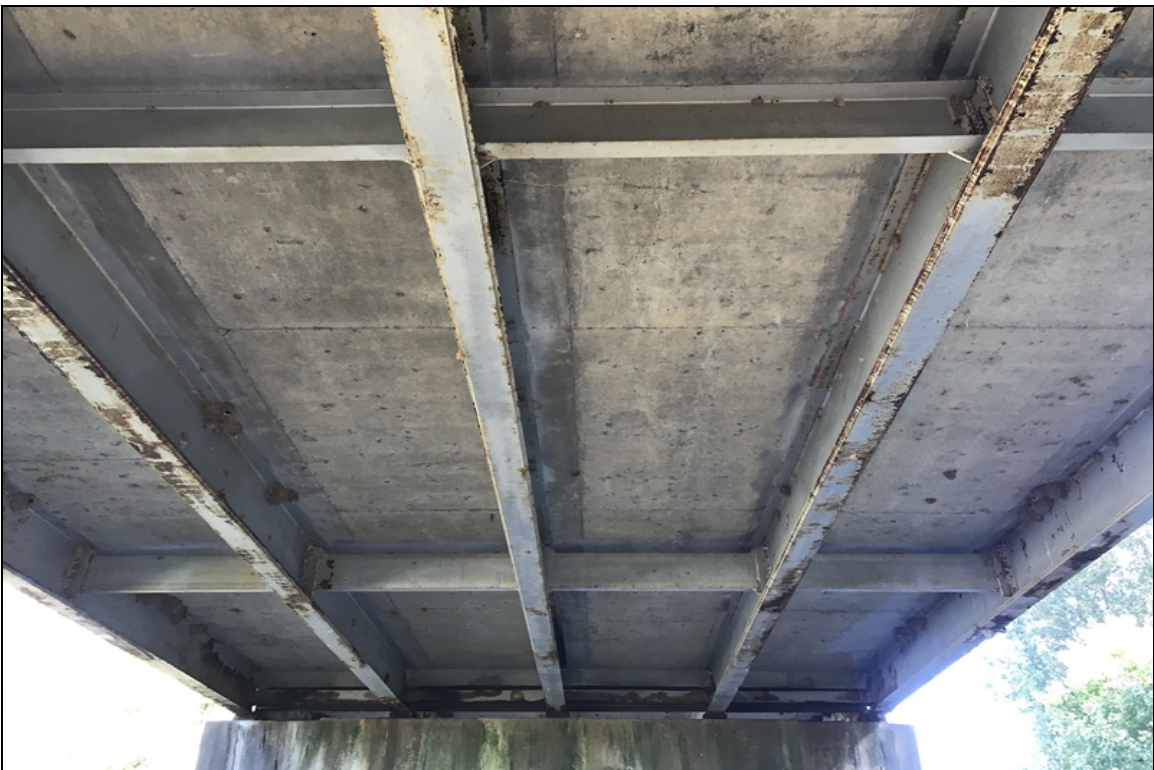
Span 2 soffit

Soffit has several cracks with efflorescence.

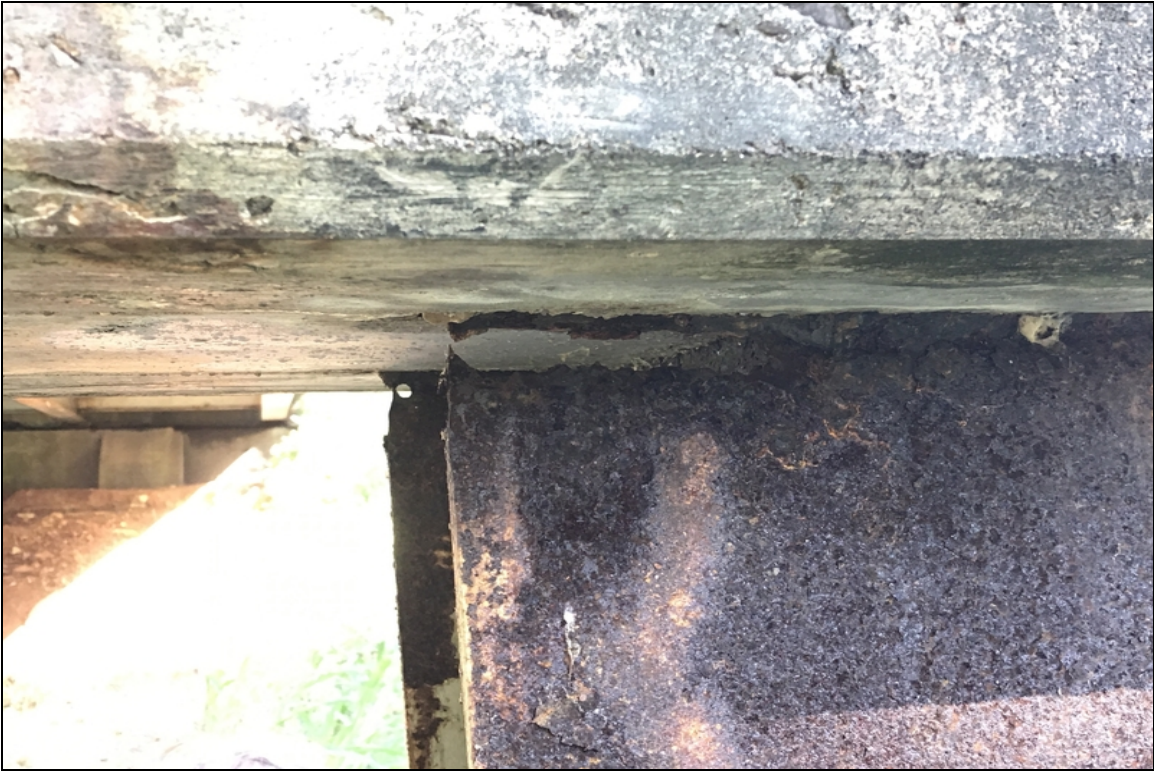
Span 5 bent 6 pile 4 2019

Bent 6  
pile 4 has a 5 in. x 1 in. hole in flange on span 5 side & a 1/2 in. diameter  
hole in left flange on span 6 side. See 2019 photo.

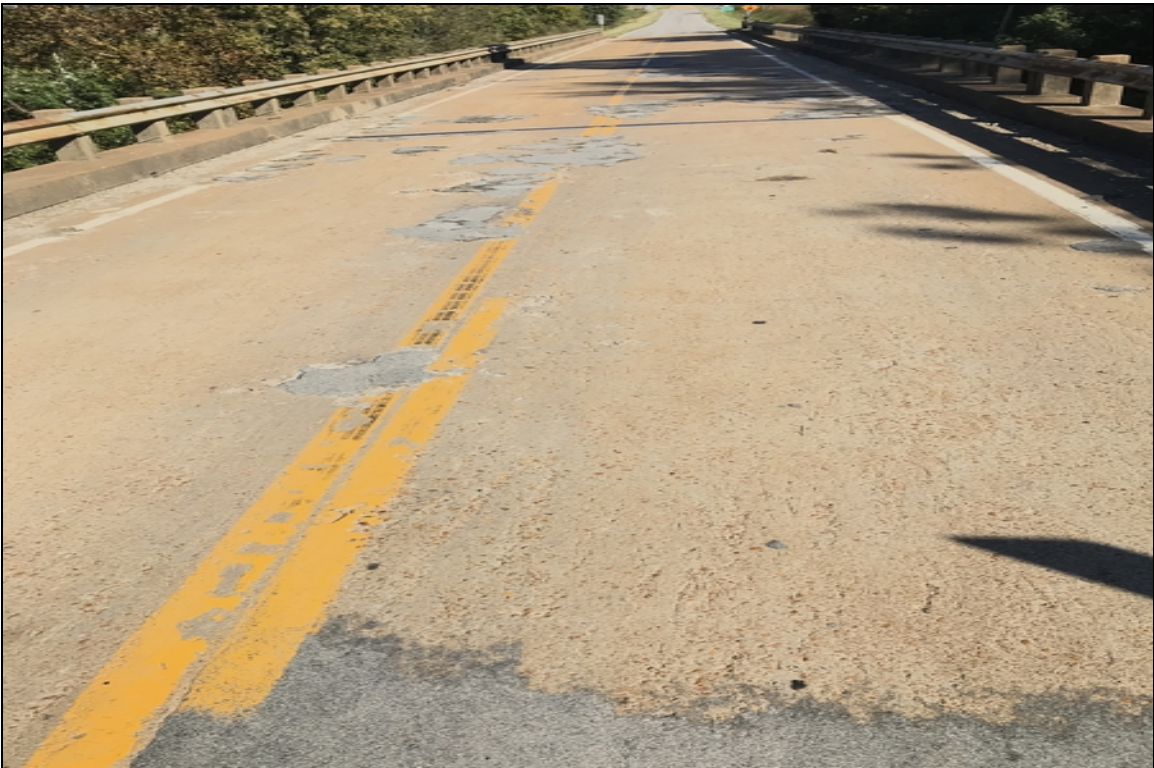
Deck has several unsealed transverse cracks, delaminated areas, and spalls with some exposed rebar. Deck has several cracked and delaminated areas along edge of joint slide plates.

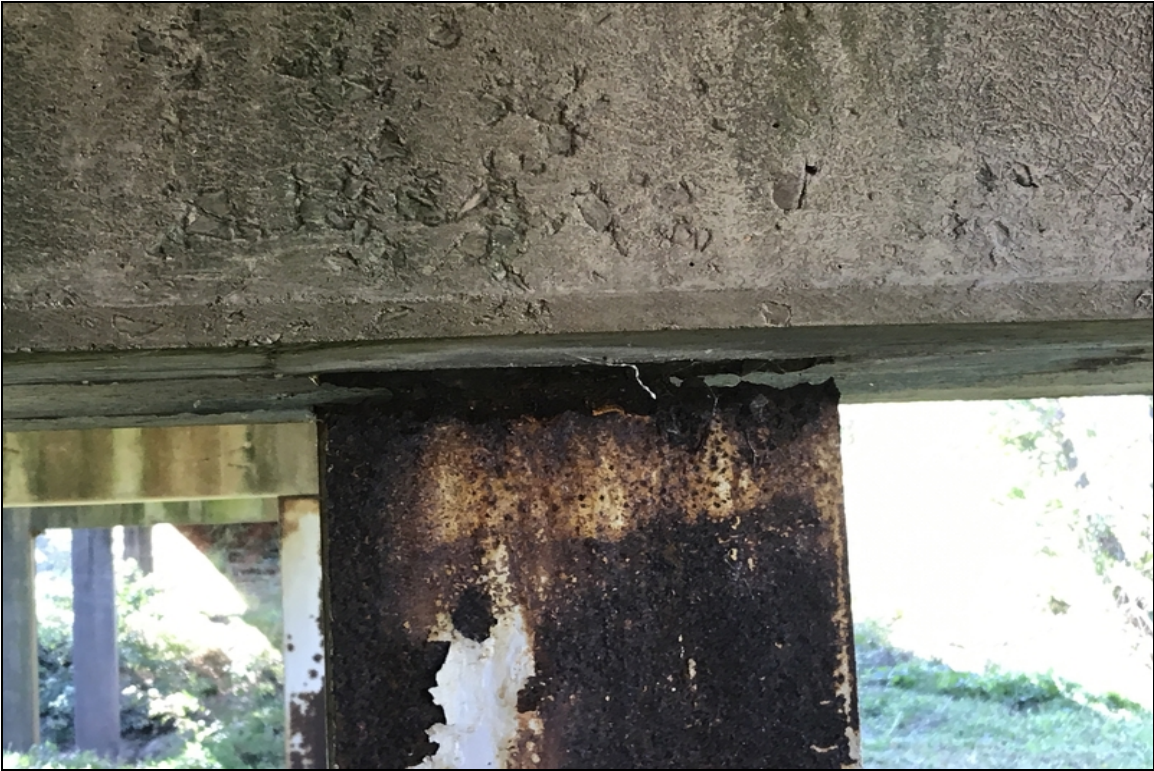
Span 6 bent 6 pile 2 2019

Bent 6 pile 2 has a 3.5  
in. x 1 in. hole in left flange on span 6 side, and a 2 in. diameter hole at  
edge of right flange on span 6 side. See 2019 photo.

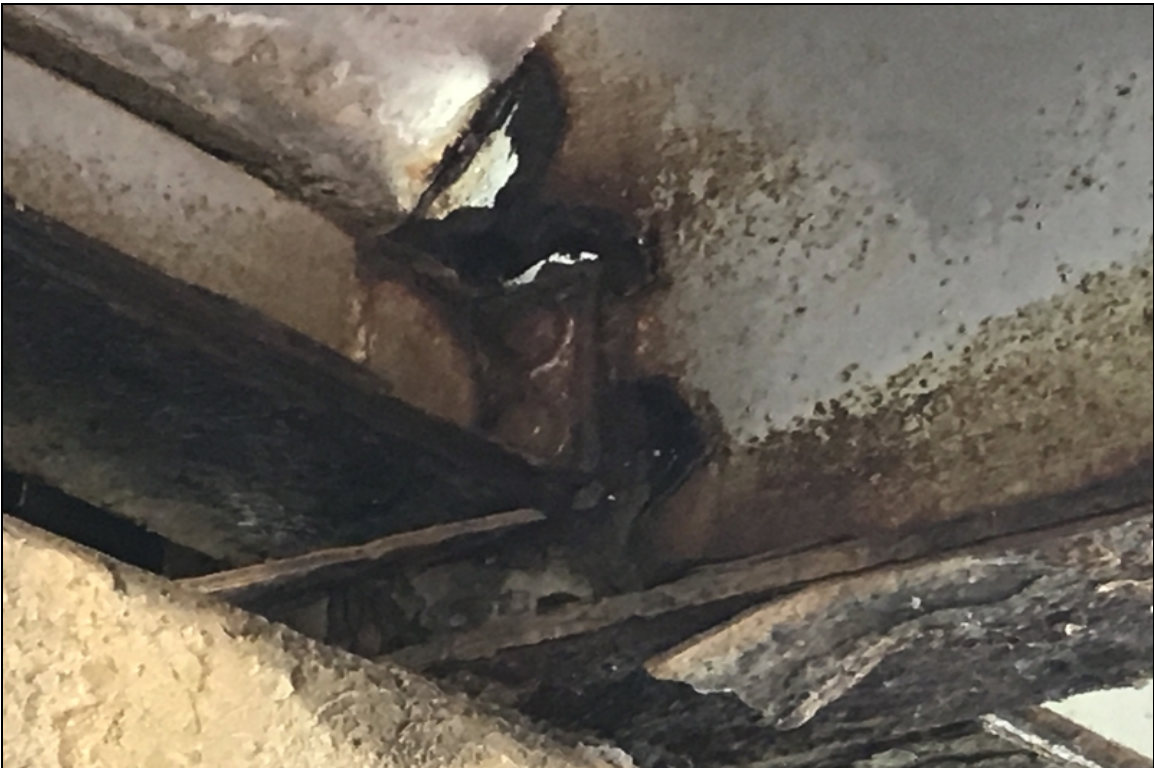
Span 6 bent 6 girder 2 2019

Girders have areas of rust with initial to measurable section loss along bottom flange and bottom of web. Ends of most girders have section loss at concrete haunches, diaphragm connections and some along bottom of web and bottom flange. Span 1 bent 1 girder 2 has some section loss at bottom of web and bottom flange near bearing. Span 1 bent 2 girder 2 has section on bottom flange. Right bottom flange near bearing has heavy section loss. Span 2 bent 2 girder 2 has a 2 in. x 1 in. hole in web below haunch. Span 2 bent 2 girder 4 has a 1 in. diameter hole in web below haunch. Span 2 bent 2 girder 5 bottom flange has 2 ft. of heavy section loss at bearing & utility connection. Span 3 girders have section loss along bottom of web up to 2 in. high throughout span. Span 3 bent 3 girder 2 has a 3 in. x 1 in. hole in web below haunch. Span 3 bent 3 girder 3 has a 3 in. x 1 in. hole in web below haunch. Span 3 girder 5 has section loss to bottom flange approx. 10 ft. ahead of bent 3 at utility connection. Span 4 bent 4 girder 2 has a 5 in. x 2 in. hole in web below haunch & a 1 in. diameter hole in web at diaphragm connection. Span 4 bent 4 girder 3 has a 3.5 in. x 1 in. hole in web below haunch. Span 4 bent 4 girder 4 has a 4 in. x 1 in. hole in web below haunch, and a 1 in. hole in web at diaphragm connection. Span 4 girder 5 at bent 5 has heavy section loss to bottom flange at anchor bolt. Span 5 bent 5 girder 2 has section loss for 8 ft. on bottom flange. Span 5 bent 5 girder 3 has a 4 in. x 2 in. hole in web below haunch. Span 5 bent 5 girder 4 has a 3 1/2 in. x 1 in. hole in web below haunch. Span 6 bent 6 girder 2 has a 4 in. x 1.5 in. hole in web below haunch, and a 3 in. x 1 in. hole at diaphragm connection. See 2019 photo. Span 6 bent 6 girder 3 has a 2 in. x 1 in. hole in web below haunch. Span 6 bent 6 bearing 4 is floating (up to 1/8 in. gap.) Span 6 bent 7 girder 3 has 2 ft. of section loss along bottom of web and bottom flange. Bottom flange has heavy section loss on left side. Bearings have pack rust and section loss. Anchor bolts and nuts have rust with section loss, some have complete section loss. Span 2 bent 2 bearing 5 is missing 1 anchor bolt nut. Span 2 bent 3 bearings 1 - 4 are missing 2 anchor bolt nuts. Span 3 bent 4 bearings 2 - 4 are missing 2 anchor bolt nuts. Span 3 bent 4 bearing 5 is missing 1 anchor bolt. Span 6 bent 6 bearing 1

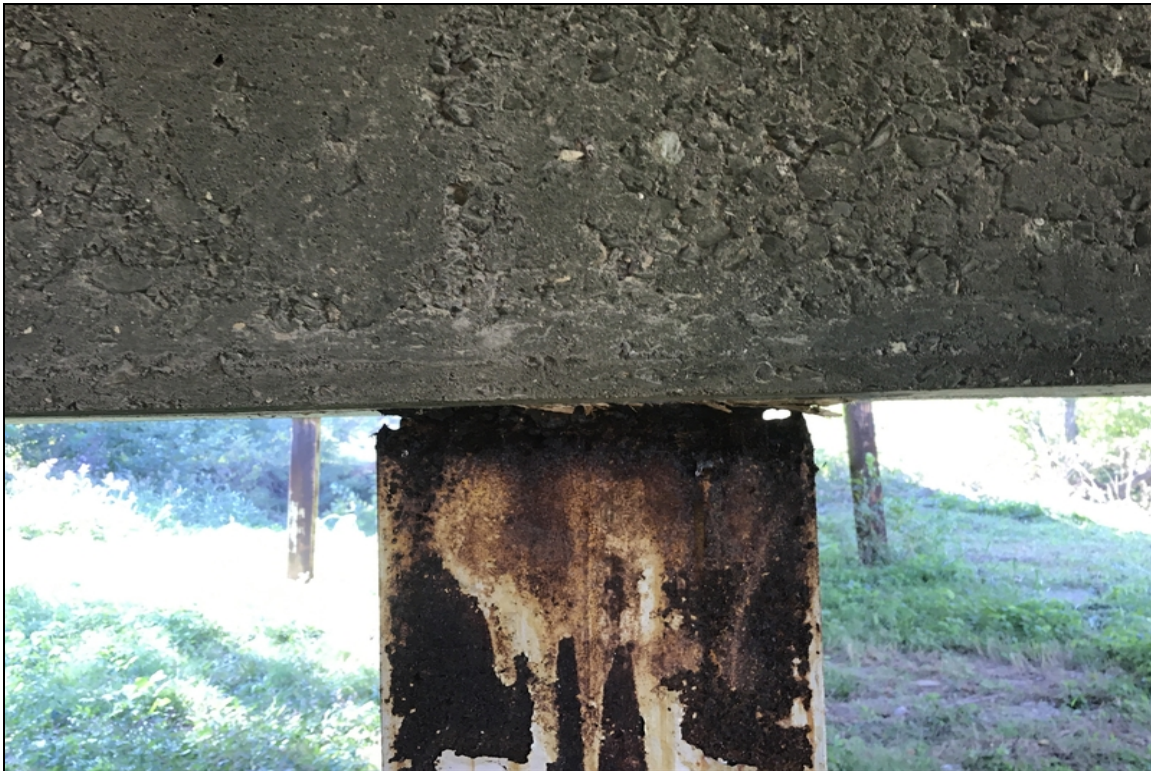
Span 6 bent 6 pile 3 2019

Bent 6 pile 3 has a 1  
in. diameter hole at each edge of flange on span 6 side. See 2019 photo.

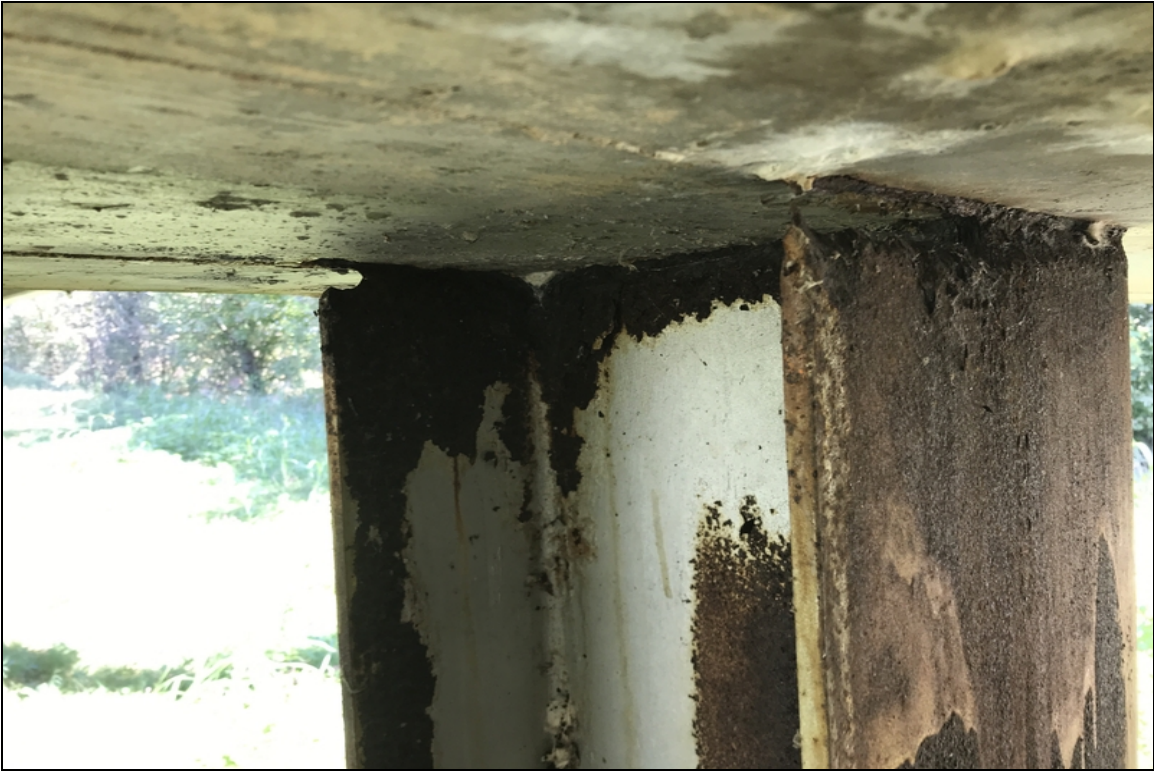
Bent 5 pile 3 2019

Bent 5 pile 3 has a 5.5  
in. x 1 in. hole rusted through flange on span 4 side, 1 in. on span 5 side. See 2019 photo.

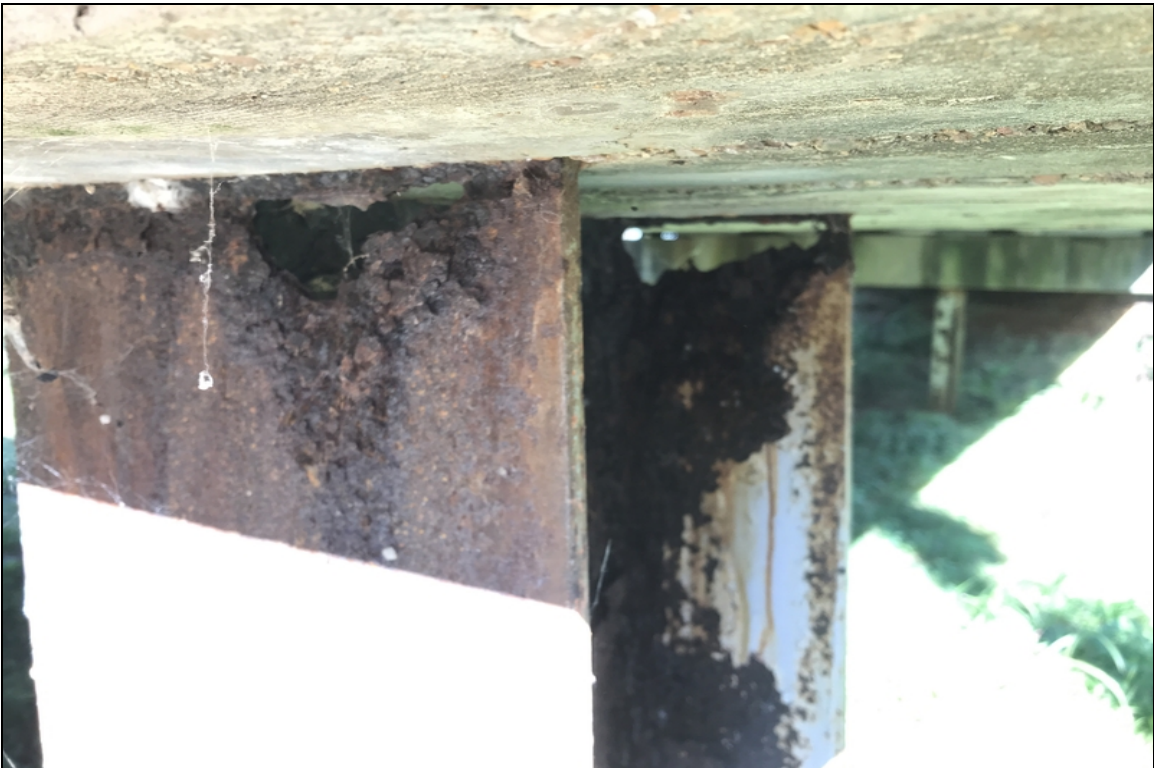
Bent 5 pile 4 2019

Bent 5 pile 4 has a 3  
in. x 1.5 in. hole in flange on span 4 side, and a 5 in. x 2 in. hole in flange  
on span 5 side. See  
2019 photo.
