Bridge Inspection Report

02729

SH 137-01S-LM 1.20

DITCH 38

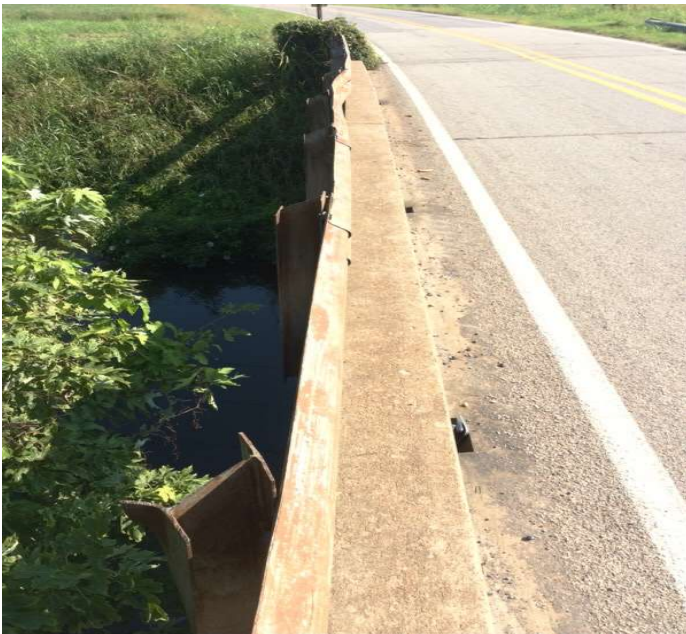
PHOTO 1 Description

Metal Bridge Rails have 100% paint deterioration and rusted with some pitting.
Left side of Span 2 has 13LF collision damage of Bridge Rail and left side of bridge has 3 metal Post twisted or bent, see 2016 photo.

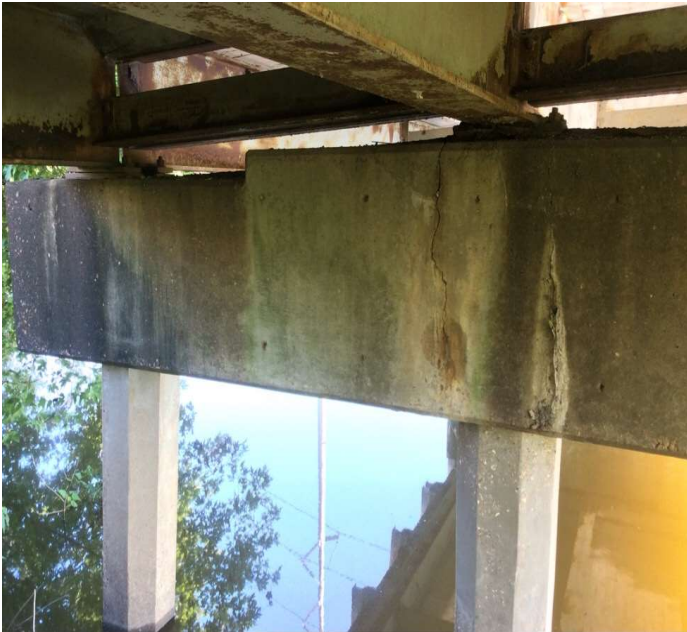
PHOTO 1 Description

Cap Bent 2 has 2 sealable cracks over Pile 2 with efflorescence. Left end of cap has some cracking with light efflorescence.

Left end of Cap Bent 3 has some map cracking with some light efflorescence.

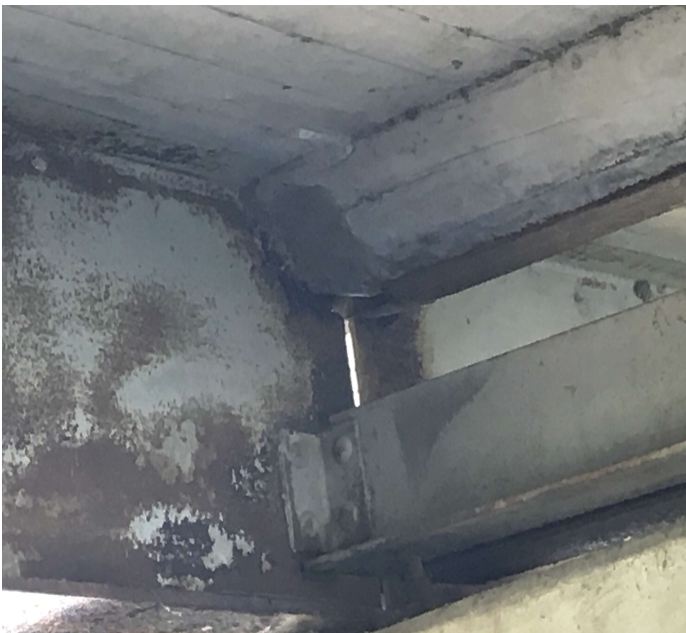
Span 3 girder 3 at bent 3 has a 1 in. x 2 in. hole in web at haunch.

PHOTO 1 Description Span 3 girder 3 over bent 3
