Asset #A3162(Routine)

I 55-12SB-LM 63.29 over US 61-SEC 3

Location: JCT 61& I 55

Team Lead: Jacob Turner, Inspection Date: 06/15/2021

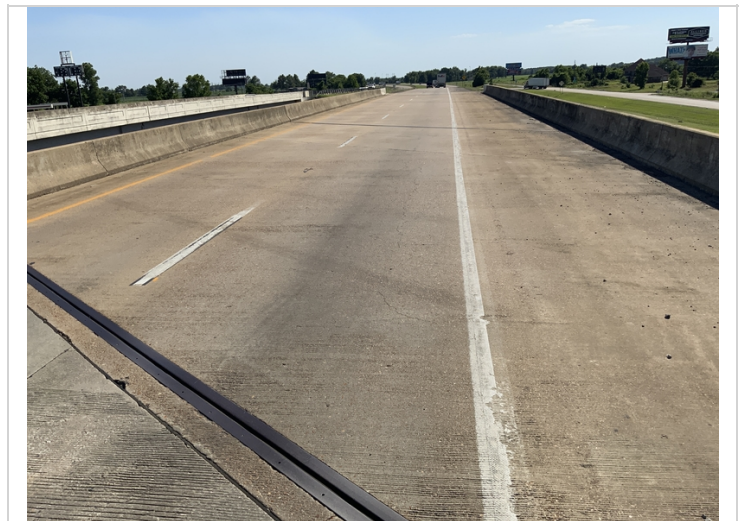
Typical driving surface

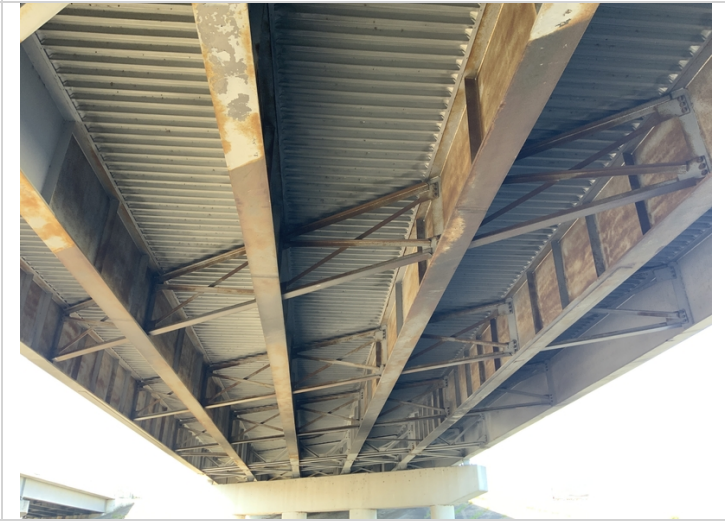
Typical under surface

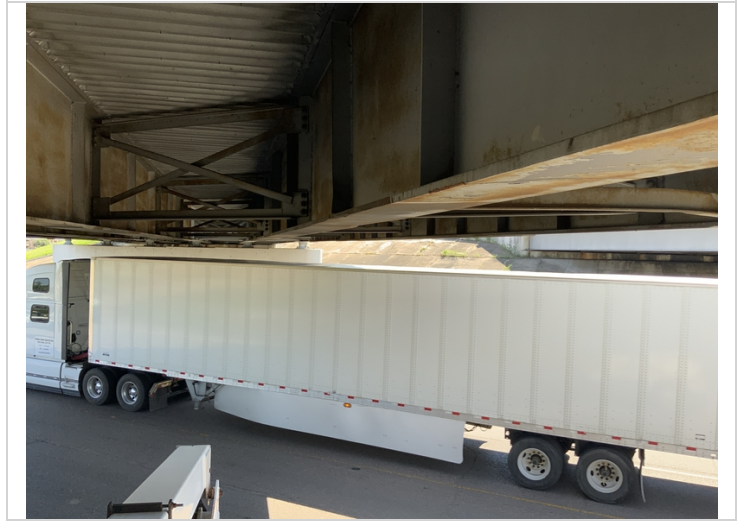
Span 2 (Girder 5) has out of plane bending between diaphragms 3 and 4 adjacent to bent 2.

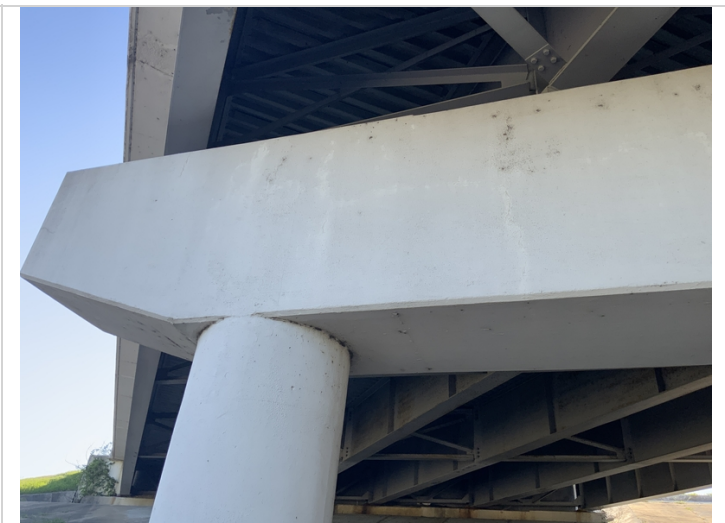
(234) 06/22/2021 - JRT & VCL							
- Both caps at bents 2 and 3 have vertical and horizontal cracking with efflorescence

Typical cracking with efflorescence along bent 3 cap

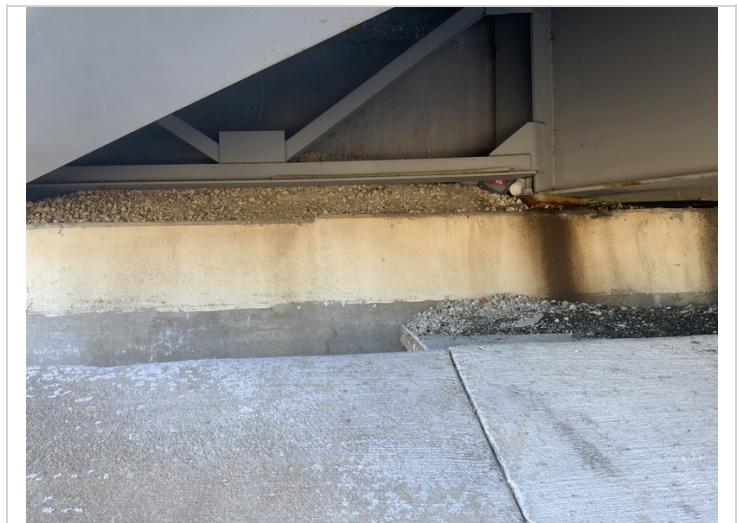
Bent 1 (West Abutment) and Bent 4 (East Abutment) has an accumulation of roadway debris from the failed joints.

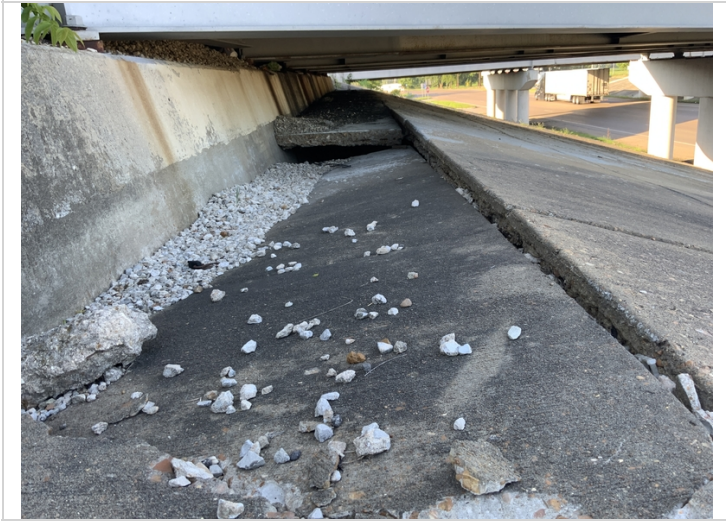
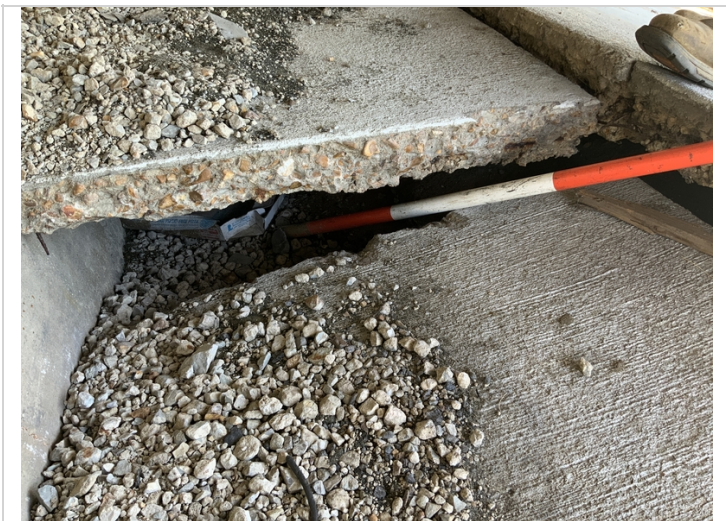
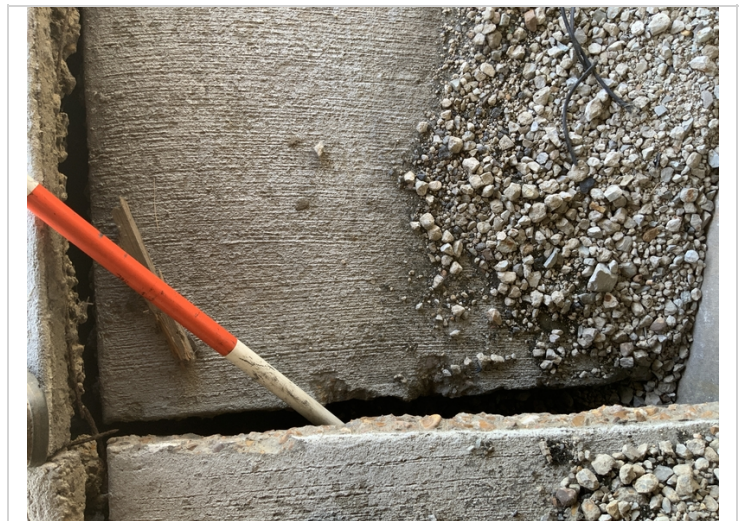
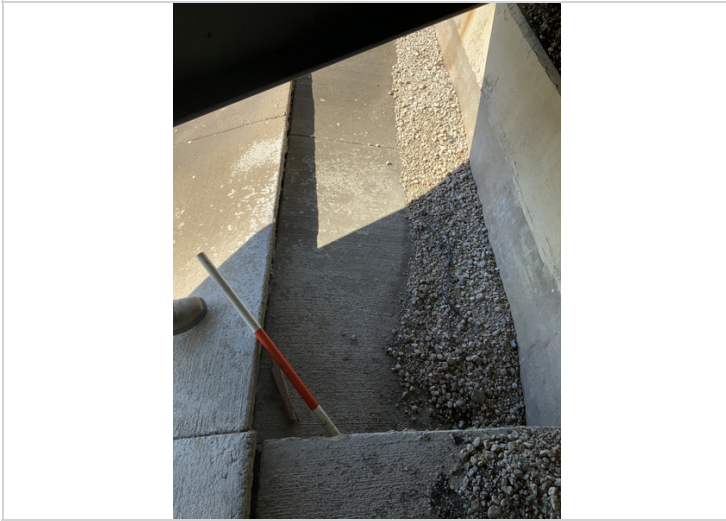
- Bent 4 (East Abutment) has spalling along the top of the head wall in the outside lane							
- Bent 4 (East Abutment) has erosion and undermining along the bridge seat on the North end of the abutment.

Bent 4 (East Abutment) has erosion and undermining along the bridge seat on the North end of the abutment.

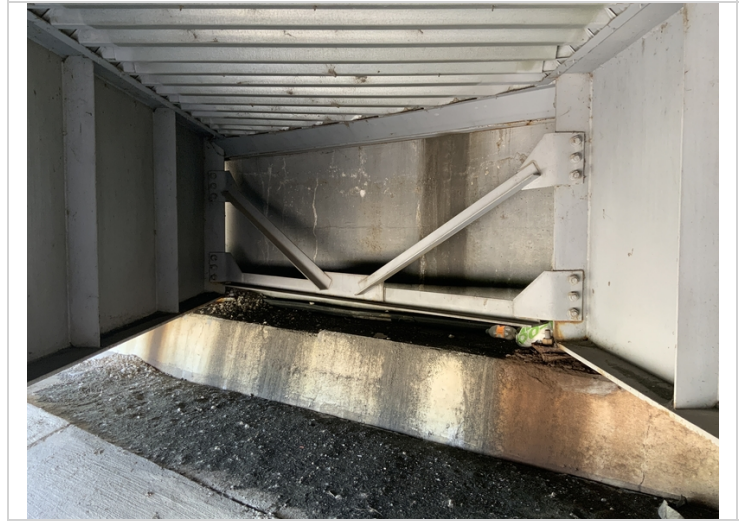
Typical cracking with efflorescence along the back walls of both abutments.

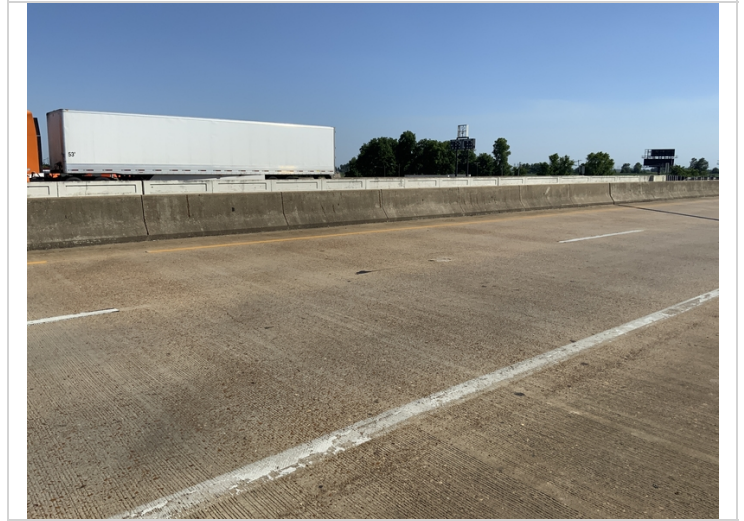
-	The bridge railing on the North side of the structure has spalling with exposed reinforcing steel

Typical spalling with exposed reinforcing steel along the concrete bridge railing

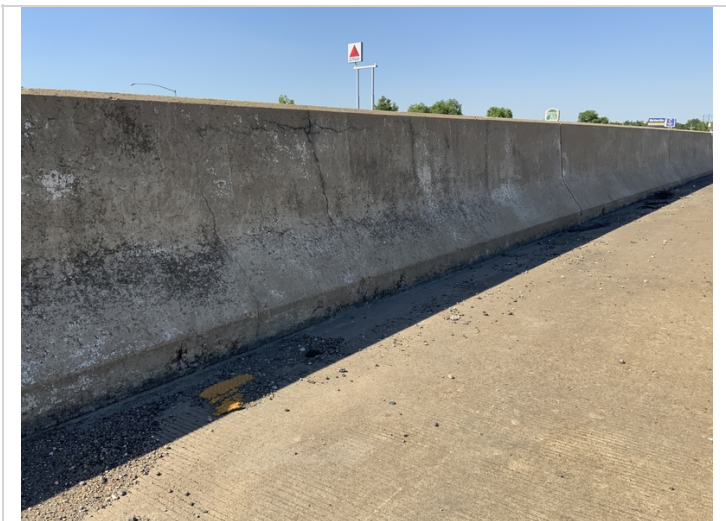
(331)	06/22/2021 - JRT and VCL						
-	The bridge railings on both sides of the bridge has vertical and map cracking at various locations throughout the driving surface

Typical cracking along the concrete bridge railing

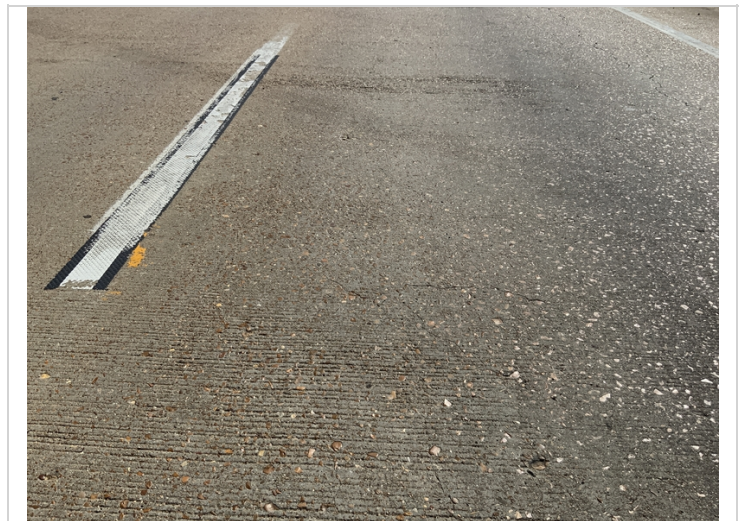
Typical abrasion throughout the driving surface

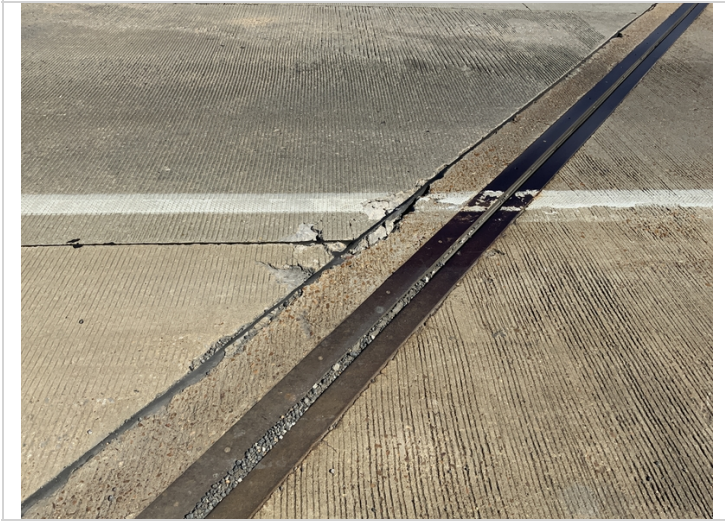
(321)	06/22/2021 - JRT and VCL						
-	East approach slab has spalling along the outside lane adjacent to the top head wall of bent 4 abutment.						
331	Reinforced Concrete Bridge Railing	LF	452	268	158	26	0
1090	Exposed Rebar	LF	26	0	0	26	0
1130	Cracking (RC and Other)	LF	158	0	158	0	0

East approach slab has spalling along the outside lane adjacent to the top head wall of bent 4 abutment.

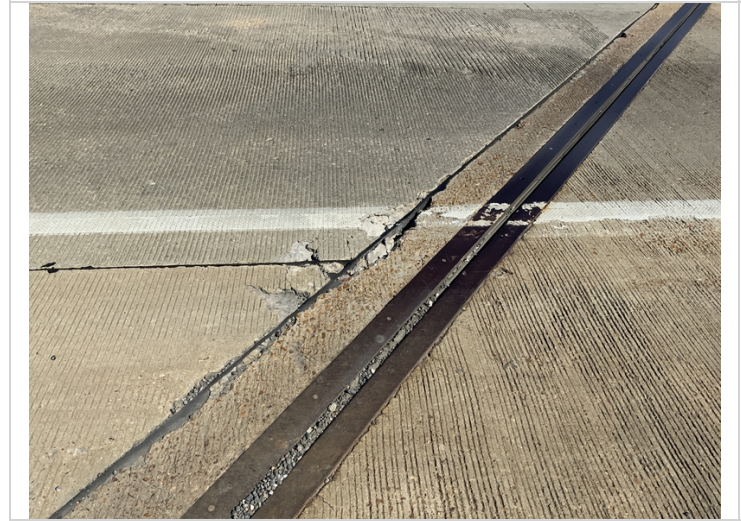
Bent 4 (East Abutment) has spalling along the top of the head wall in the outside lane

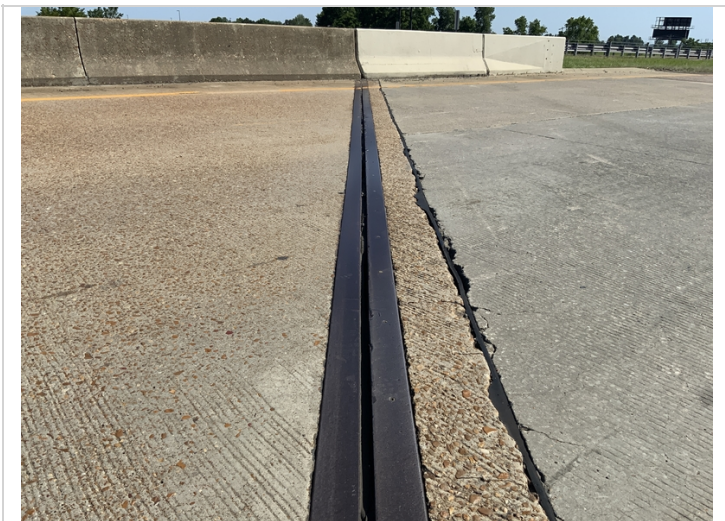
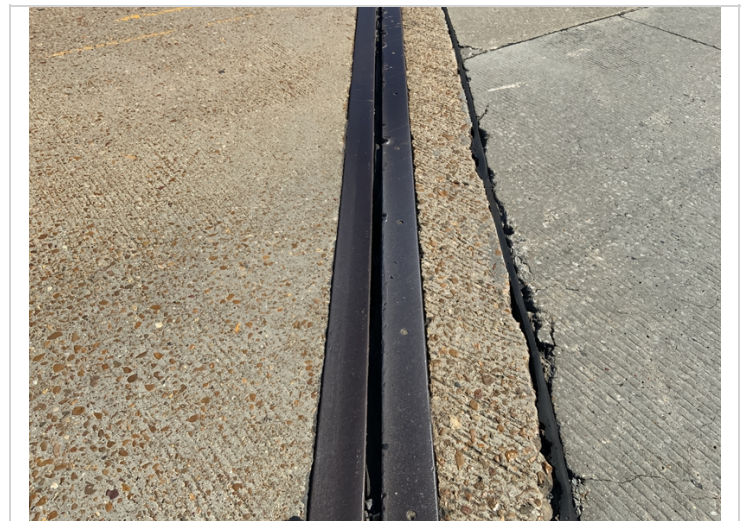
(301) 07/06/2021 - JRT & VCL							
- Bent 1 (West Abutment) has adhesion failure, cracking, and joint failure causing water and road debris to accumulate on top of the bridge seat.							
311	Movable Bearing	EA	12	12	0	0	0
313	Fixed Bearing	EA	12	0	2	10	0
1000	Corrosion	EA	6	0	0	6	0
1020	Connection	EA	2	0	2	0	0
2210	Movement	EA	3	0	0	3	0
2220	Alignment	EA	1	0	0	1	0

Bent 1 (West Abutment) has adhesion failure, cracking, and joint failure causing water and road debris to accumulate on top of the bridge seat.

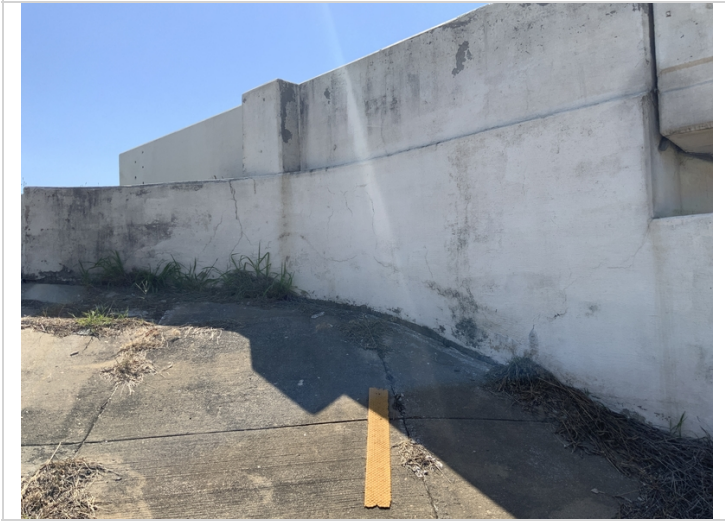
Typical cracking along the wing-walls of both abutments

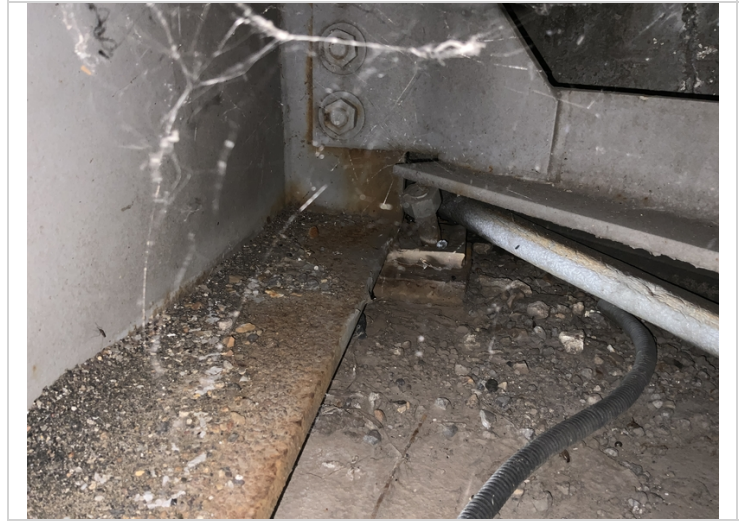
-	Bent 1 (West Abutment) - (Girder 4 / Bearing 4) has active corrosion with flaking rust along with one sheared anchor bolt.						
-	Bent 4 (East Abutment) - (Bearing 4) has active corrosion with measurable section loss. The bearing at this locations is floating (See files for video of floating bearing).

Bent 1 (West Abutment) - (Girder 4 / Bearing 4) has active corrosion with flaking rust along with one sheared anchor bolt.

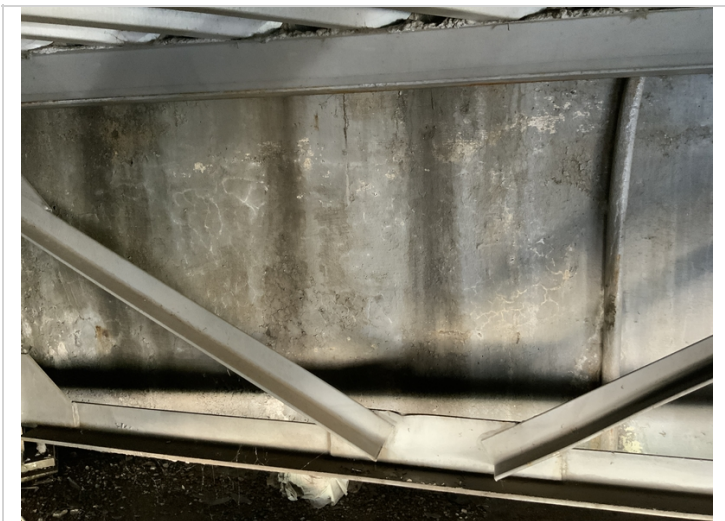
(215) 006/22/2021 - JRT & VCL							
- Bent 1 (West Abutment) has map cracking with efflorescence along the backwall between girders 1 and 2 (Bay 1)

Bent 1 (West Abutment) has map cracking with efflorescence along the backwall between girders 1 and 2 (Bay 1)

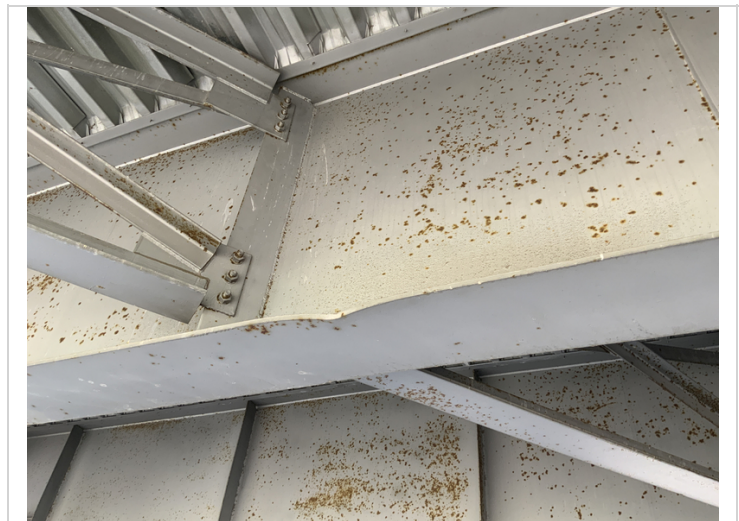
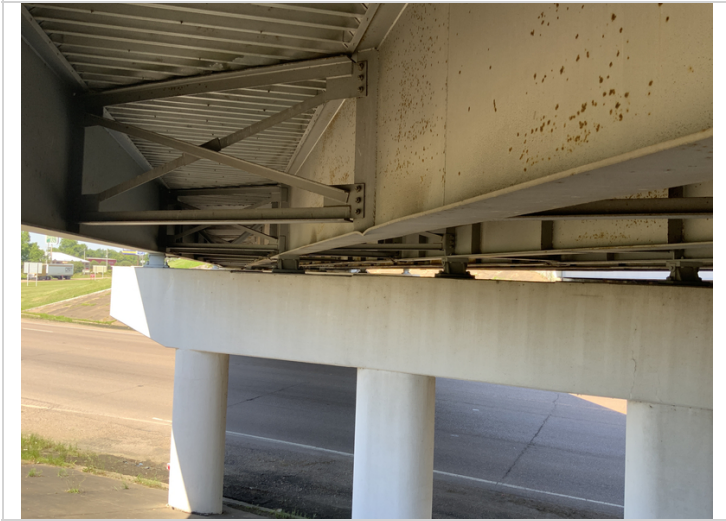
Span 2 (Girders 1 thru 6) distortion along the bottom flanges in the Northbound lane from what appears to be from vehicular impactation.

Span 2 (Girders 1 thru 6) distortion along the bottom flanges in the Northbound lane from what appears to be from vehicular impact.

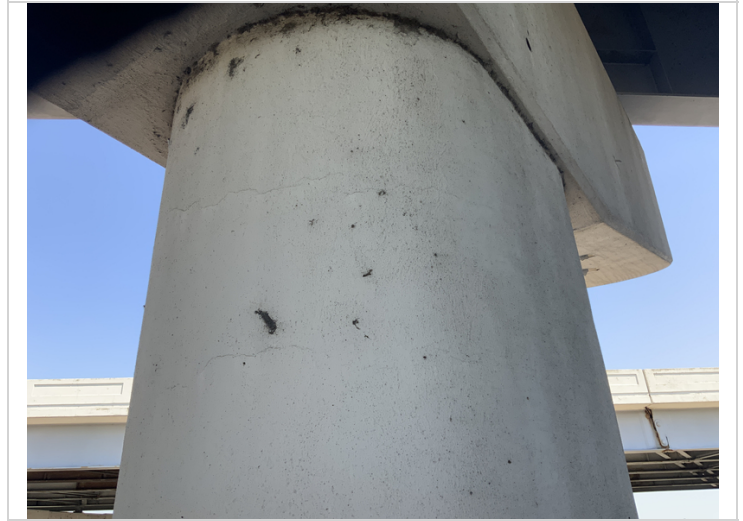
(205) 06/22/2021 - JRT & AMJ							
- Columns 3 and 4 (Bent 2) has cracking going around both columns.							
215	Reinforced Concrete Abutment	LF	106	76	30	0	0
1120	Efflorescence/Rust Staining	LF	15	0	15	0	0
1130	Cracking (RC and Other)	LF	15	0	15	0	0

Bent 2 (Columns 3 & 4) has cracking going around the columns

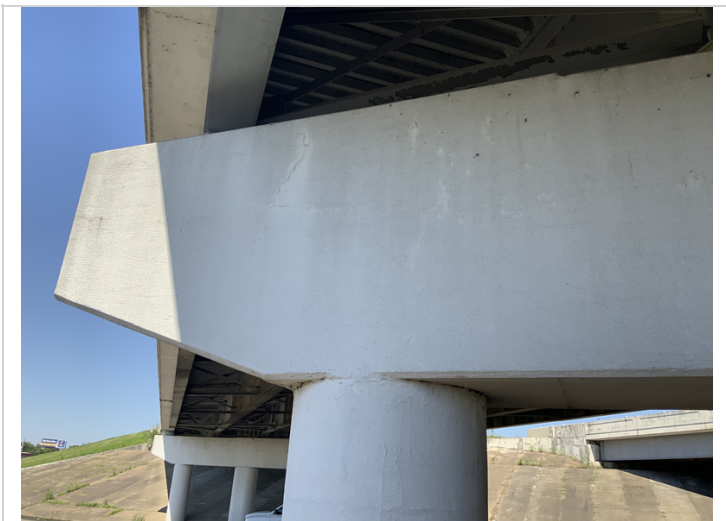
Bent 2 concrete cap has 3 moderate width cracks in cap near column 3.

Typical vertical and horizontal cracking with light efflorescence along the cap at bent 2

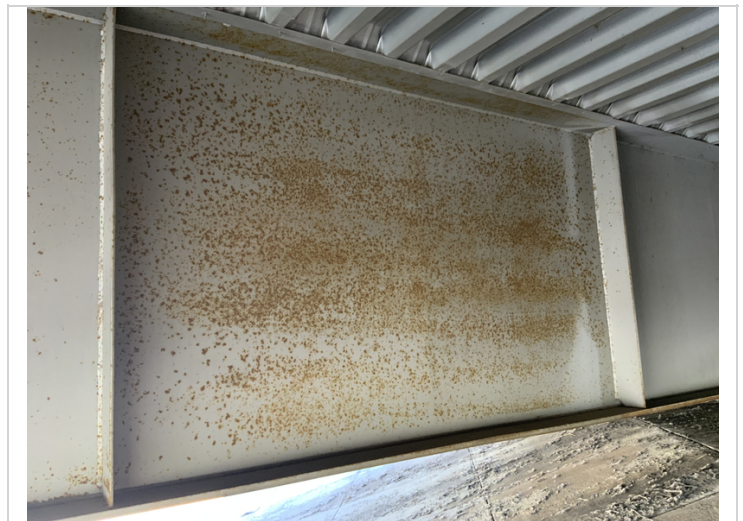
Typical minor pitting in various locations throughout structure.

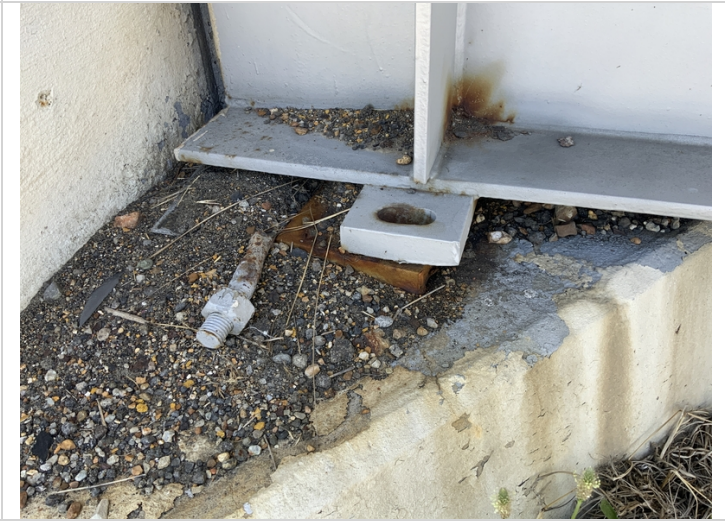
Bt1 sp1 g6

Span 1 Girder 6 Bent 1 has 1 anchor bolt rusted or sheared off and 1 nut missing from the other bolt, bearing has shifted.

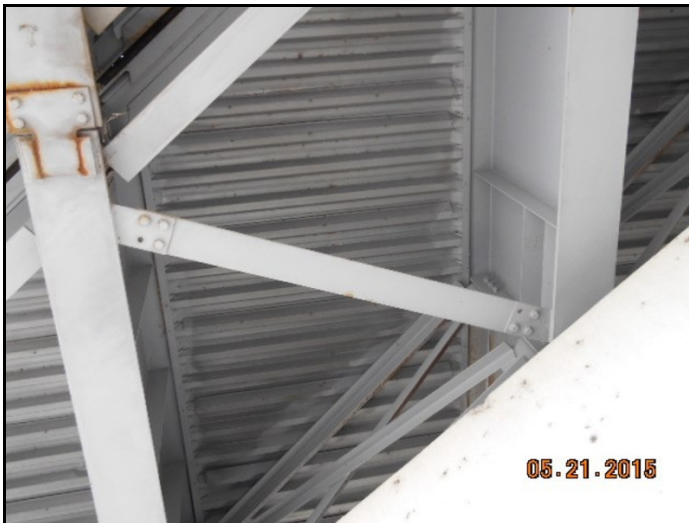
A3162 05-21-2015 Span 2 Bay 2 near Bent 3

Span 2 Bay 2 near Bent 3 has 2 bolts missing from bottom lateral bracing.

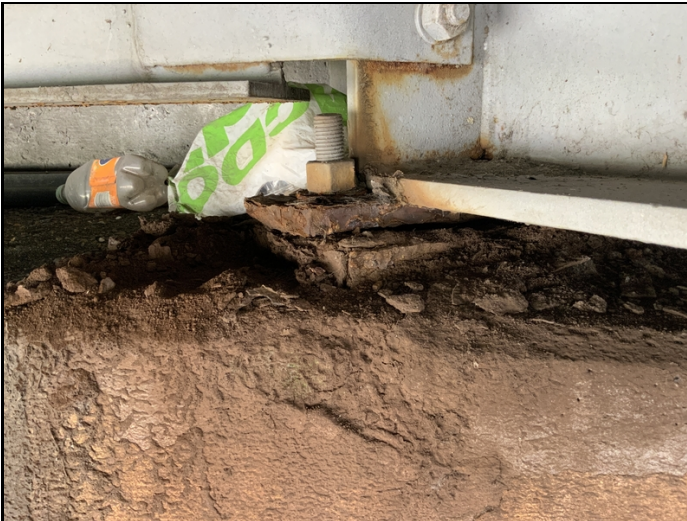
- Bent 4 (East Abutment) - (Bearing 4) has active corrosion with measurable section loss. The bearing at this locations is floating (See files for video of floating bearing).

Bent 4 (East Abutment) - (Bearing 4) has active corrosion with measurable section loss. The bearing at this locations is floating (See files for video of floating bearing).

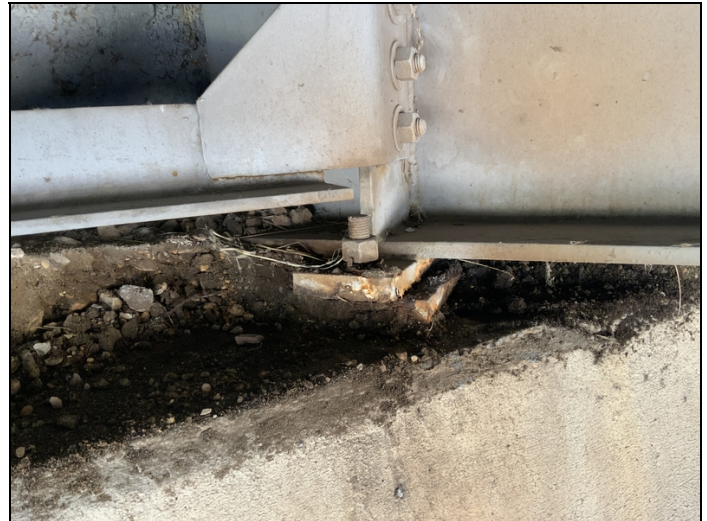
- Bent 1 (West Abutment) - (Girder 5 / Bearing 5) has active corrosion with measurable section loss. The bearing at this locations is floating (See files for video of floating bearing).

Bent 1 (West Abutment) - (Girder 5 / Bearing 5) has active corrosion with measurable section loss. The bearing at this locations is floating (See files for video of floating bearing).

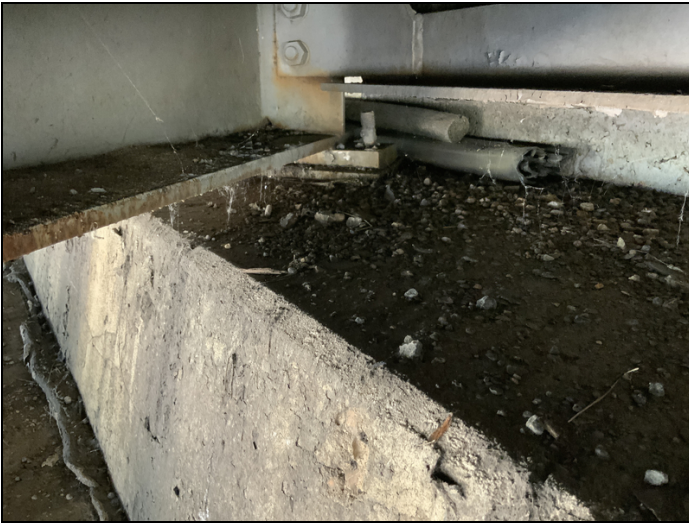
Span 1 girder 3

Span 1 Girder 3 Bent 1 has 1 anchor bolt missing.

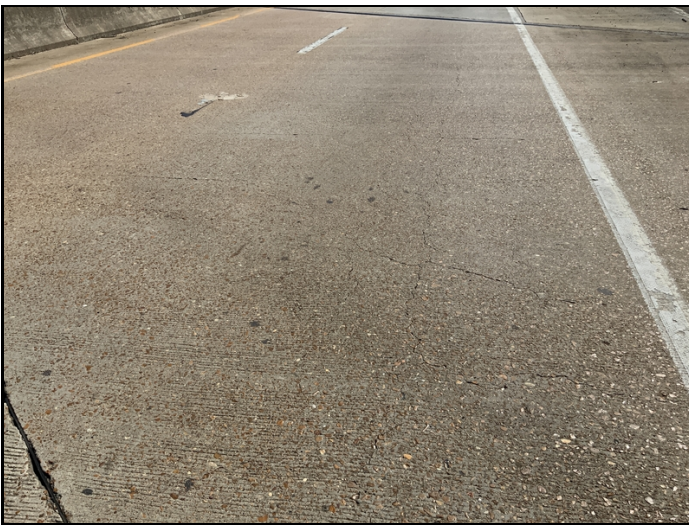
- The driving surface has open transverse cracking at various spacing throughout the structure
- There are areas of map cracking along the driving surface throughout the structure

Typical map cracking along the outside lane throughout the length of the driving surface

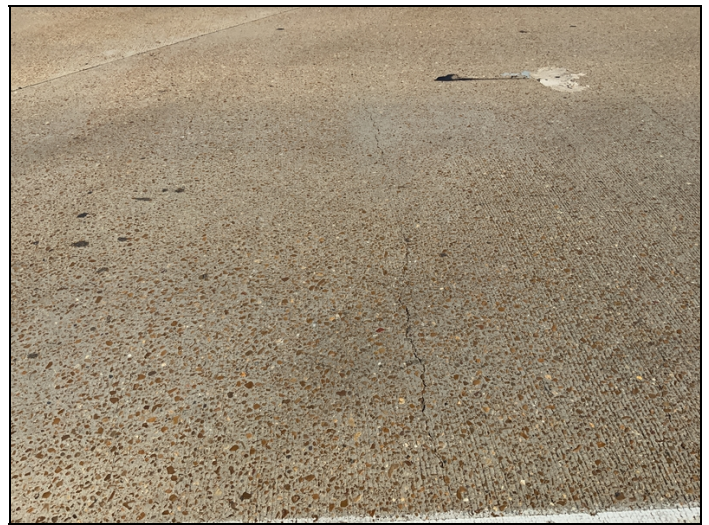
Typical transverse cracking at various spacing throughout the driving surface

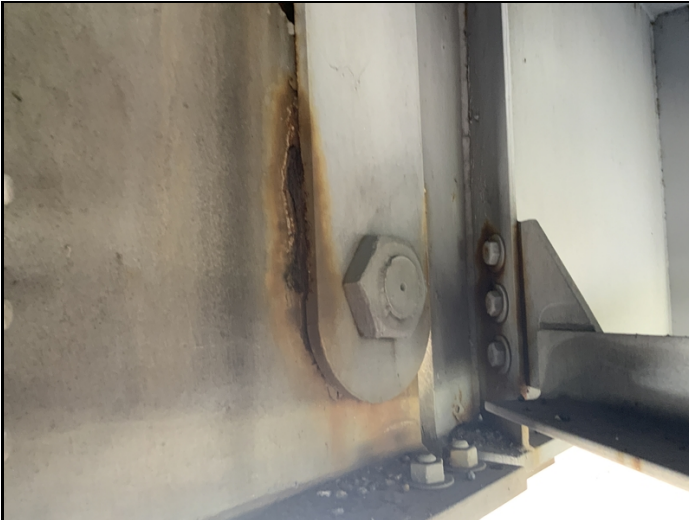
- Each of the pin and hanger assemblies have active corrosion with pack rust plus section loss between the hanger bar and the steel girder

Typical active corrosion with flaking rust and pack rust along the pin and hanger connections

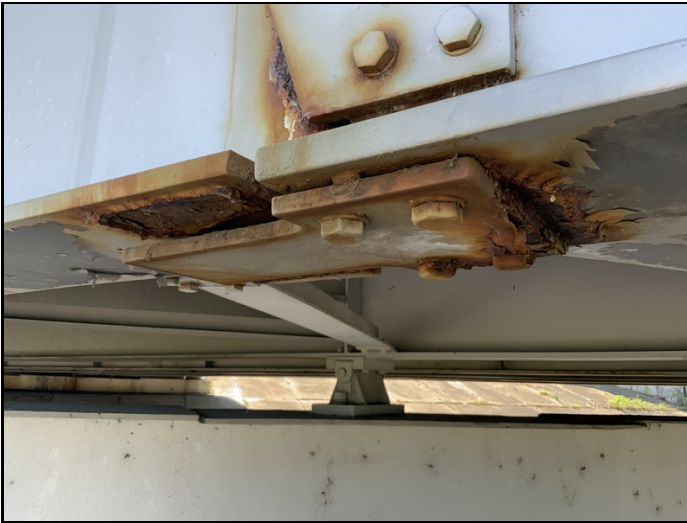
(161) 06/22/2021 - JRT & VCL							
- Span 2 (Girder 1) has active corrosion with flaking rust and section loss along the wind-lock connection adjacent to bent 3.

Span 2 (Girder 1) has active corrosion with flaking rust and section loss along the wind-lock connection adjacent to bent 3.

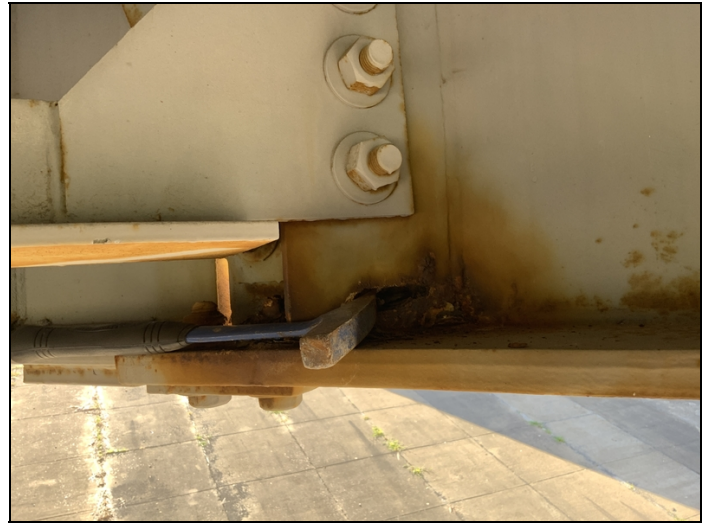
- The beam ends along each bent has corrosion with flaking rust and pitting.
- Span 2 (Girder 6) has active corrosion with 100% section loss along the diaphragm connection adjacent to bent 3.

Span 2 (Girder 6) has active corrosion with 100% section loss along the diaphragm connection adjacent to bent 3.

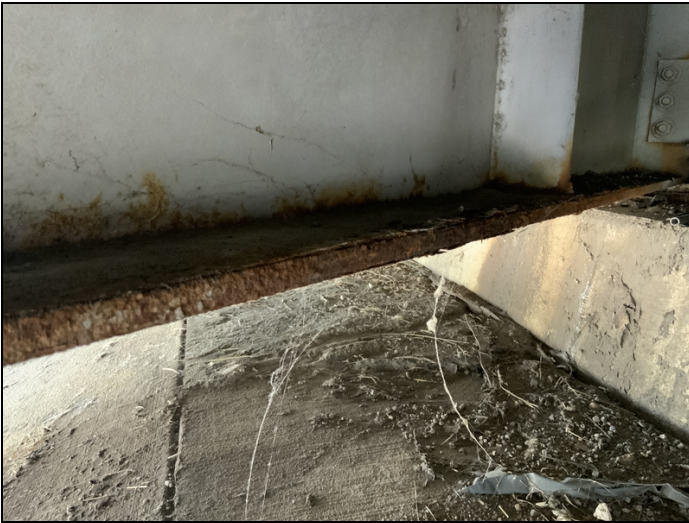
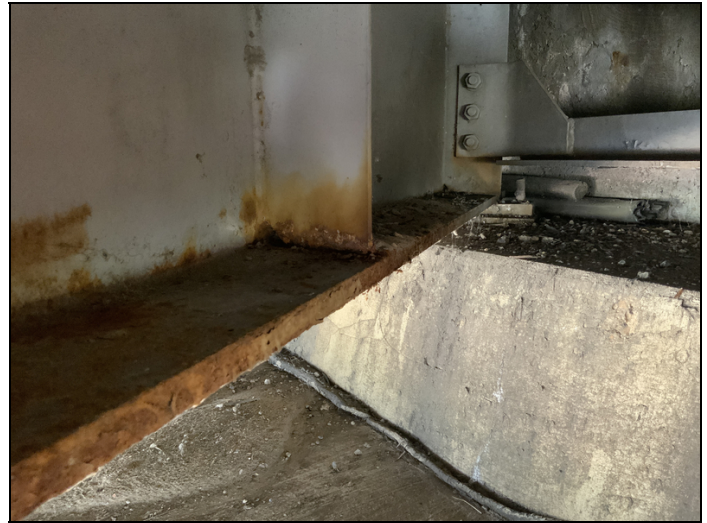
(107) 06/21/2021 - JRT & VLC							
- Bent 1 (West Abutment) - (Span 1 / Girder 4) has active corrosion with flaking rust along the bottom flange of the beam end.

Bent 1 (West Abutment) - (Span 1 / Girder 4) has active corrosion with flaking rust along the bottom flange of the beam end.

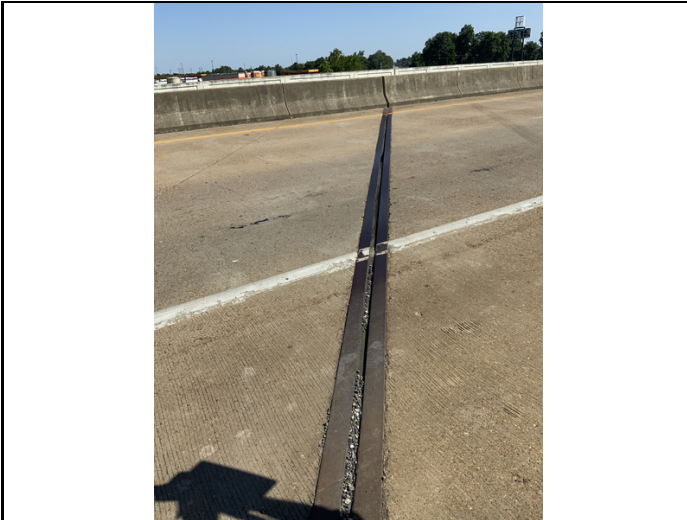
- The pourable joints have lost its adhesion and is failing causing water and road debris to accumulate on top of the girder ends and bridge seats and bent caps.

Bent 3 pourable joint has sections of adhesion failure, 100% joint failure (Inside lane approximately 2'), and debris impaction (along the gutter lines).

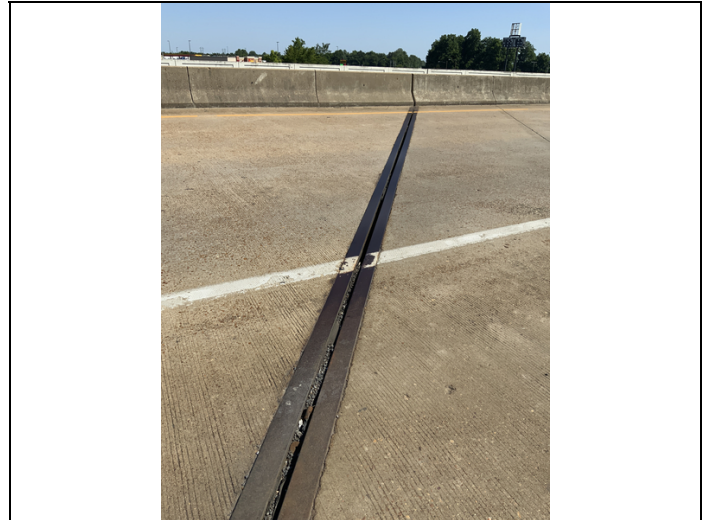
Bent 2 pourable joint has 100% along both of the travel lanes

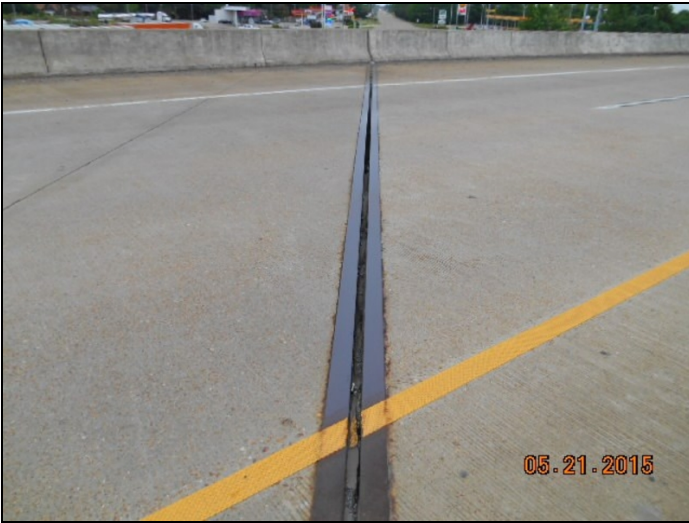
A3162 05-21-2015 Bent 2 Joint seal

Some of seal has debris impact (24 ft.). Bent 2 Joint has 35ft. and bent 3 has 4ft that has come loose and has fell down.

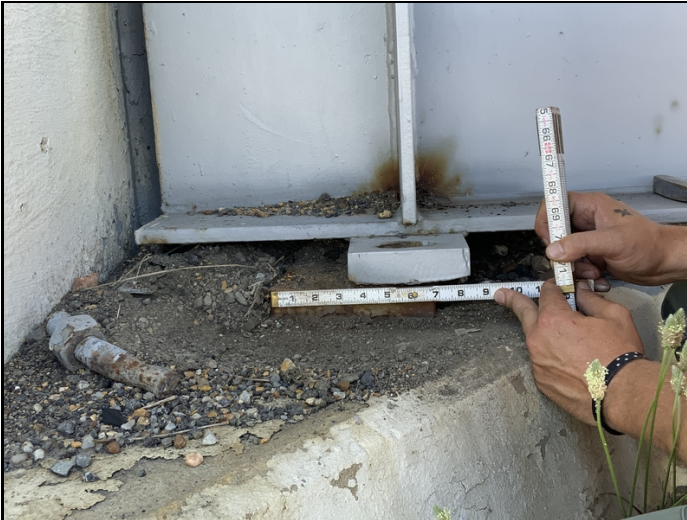
Bent 1 (West Abutment) - (Girder 6 / Bearing 6) has a anchor bolt that has been sheared off with misalignment of approximately 3.25"

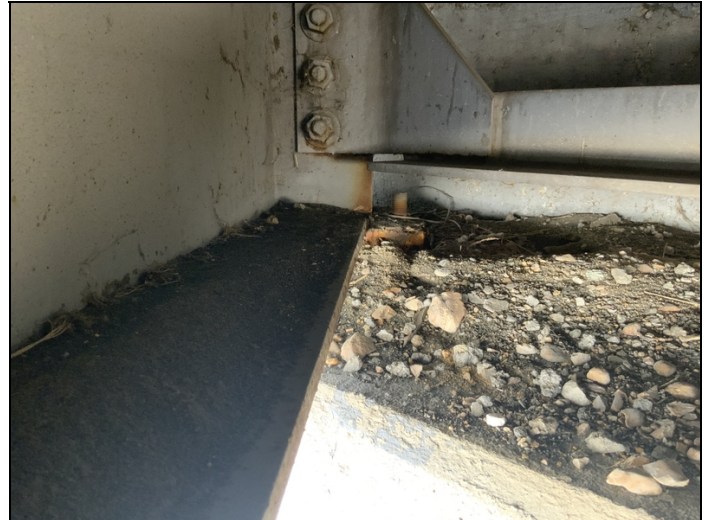
-	Bent 1 (West Abutment) - (Girder 1 / Bearing 1) has active corrosion with flaking rust and section loss						
-	Bent 1 (West Abutment) - (Girder 6 / Bearing 6) has active corrosion with flaking rust along with one anchor bolt that is sheared off on the North side and one missing nut on the South side. (Bearing 6 also has misalignment of approximately 3.25")

Bent 1 (West Abutment) - (Girder 6 / Bearing 6) has active corrosion with flaking rust along with one anchor bolt that is sheared of on the North side and one missing nut on the South side. (Bearing 6 also has misalignment of approximately 3.25")

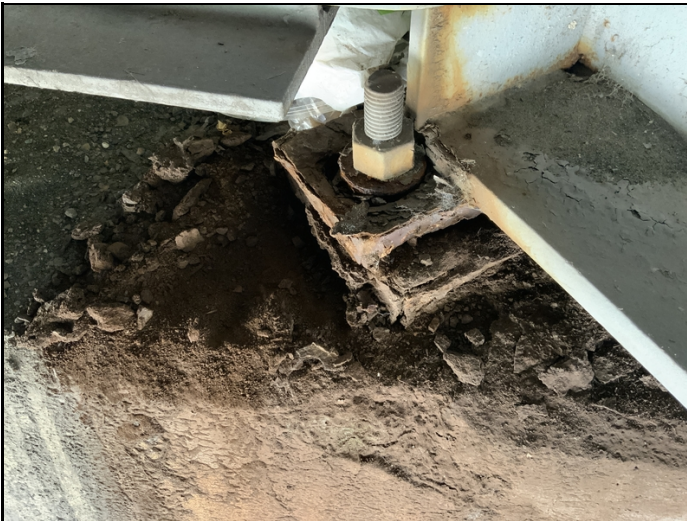
- The bearings along bent 1 and bent 4 each have heavy corrosion with an accumulation of flaking rust and pack rust

Bent 4 (East Abutment) - (Bearing 4) has active corrosion with measurable section loss.

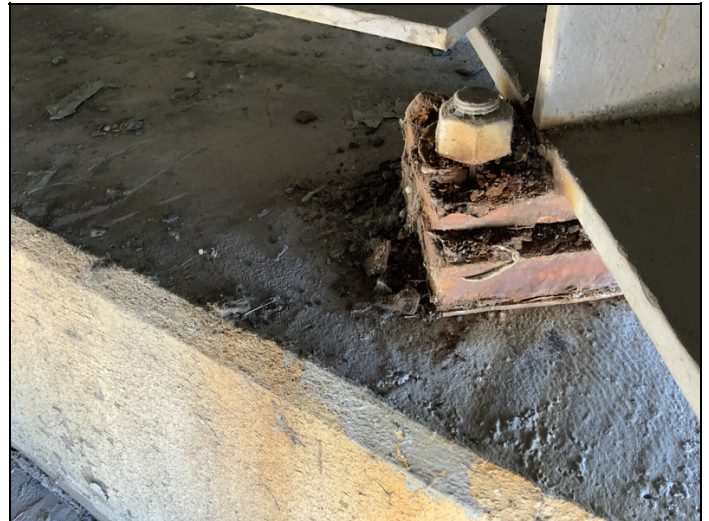
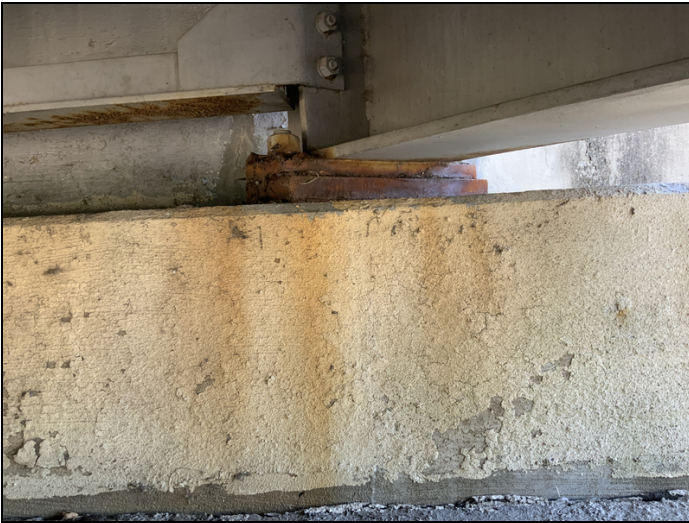
Bent 1 (West Abutment) - (Girder 1 / Bearing 1) has active corrosion with flaking rust and section loss
