Asset #B3162(Routine)

I 55-12NB-LM 63.28 over US 61-SEC 3

Location: JCT US 61 & I 55

Team Lead: Jacob Turner, Inspection Date: 06/15/2021

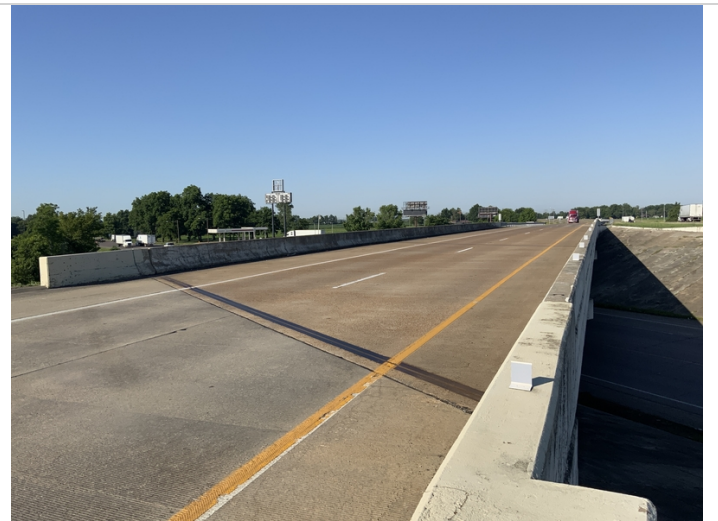
Typical deck

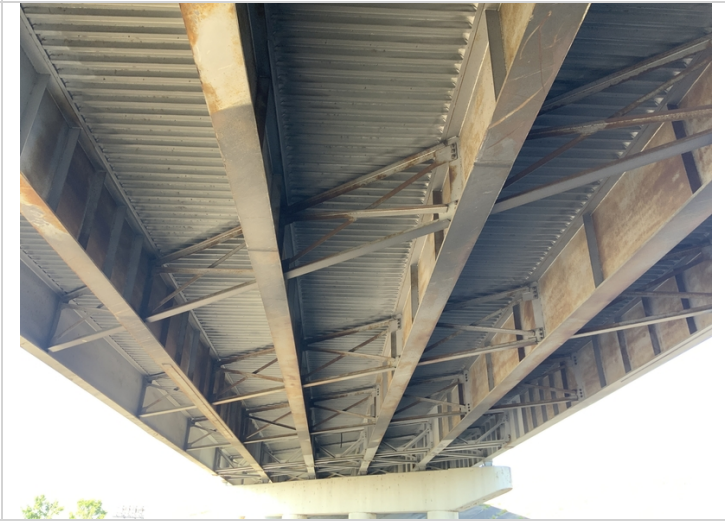
Typical under surface

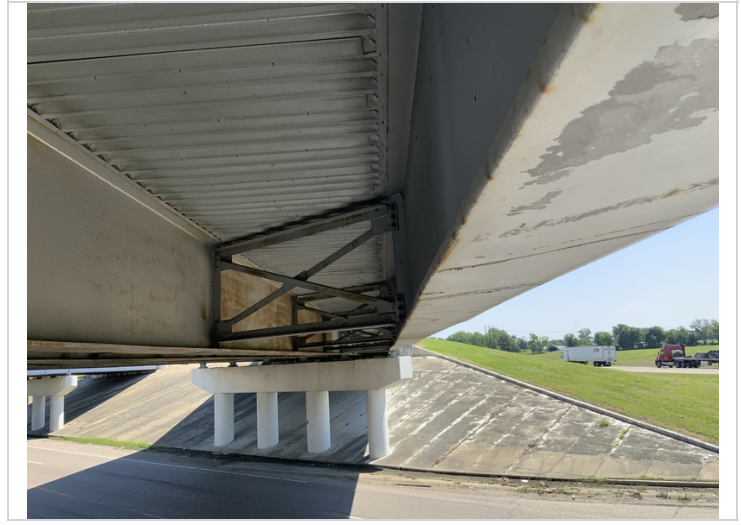
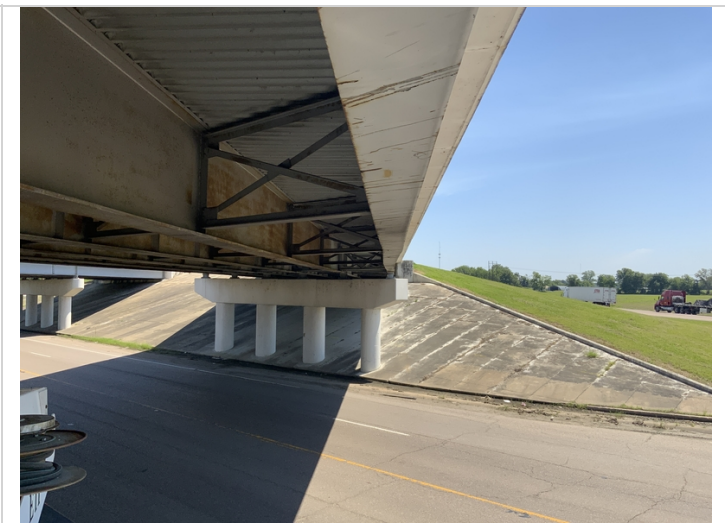
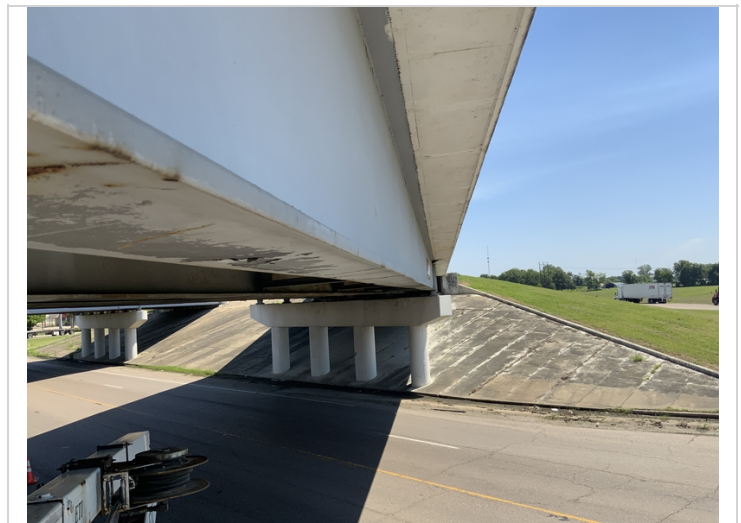
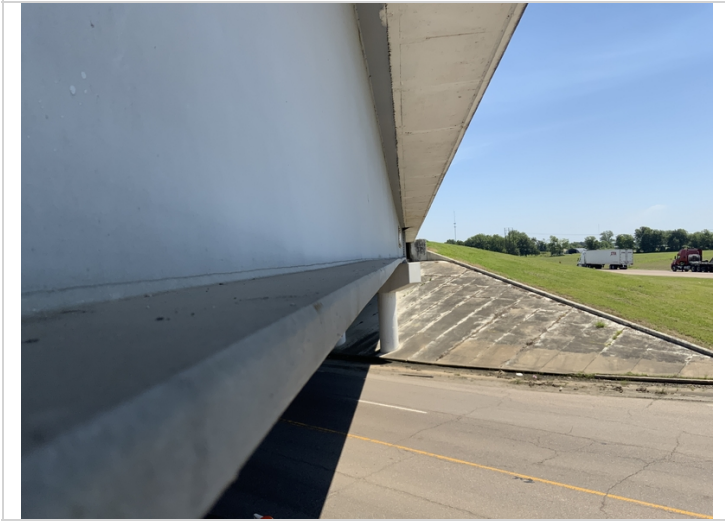
Girder 6 in span 2 has out of plane bending along the bottom flange likely from vehicular collision as evidenced by impact marks.

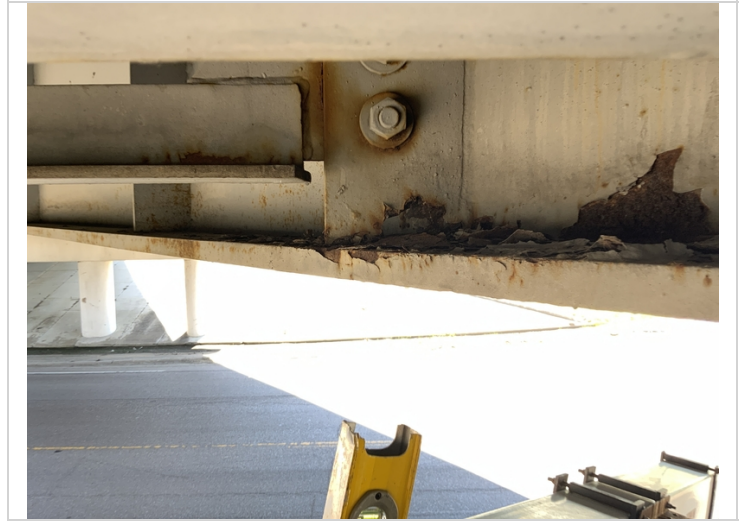
Girder 2 (Span 2) has active corrosion with a 100% section loss along the bottom section of the diaphragm connection.

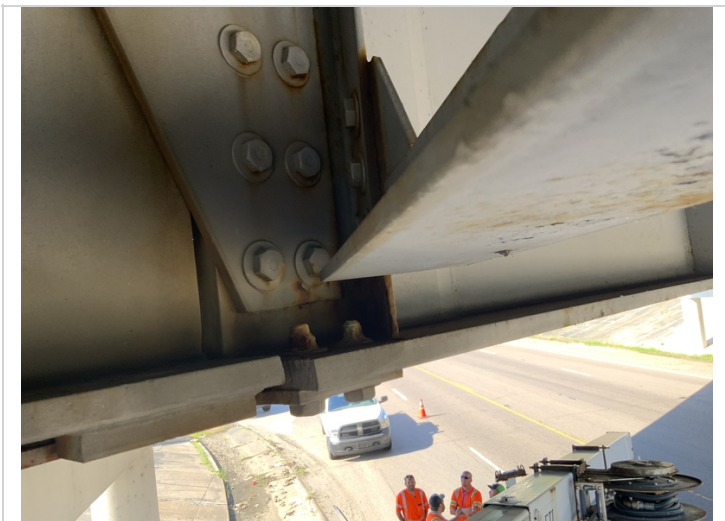
Typical section loss along the wind-lock connections

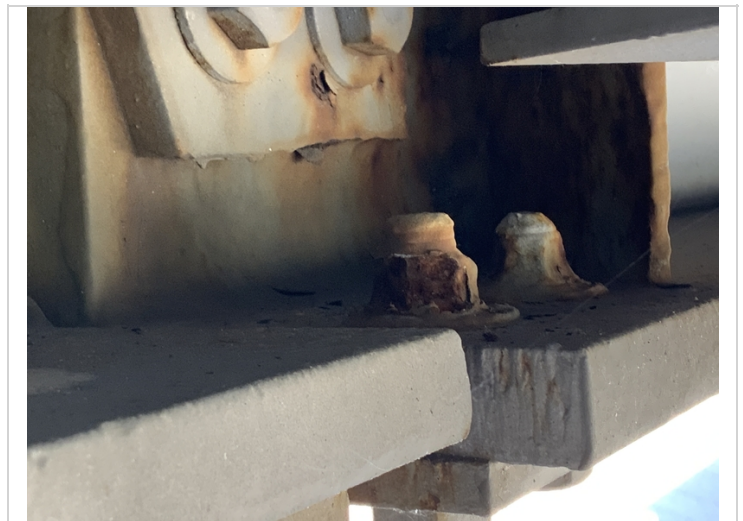
Girder 2 (Span 2) wind-lock connections adjacent to bent 3 has active corrosion with section loss.

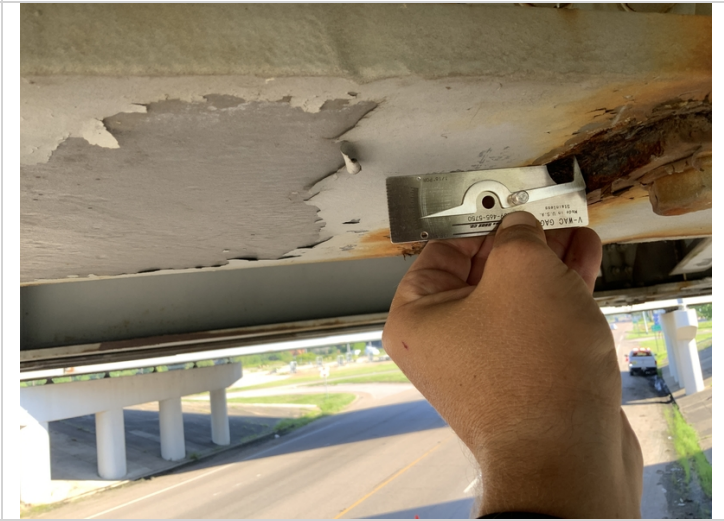
Girders 4 and 5 (Span 2) wind-locks adjacent to bent 3 have 1/8" section loss along the bottom flanges.

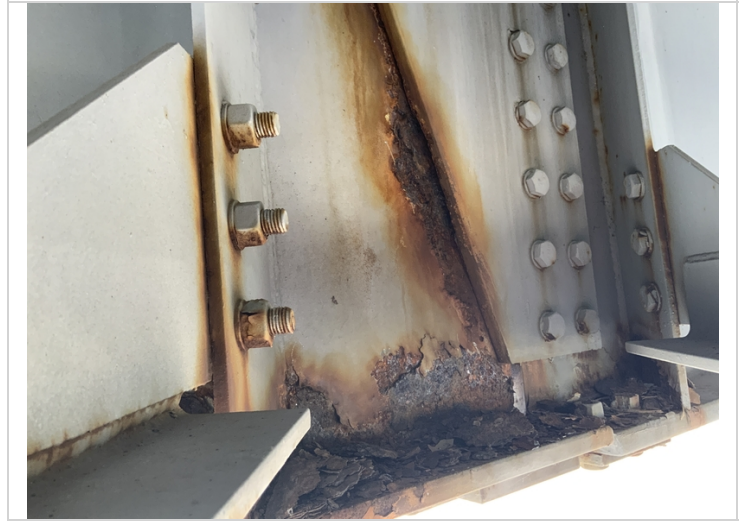
Girder 6 (Span 2) has 3/16" section loss along the web adjacent to the pin and hanger assembly.

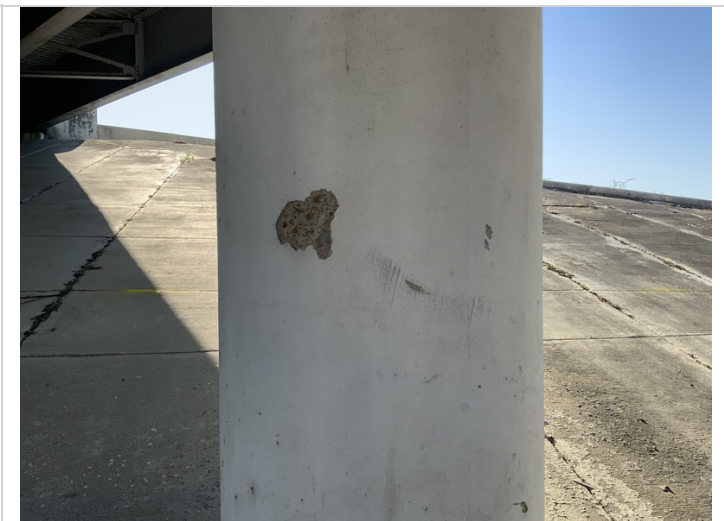
Bent 3 (Column 3) has one shallow spall

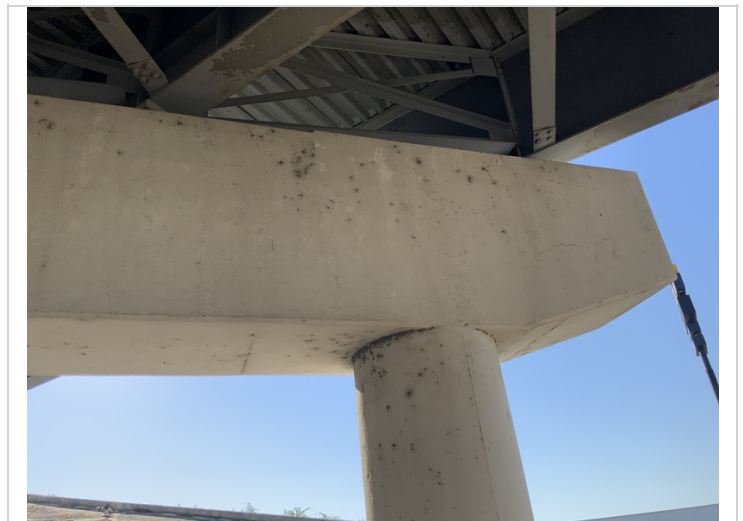
Bent 3 cap has map cracking on both sides

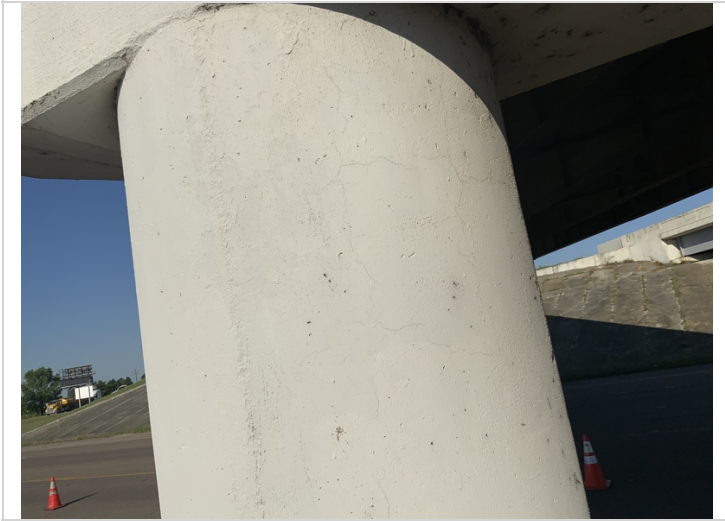
Bent 3 (Column 4) has map cracking

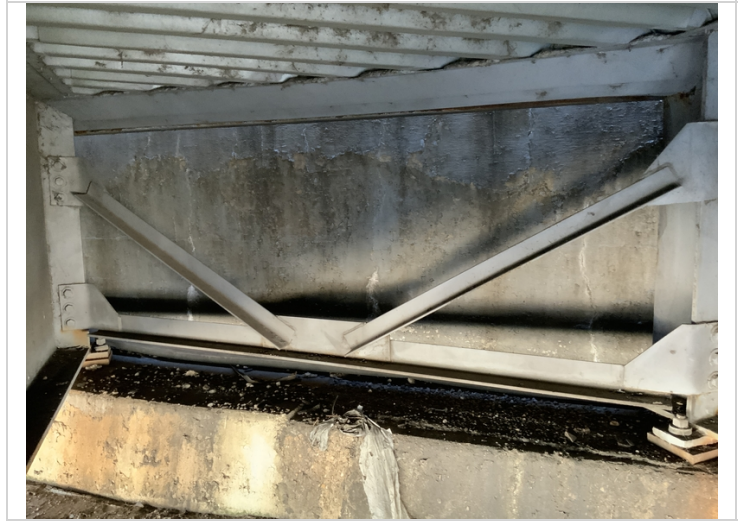
Typical cracking with efflorescence along the back walls of both abutments

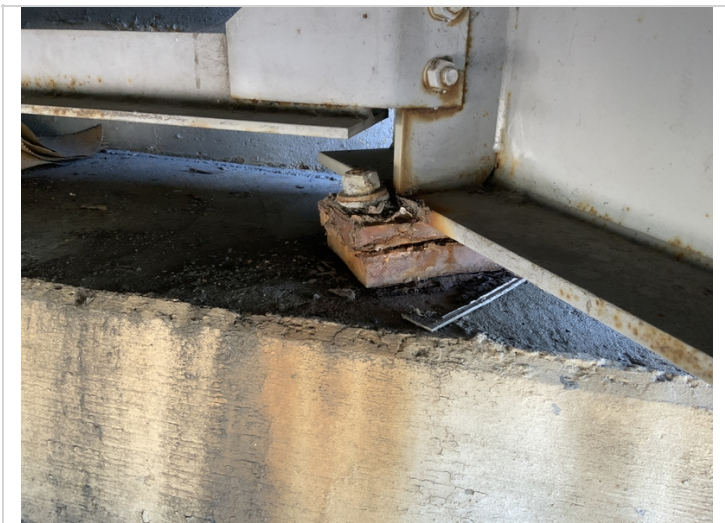
Bent 2 (Girder 6 / Bearing 6) has heavy corrosion with flaking rust, pack rust, and section loss.

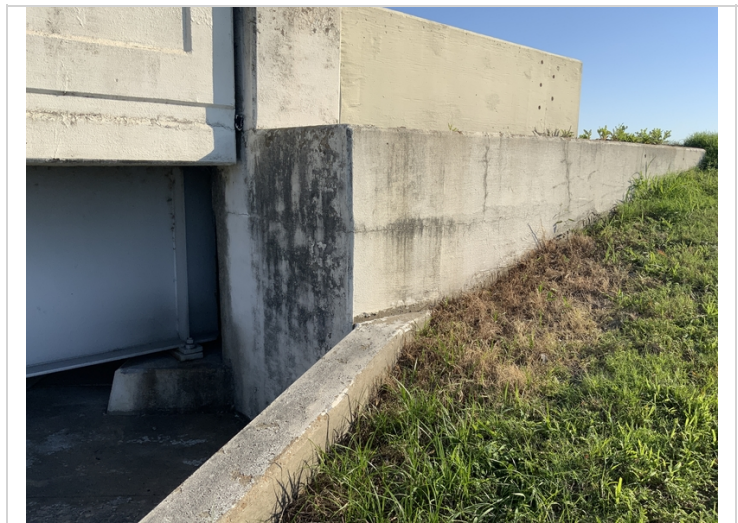
Typical cracking along the wing-walls of both abutments

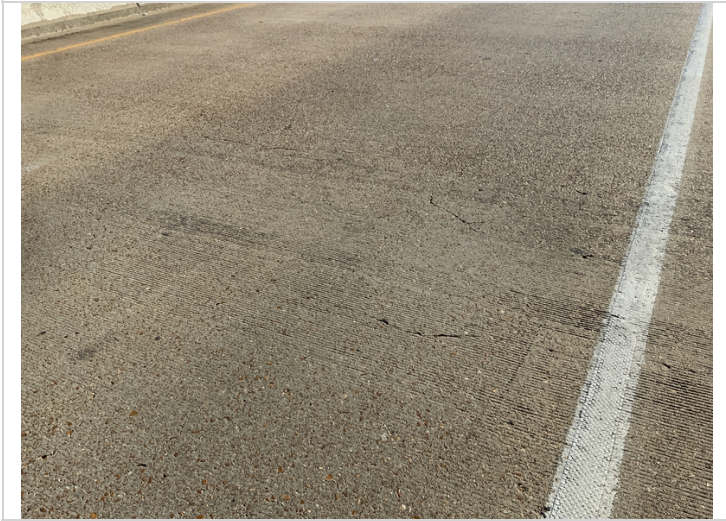
Typical map cracking in various locations throughout the driving surface

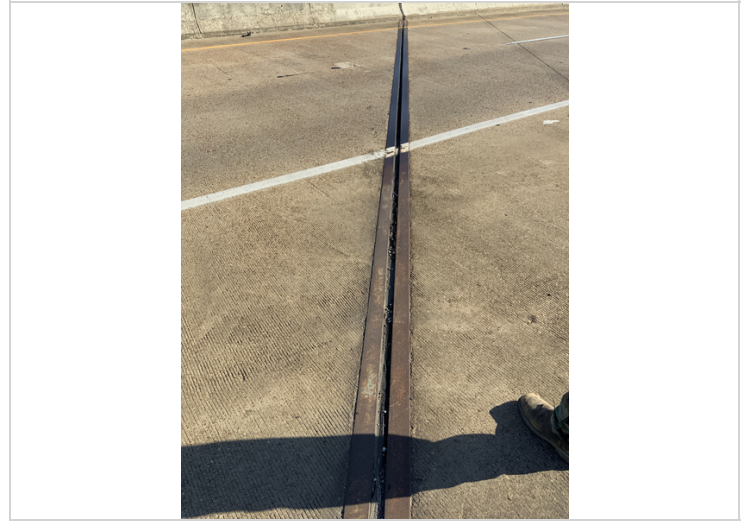
Bent 3 joint has seal cracking along the gutter lines and 100% leakage along the travel lanes allowing water and road debris to accumulate along the bent caps and beam ends.

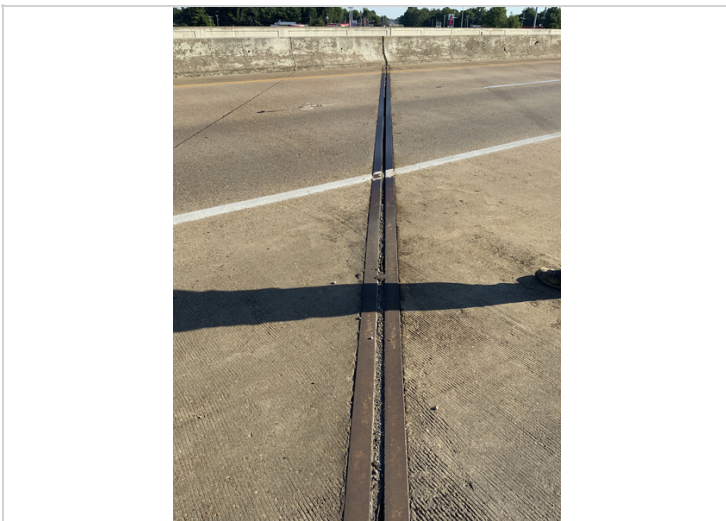
Bent 2 joint has debris impact and seal cracking along the gutter lines, plus 100% leakage along the travel lanes allowing water and road debris to accumulate along the bent caps and beam ends.

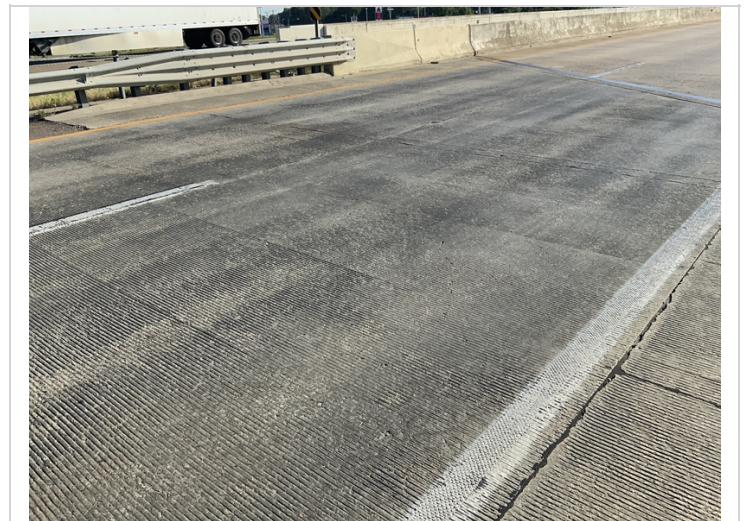
Typical map cracking in various locations throughout the driving surface

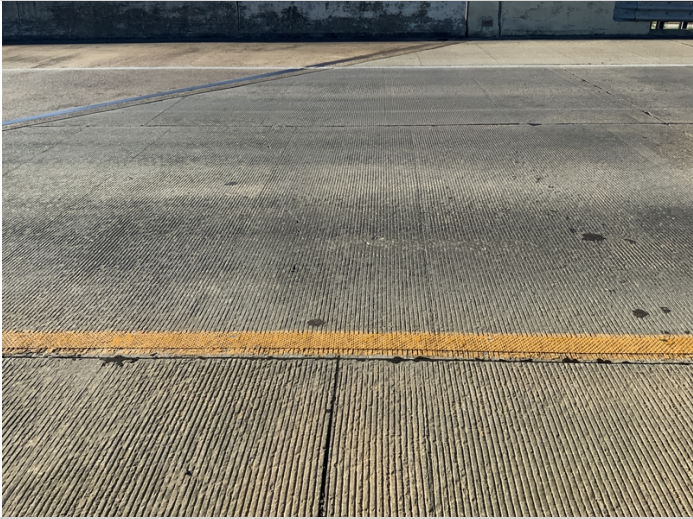
Bent 1 (West Approach Slab) has typical cracking

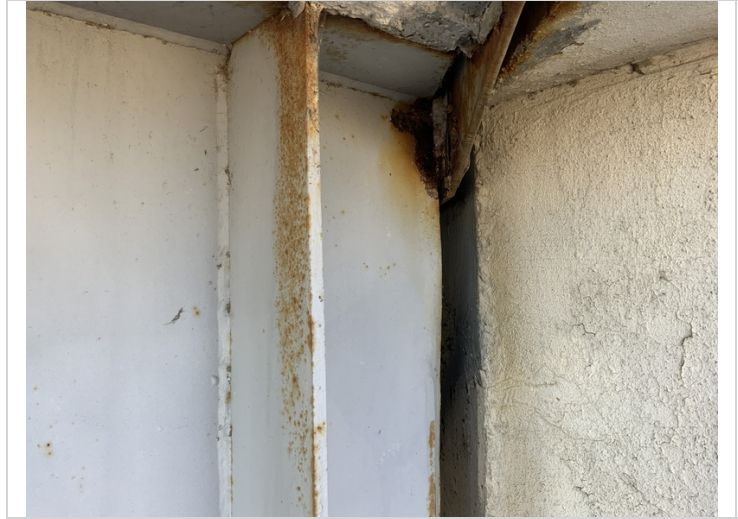
Bent 1 (Girder 1) has active corrosion with flaking rust along the top web juncture.

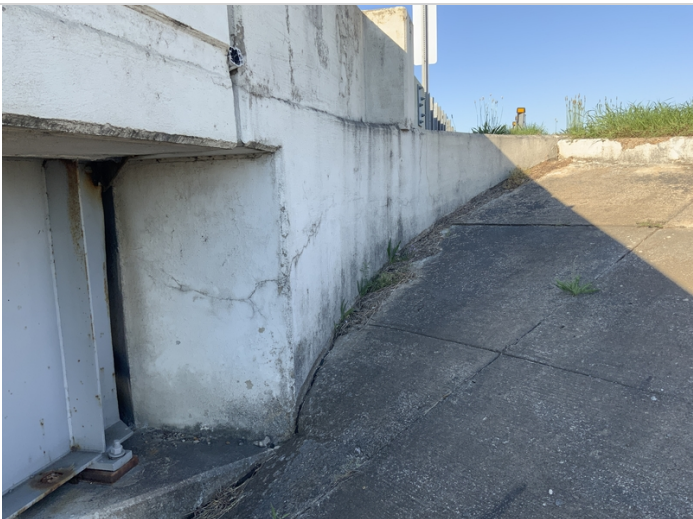
Typical cracking along the wing walls of both abutments

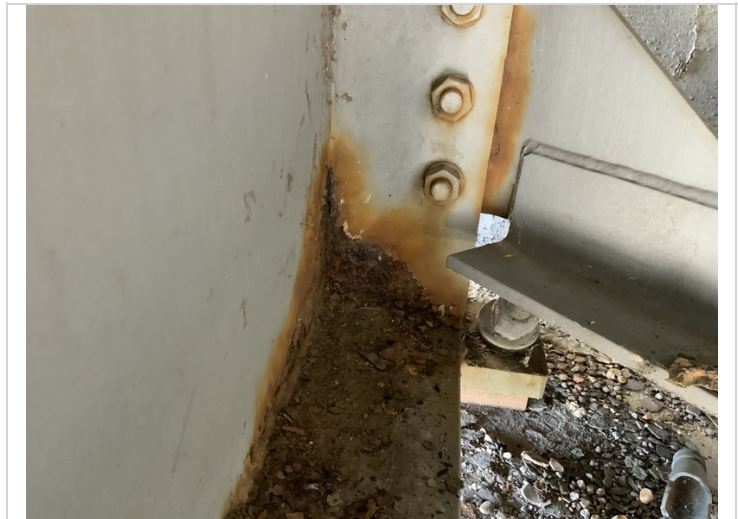
Bent 1 (Girder 6) has active corrosion with flaking rust and light to moderate pitting along the beam end.

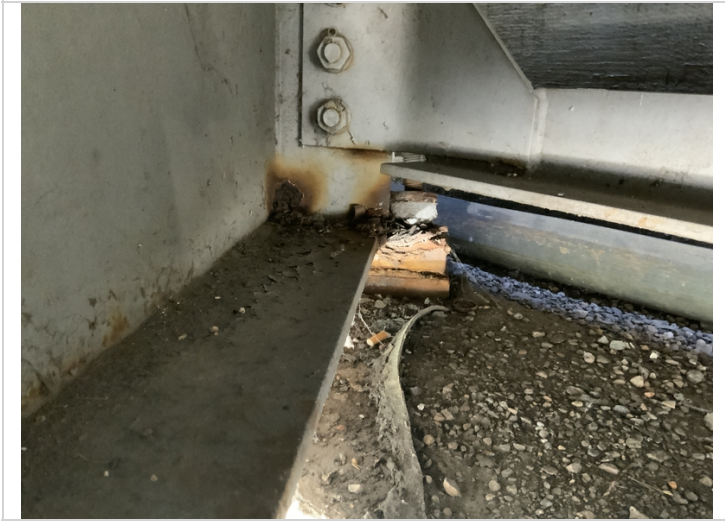
Bent 1 (Girder 6) has active corrosion with flaking rust.

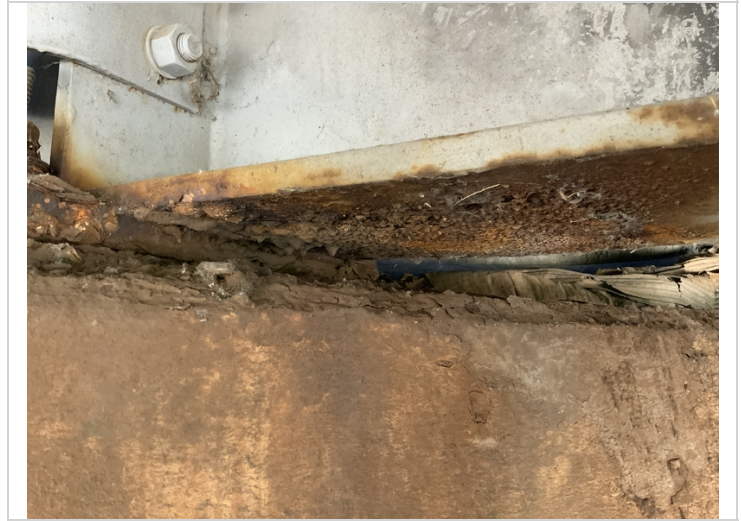
Bent 1 (Girder 4) has active corrosion with heavy pitting along the bottom flange. Bt1 sp4 g4 heavy corrosion flaking rust

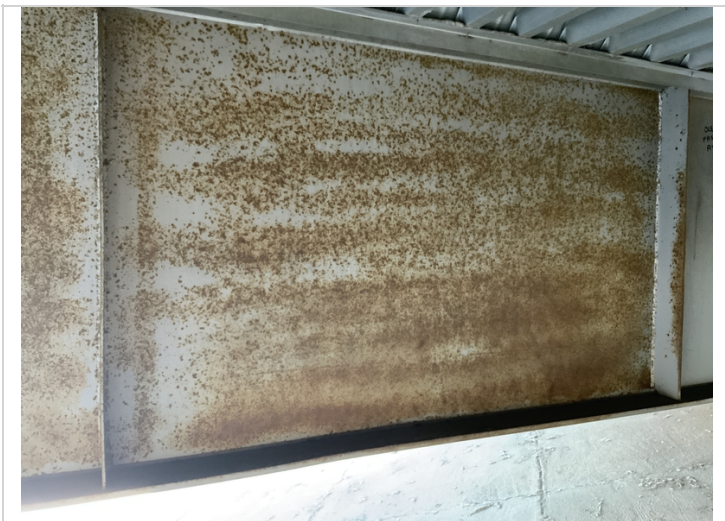
Typical failing paint with light to moderate corrosion along the webs of the girders throughout the structure.

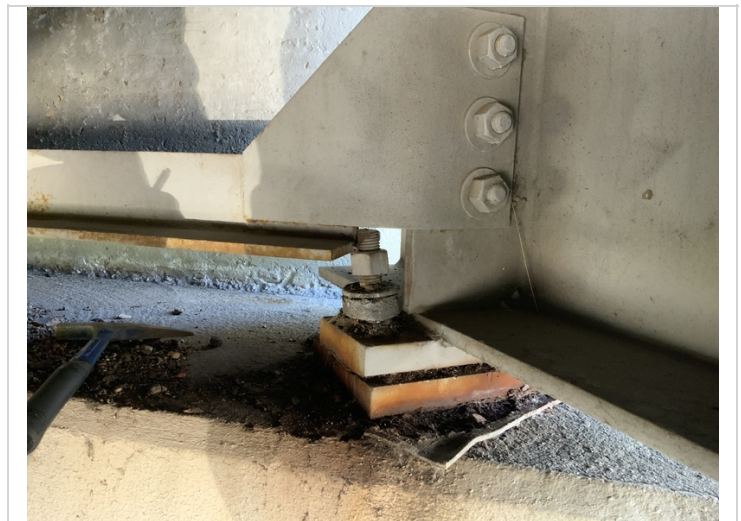
Bent 1 (Girder 1 / Bearing 1) has active corrosion with pack rust.

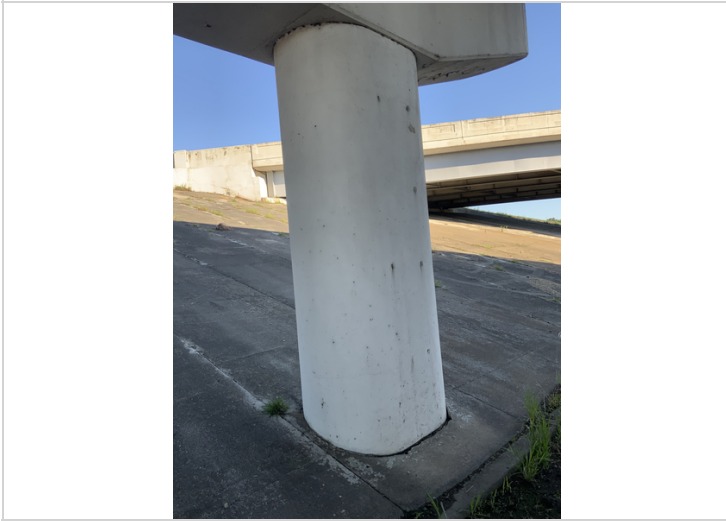
Bent 2 (Column 1) has cracking going around the column.

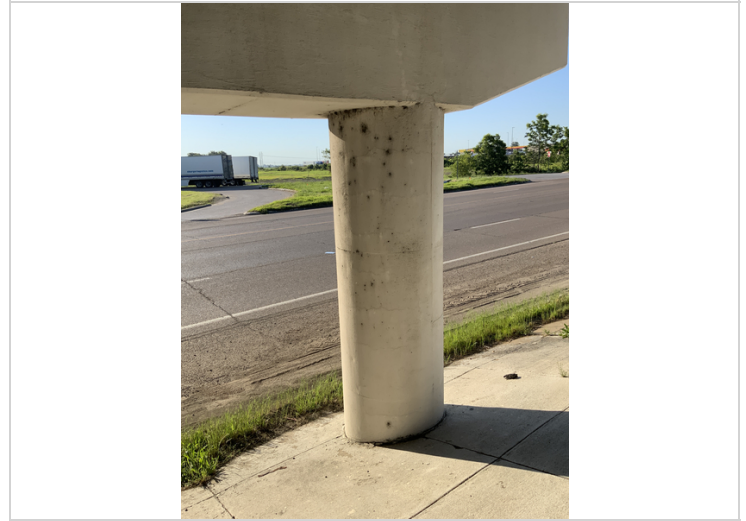
Bent 2 (Column 4) has map cracking going around the column.

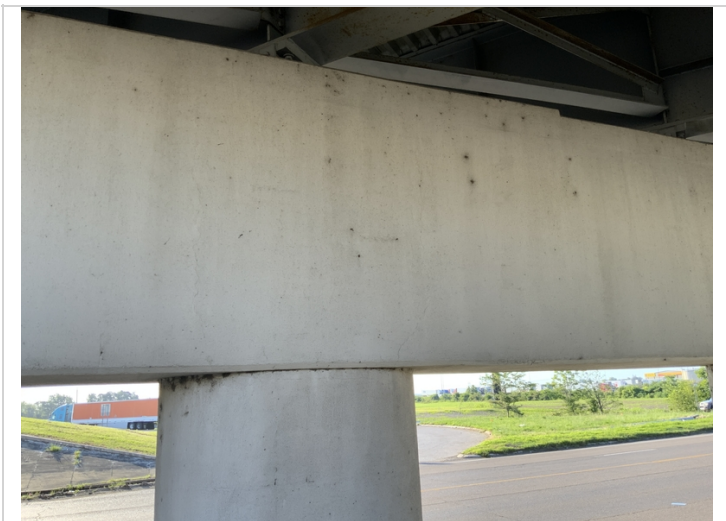
Typical cracking along bent 2 cap.

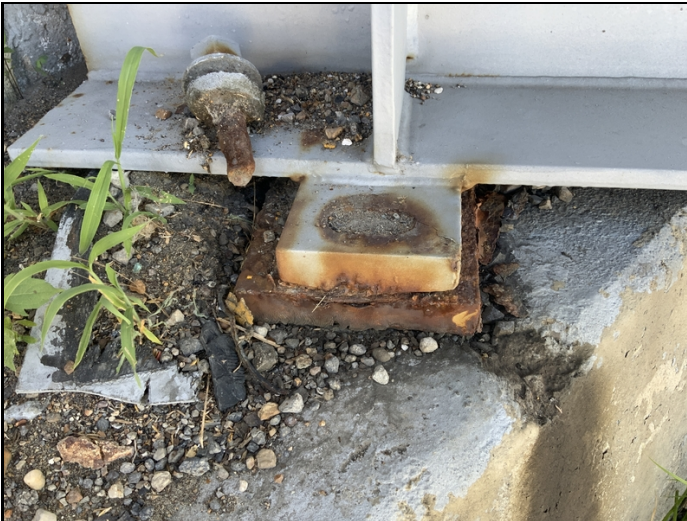
Span 3 Bent 4 girder 1 Bearing has 1 anchor bolt rusted or sheared off and laying on Girder.

Bent 4 (Girder 1 / Bearing 1) has active corrosion along the bearing and one anchor bolt that has been sheared off due to corrosion.

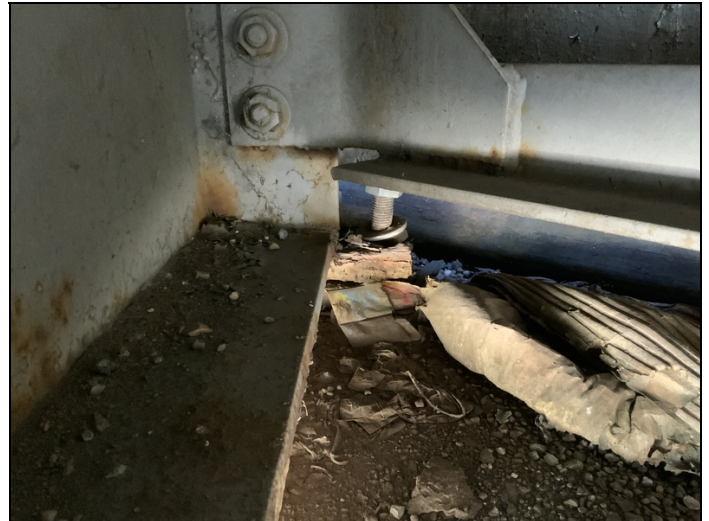
Bent 1 (Girder 4 / Bearing 4) is floating and has heavy corrosion.

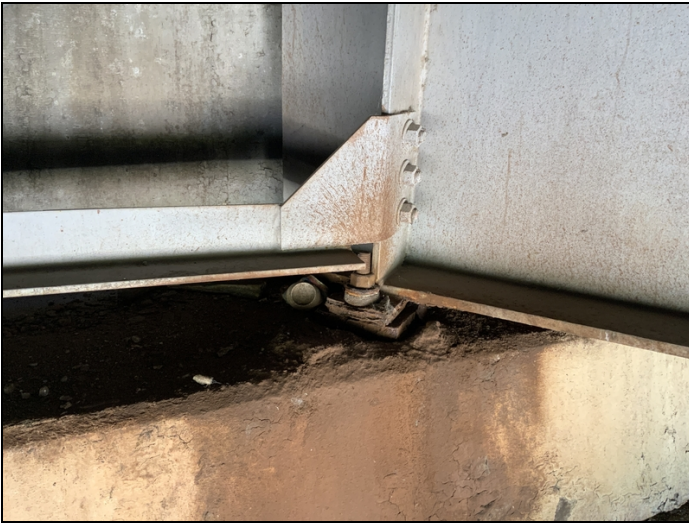
Bent 1 (Girder 3 / Bearing 3) is floating and has heavy corrosion.

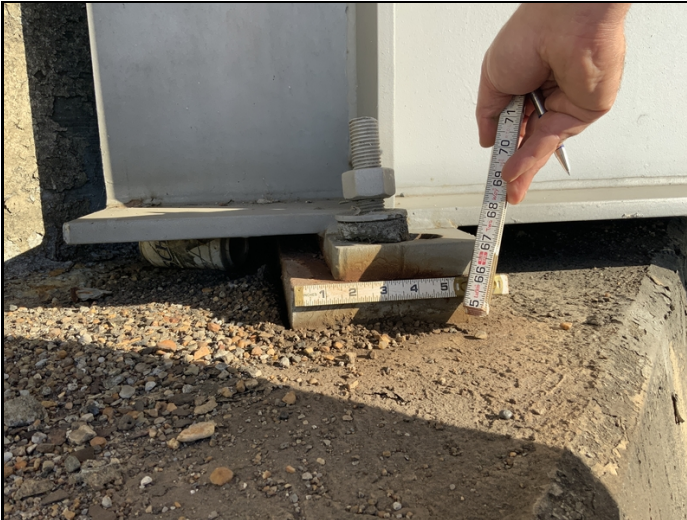
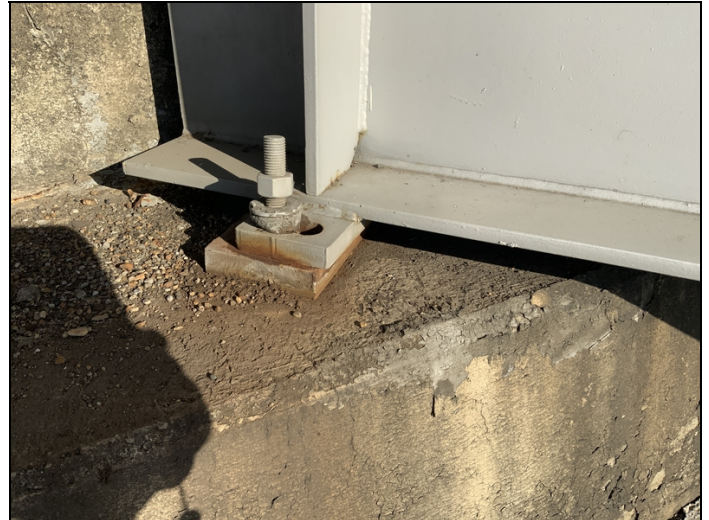
Bent 1 (Girder 6 / Bearing 6) has 1.75" of misalignment

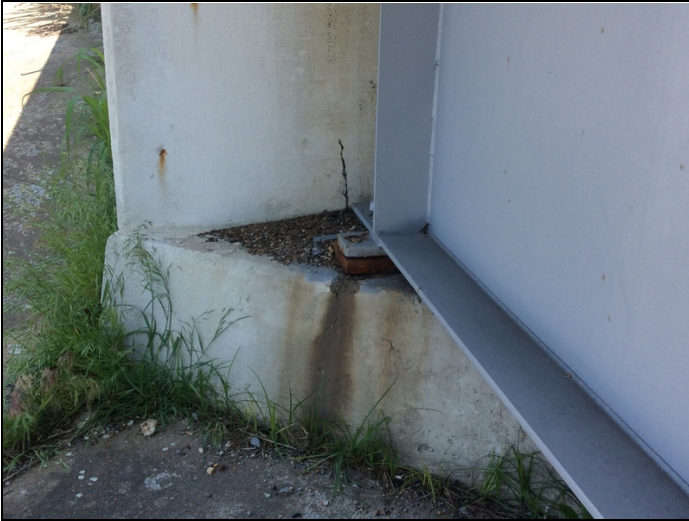
Bent 4 girder 1. Anchor bolt missing.

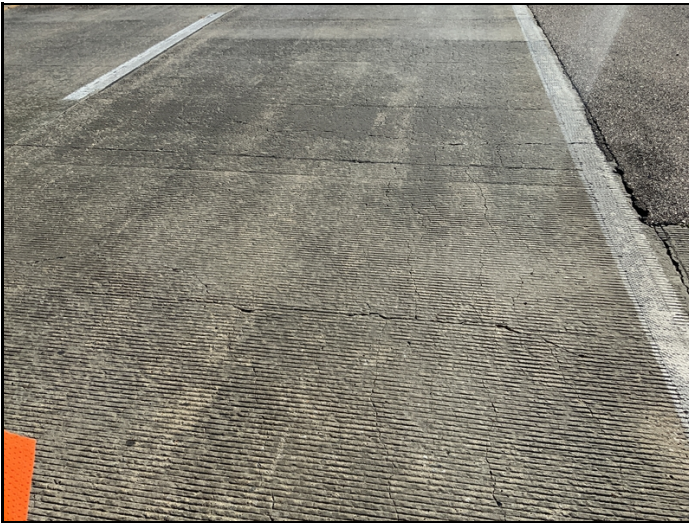
- The driving surface has open transverse and map cracking in various locations throughout structure

Typical map cracking in various locations throughout the driving surface

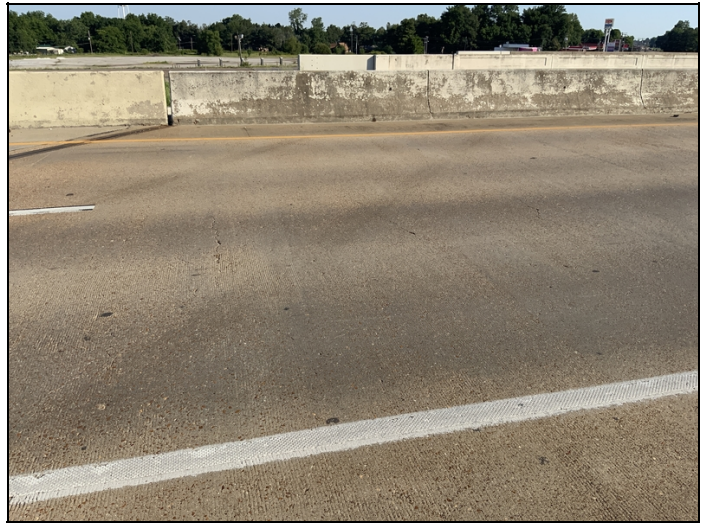
Typical transverse cracking at various spacing throughout the driving structure

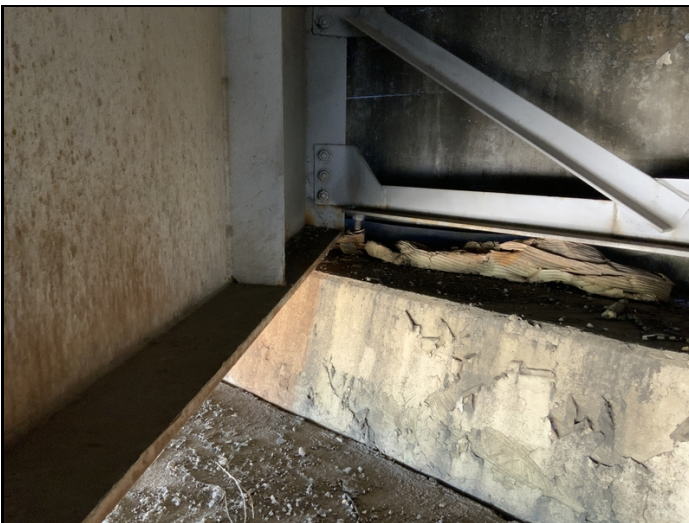
Bent 1 (Girder 4 / Bearing 4) is floating and has heavy corrosion.

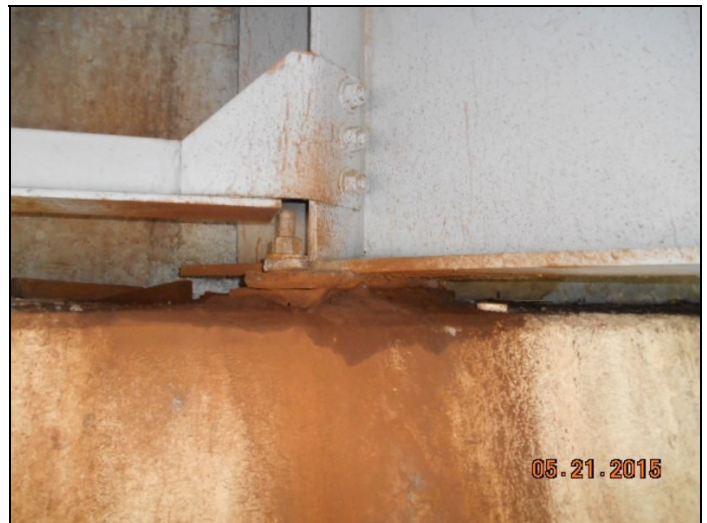
B3162 05-21-2015 Bent 1 Bearing 4

- Bent 1 (Girder 4 / Bearing 4) is floating and has heavy corrosion.

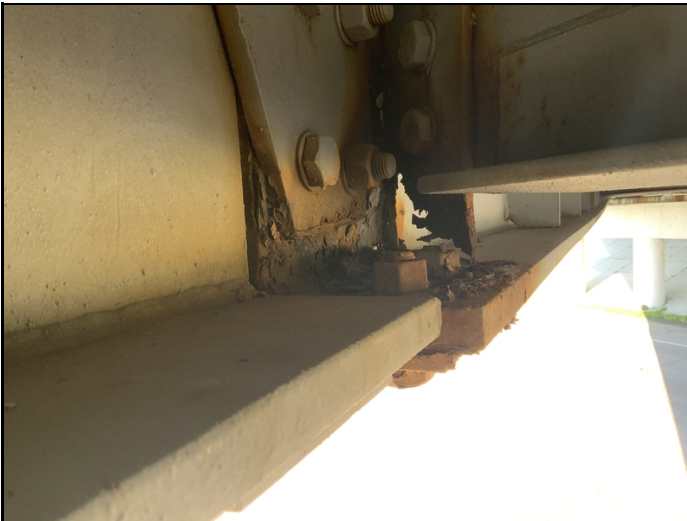
Girder 5 (Span 2) has active corrosion with 100% section loss along the bottom diaphragm connection adjacent to bent 3.

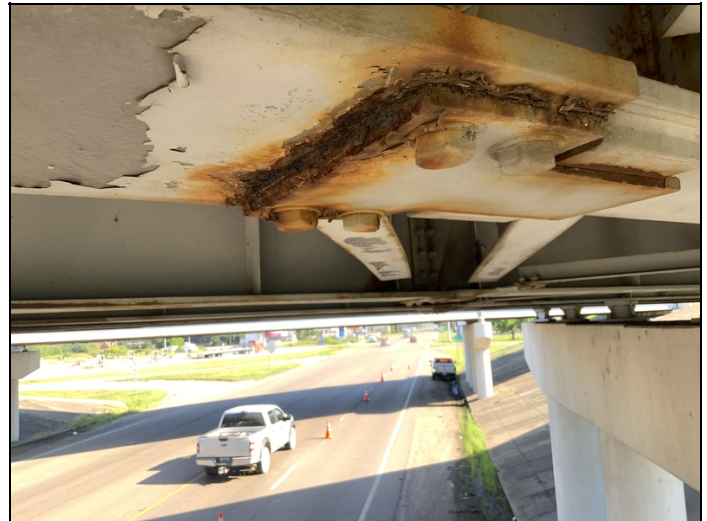
Girders 4 and 5 (Span 2) wind-locks adjacent to bent 3 have 1/8" section loss along the bottom flanges.

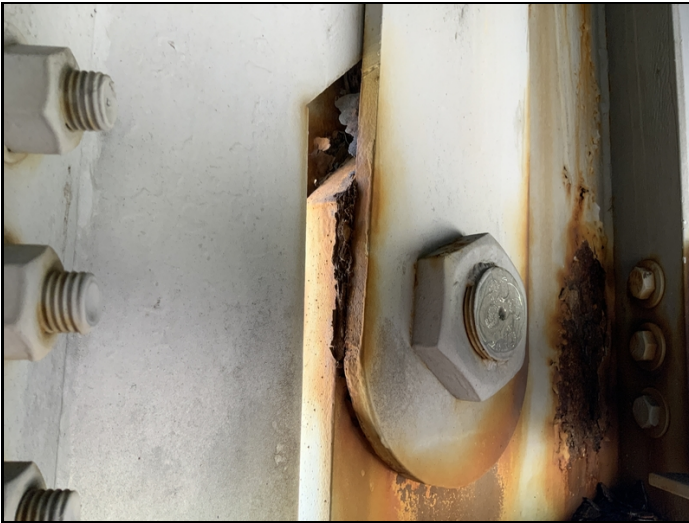
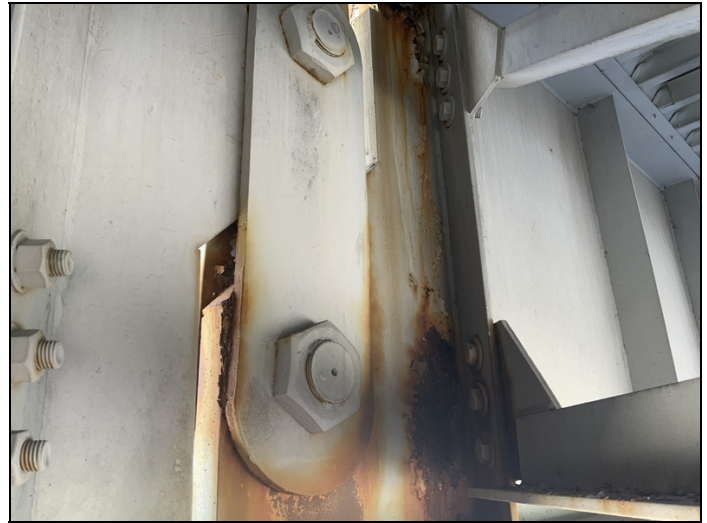
- Each of the wind-locks has active corrosion with flaking rust and initial section loss
- The hanger bars have active corrosion with flaking rust and pack rust between the hanger bar and beam
- The connections at each of the wind-locks have active corrosion with section loss along the bolts and nuts.

Typical active corrosion with flaking rust and pack rust along the hanger bars

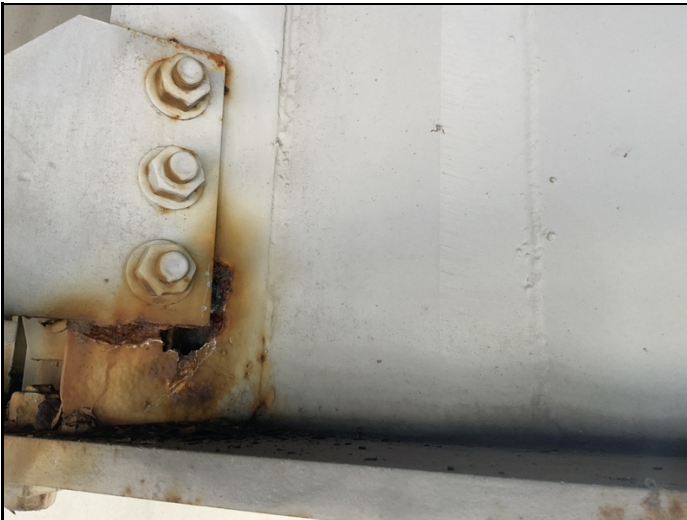
Girder 3 (Span 2) has active corrosion with 100% section loss along the bottom diaphragm connection adjacent to bent 3.

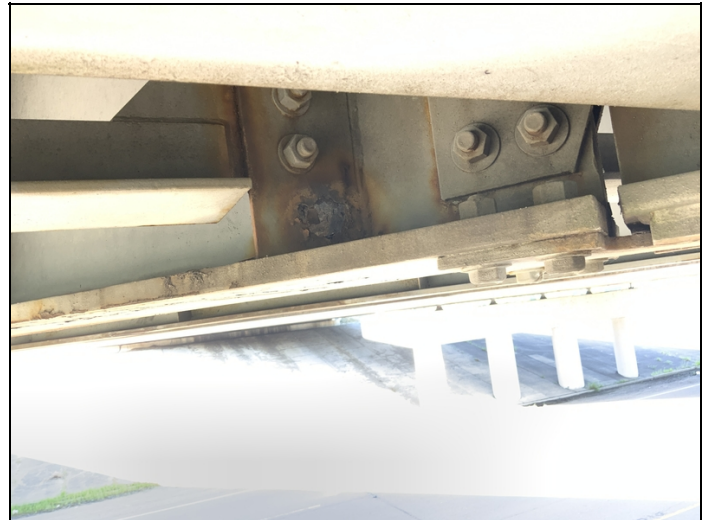
Girder 4 (Span 2) has active corrosion with 100% section loss along the bottom diaphragm connection adjacent to bent 3.

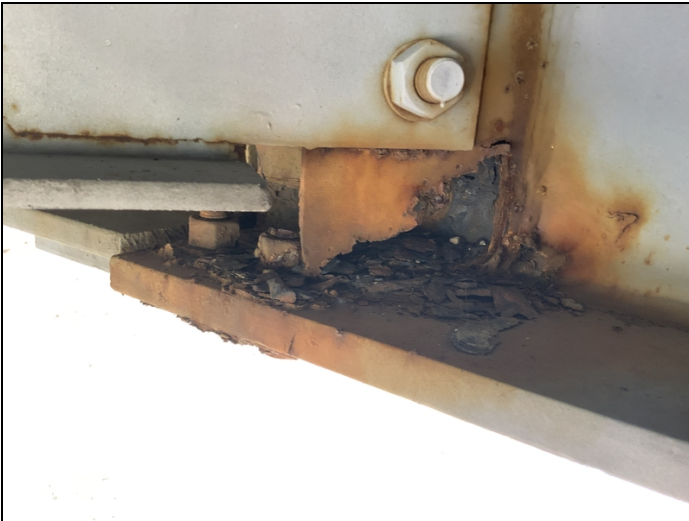
Girder 5 (Span 2) has active corrosion with 100% section loss along the bottom diaphragm connection adjacent to bent 3.

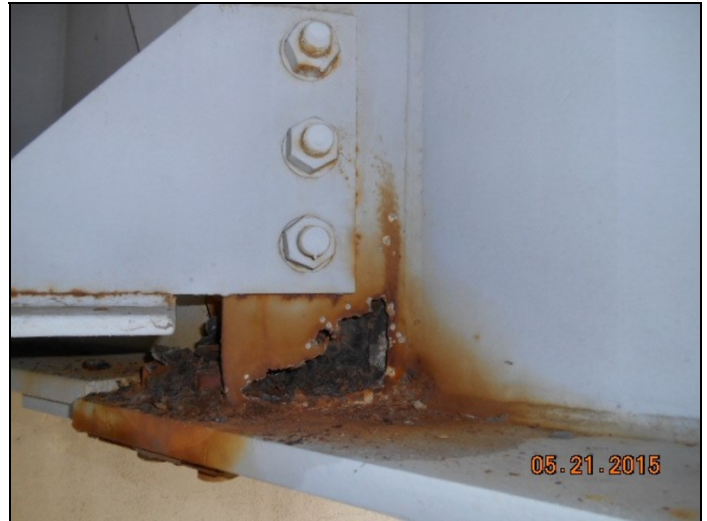
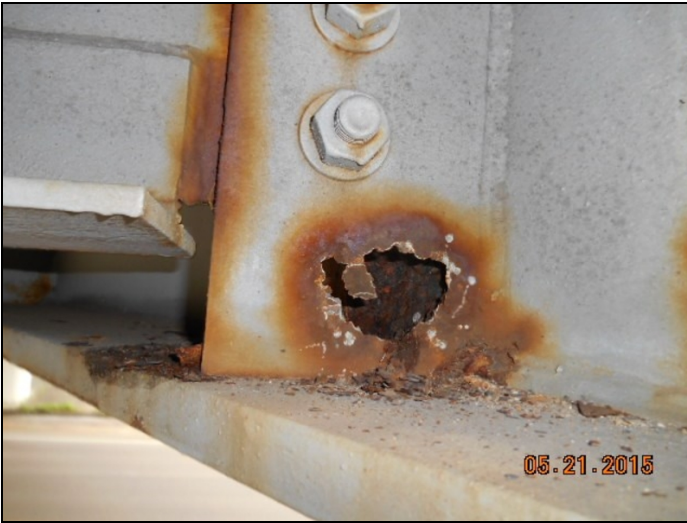
B3162 05-21-2015 Span 2 Girder 5 Bay 4 @ joint 2B

Span 2 Bay 4 on Girders 4&5 at Joint 2B Web Stiffener Plates at diaphragm connection has holes rusted thru plate: Girder 4 - 2 1/2in. x 4in. Girder 5 - 4in. x 4in.

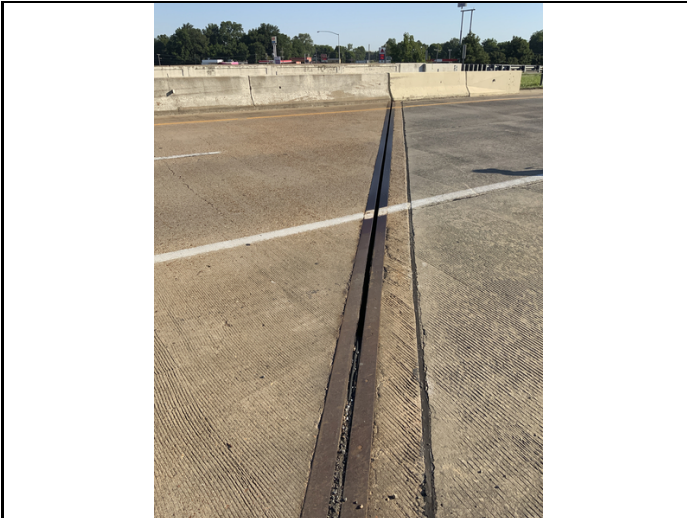
Bent 4 joint seal has adhesion failure and loss of joint material causing 100% leakage.

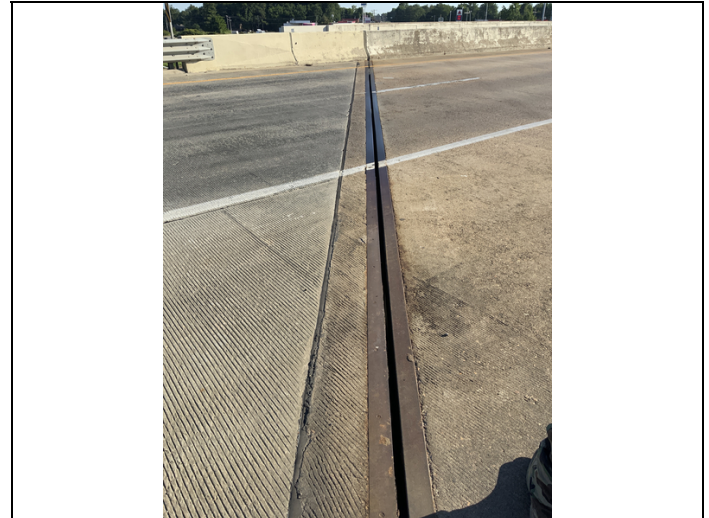
Bent 1 compression joint has 100% of the joint laying on top of the bridge seat causing water and road debris to leak onto the bridge seat and beam ends.

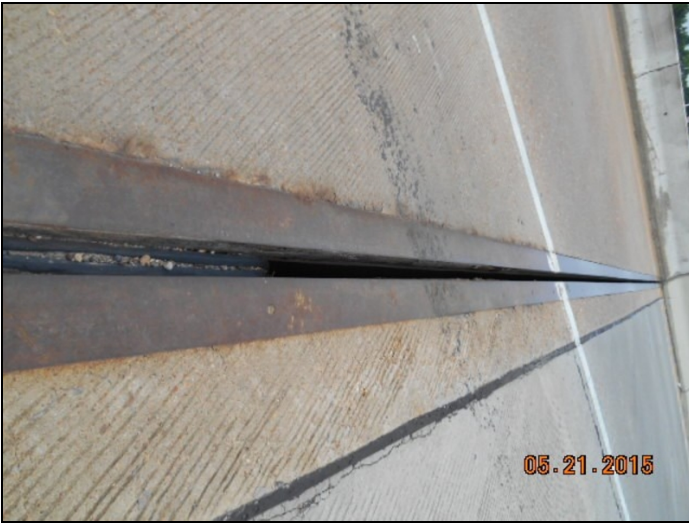
B3162 05-21-2015 Bent 4 Compression seal

- Bents 1 and 4 both have adhesion failure with the joint material resting on the bridge seats, causing water and road debris to accumulate on top of the beam ends

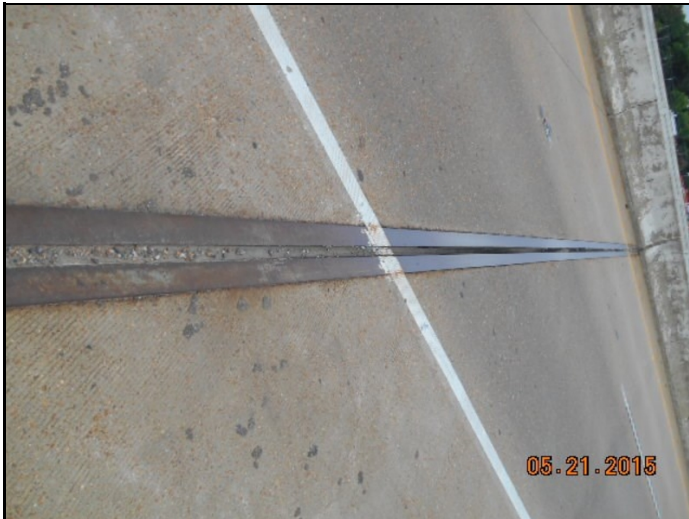
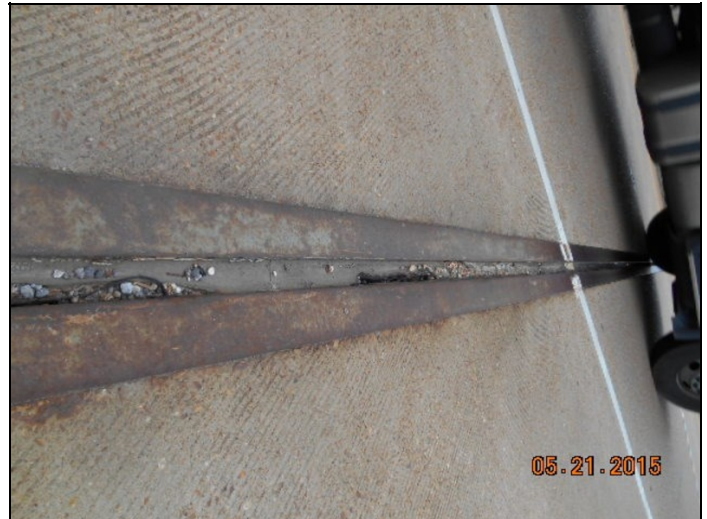
- Bent 2 & 3 has joint material that is cracking, adhesion failure, and leakage.

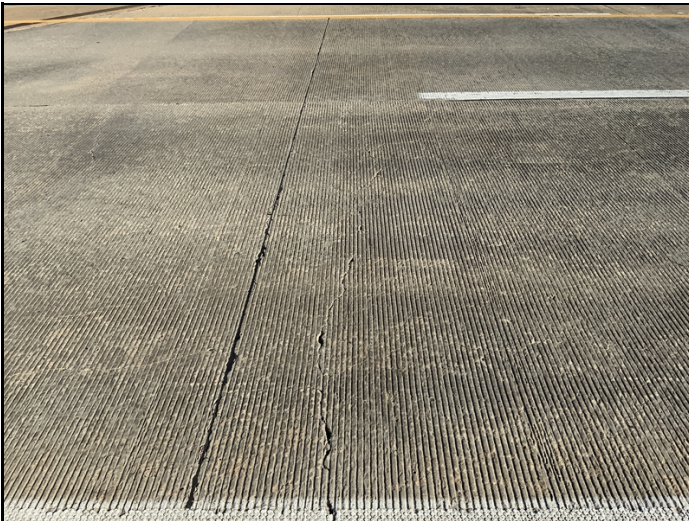
- Bent 4 (East Approach Slab) has open transverse and longitudinal cracking

Bent 4 (East Approach Slab) has open transverse cracking

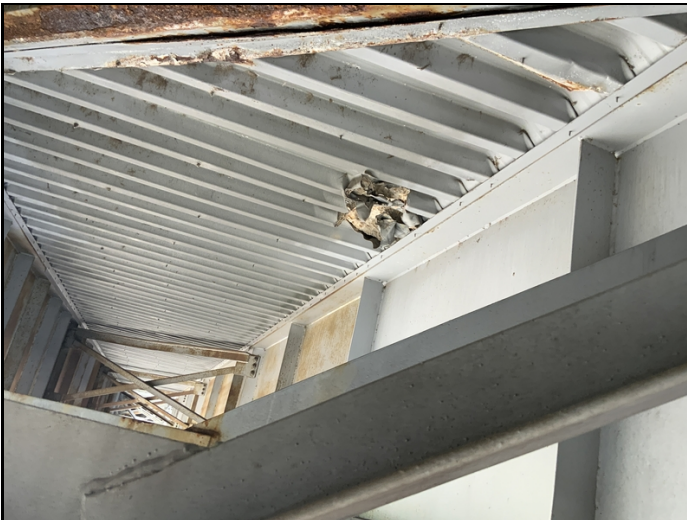
Between girders 4 & 5 (Span 2) adjacent to bent 3 there is damage to the SIP form along with spalling (This is visible from the undersurface of the deck)
