Asset #B3162(Routine)

I 55-12NB-LM 63.28 over US 61-SEC 3

Location: JCT US 61 & I 55

Team Lead: Jacob Turner, Inspection Date: 06/15/2021

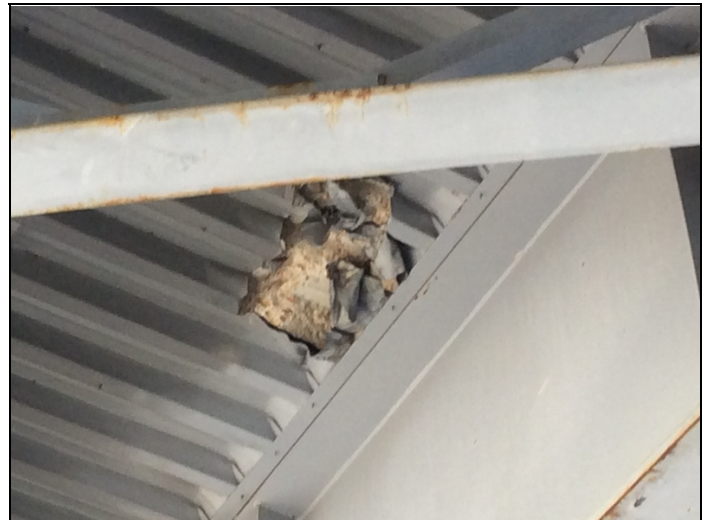
Span 2 bay 3. collision damage to stay in place form.
