Asset #A3163(Routine)

I-55-SB-12-64.18 over BURLINGTON RR

Team Lead: Richard Jones, Inspection Date: 11/02/2022

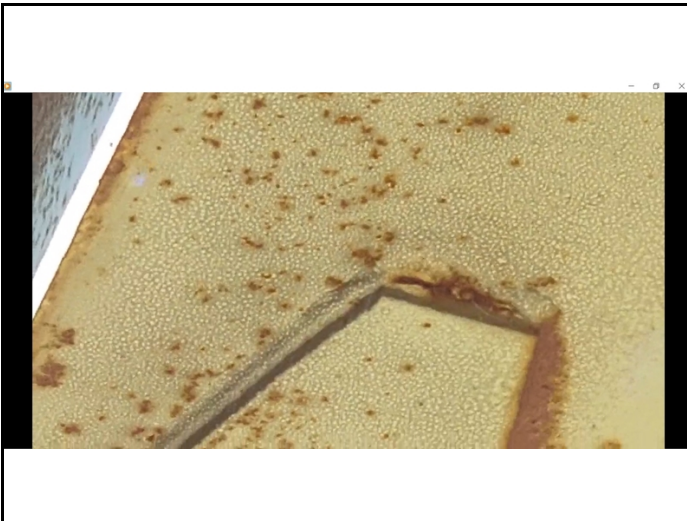
Span 3 girder 6 has a possible crack in weld at end of cover plate near bent 4.

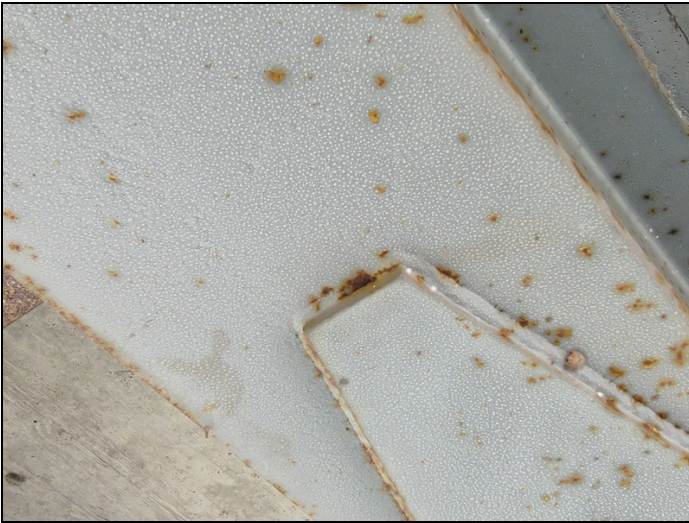
Span 12 girder 2 has a possible crack in weld at end of cover plate near bent 13.

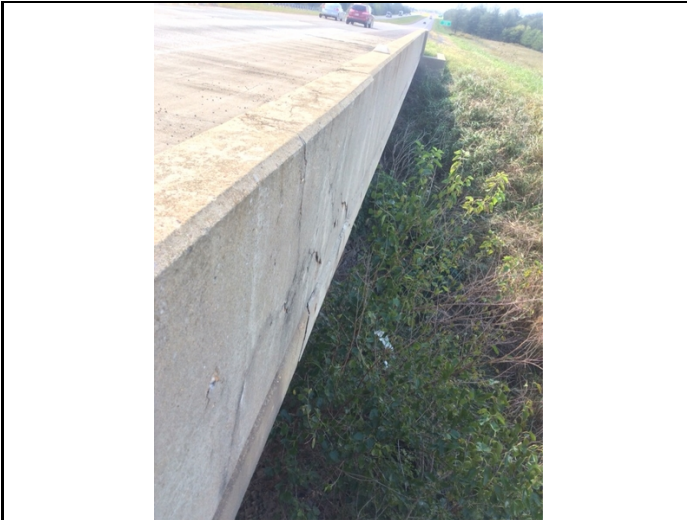
Lt bridge rail at Span 1 is cracked/delaminated on back face. Rails have several cracks and some rebar exposed.

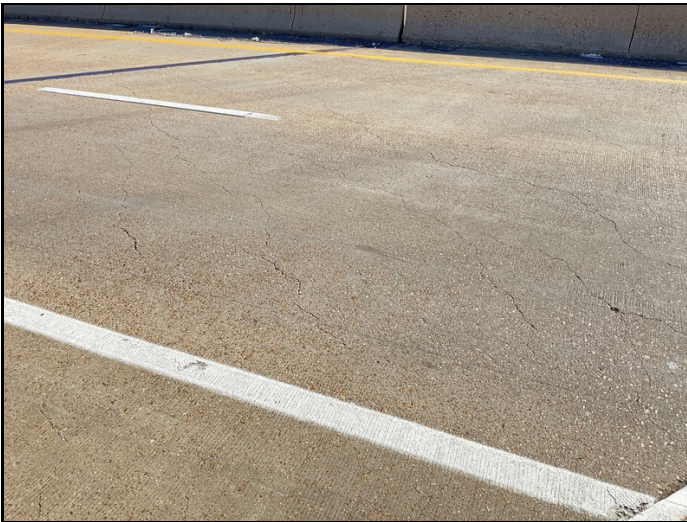
Deck has numerous unsealed cracks and areas of abrasion.
Main slab span 8 has numerous unsealed diagonal cracks.

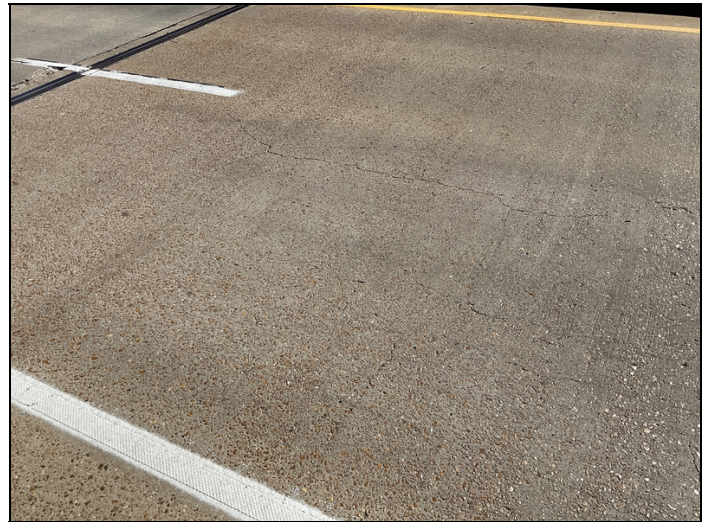
typ deck cracks

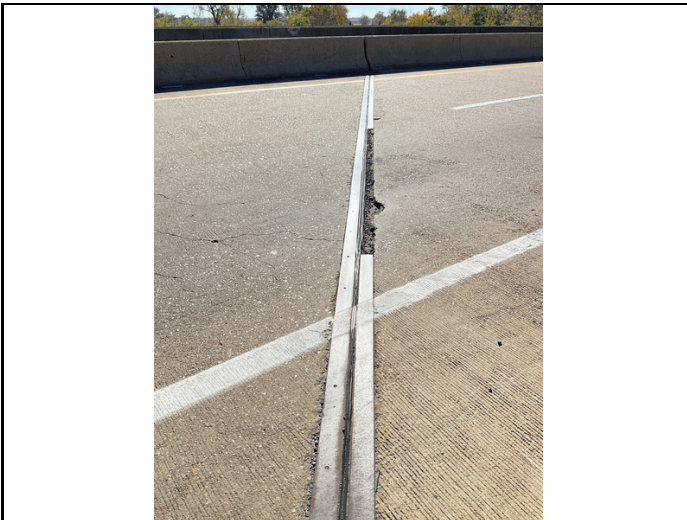
Bent 8

Compression seals are ripped and torn with several areas missing. Road irons have a few areas loose. Road iron has been partially removed at bent 8.

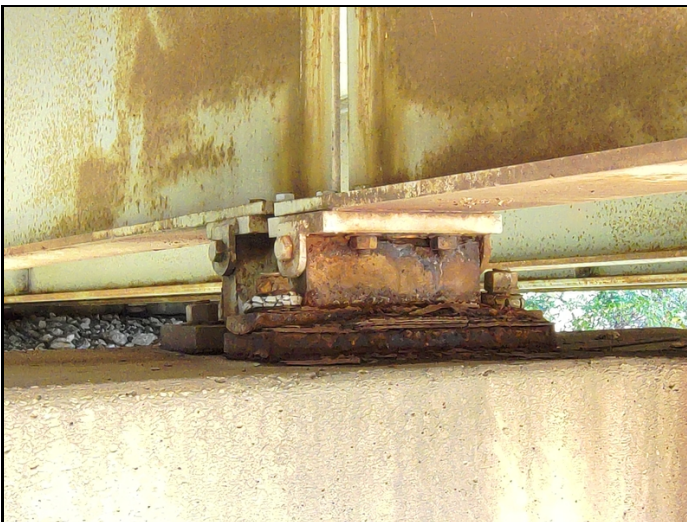
Span 2 bent 2 bearing 5

Span 2 bent 2 bearings 3 and 5 have 1/8" gap between masonry and sole plates.

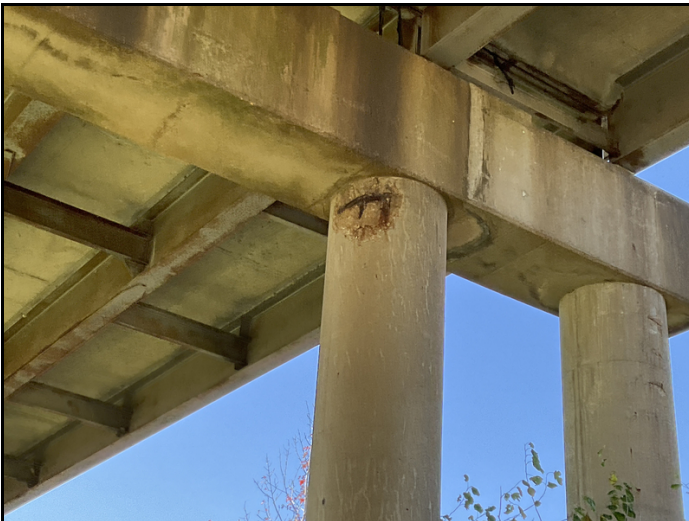
Bent 11 column 2 has a 2' spall with exposed rebar near top.

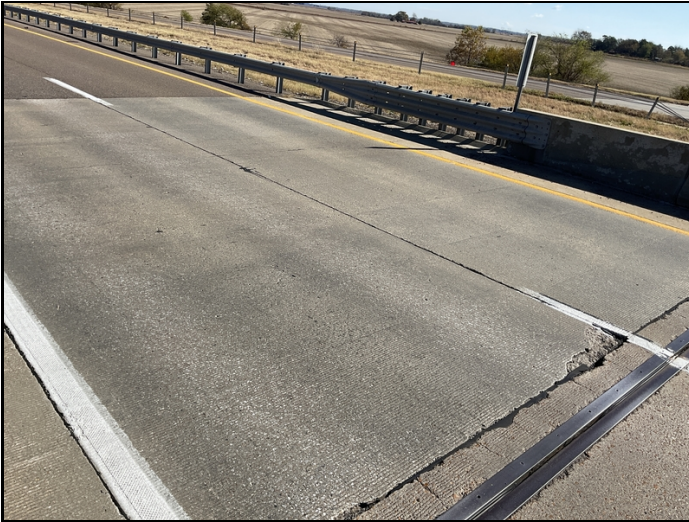
Approach slab at end

Approach slabs have a few minor cracks and a few spalled areas.
