Asset #B3163(Routine)

I-55-NB-12- 64.17 over BURLINGTON NORTH RR

Location: 0.9 MI NE JCT US 61

Team Lead: Richard Jones, Inspection Date: 11/02/2022

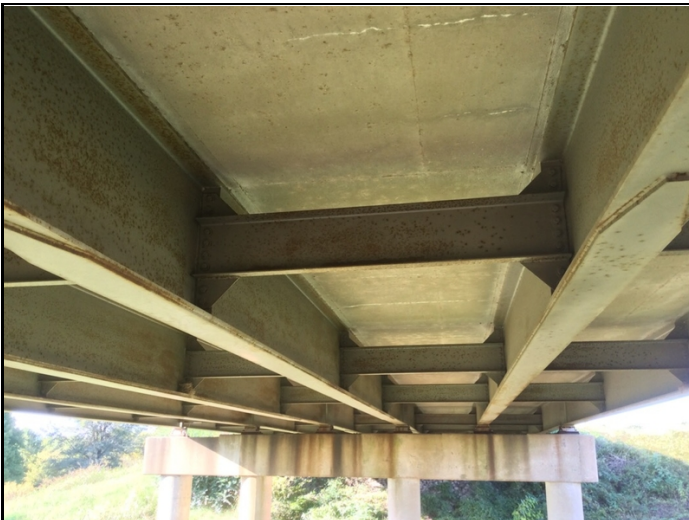
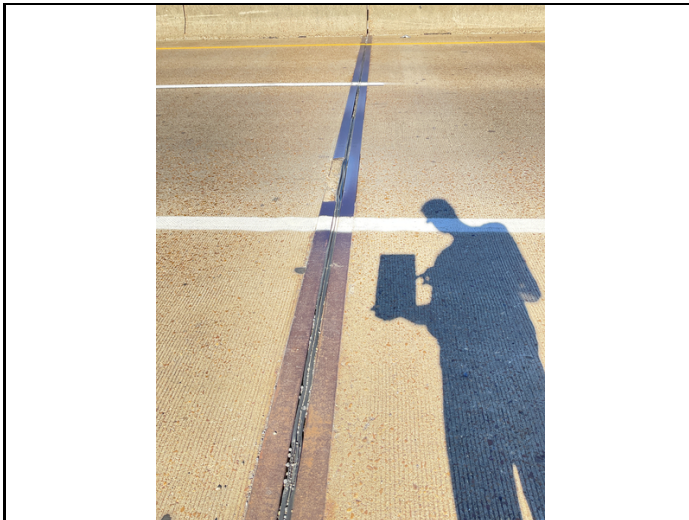
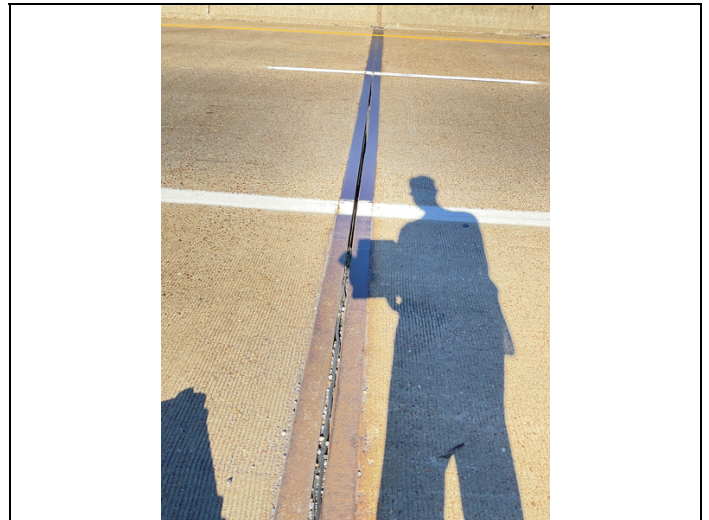
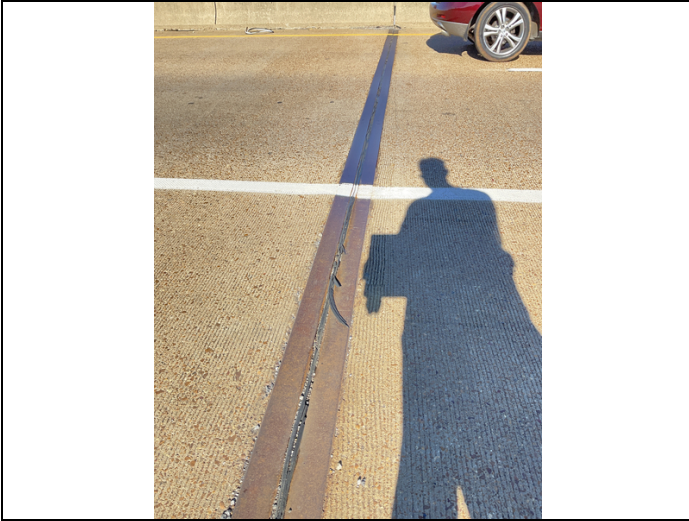
Typ compression seals

Compression seals have cracks, and tears with some sections missing. Road irons have a few areas loose. Road iron has been partially removed at bent 4.

Type of Work: Replace (General)

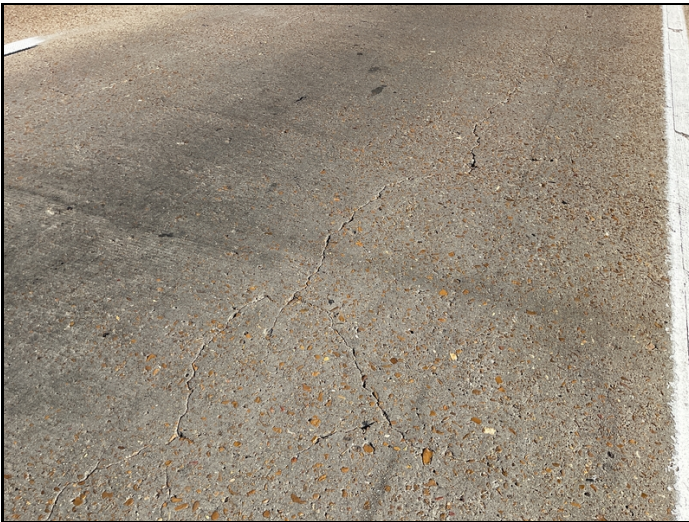
Deck has numerous unsealed cracks. Deck has minor abrasion in wheel paths.
Main slab span 7 has unsealed longitudinal cracks.

typ cracks

Type of Work: Repair (General)

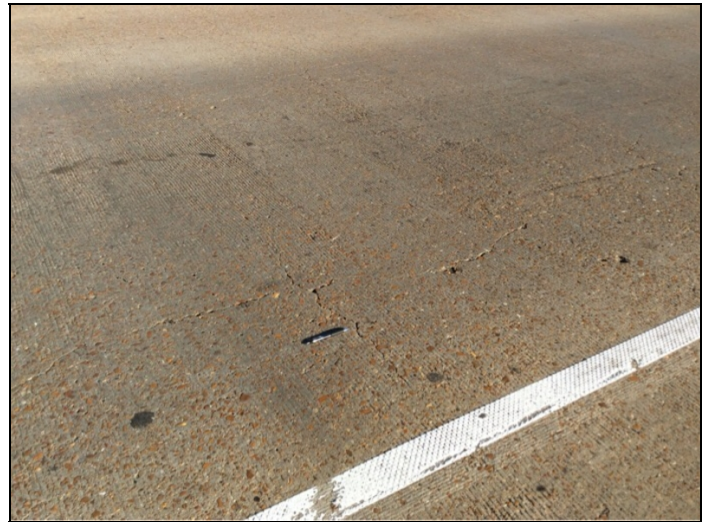
Typical deck cracking

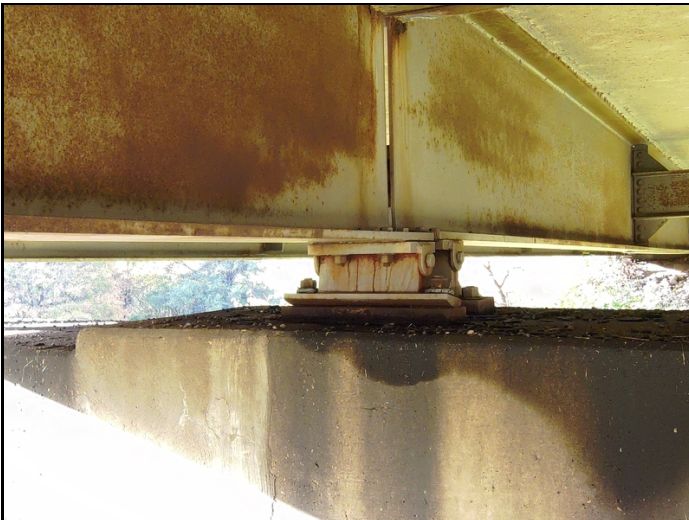
Span 2 bent 2 bearing 5

Bearings have some pack rust.

Type of Work: Repair (General)

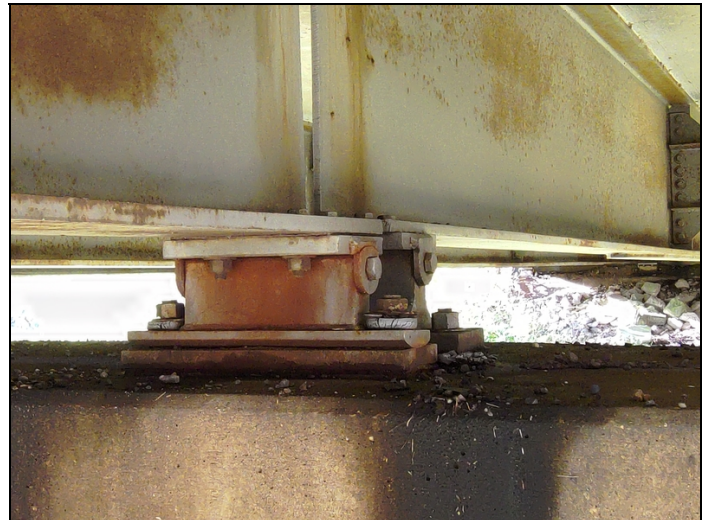
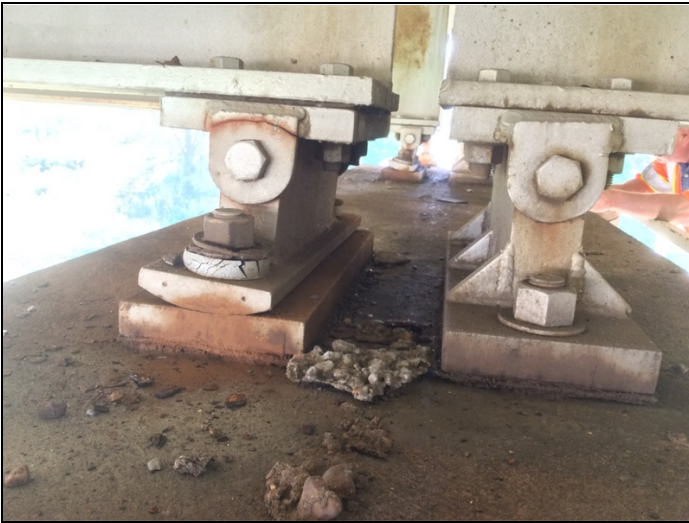
Span 2 bent 2 bearing 4 has a cracked sole plate bracket at cap screw connection.

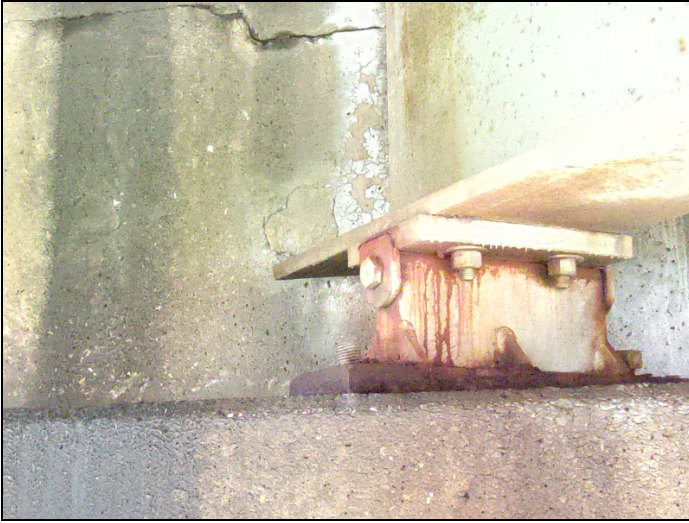
Span 6 bent 7 bearing 4 has one anchor nut missing. Sole plate has a crack in weld at cap screw connection.

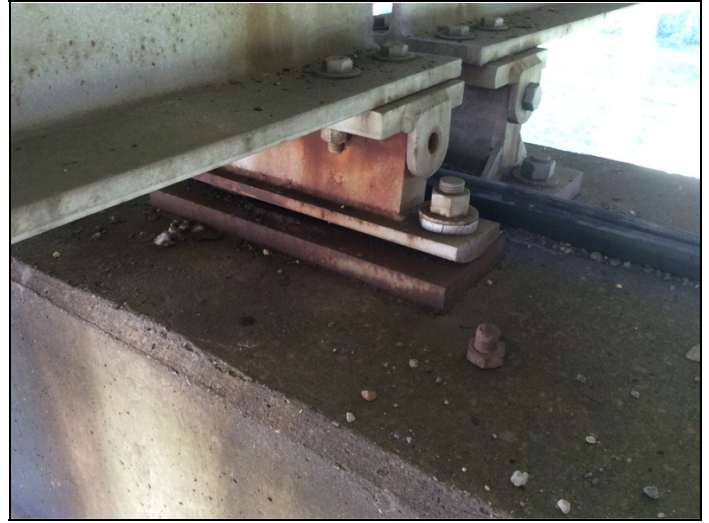
span 10 bent 11 girder 3

Span 10 bent 11 bearing 3 is missing 1 cap screw.

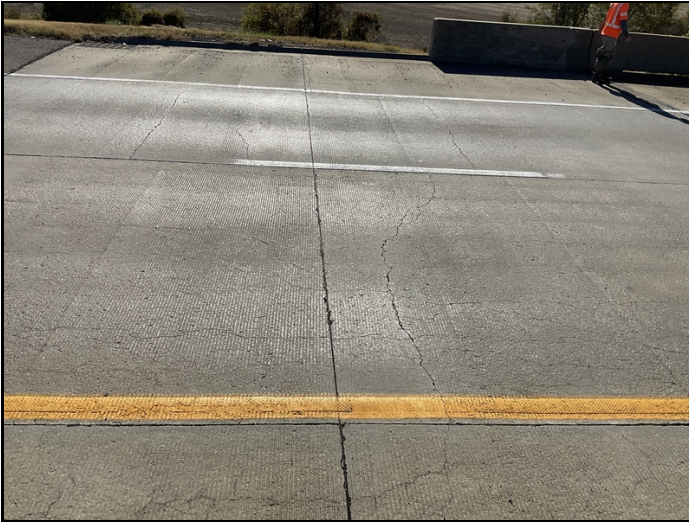
Approach slab at end

Approach slabs have numerous unsealed cracks and a few spalled areas.

Type of Work: Repair (General)
