Asset #A3166(Routine)

I-55-SB-12- 66.76 over SH 239 & RR

Location: 0.5 MI S SH 18

Team Lead: Richard Jones, Inspection Date: 11/03/2022

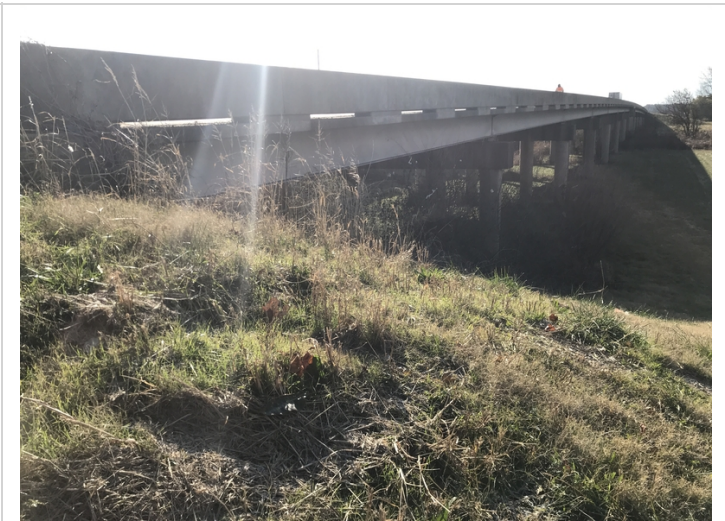
Main span 8

Main slab span at span 8 has several unsealed cracks. Slab soffit has some efflorescence.

Main slab span at span 8 has several unsealed cracks.

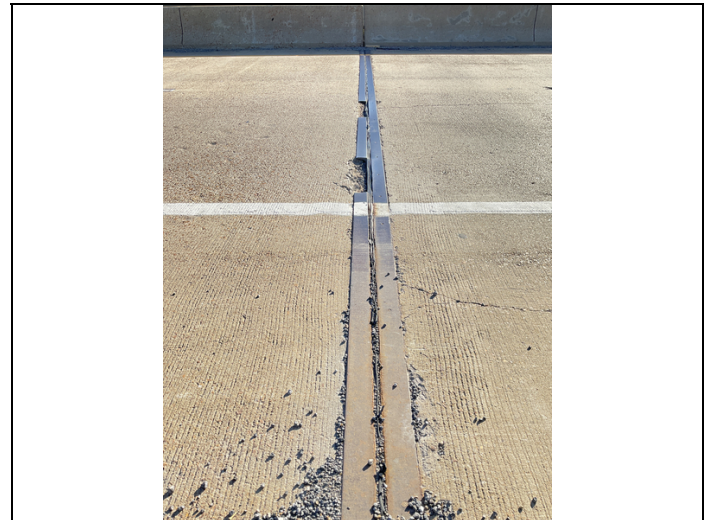
Bent 10

Compression seals have several areas that are ripped or torn and have several sections missing. Road irons have a few areas that are loose. Some have been partially removed at bents 2, 9, and 10.

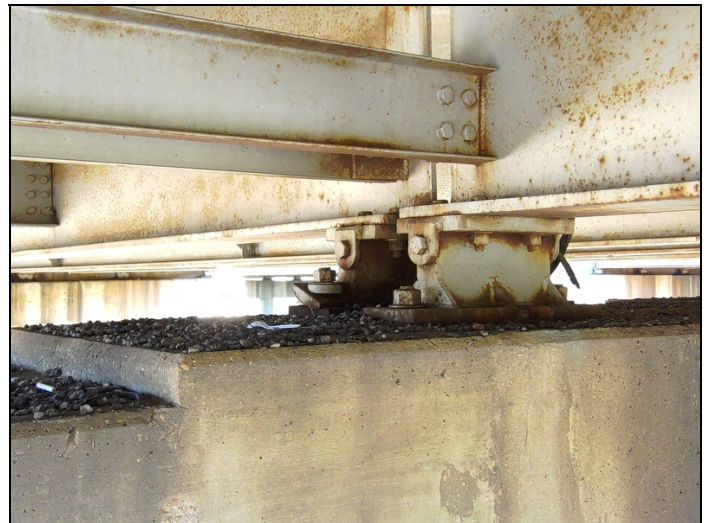
Bent 4 bearing 5

Span 4 bent 5 bearing 5 has a loose cap screw.

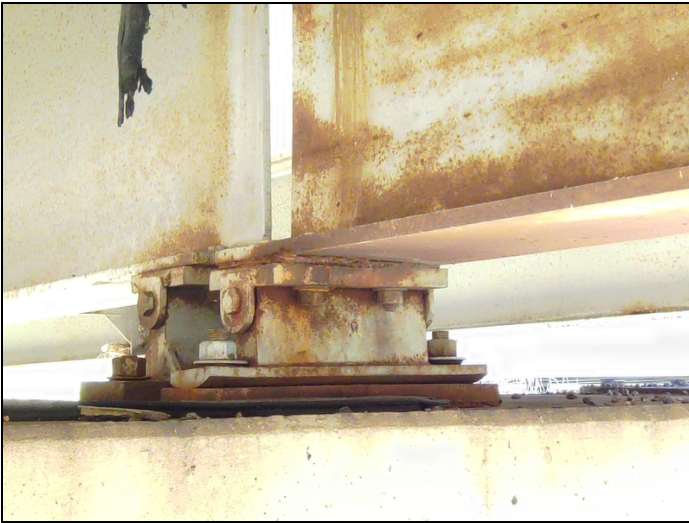
span 7 bent 7 bearing 2

Span 7 bent 7 bearing 2 is near max rotation.

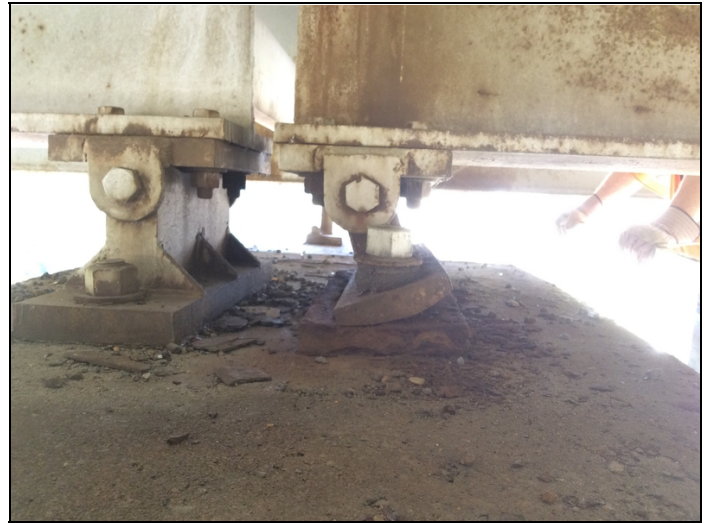
Span 13 bent 14 bearing 5 has loose bolts and pack rust between sole plate and bottom flange of girder.

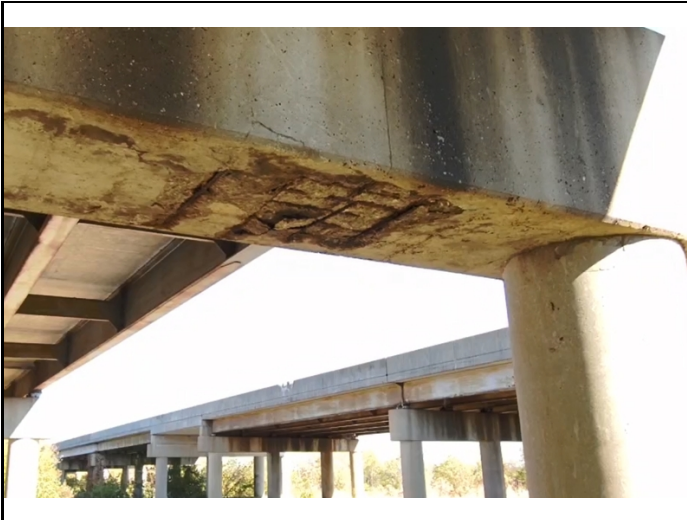
Bent 6 cap has spalls with rebar exposed on bottom near column 4.

Bent 6 has a spall with rebar exposed on bottom near column 4.

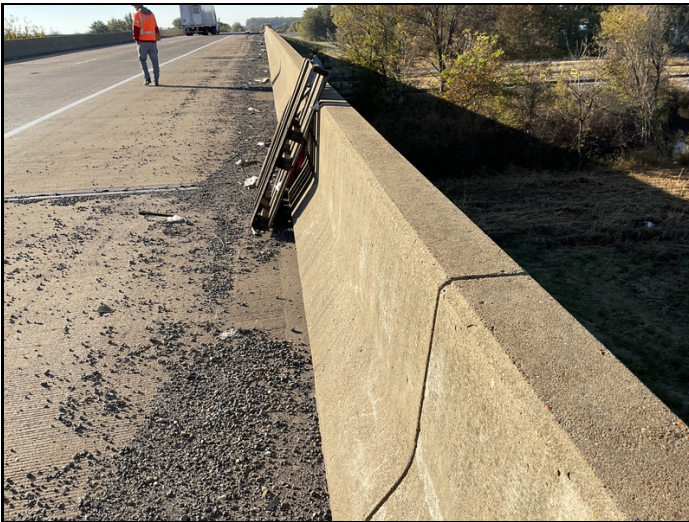
Rt gutter has debris buildup.

Debris in gutters
