**Asset #B3166(Routine)**  
**I-55NB-12-LM 66.75 over BURLINGTON,SH 239S**

**Location: 0.5 MI SO SH 18**

**Team Lead: Richard Jones, Inspection Date: 11/03/2022**

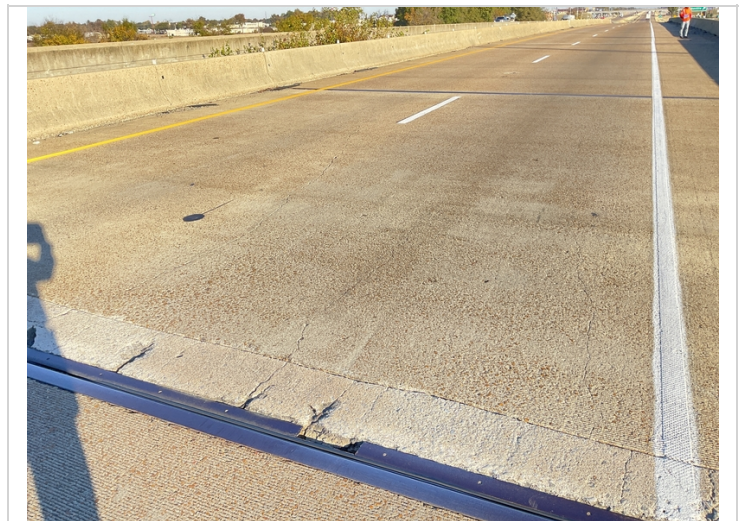
Main slab span at span 8 is patched along joint over bent 8. Slab has several unsealed cracks. Slab soffit has some efflorescence.

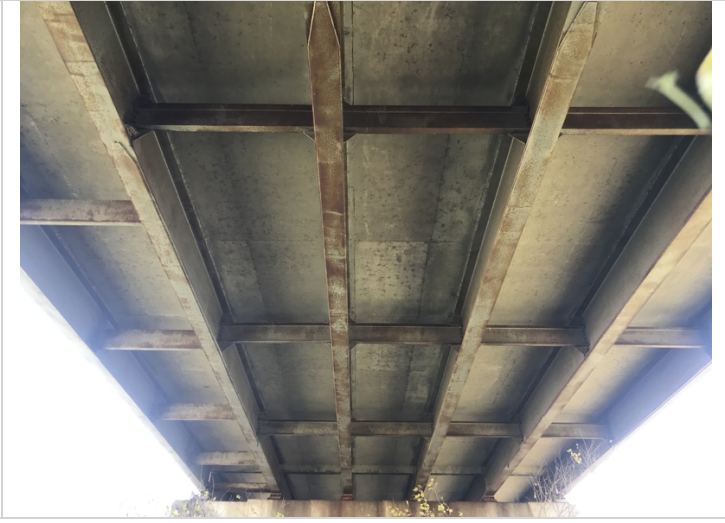
Span 2 soffit

Girders have freckled surface rust throughout. Ends of girders have flaking rust with some section loss at web below haunch.

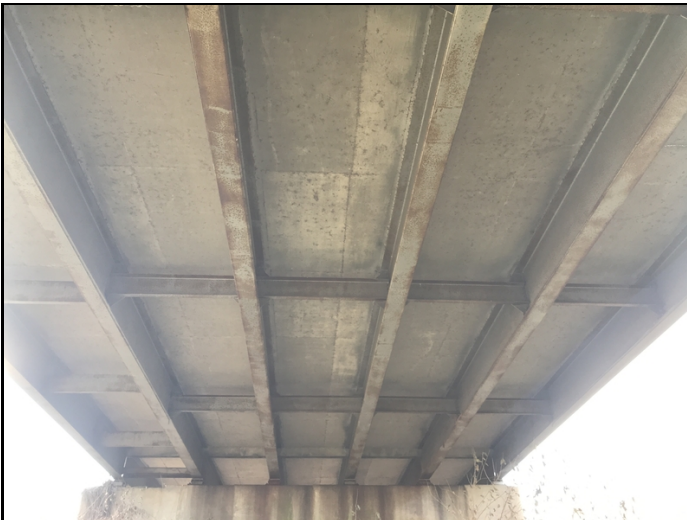
Soffit has several transverse cracks with efflorescence.

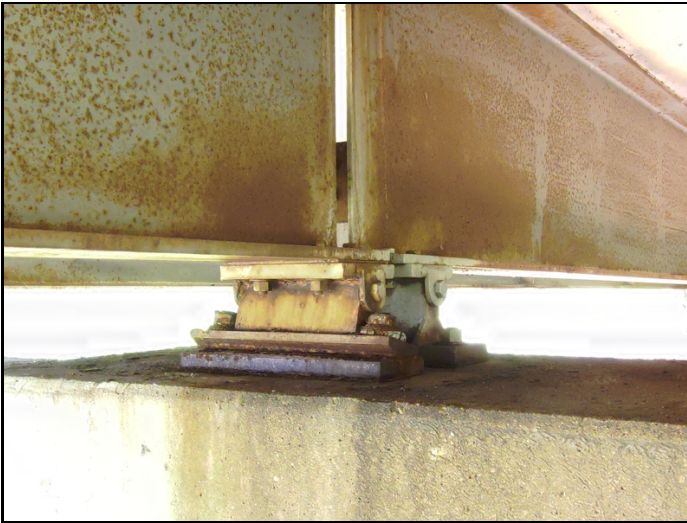
Span 2 bent 2 bearing 5

Span 2 bent 2 bearings 1 - 5 are rotated back and are near max rotation.

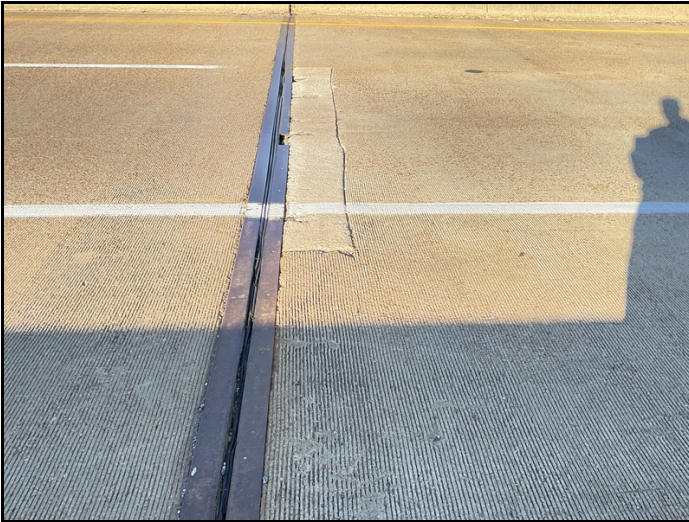
Bent 8 joint

Road irons have a few areas that are loose. Some have been partially removed at bents 8 and 11.

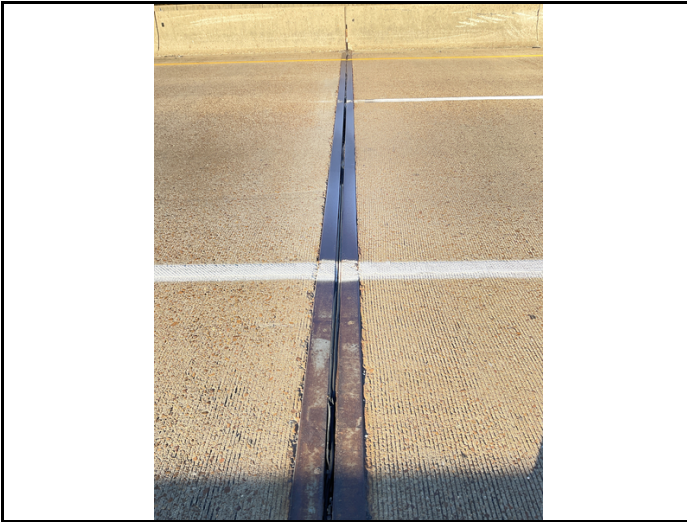
Typ joint

Compression seals have several areas that are ripped or torn and have several sections missing.

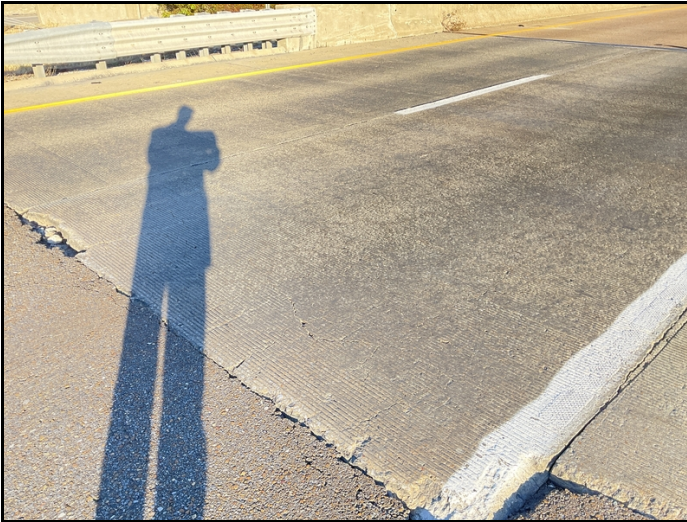
Approach slab at beginning

Approach slabs have a few unsealed cracks, and a few spalls.

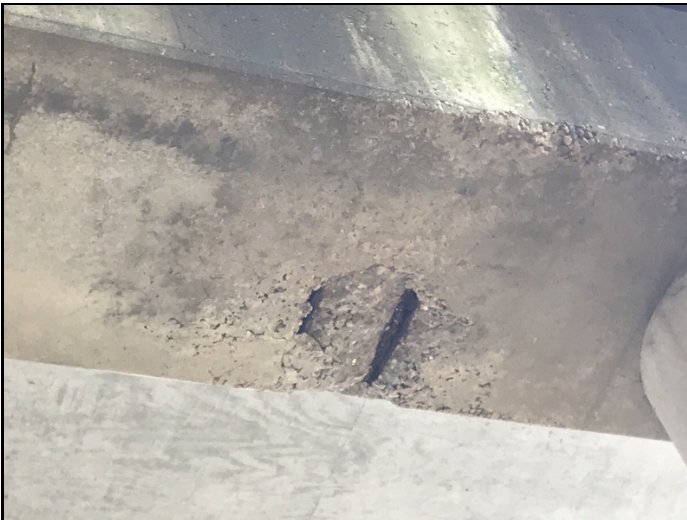
Bent 8 cap bottom

Bent 8 bottom of cap has some exposed rebar.

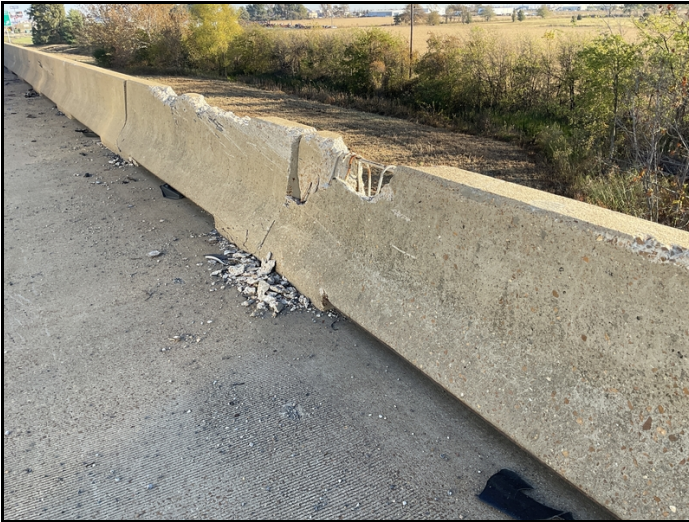
Span 10

Bridge rails have a few spalled areas from impact damage. (Span 7, Span 10)
