Asset #A3169(Routine)

I-55SB-12-LM 71.64 over PEMISCOT BAYOU

Location: .34 NO JCT SH 150

Team Lead: Richard Jones, Inspection Date: 04/04/2022

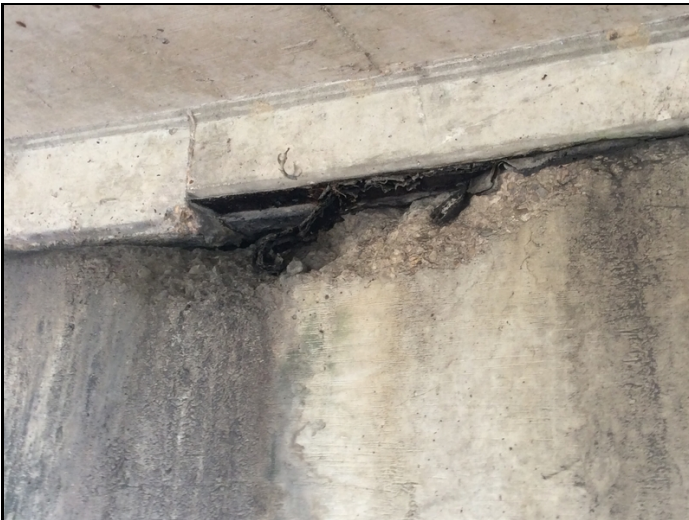
Span 2 bent 2 cap

Caps have a few minor cracks. Caps have a few spalls near key ways.

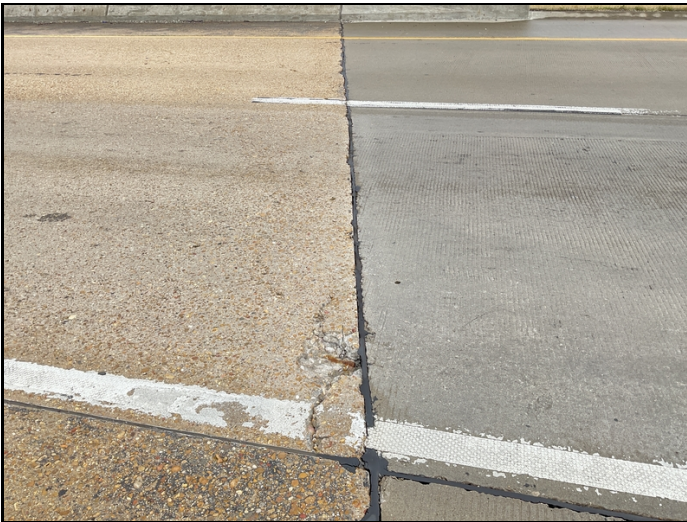
Bent 1 joint

Joint material is losing adhesion and separating with very little effectiveness.

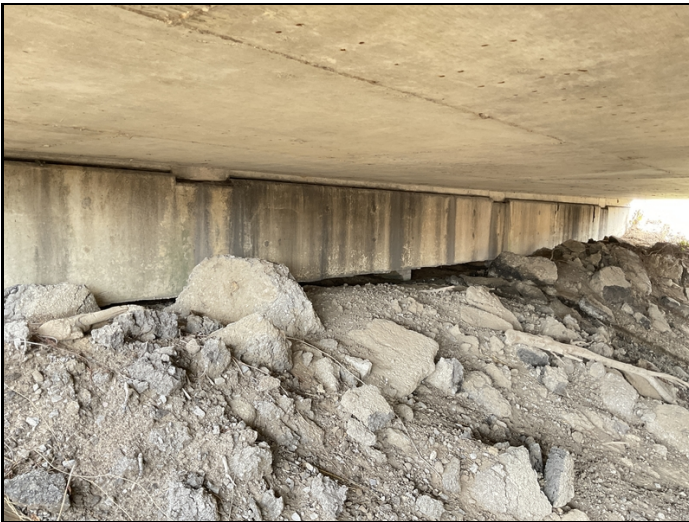
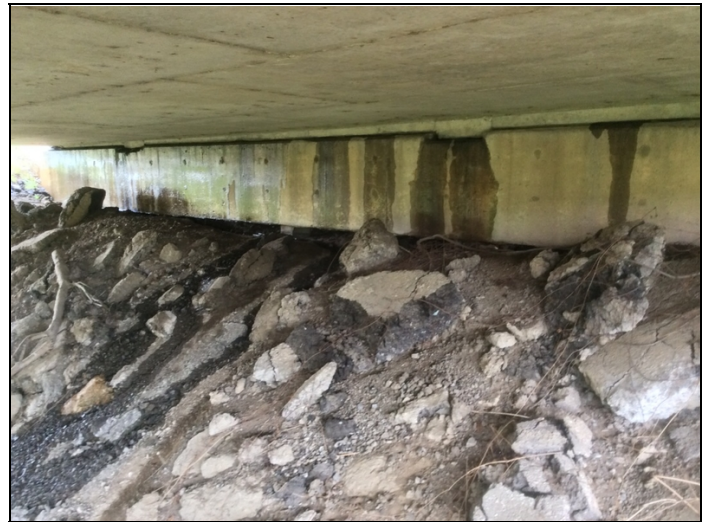
2022 - Bent 6

Bent 6 abutment is undermined for approximately 30' up to 6" below and 2' back under.

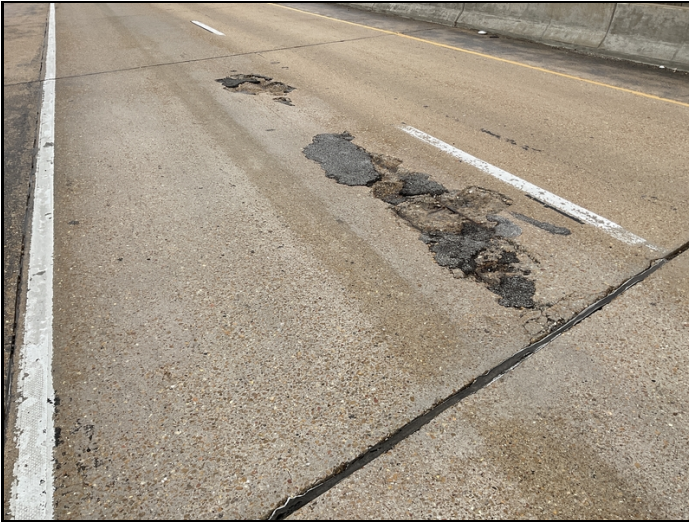
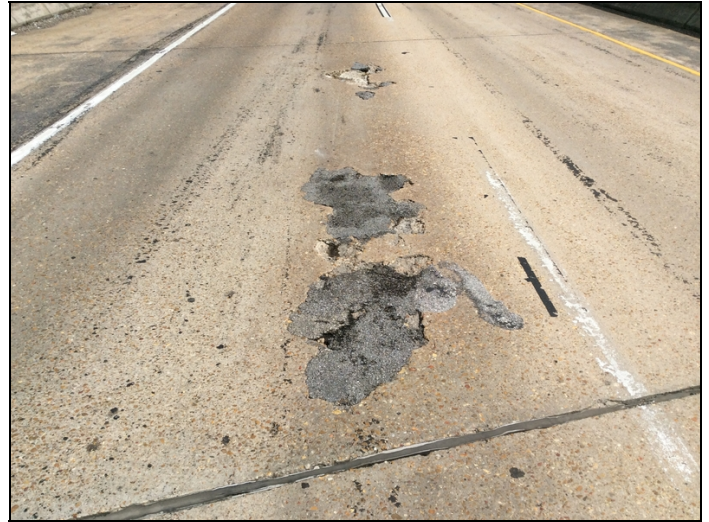
2022 - Span 2

Span 2 has a 3' x 7' and a 3' x 13' spall with rebar exposed in Lt lane. Spalls have been partially filled with cold mix.

Span 2 has a 3' x 7' and a 3' x 13' spall with rebar exposed in Lt lane.
