Asset #B3169(Routine)

I-55NB-12-LM 71.65 over PEMISCOT BAYOU

Team Lead: Richard Jones, Inspection Date: 04/04/2022

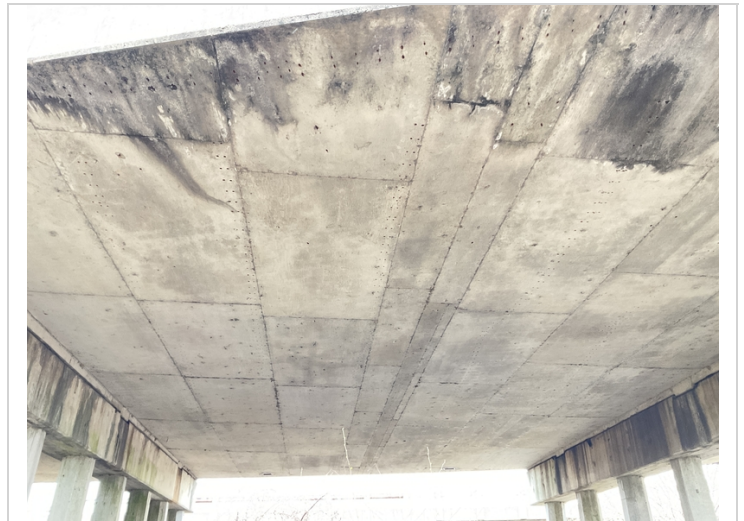
Span 4 soffit

Slab soffit has a few hairline longitudinal cracks.

Soffit has a few small delaminated areas, mostly near drain openings.

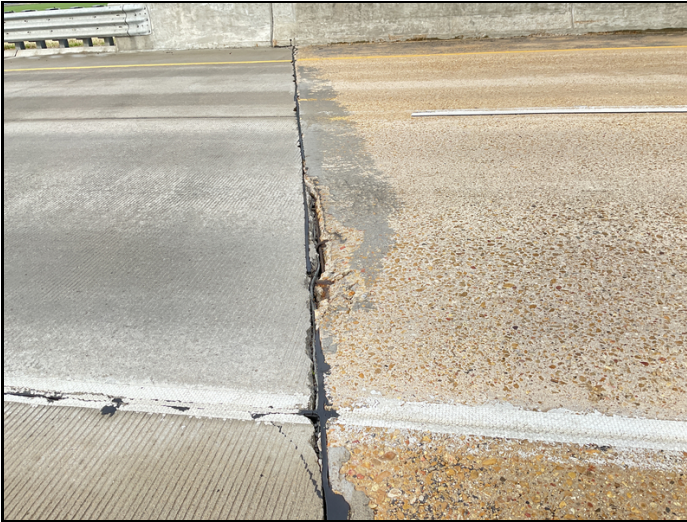
Bent 1 joint

Slabs have a few spalls with rebar exposed along joints.

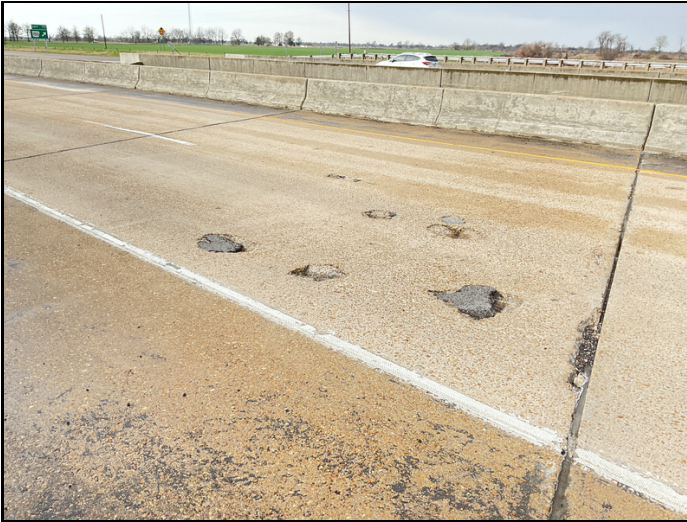
2022 - Span 4

Slab at span 4 has spalls in Rt lane with some exposed rebar.

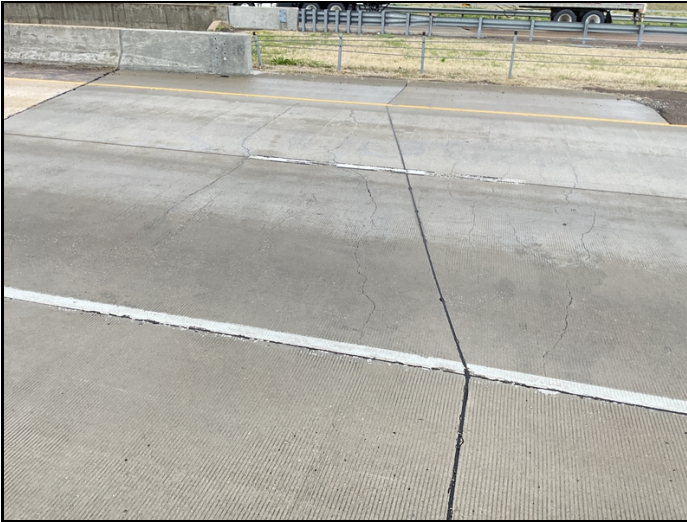
Approach slab at end

Approach slabs have several unsealed transverse cracks.
