Bridge #03285(Routine)

CR 44/911=385 over I 55-SEC 12- Log 59.75

Location: 2.31 NO JCT SH 148

Team Lead: Tim Myrick Inspection Date: October 14, 2020

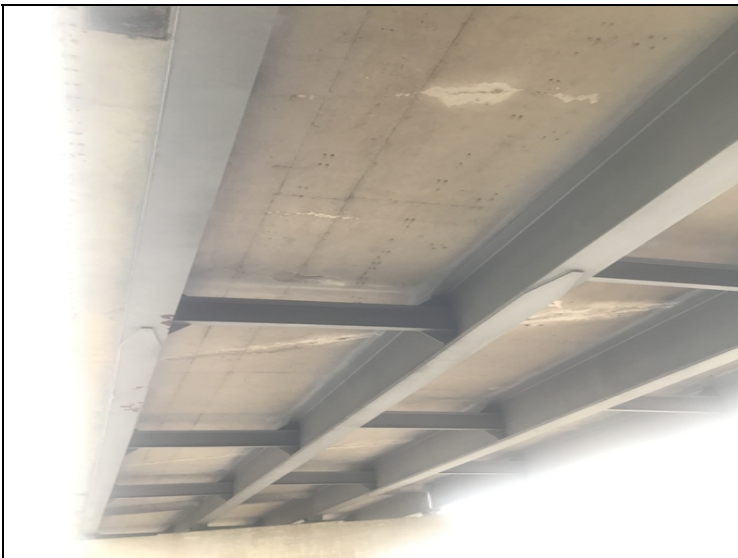
Steel Girders have been repainted by HBM. Span 2 girder 1 & span 3 girder 4 has a few minor areas of missing paint, see 2018 photo's. JFA/CWS

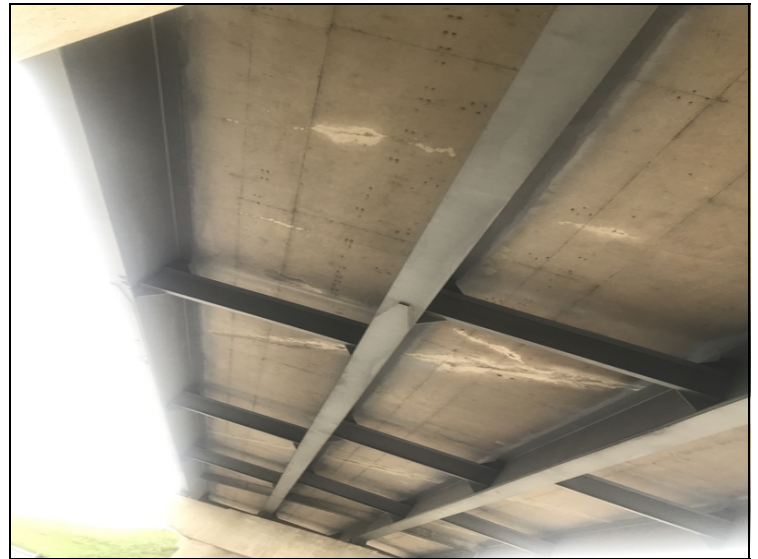
Span 2 bay 1

Span 2 Bay 1 Diaphragm Brackets 1 & 2 are bent at connection to girder with 3 bolts missing at diaphragm 1 connection, See 2010 & 2014 photos.

Span 2 Bay 1 Diaphragm Brackets 1 & 2 have been straightened & bolts replaced by HBM. JFA/CWS

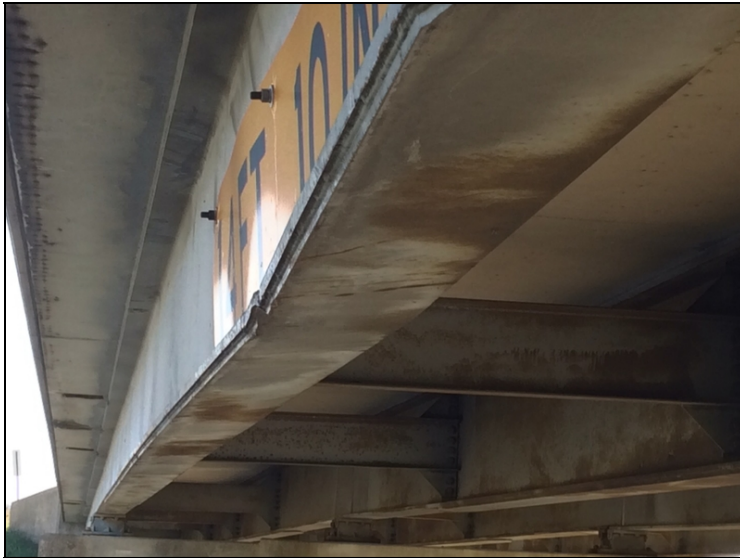
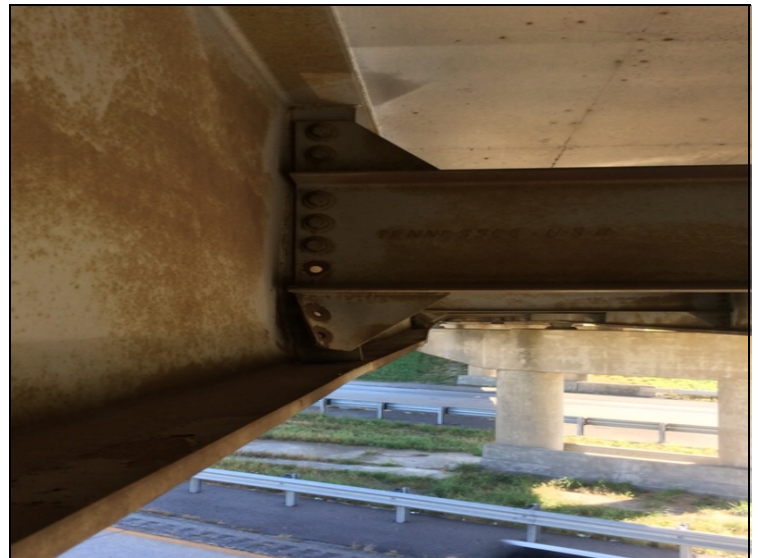
Span 2 Girder 1 is bowed in 3 to 4 inches due to collision damage, see 2014 & 2016 photos.

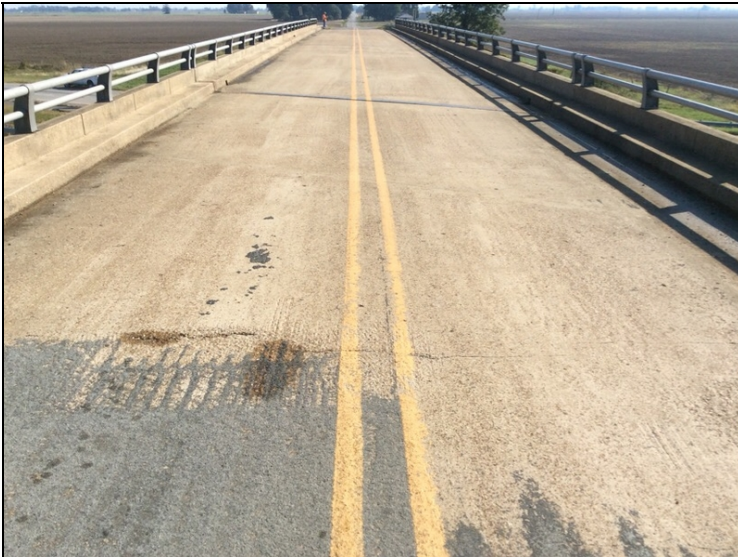
Top of Deck has some scaling with minor size and density cracks, especially Span 1.

Bottom of Deck has some cracks with some efflorescence and some delamination with, especially Span 1.

Span 3 Bottom of Deck has a 6" diameter spall with rebar exposed.

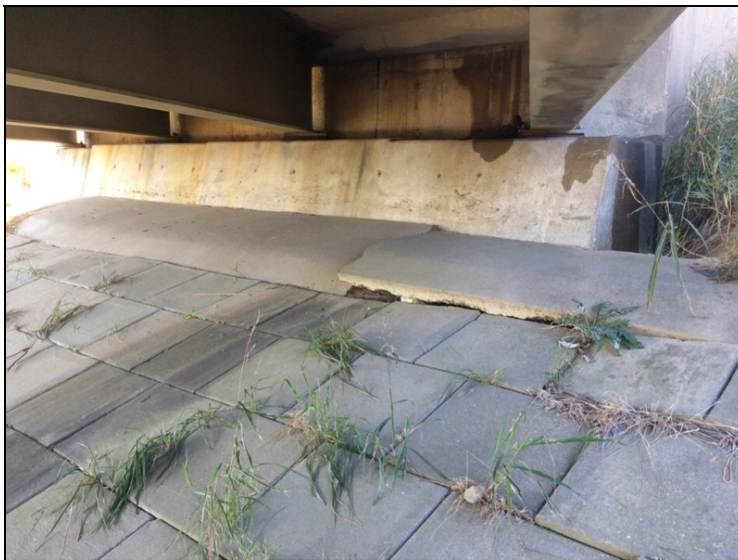
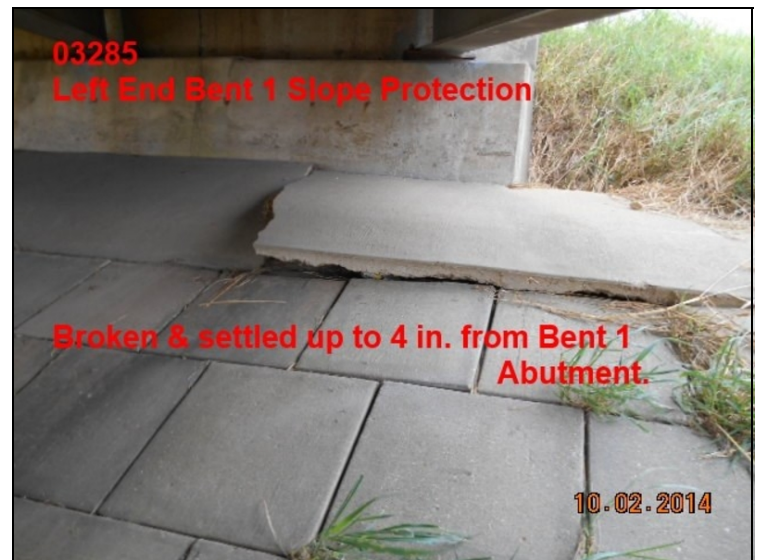
Concrete Slope Protection under Span 1 is broken and settled up to 4 inches from Bent 1 Abutment, see 2014 & 2016 photo.

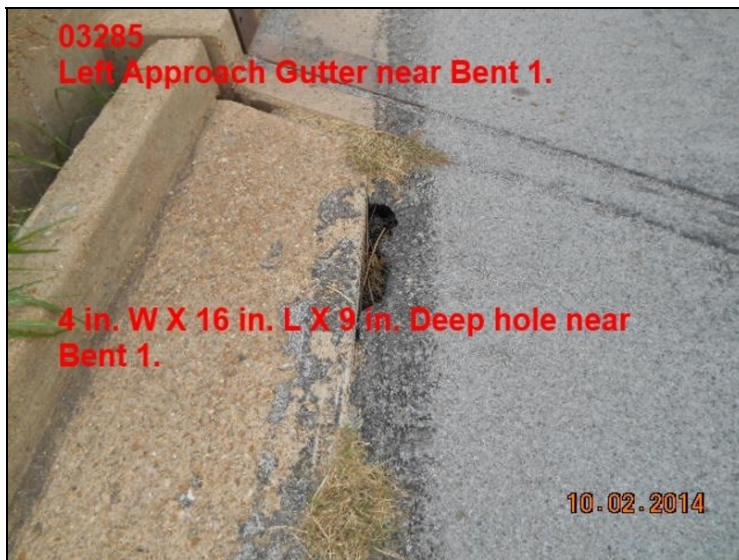
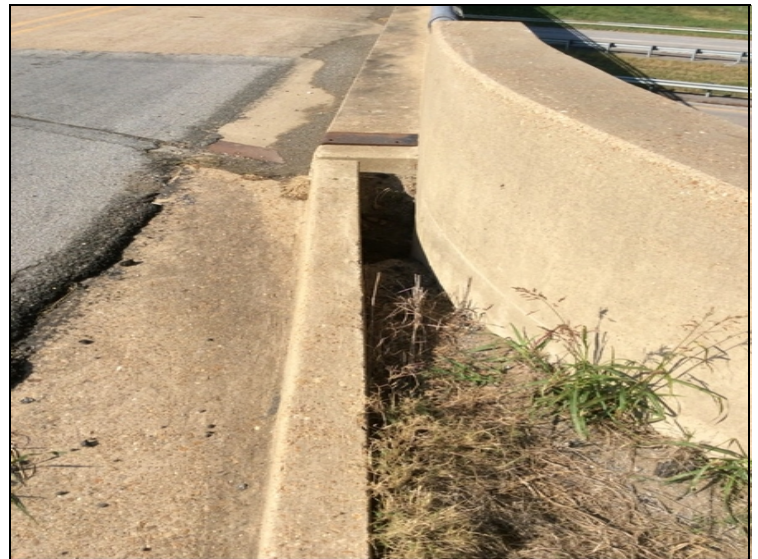
Left Approach Gutter near Bent 1 has a 4" x 16" x 9" deep hole in asphalt approach.
Left Approach Gutter near Bent 4 has a 9" x 18" deep void, see 2016 photo of location.

Hole at bent 1 approach has been repaired. Observed at inspection. 10/16/2018 JFA/CWS .

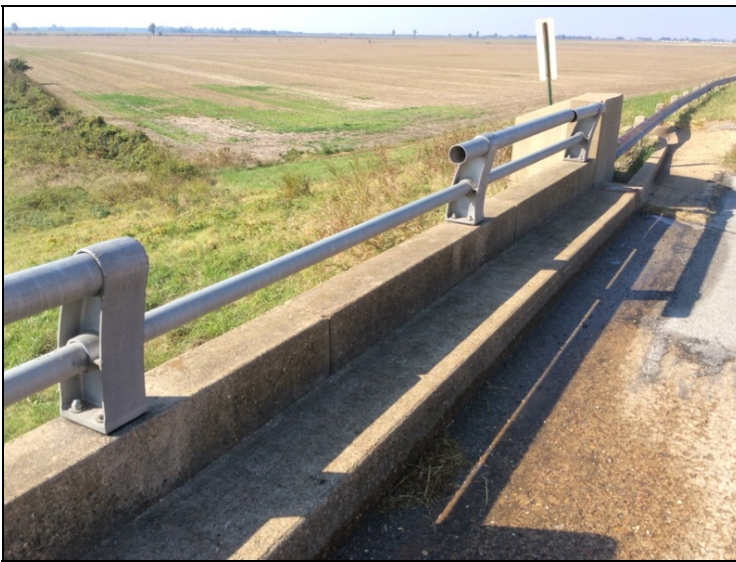
Several sections of Bridge Rail (mostly top rail) is loose, set screws need to be tightened and the right side of Span 1 has 8ft. of Top Rail missing and the left side of Span 4 has 10' ft. of rail with one end dropped down, see 2016 photo of Span 1.
