District 10, Mississippi County

Bridge #03287 (Routine)
SH 312-01- LM 4.13 over I 55-SEC 12

Team Lead: Tim Myrick Inspection Date: October 14, 2020

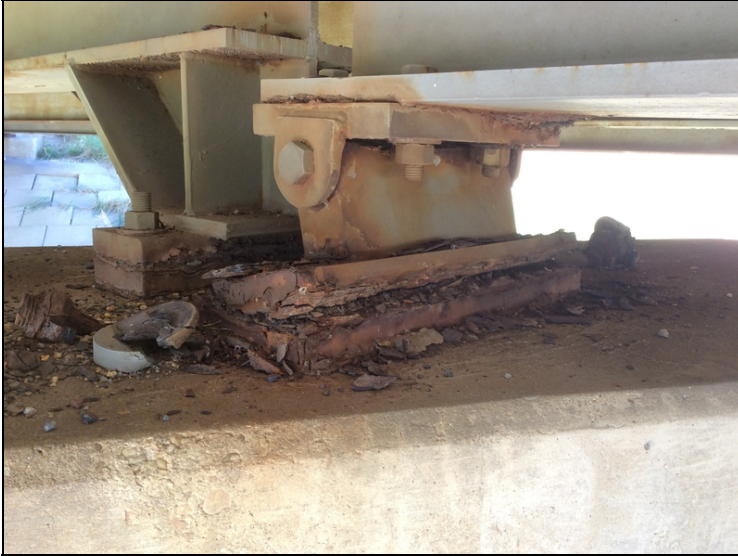
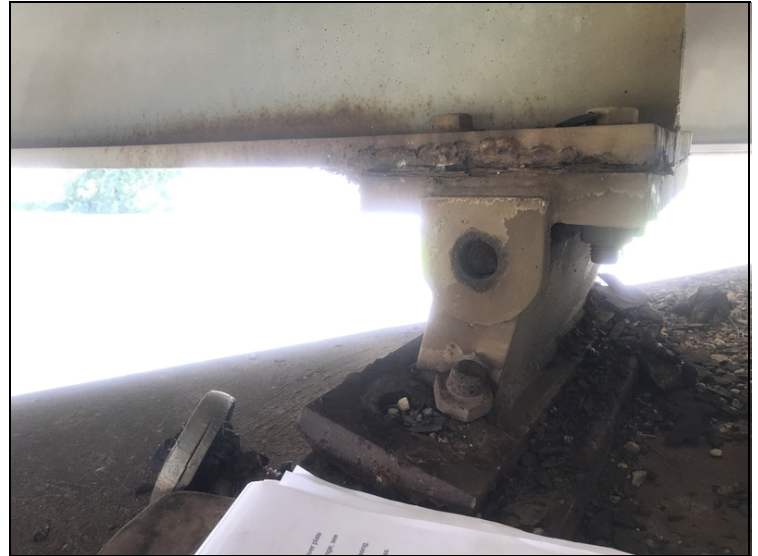
Bents 1 thru 5 has majority of bearings rusted with pitting and some have up to 1/8 in section loss.
Bents 1, 2, 4 & 5 has majority of bearing plates have pack rust between bearing plate and masonry plate.

Span 2 Bent 2 Bearing 4 Girder plate connection dog ear weld is broke, see 2016 photo. 1 Cap bolt between bearing & girder is broke, see 2018 photo.

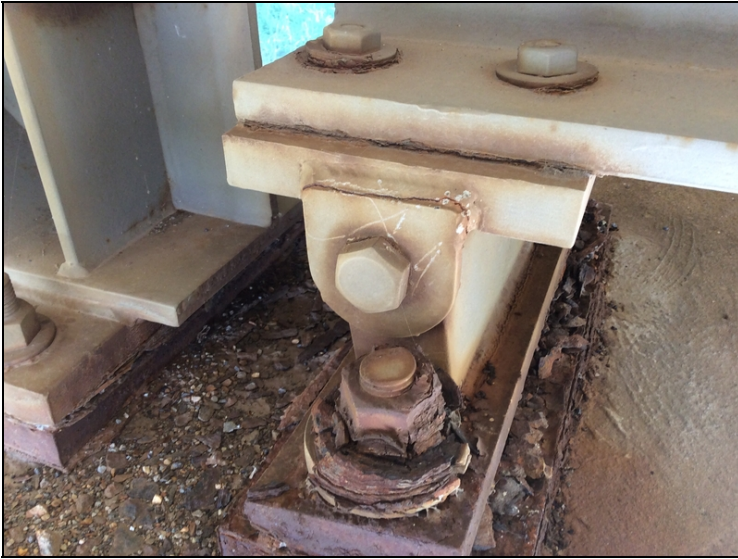
Span 2 bearing 3 at bent 3

Several Anchor Bolts missing:
Span 2 Bent 2 Bearings 2&5 has 1 each
Span 2 Bent 2 Bearing 3 has 2
Span 2 Bent 2 bearing 4 has 2.
Span 3 Bent 4 Bearing 2 has 1
Span 3 Bent 4 Bearings 3&4 has 2 each

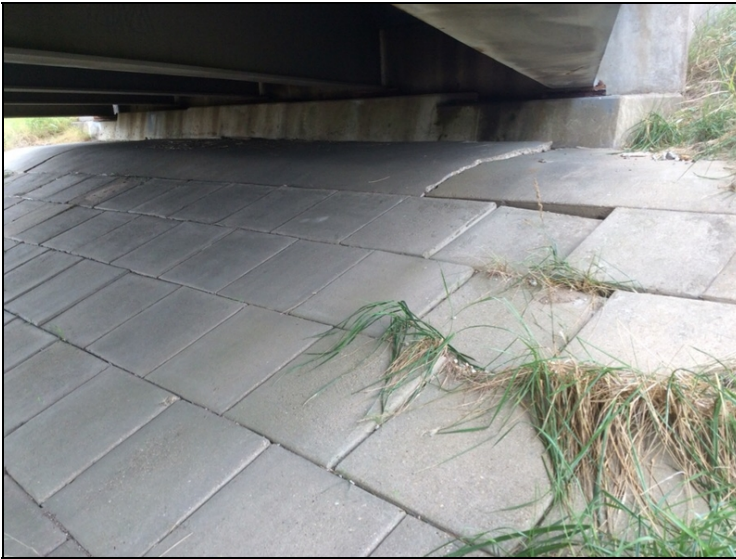
Concrete slope protection near Bt's 1 & 5
some settlement, cracking and separating from abutment, 3 inches typical.

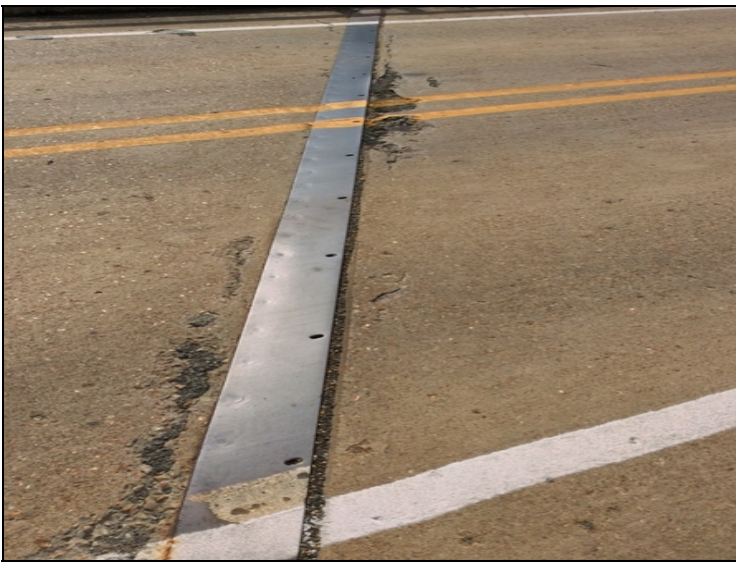
Concrete Deck, adjacent to road irons, Bents 2, 3 & 4 has a few spalled areas and delamination, see 2016 photo.

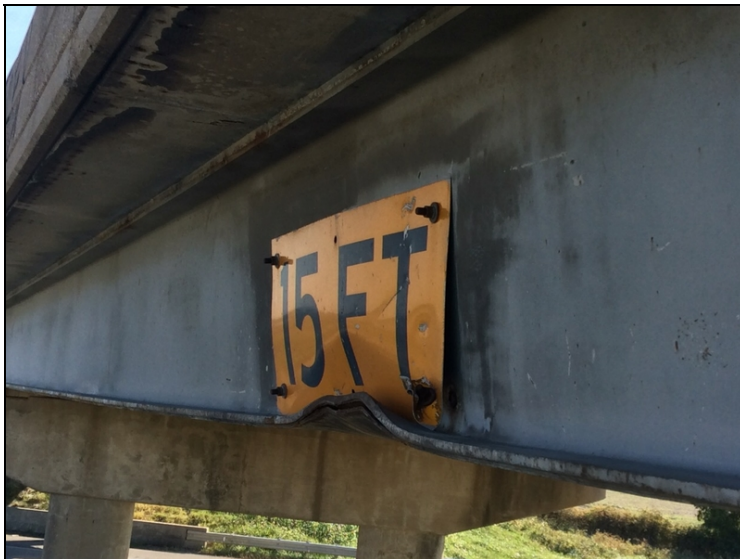
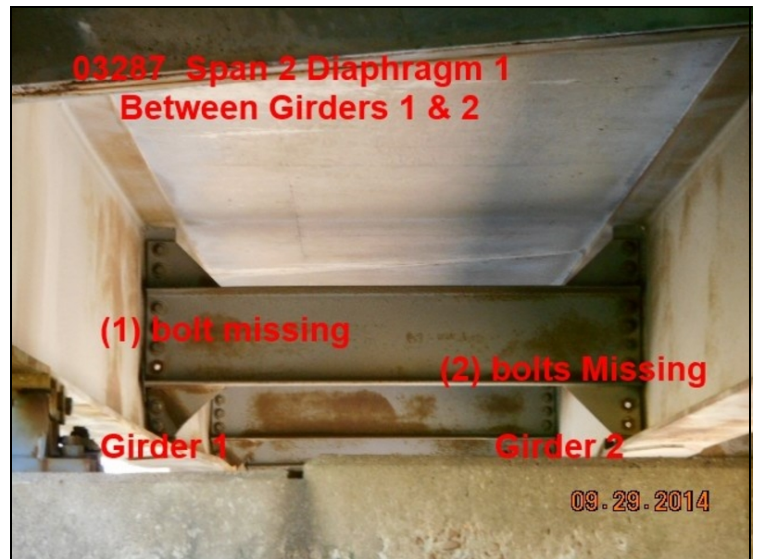
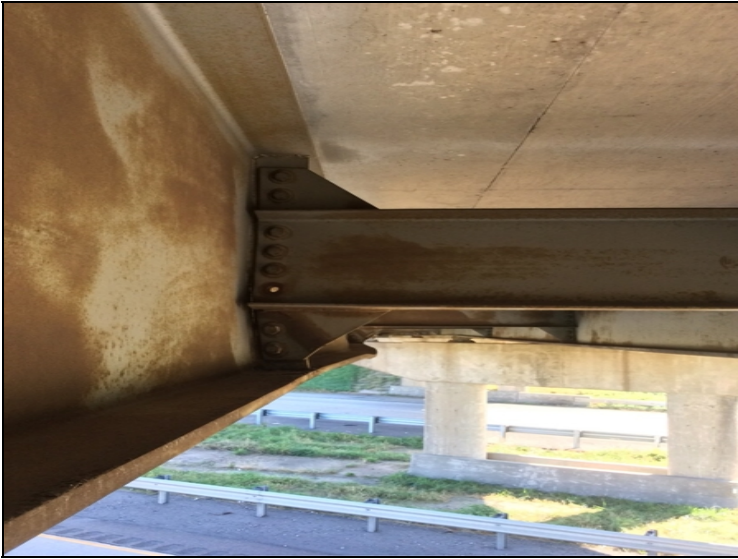
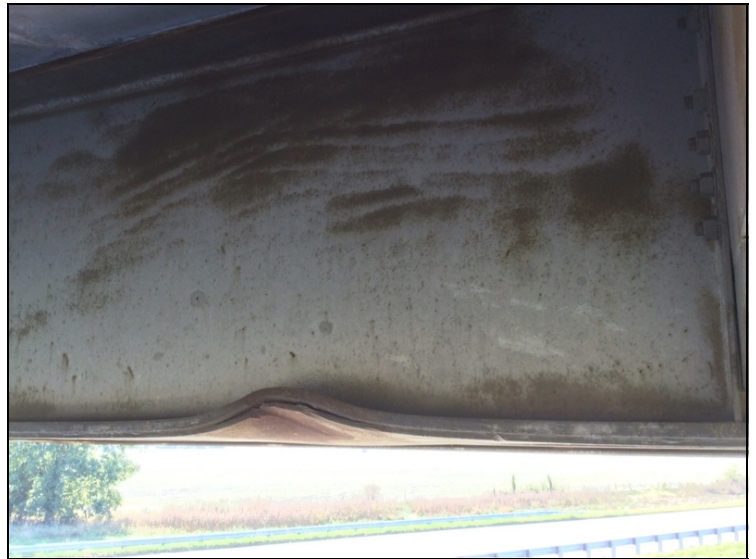
Span 2 Girder 1 has a 3in. bow in girder due to collision damage with a crack between cover plate and bottom flange as reported in 1992 inspection, see 2016 photo.

Span 2 Girders 2&5 has collision damage with a crack between cover plate and bottom flange, see 2016 photo.

Span 2 Bay 1 Metal Diaphragm 1 between Girders 1&2 has 3 diaphragm connection bolts missing, 1 at Girder 1 and 2 at Girder 2, see 2016 photo.

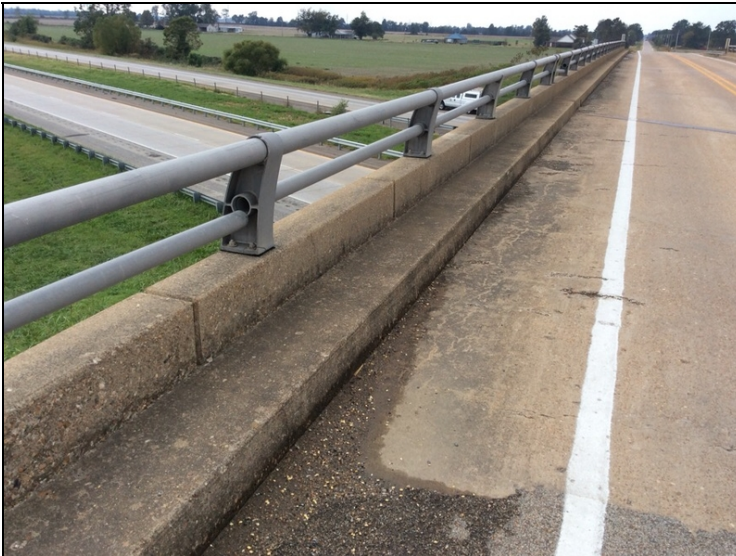
Left & right side Span 3 Metal Railing has some collision Damage, 1 Post is cracked and Broke with some railing hanging down and loose, see 2016 photo.

Right side Span 4 Metal Railing has some collision Damage, 2 Post are cracked and Broke.
