Bridge #A3284(Routine, Underwater type 2)
I-55SB-12-LM 57.99 over DRAINAGE DITCH NUMBER 6

Location: .55 MI NO OF SH 148

Team Lead: Alan Walter Inspection Date: June 17, 2020

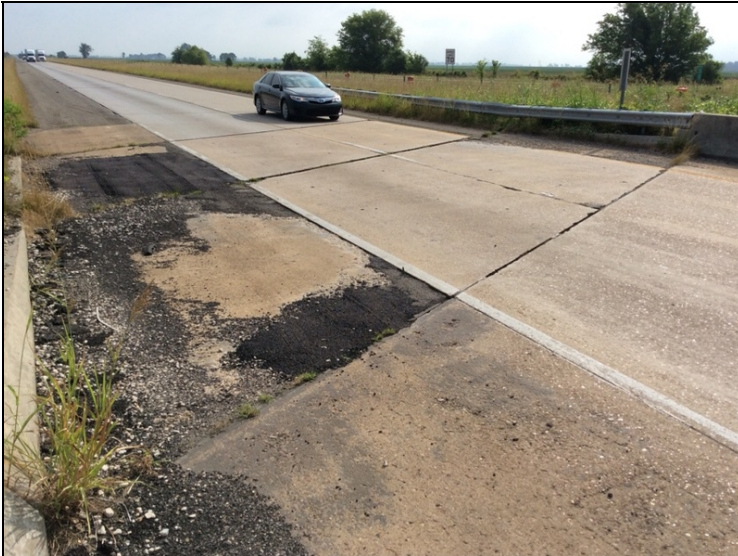
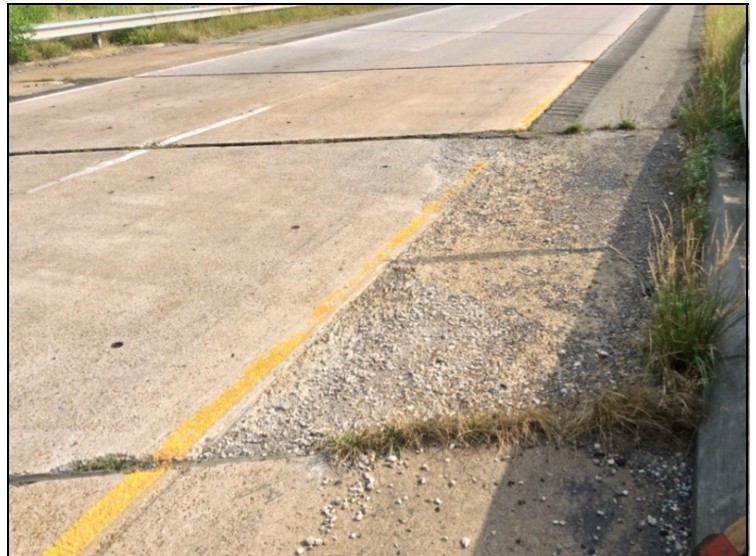
Approach Slab has some sealable cracking with a few deteriorated areas to the North Approach Slab. North Approach Slab Concrete Gutters, left & right, has heavy deterioration and up to 2in. deep spalls, see 2016 photo. Some asphalt patched areas to the left approach gutter since last inspection, see 2016 photo.

Approach Slab has some seal able cracking with a few deteriorated areas to the North Approach Slab.

North Approach Slab Concrete Gutters, left & right, has heavy deterioration and up to 2" deep spalls.

Some asphalt patched areas to the left approach gutter since last inspection.

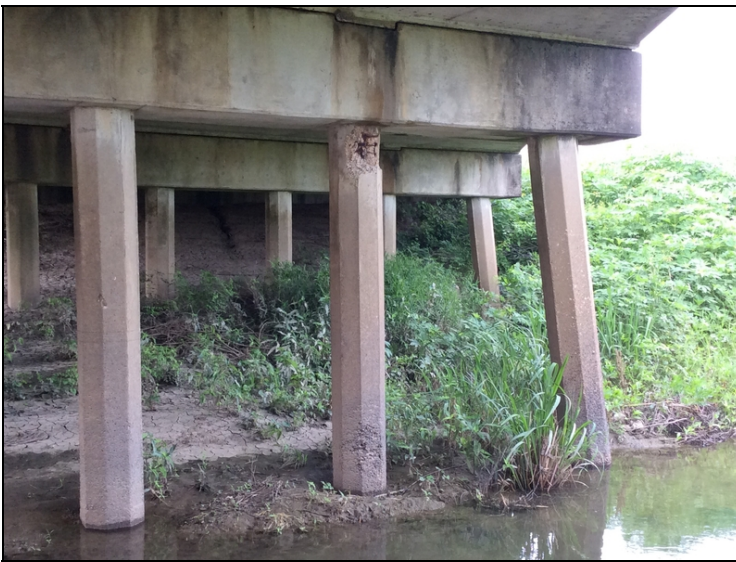
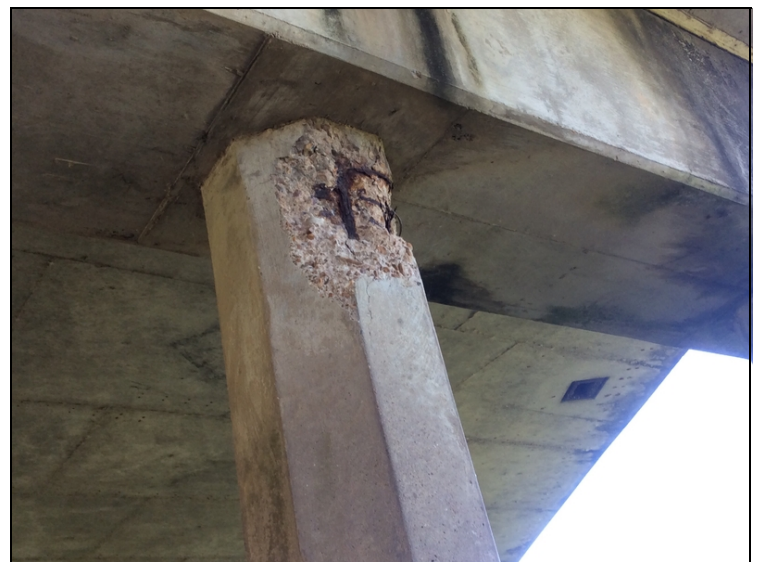
Bent 3 Concrete Pile 2 has a 1.5' X 1' X 2" deep spall with exposed reinforcement at top of pile.

Bent 3, concrete pile 2, has a 1.5' X 1' X 2" deep spall with exposed reinforcement at top of pile.

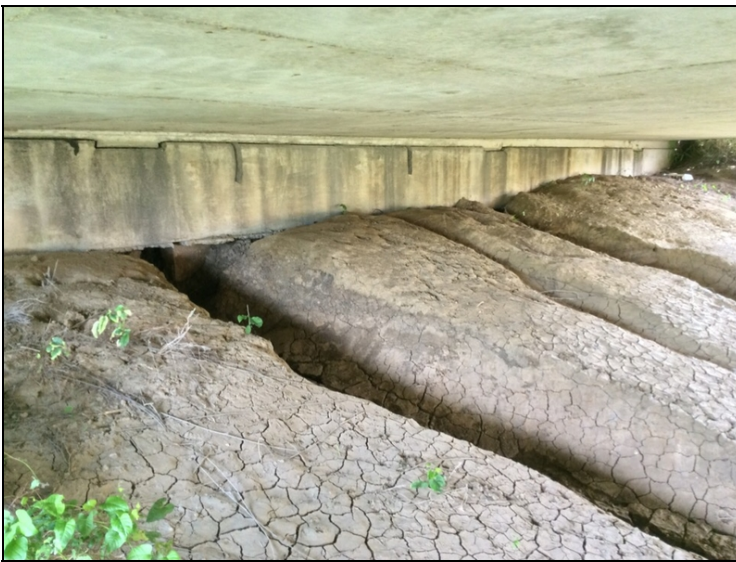
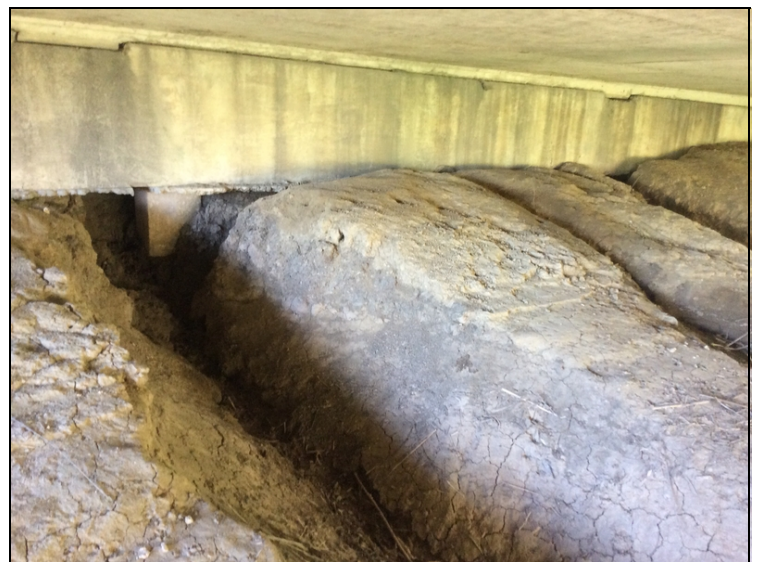
Concrete Abutment Bent 5 has some embankment erosion with up to 2.5' of undermining of cap from roadway runoff exposing Pile 2.

Bent 5 abutment has some embankment erosion with up to 2.5' of undermining of cap from roadway runoff exposing 2 piles.
