Bridge #B3284(Routine, Underwater type 2)

I-55NB-12-LM 58.00 over DITCH NO 6

Team Lead: Alan Walter **Inspection Date:** June 17, 2020

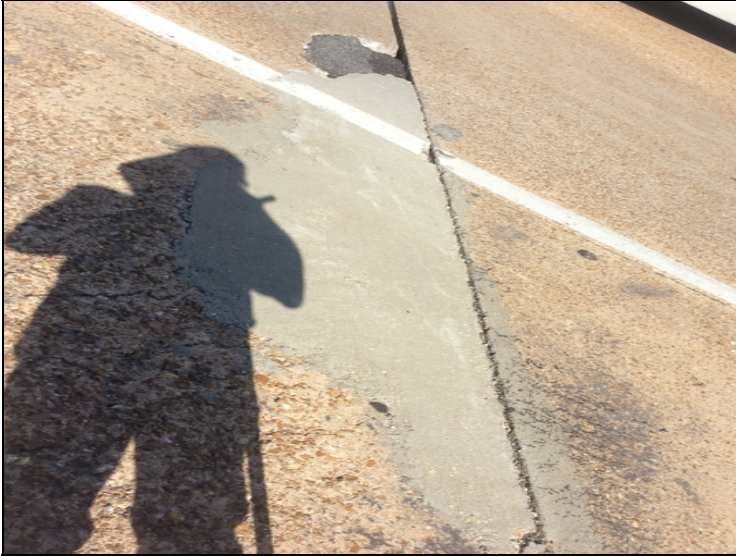
Top of concrete slab has several open unsealed cracks and medium scale.
Left side of slab spans 1 & 2 at Bent 2 has some minor scrapes from impact damage.
Top of slab span 1 has a 6" x 12" spall in the right lane.
Span 2 right lane bent 3 has a 1' diam. spall filled with asphalt.
Top of slab span 3 has a 12" x 12" spall and a 6" diameter spall with no exposed rebar.

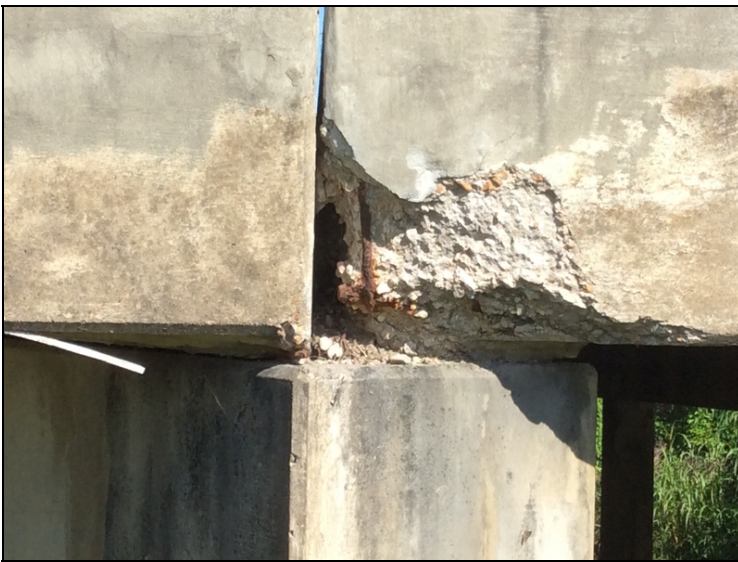
Span 2 slab over bent 2, right side has a 2.5' x 14" x 12" deep spall with exposed rebar.

Soffit portion of slabs have some hairline cracks.
Span 2 bent 2 right side has a 2 1/2' x 14" spall with rebar exposed.
