Bridge #A3286(Routine)

I-55 SB-12- 60.29 over DRAINAGE DITCH NO. 20

Team Lead: Tim Myrick Inspection Date: August 05, 2020

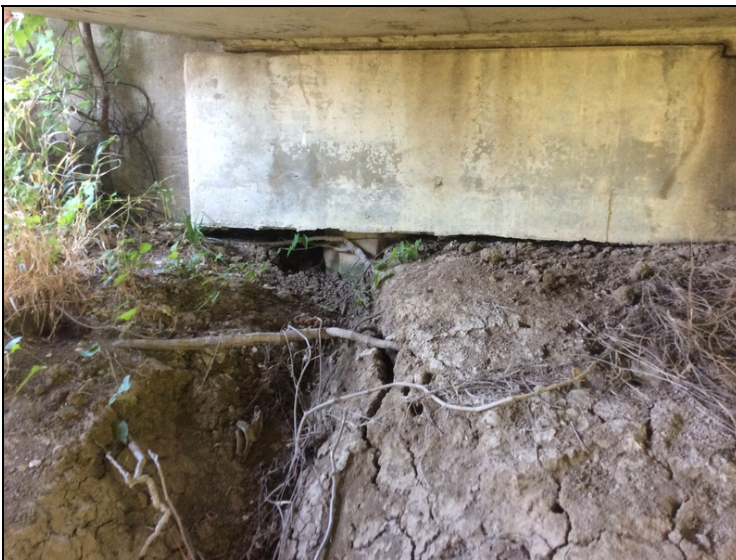
Abutment Bent 4 has slope erosion from roadway runoff and it is causing some undermining to left side of cap exposing piling(up to 1 ft.) with some undermining on right side of cap, up to 6in. of exposure.

Bent 4 abutment has slope erosion from roadway runoff causing some undermining to left side of cap exposing piling (up to 1 ft.) with some undermining on right side of cap, up to 6" of exposure.

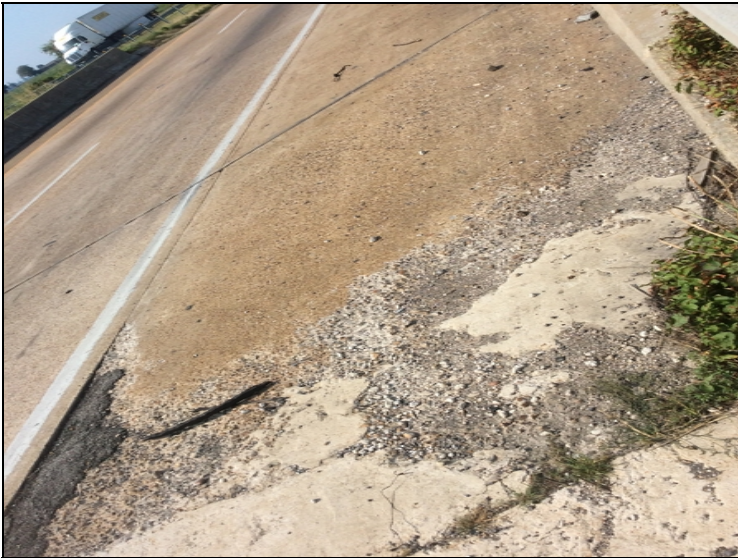
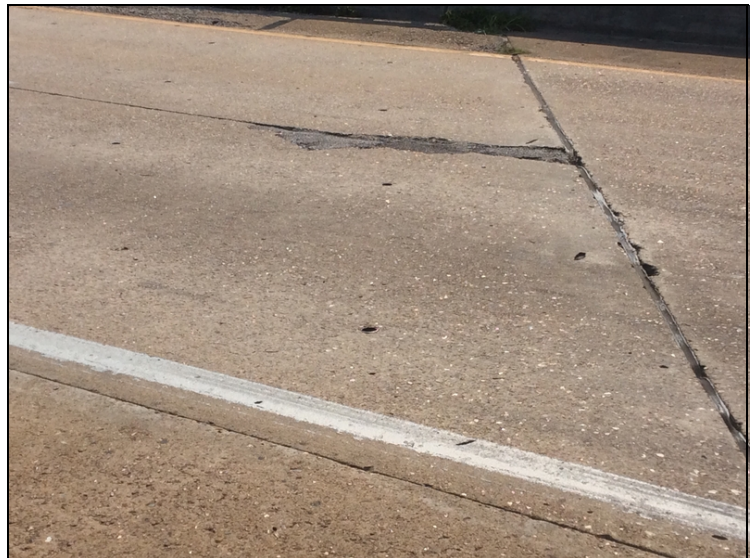
Approach slabs & gutters heavy scaling and/or spalling top of approach slabs & gutters 3 ft.- 4 ft. wide x 1 in.- 2 in. deep typical, retaining water

A few spalled out areas in approach slabs have been patched, some patches are beginning to fail.

Approach slabs & approach gutters have heavy scaling and spalling 3' - 4' wide x 1" - 2" deep, retaining water.

Approach slabs have spalled & patched areas, some patches are beginning to fail, see photo of bent 4 (North) approach slab.

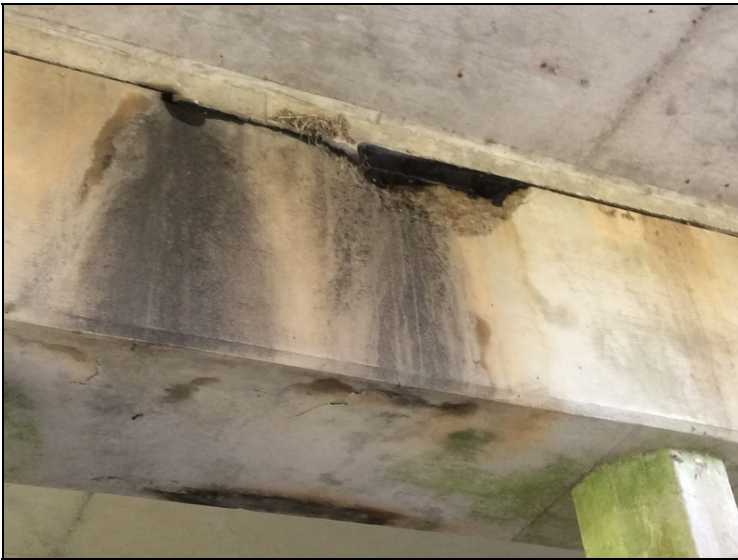
Span 2 side face of bent 2 cap near center line at key way has a spalled area 2' x 1' with no exposed rebar.

Span 2 side face of Cap Bent 2 near center line at key way has a spalled area 2' x 1' x 4" deep with no exposed rebar.

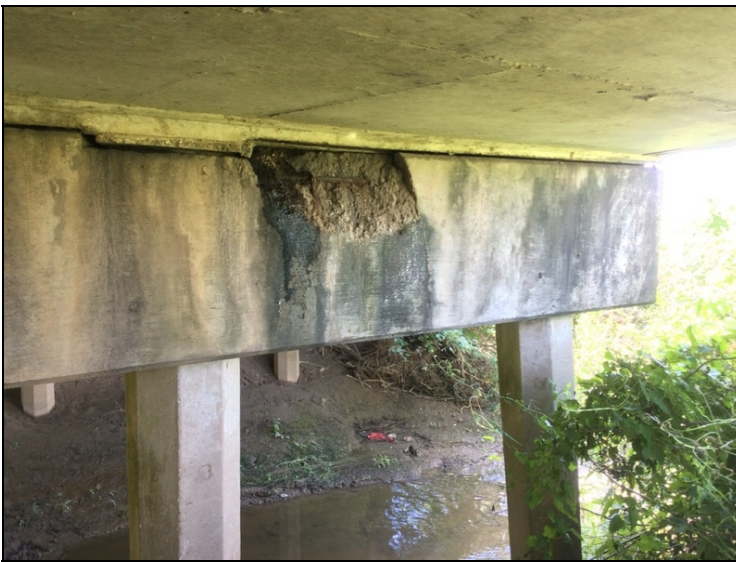
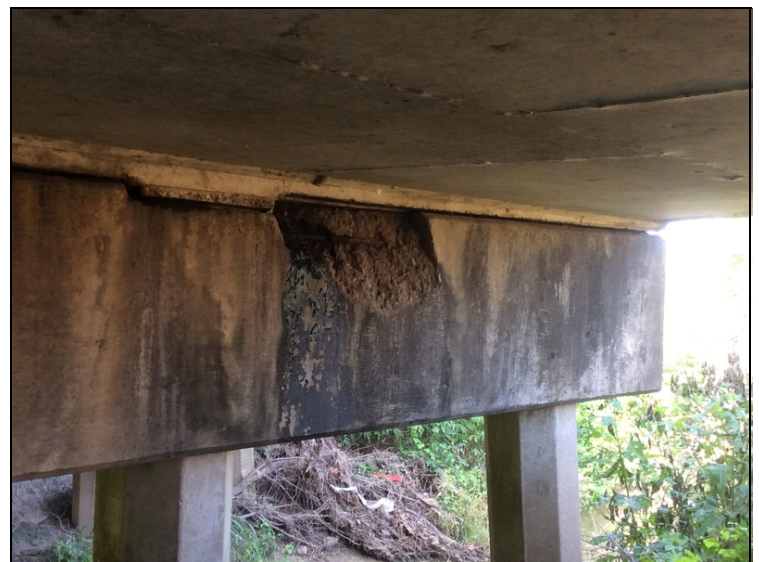
Bent 3 cap span 3 side at left key way has a 3' x 2' x 6" deep spalled area with exposed rebar.

Bent 3 cap Span 3 side at left key way has a 3' x 2' x 6" deep spalled area with exposed rebar.
