Bridge #B3286(Routine)

I-55NB-12-LM 60.30 over DITCH NO 20

Location: 2.87 MI N JCT SH 148

Team Lead: Tim Myrick Inspection Date: August 05, 2020

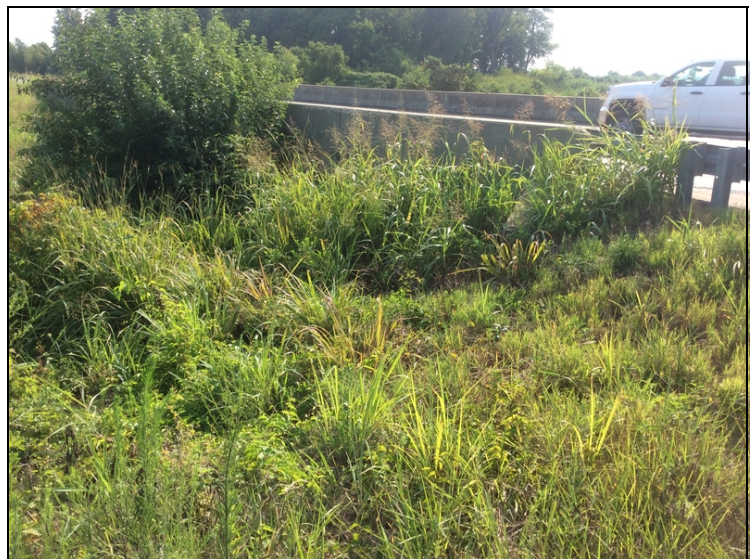
Some minor embankment erosion under Spans 1 & 3.
Left end of bent 4 is beginning to undermine abutment up to 2' back under cap, exposing 1' of pile 1.
Heavy vegetation & trees growing in channel & around bridge restricting channel flow.
4.7 ft. loss of pile penetration at bent 2 since 1992.
