Asset #02474(Routine)

SH 135-01-LM 15.09 over Right Chute Little River

Location: 2.12 Mi S Craighead CoLn

Team Lead: Tim Myrick, Inspection Date: 11/01/2022

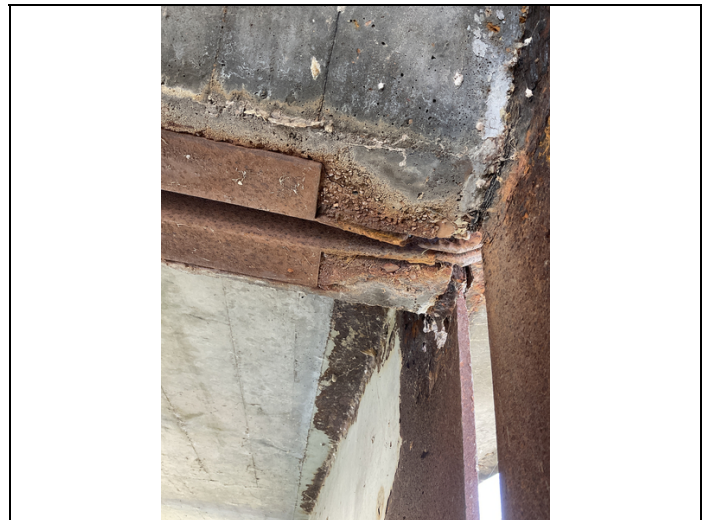
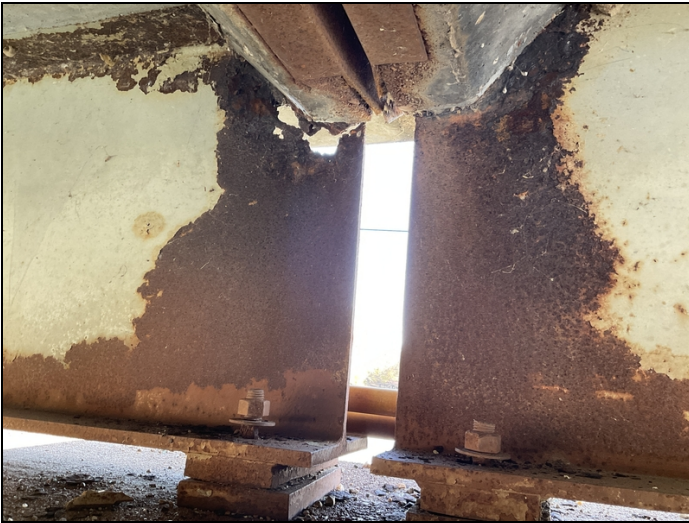
S12&11 b12 g5

Span 12 bent 12 girder 5 has a 7" x 6" area of heavy section loss, with a 6" x 3" hole in web below haunch. Web has some distortion due pack rust.

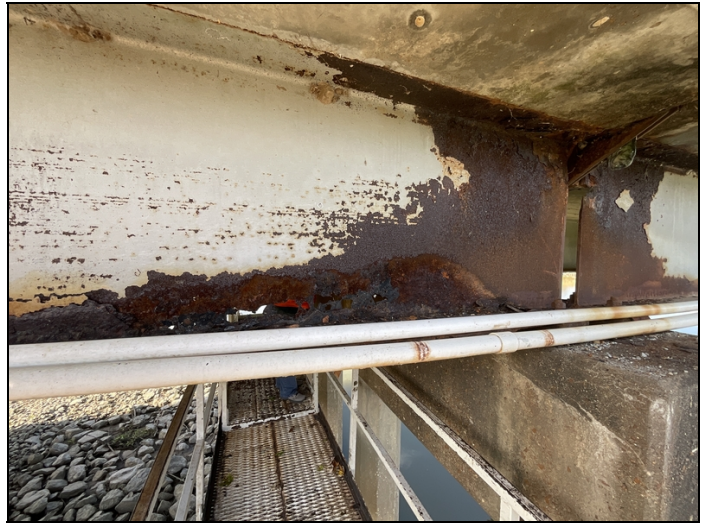
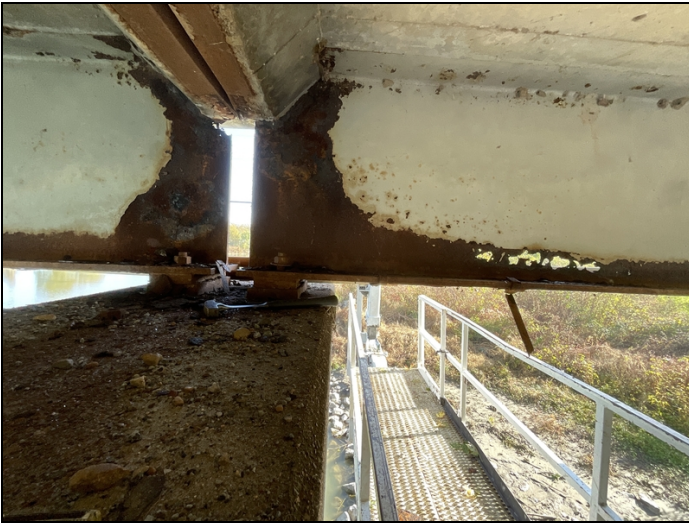
S7&8 b8 g5

Span 7 Bent 8 Girder 5 has a 24" x 8" area of heavy section loss along bottom of web with multiple holes rusted through 53" back from Bent 8. Outside right bottom flange has heavy section loss. A

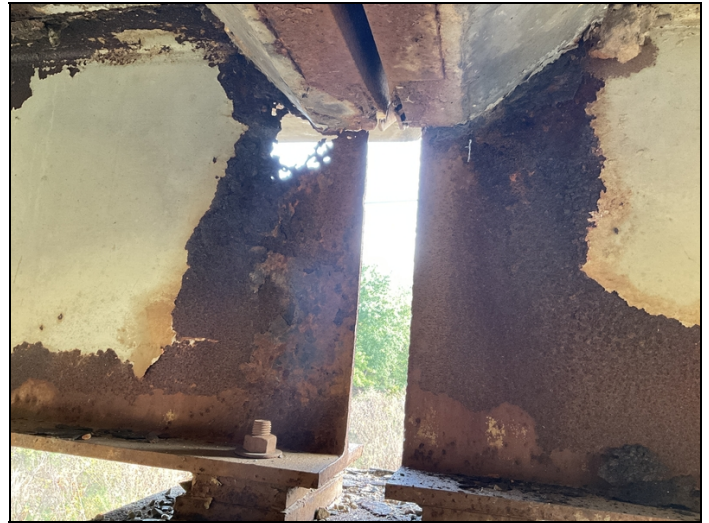
S4&3 b4 g5

Span 4 Bent 4 Girder 5 has a 7" diameter area of section loss, with a 4" x 6" hole in web below haunch. Web has some distortion due to pack rust.

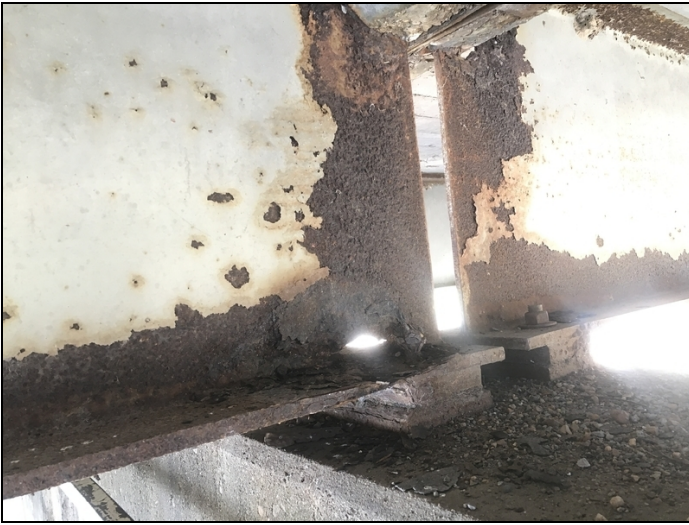
Span 13 bent 14 girder 4

Span 13 Bent 14 Girder 4 has 4" x 1" hole in bottom of web, 5" from end with a 1" crack in web.

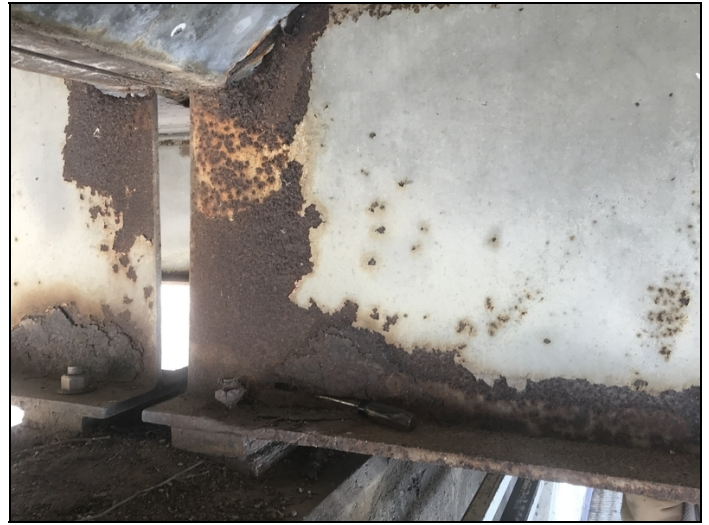
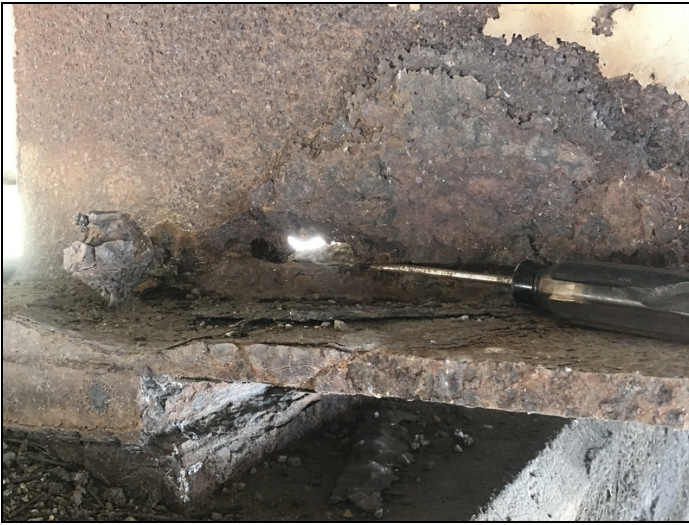
Span 13 bent 14 girder 3

Span 13 Bent 14 Girder 3 has a 4" x 1" hole in web below haunch and a 3" x 1" hole in bottom of web 6.5" from end, web is cracked 2" on span 13 end & 1" on span 14 end. A

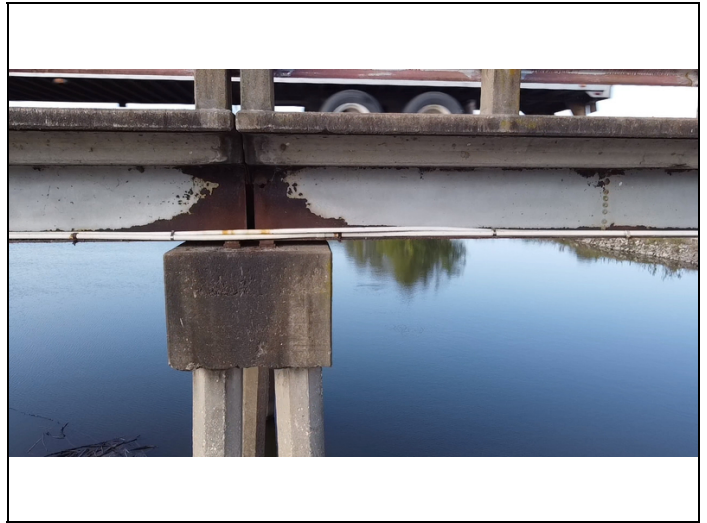
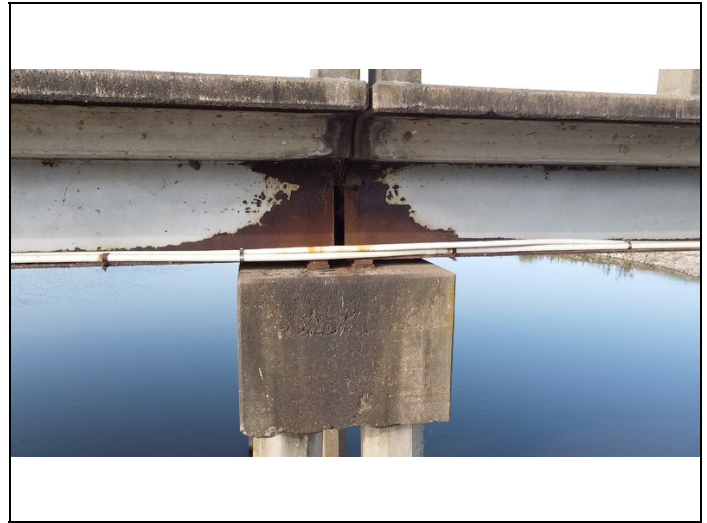
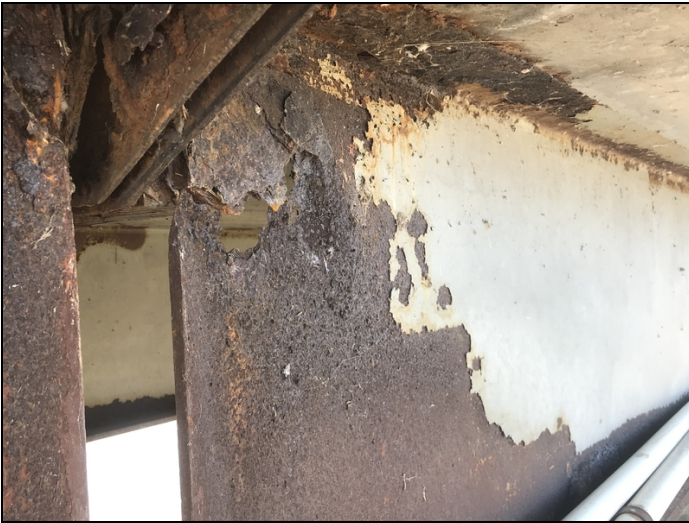
S12 b12 g5 pic 1

Span 12 Bent 12 Girder 5 has a 7" x 6" area of heavy section loss with a 6" x 3" hole in web below haunch. Web has begun to crush due to pack rust.

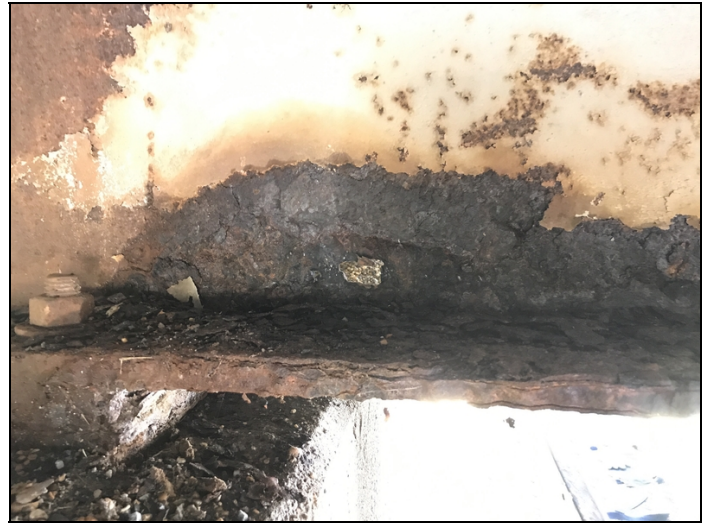
Span 2 Bent 2 Girder 3 has a 8" x 2" hole in web below haunch and cracked extends to end of web. Bottom of web has a 3' x up to 5" area of heavy section loss with a 2" diameter hole 12" from end of girder.

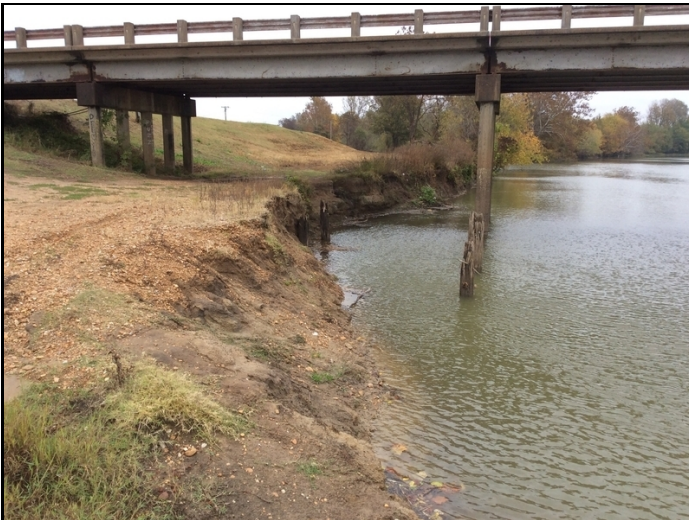
Bent 8 1-15-2020

Channel has realigned toward Bent 8, Heavy erosion with loss of embankment at this location, see channel profile, "02474 Soundings 121020.dgn". Piles have lost several feet of penetration. Repairs are currently ongoing.

Rip Rap placement/Repairs are currently ongoing. 1-14-2021 JFA/CWS

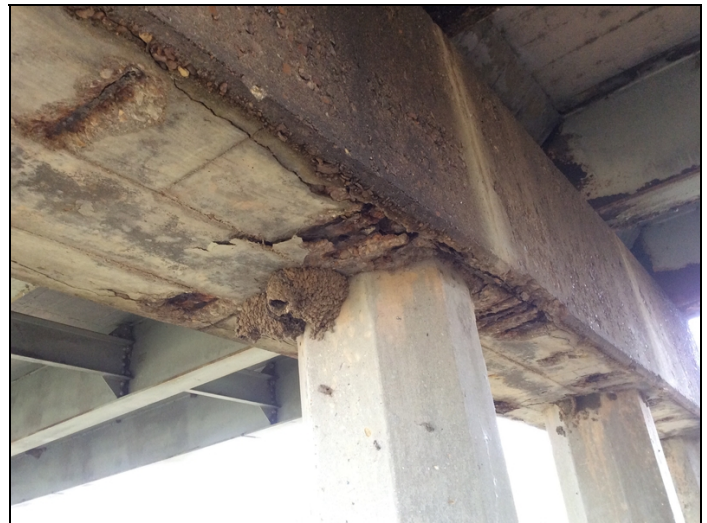
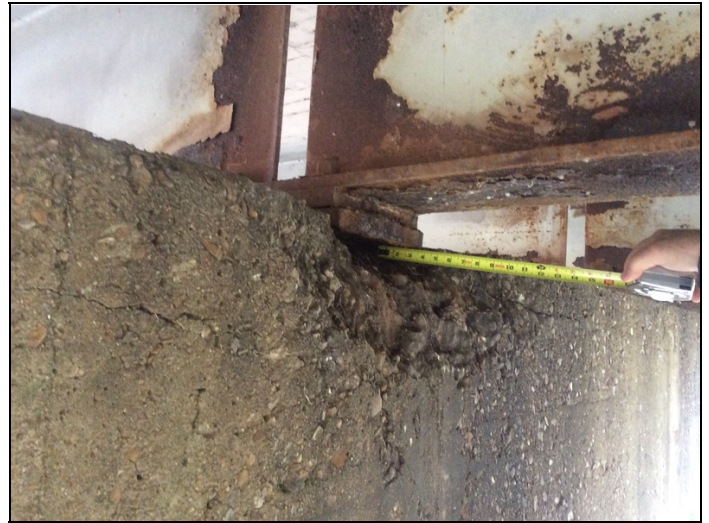
Bent 5 cap

Bent 5 Cap has a 3' x up to 8" deep spall under bearing 4 on span 4 side of cap. Cap has spalls on ahead side under bearings 3 and 4 on span 5 side with 10% loss of bearing area. Girder 3 is worse. Bearing pads have some loss of bearing area.

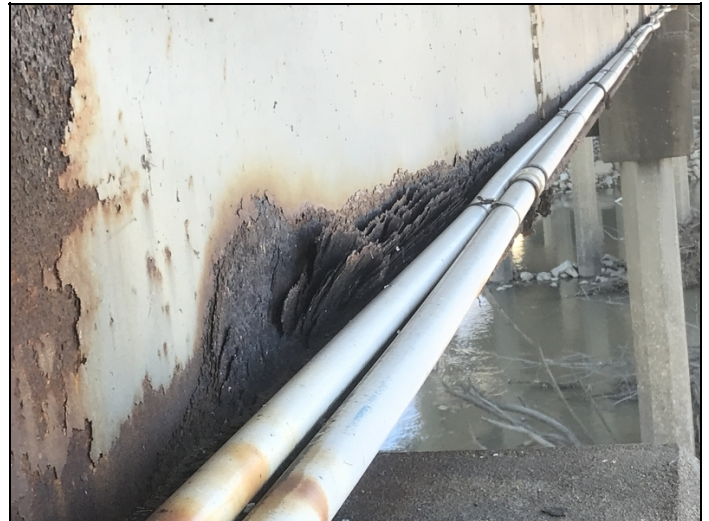
Span 11 girder 5

Several outside girders at haunch and web area has some out of plane bending due to pack rust, especially girder 5.
