Asset #02884(Routine, Underwater type 2)
SH 135-01- LM 0.99 over DEAD TIMBER LAKE
Location: .99 MI N JCT OF US 63

Team Lead: Tim Myrick, Inspection Date: 04/07/2022

SH 135-01- LM 0.99 over DEAD TIMBER LAKE

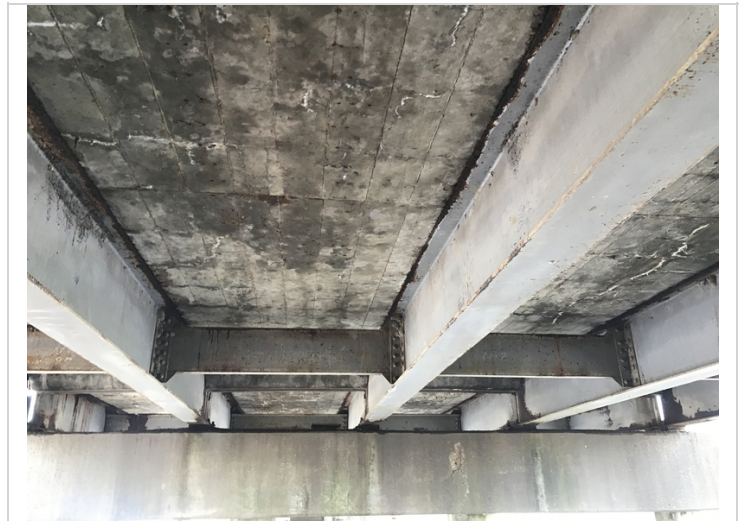
Span 5 soffit

Soffit has several areas of transverse and/or map cracking with efflorescence.

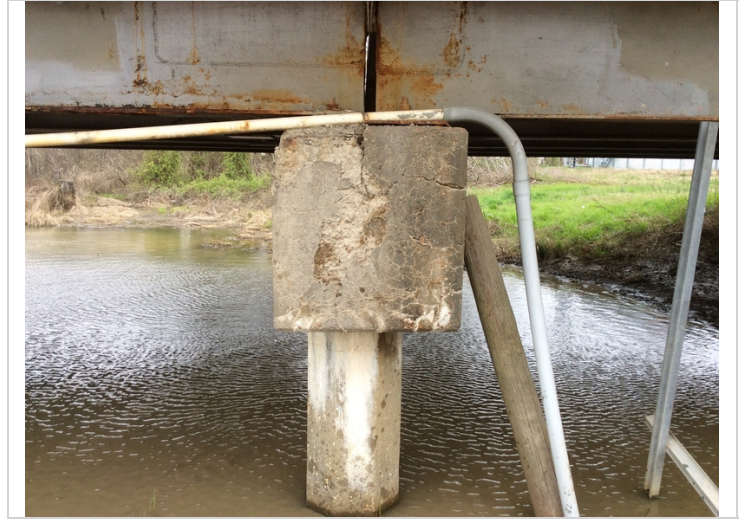
Bent 2 Cap Left

Bent 2 cap has deterioration on Lt end with rebar exposed.

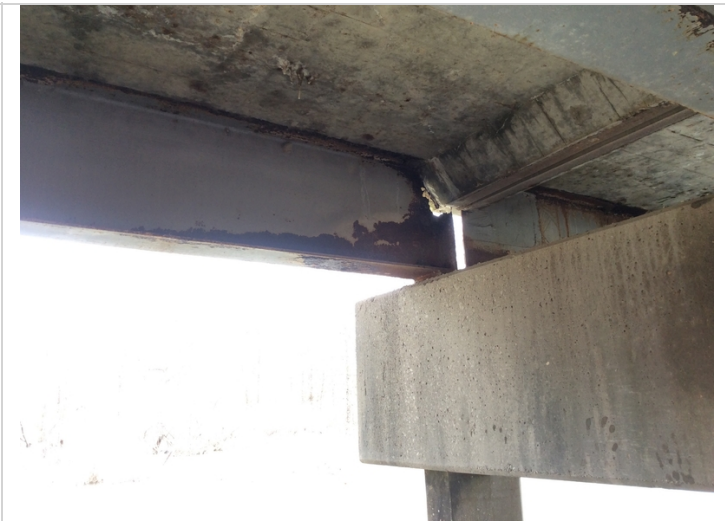
Span 5 Bent 5 Girder 5

Span 5 bent 5 girder 5 has a 1' of heavy section loss on top half of web with a 8" x 2" hole in web below haunch.

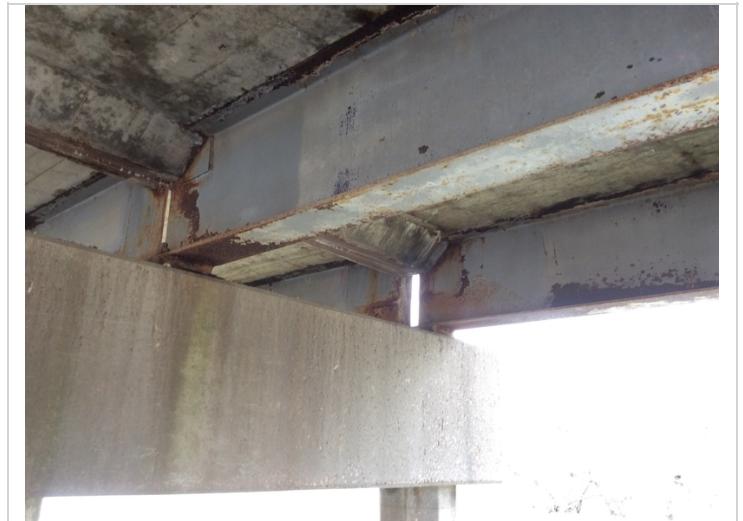
Span 2 Girders 4 and 5

Span 2 bent 3 girders 1 and 5 have splices at top of web.

Span 2 bent 3 girder 4 has plates welded over holes below haunch.

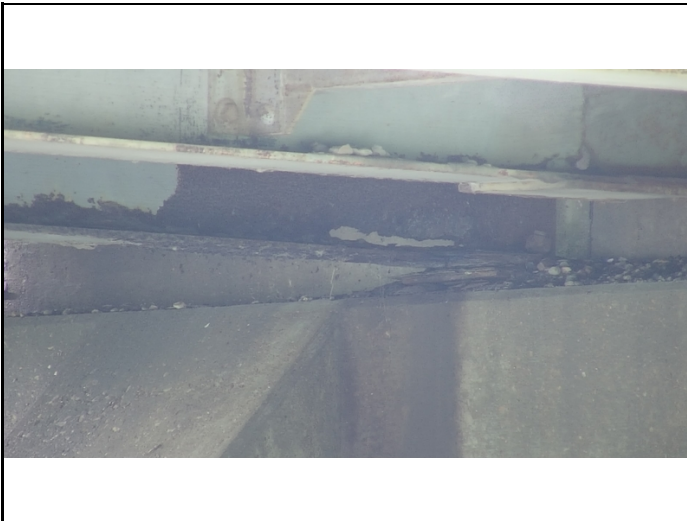
span 5 bent 6 girder 2

Span 5 bent 6 girder 2 has a 12" x 1" hole in bottom of web 1' from end of girder. Rt bottom flange has section loss near bearing (beginning to knife edge). 1' x 3" hole Lt bottom flange has 3/16" remaining on edge of bottom flange. Hole in web below haunch has been filled with weld in the past.

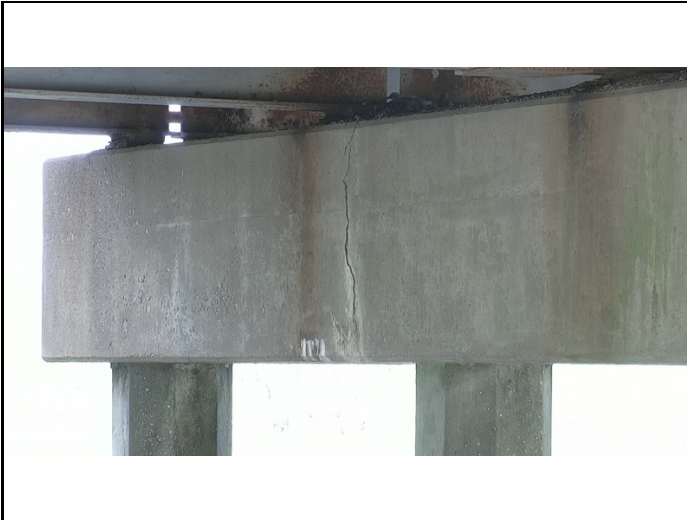
bent 4

Bent 4 cap has vertical cracks near piles 2 and 3.

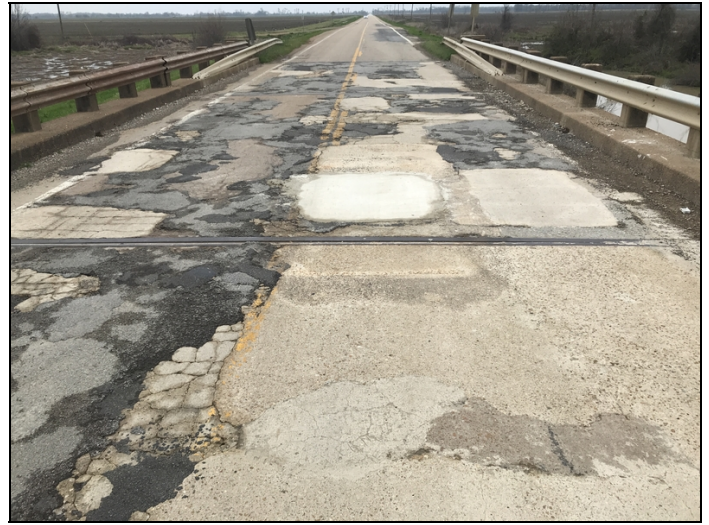
Span 4 & 5

Majority of deck is delaminated, spalled, patched, or cracked. Most patches are in fair to poor condition. Soffit has several areas of transverse and/or map cracking with efflorescence. Span 4 has 4' x 8' full depth patches in bays 3 and 4.

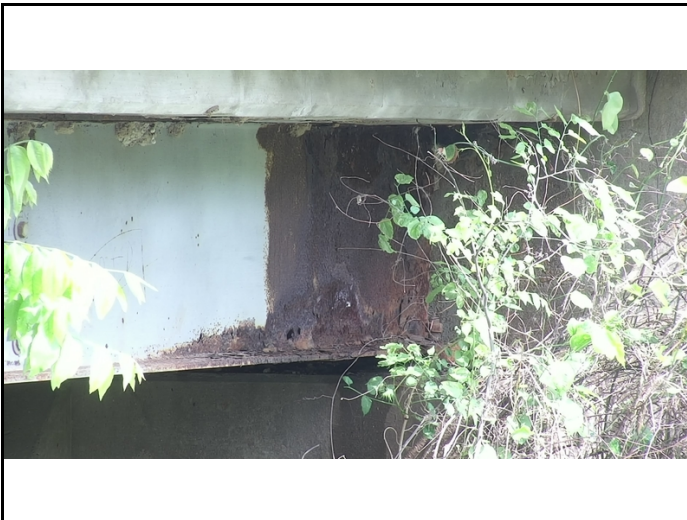
Span 5 bent 6 girder 5 has 2' of 1/8" section loss along bottom of web 2.5' from end.

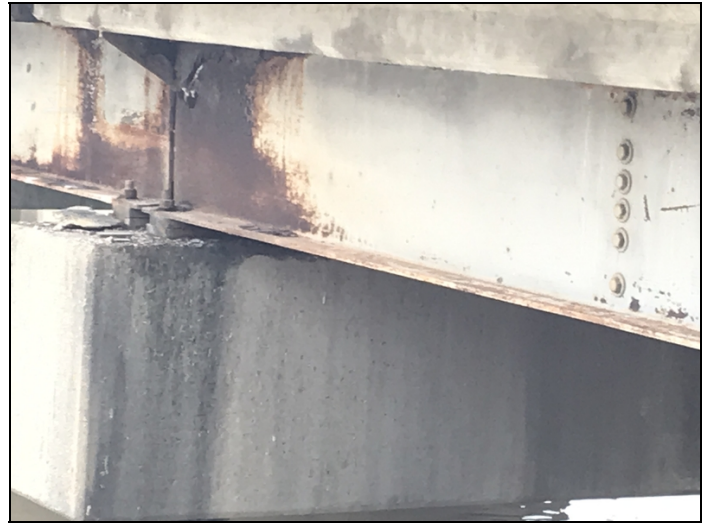
Span 5 Bent 5 Girder 5

Span 5 bent 5 girder 5 has a 1' of heavy section loss on top half of web with a 8" x 2" hole in web below haunch.

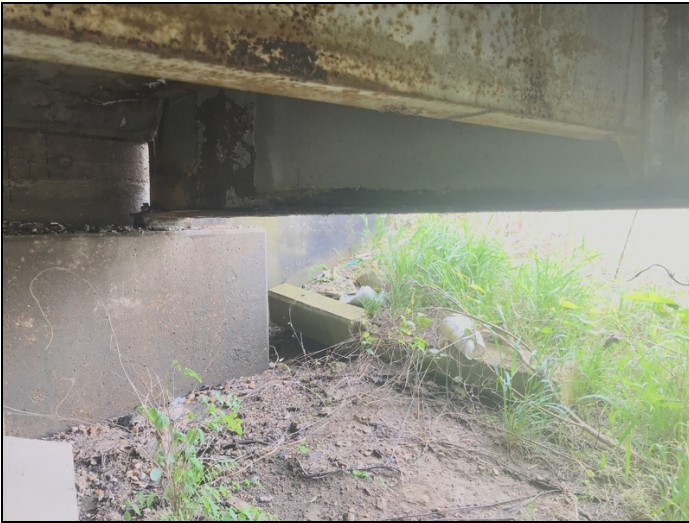
S1 b1 g1

Span 1 bent 1 girders 1 and 5 have splices at top of web 5' back from Bt.1 cap has rust with moderate section loss.
