Asset #02886(Routine)

SH 135-01-LM 6.03 over DITCH NO 47

Location: 3.0 MI N OF SH 118

Team Lead: Tim Myrick, Inspection Date: 09/19/2022

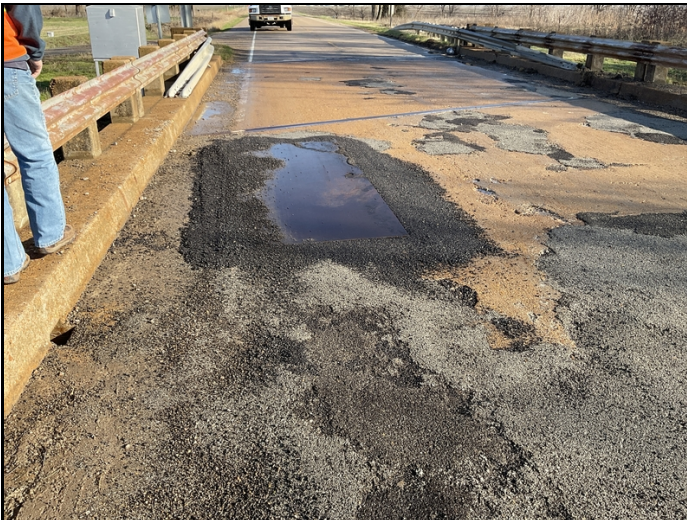
S4 steel plate

Span 4 (Left side) Bay 1 lowered deck to 3 due to hole in deck steel plate has been place over deck failure .

Hole in deck has been chip out and repaired with concrete by District bridge crew. 9/27/2022 CCP

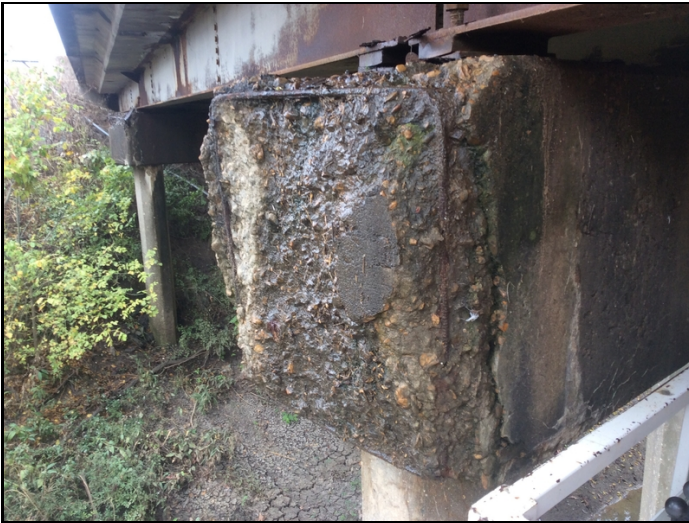
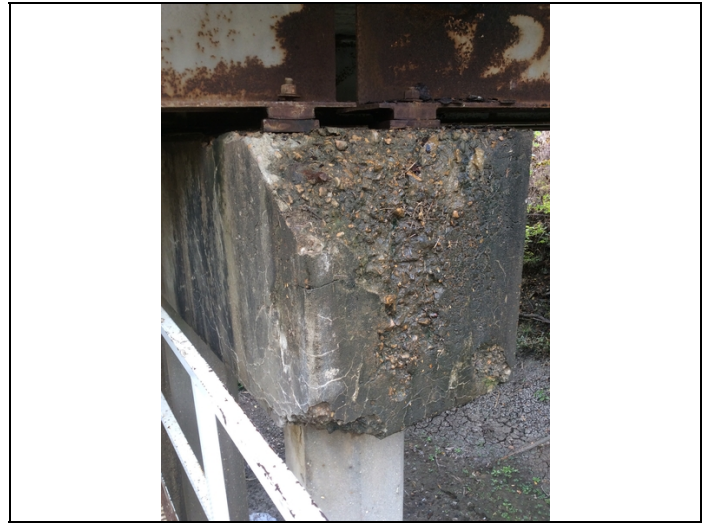
Left and Right Ends of Bent 4 Cap is shelled off with heavy cracking, efflorescence and exposed rebar, see left end of bent 4 cap of 2011 photo.

Left End of Bent 5 Cap is shelled off with heavy cracking, efflorescence and exposed rebar.

Bent 5 Cap Span 4 side has two 1 ft. areas with rebar exposed over Pile 3 & 4.

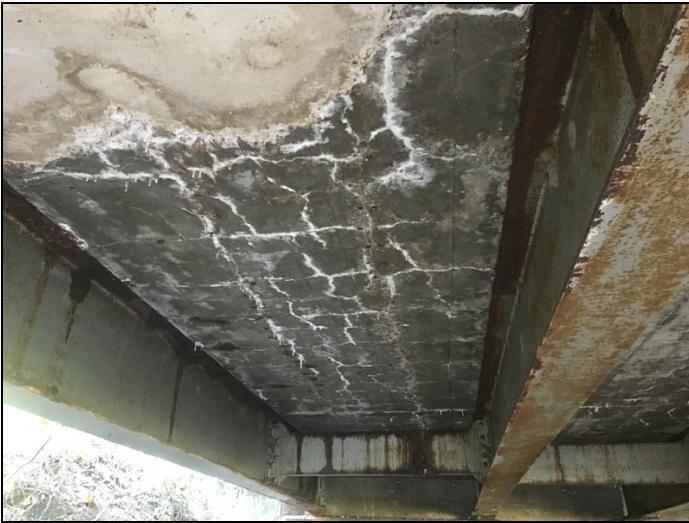
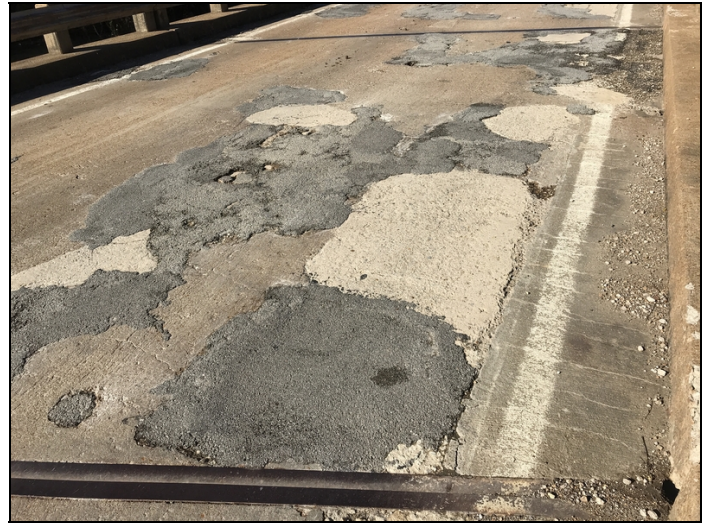
Span 2 Deck

Majority of deck has transverse cracks, large spalls, delaminated areas, and patched areas. Patches are in poor condition.

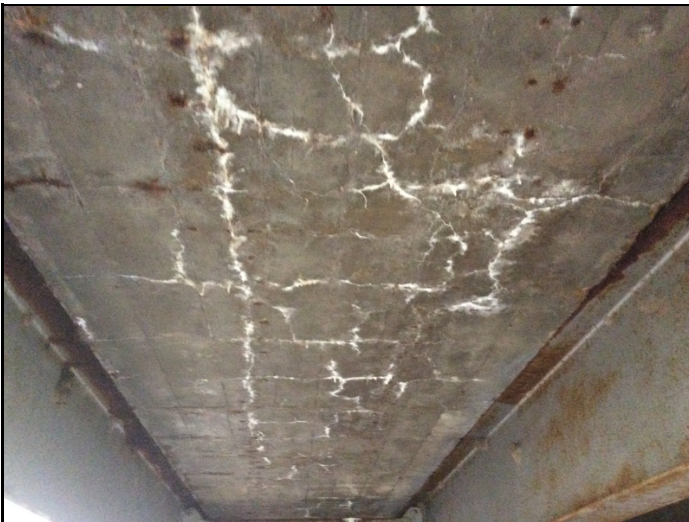
EFFLORESCENCE

Bottom of Deck has minor size and moderate density cracks with heavy efflorescence and some icicles:

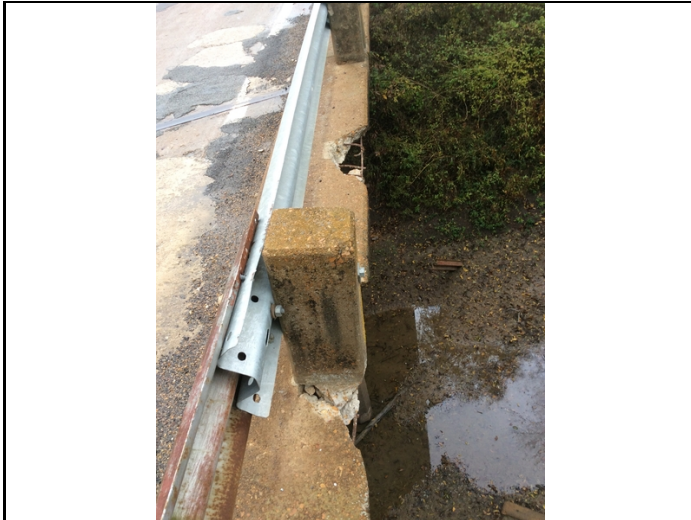
Right side of Span 3 Bridge Rail Post is broke with rebar exposed and 1 post missing with rebar exposed on overhang.

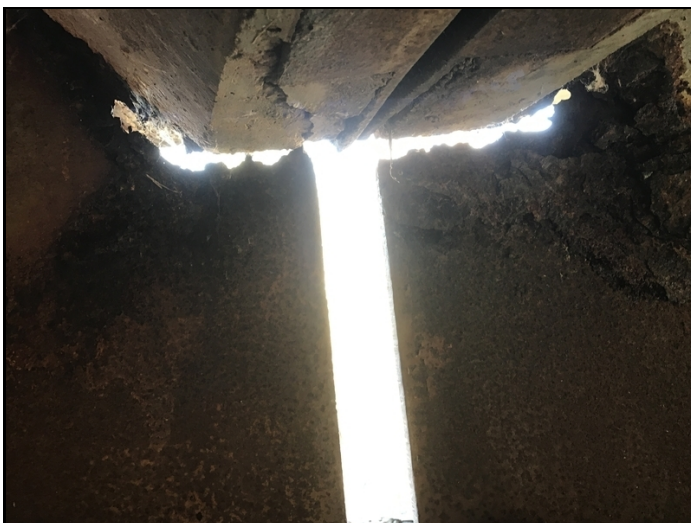
Span 1&2 bent 2 girders 1

- *Span 1 bent 1 girder 2 has a 4 1/2 in. x 1 in. hole in web below haunch. Old t-splice has section loss. Girder is moving under traffic.
- *Span 1 bent 2 girder 1 has a 8 in. x 1 in. hole in web below haunch.

- *Span 1 bent 2 girder 3 has a 3 in. x 1 in. hole in web below haunch.
- *Span 2 bent 2 girder 1 has a 7 in. x 1 in. hole in web below haunch.
- *Span 2 bent 3 girder 1 has heavy section loss with a 2 in. diameter hole in web below haunch.

Inspection 9-16-2021 for girder repairs made to superstructure by State Heavy Bridge crew. CCP

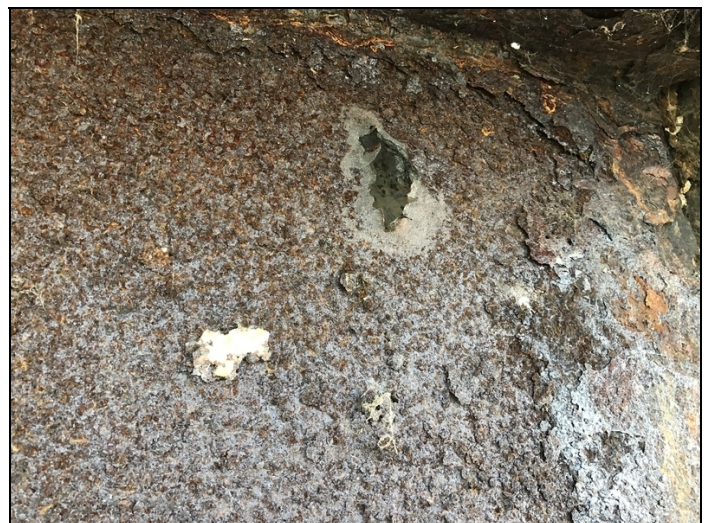
Span 2 girder 5 bent 3

- *Span 2 bent 3 girder 3 has a 5in. x 1in. hole in web below haunch. Bottom flange has heavy section loss
- *Span 2 bent 3 girder 5 has heavy section loss to web below haunch with a 2 in. x 1 in. hole near haunch & some out of plane bending.

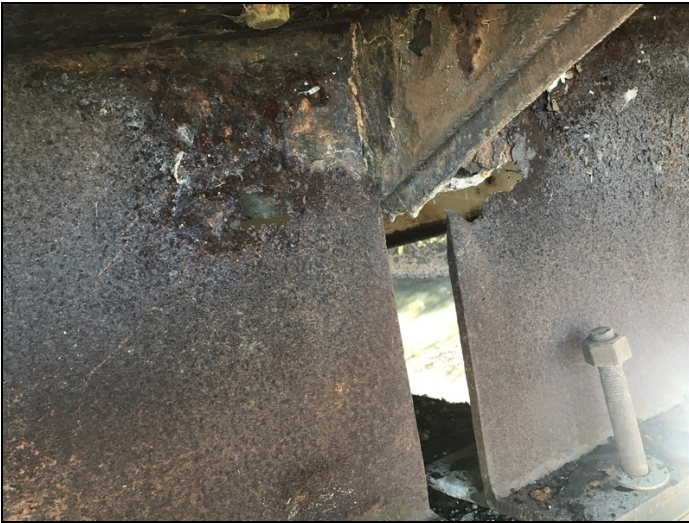
Span 4&5 bent 5 girders 1

- *Span 4 bent 4 girder 4 has a 6in. x up to 1in. hole in web below haunch.
- *Span 4 bent 5 girder 1 has a 4 in. x up to 2 in. hole in web below haunch. Girder is moving under traffic.

- *Span 5 bent 5 girder 1 has a 2 in. x 2 in. hole in web below haunch.
- *Span 5 bent 5 girder 5 has a 9 in. x up to 3 in. hole in web below haunch with some out of plane bending.

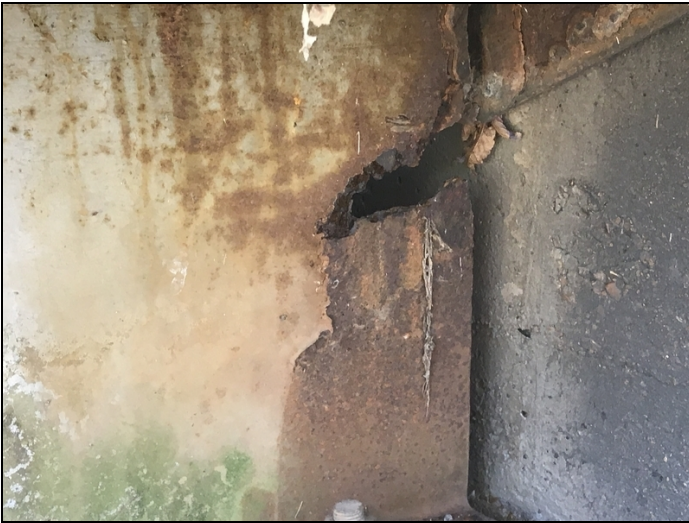
Span 5 bent 6 girder 5

- *Span 5 bent 6 girder 5 has a 5 in. x 3 in. hole in web below haunch at end of girder.

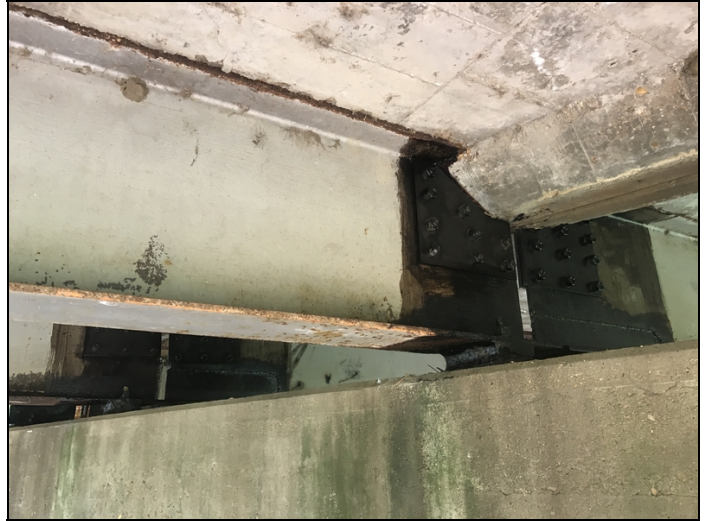
S3 b3 g3

- *Span 3 bent 3 girder 3 has a 4in. x 1in. hole in web below haunch.
- *Span 3 bent 3 girder 4 left bottom flange has heavy section loss at bearing with a 3 in. x 1 in. hole near haunch.

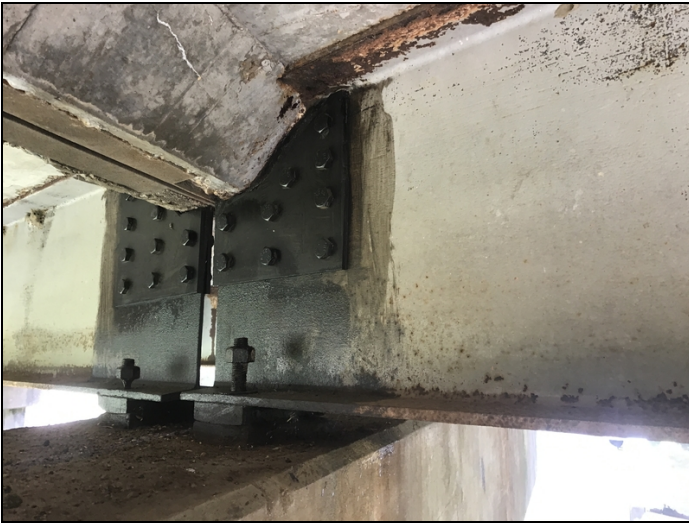
S3 b4 g3

- *Span 3 bent 4 girder 3 has a 4in. X 1in. hole in web below haunch.
- *Span 4 bent 4 girder 2 has a 2in. x 1/2in. hole in web below haunch.
- *Span 4 bent 4 girder 3 has a 4in. x 1in. hole in web below haunch.

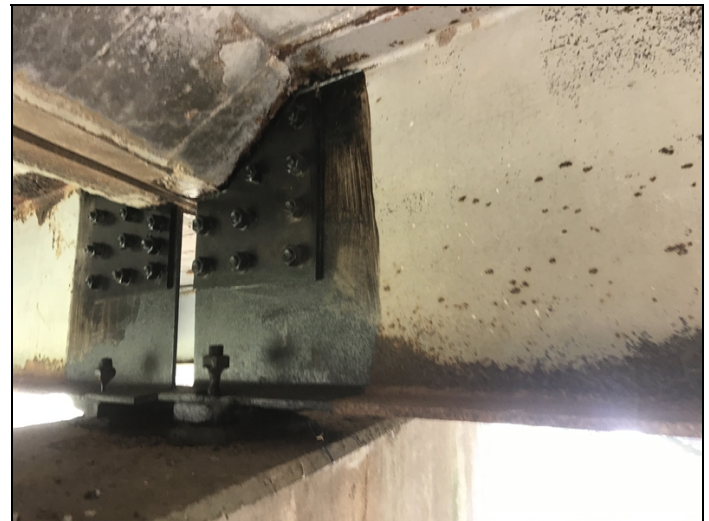
S3 b4 g4

- *Span 1 bent 1 girder 5 has heavy section loss at web below haunch, a 6 ft. x up to 1 in. area along right bottom flange, and on bottom flange. Left bottom flange has heavy section loss.
- *Span 3 bent 4 girder 4 left bottom flange has heavy section loss.
- *Span 3 bent 4 girder 5 has heavy section loss at web below haunch with some out of plane bending.
- *Span 4 bent 4 girder 1 has heavy section loss in web below haunch.
- *Span 4 bent 5 girder 3 & 4 is moving heavily under traffic.
- *Span 4 bent 5 girder 5 has some out of plane bending at web below haunch.
- *Span 5 bent 6 girder 2 & 3 are moving under traffic.

Inspection 9-16-2021 for girder repairs made to superstructure by State Heavy Bridge crew. CCP
