Asset #02905(Routine)

SH 135-01-LM 13.24 over DITCH NO 12

Location: 2.80 MI N OF LEPANTO

Team Lead: Tim Myrick, Inspection Date: 10/13/2022

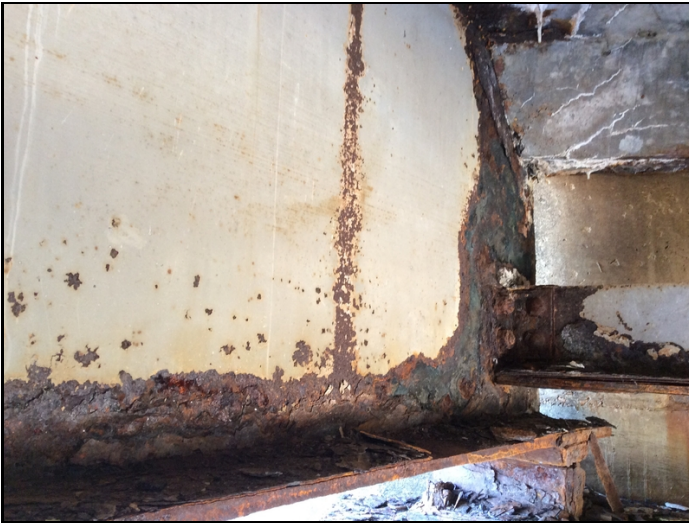
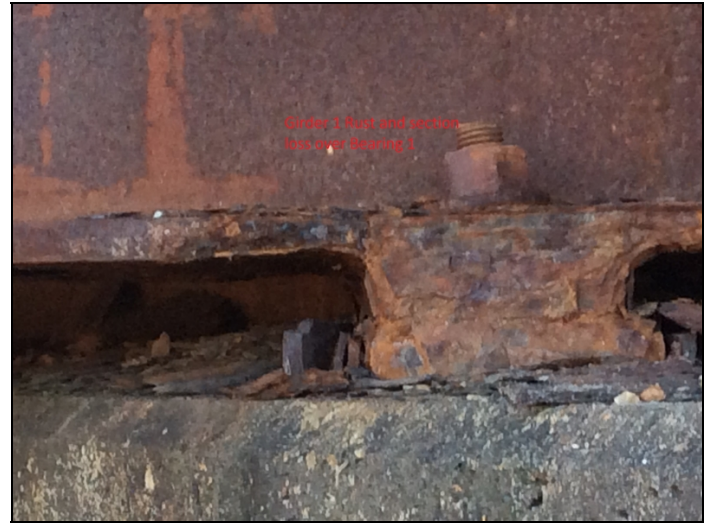
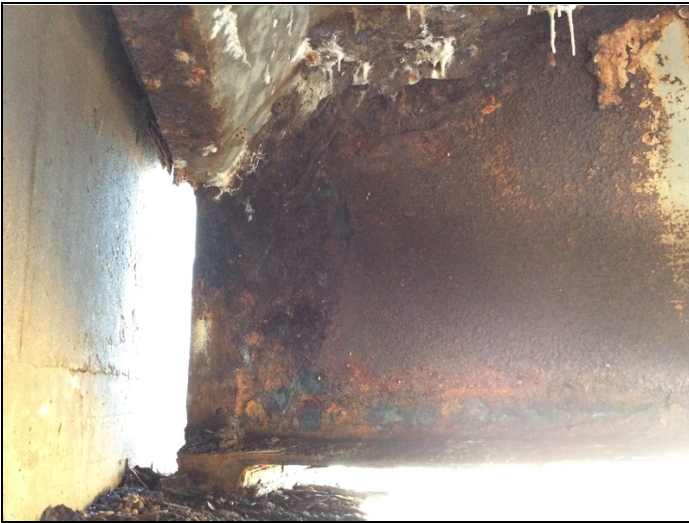
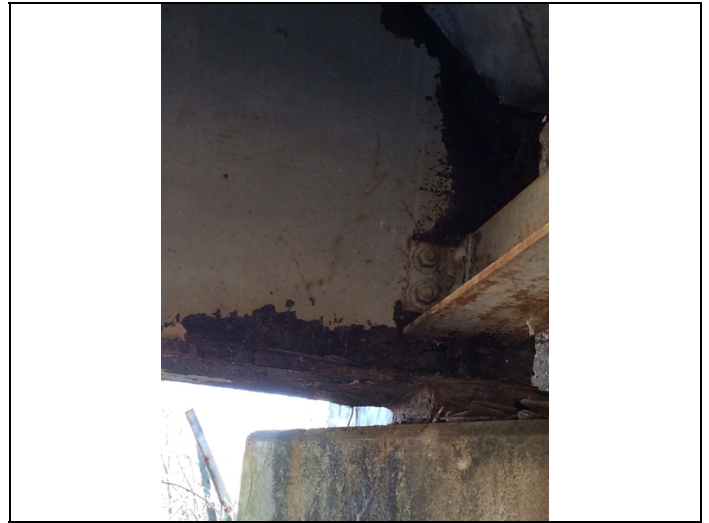
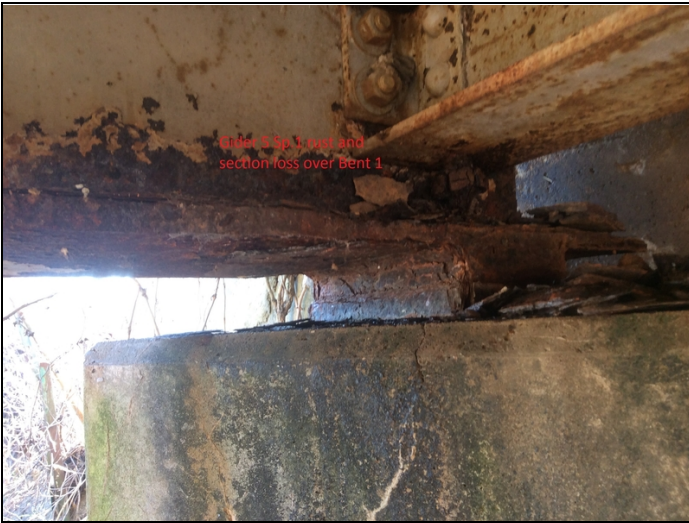
Ends of girders 1 and 5 have areas of moderate to heavy section loss.

Girder 1 over bent 1 has 4' of heavy section loss at end of web and along bottom flange and bottom of web. 2' on inside bottom flange is beginning to knife edge. Edge of flange has 3/16" remaining.

Girder 5 over bent 1 has 1' of 1/8" section loss at end and along bottom of web. 2' of bottom flange has 1/8" section loss with up to 1/4" section loss adjacent to bearing.

Girder 1 over bent 2 has 2' of heavy section loss at end of web and along bottom of web and bottom flange.

Girder 5 at bent 2 has heavy section loss to web near haunch.

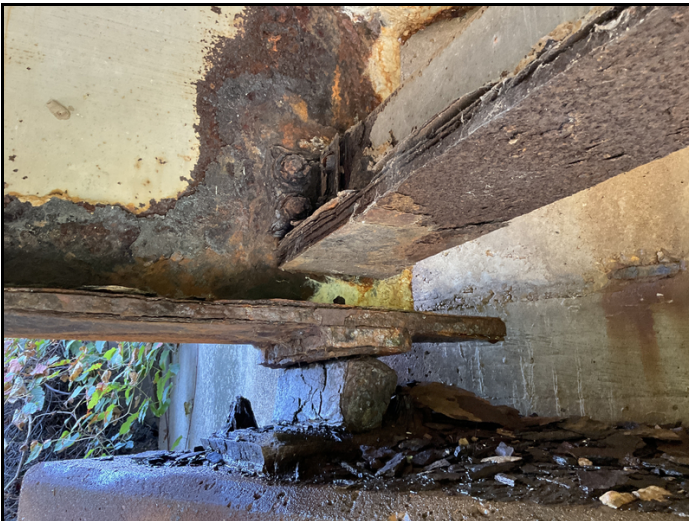
B2 g1

Bent 2 bearings 1 has heavy section loss and is rotated forward.

Bearings 1 at bent 2 has heavy section loss and is rotated forward.

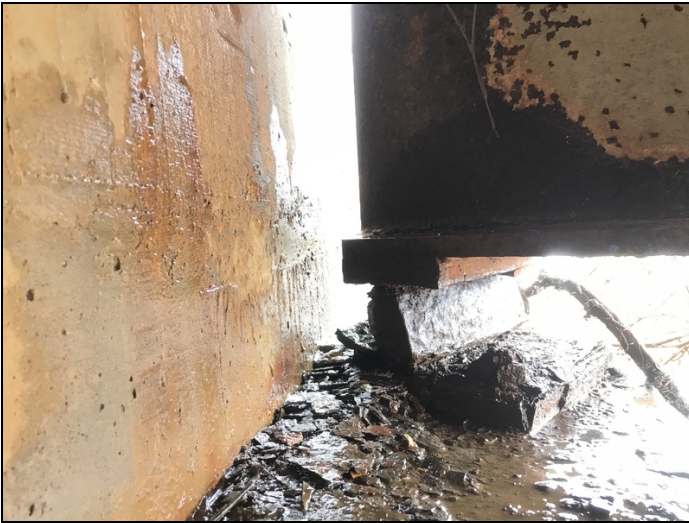
Bent 2 bearing 5 bottom metal plate heavy section loss and movable bearing has rotated on verge of falling out. see photo 2022

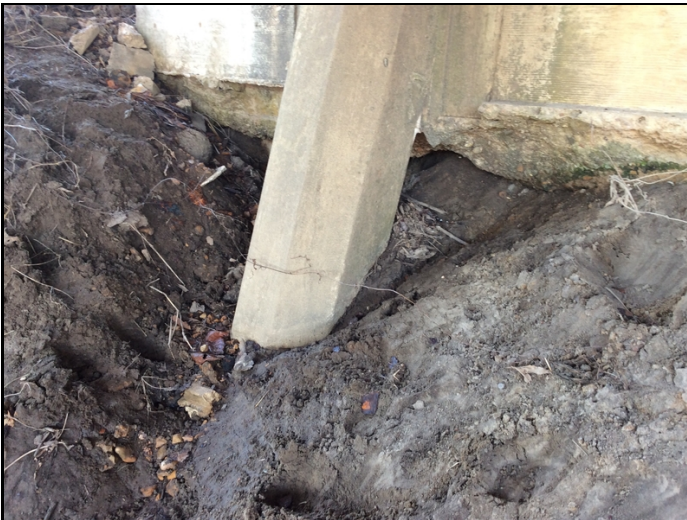
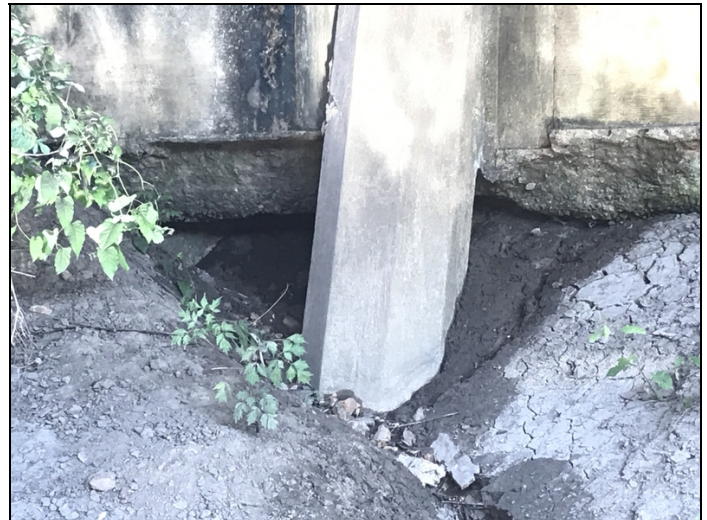
Bent 2 LT SIDE 2019

Embankment erosion has undermined approximately 5 ft. of bent 2 abutment near Lt end up to 2 ft. down and 2 ft. back under.

Embankment erosion has undermined approximately 5' of bent 2 abutment near Lt end up to 2' down and 2' back under.

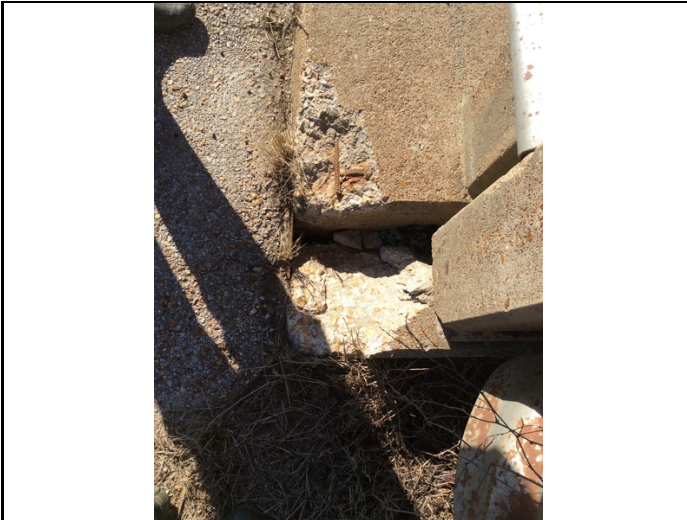
Left curb, bridge rail & end post & wing wall at bent 2 has collision damage with some exposed rebar

Lt curb and bridge rail end post at bent 2 has collision damage.
