Asset #02906(Routine)

SH 135-01-LM 15.60 over DITCH NO 4

Location: 1.65 MI S CRAIGHEAD CO

Team Lead: Tim Myrick, Inspection Date: 09/06/2022

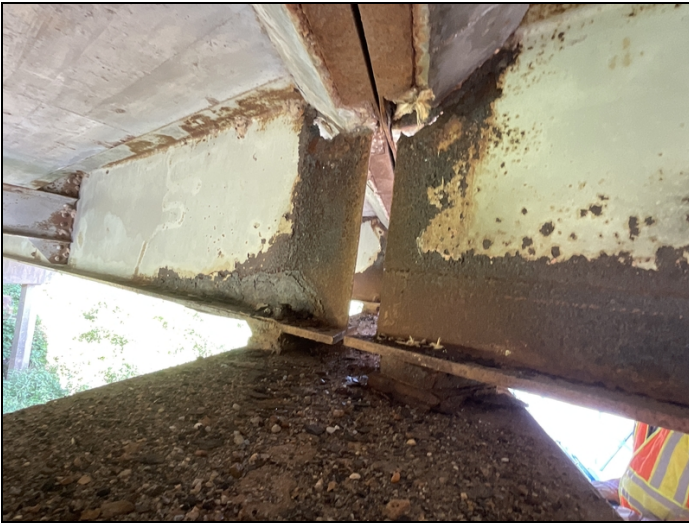
S4 & s3 b4 g4

Span 3 bent 4 girder 4 has a 4" x 1" hole in web below haunch. Bottom of web has been T-spliced.

Span 4 bent 4 girder 4 has a 5" x 1.5" hole in web below haunch, and moderate section loss at bottom of web over bearing.

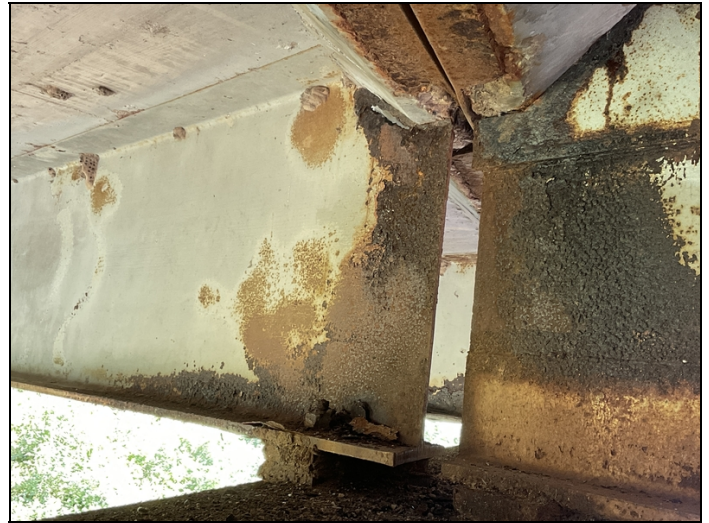
S4 b4 g3

Span 4 bent 4 girder 3 has a 9" x 1" hole in web below haunch.

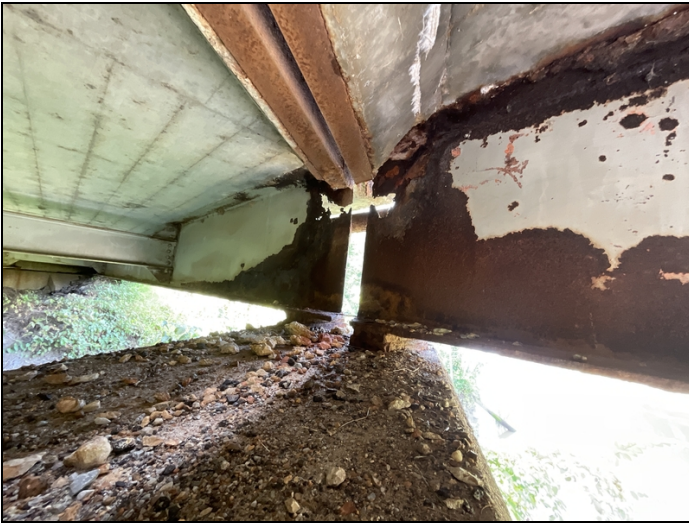
S1 & S2 b2 g1

Span 1 bent 2 girder 1 has 42" of heavy section loss along bottom of web, and a 10" x 6" area of section loss with holes at web below haunch.

Span 2 bent 2 girder 1 has a 5" x 2" hole in web below haunch. Bottom of web has a 9" x 6" area of heavy section loss at end.

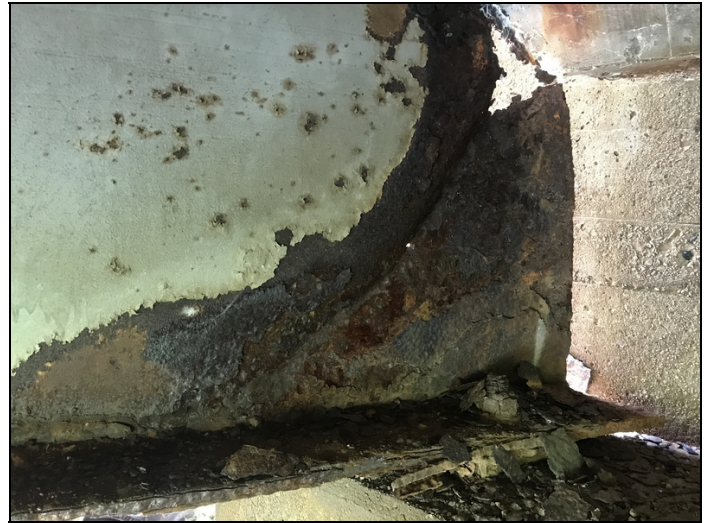
Span 5 bent 6 girder 1

***Span 5 bent 6 girder 1 has 47" of moderate to heavy section loss along bottom of web. Top of web has a 5" x up to 1.5" hole below haunch. Web is buckled. Bottom flange has heavy section loss near bearing. District bridge crew repaired with a 5 ft. splice on 06-03-2020.

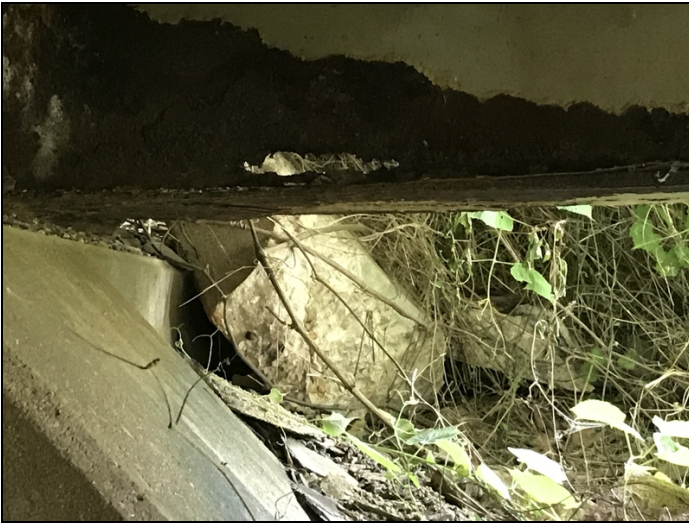
Span 5 bent 6 girder 5

***Span 5 bent 6 girder 5 has 37" of heavy section loss along bottom of web with a 9" x 1.5" hole 24" from end.

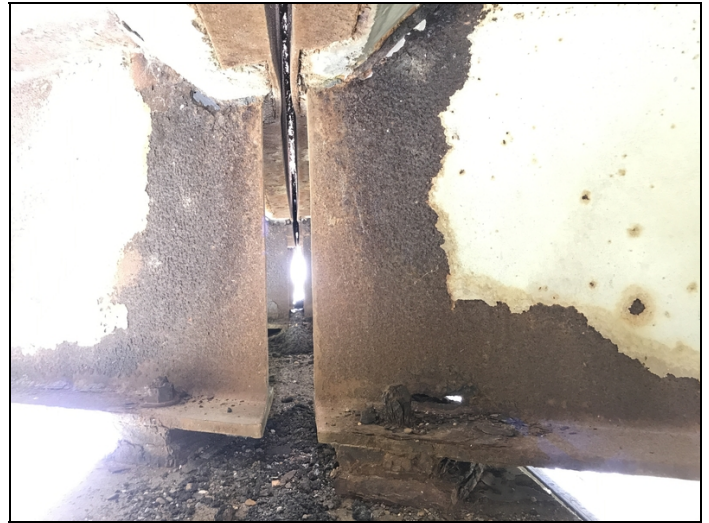
Span 2 bent 3 girder 2 has a 6" x 1" hole in web below haunch. Bottom of web has a 5" x 1" hole over bearing 6" from end of girder. Bottom flange has heavy section loss.

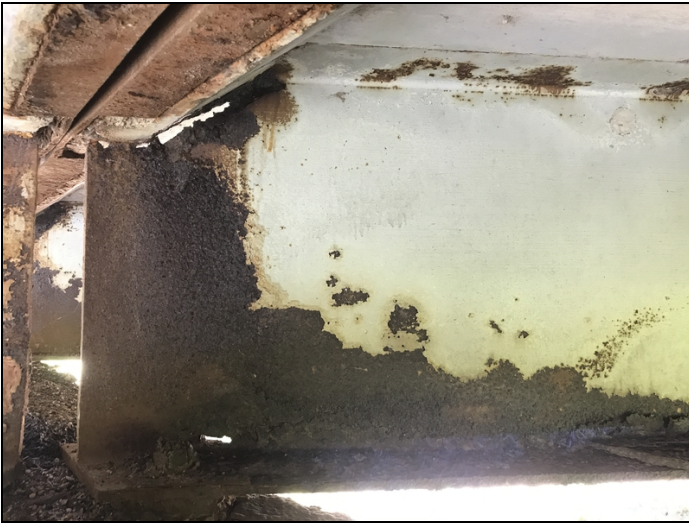
Span 5 bent 5 girder 3

***Span 5 bent 5 girder 3 has a 10" x 1" hole in web below haunch, and a 3.5" x 1" hole in bottom of web 7" from end of girder. Left bottom flange has heavy section loss with a 1" x 3" hole rusted through flange near bearing.

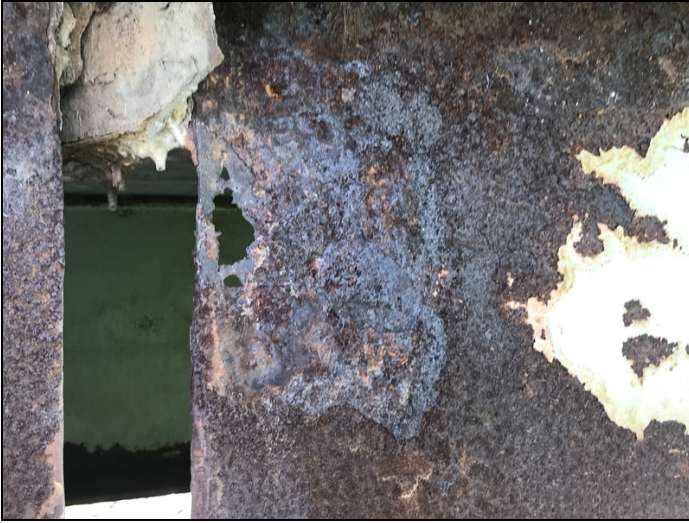
Span 5 bent 5 girder 5

***Span 5 bent 5 girder 5 has a 11" x 9" area of heavy section loss at web below haunch with a 4" diameter hole.

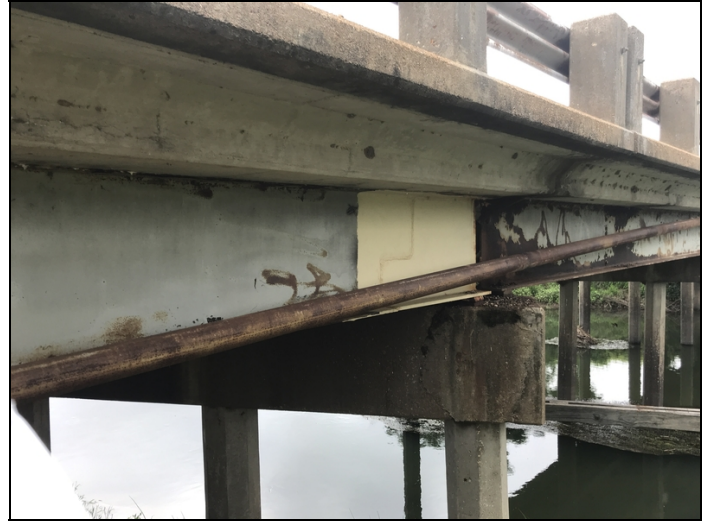
S5 b5 g1

***Span 5 bent 5 girder 1 has 3" of moderate section loss along bottom of web.

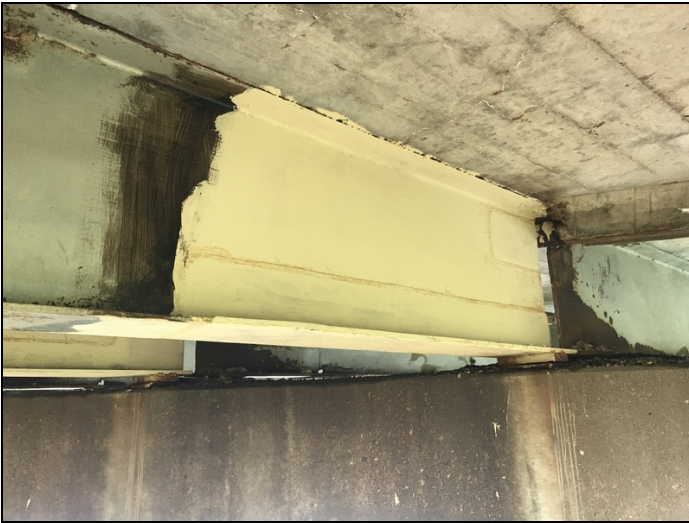
S5 b5 g2

***Span 5 bent 5 girder 2 has a 2" diameter hole in web below haunch and section loss at bottom of web over bearing.

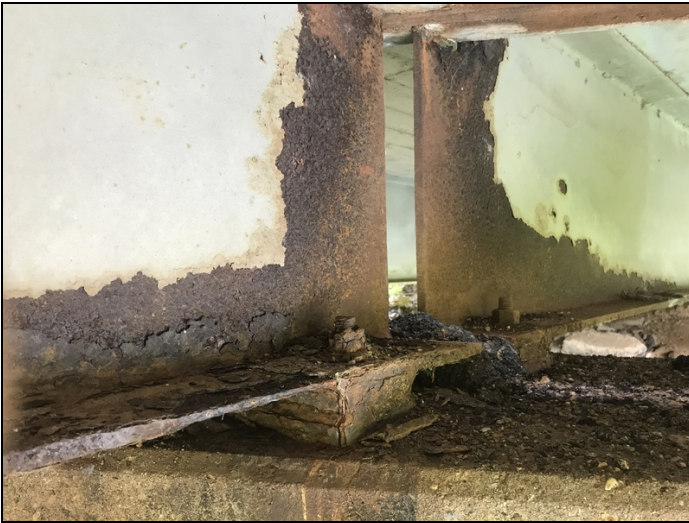
S2 b2 g2 & s1 b2 g2

Span 1 bent 2 girder 2 has a 4" x 1" hole in web below haunch. Bottom of web has 2ft. of moderate section loss near bearing.

Span 2 bent 2 girder 2 has heavy section loss to bottom flange.

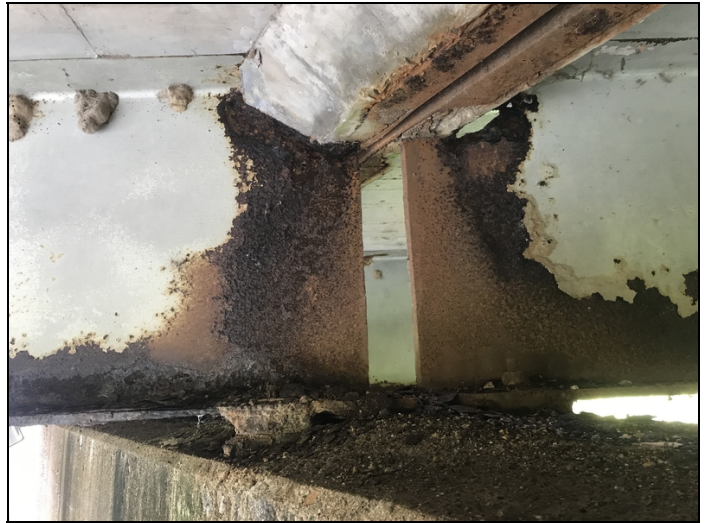
S2 b2 g3 & s1 b2 g3

Span 1 bent 2 girder 3 has a 4" x 1.5" hole in web below haunch.

Span 2 bent 2 girder 3 has 48" of moderate section loss along bottom of web, and heavy section loss to bottom flange with pin holes.

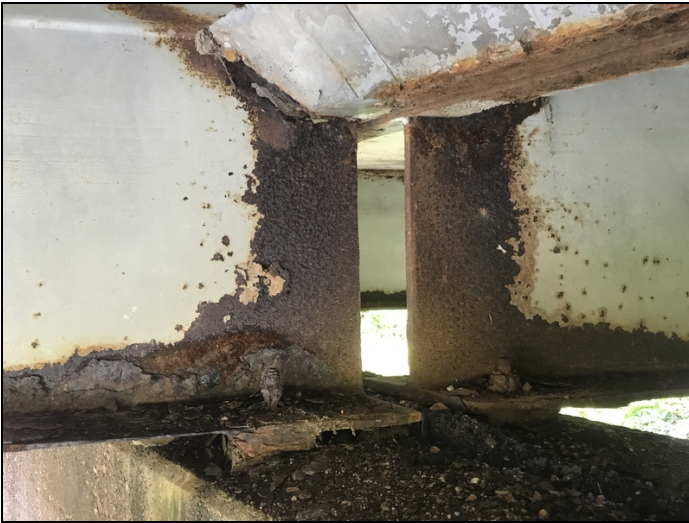
S2 b2 g4 & s1 b2 g4

Span 2 bent 2 girder 4 has a 7" x 1" hole in web below haunch. Bottom of web has 2" of moderate section loss near bearing.

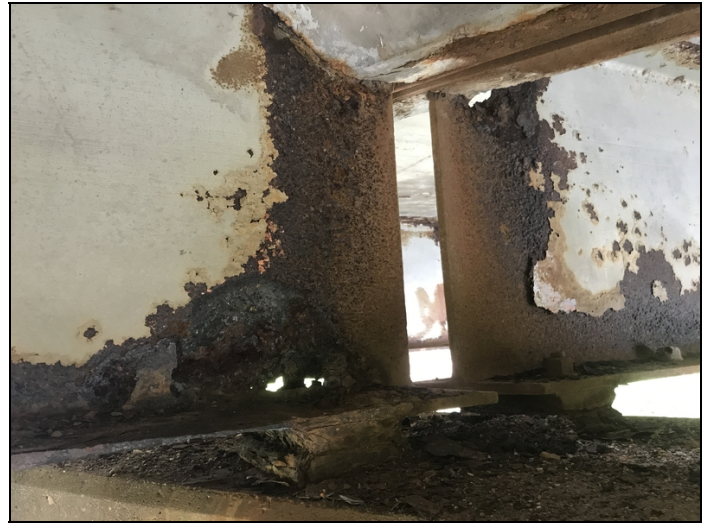
S2 b3 g2 & s3 b3 g2

Span 3 bent 3 girder 2 has a 3" x 1" hole in web below haunch.

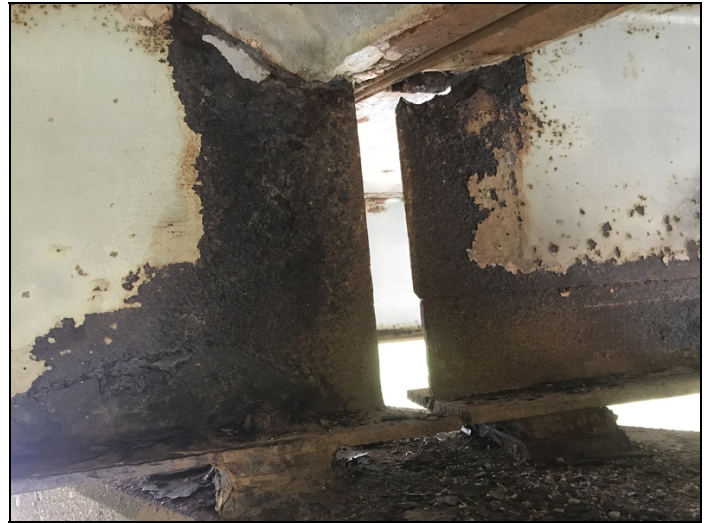
S4 b4 g4 & s3 b4 g4

Span 4 bent 4 girder 4 has a 5" x 1.5" hole in web below haunch, and moderate section loss at bottom of web over

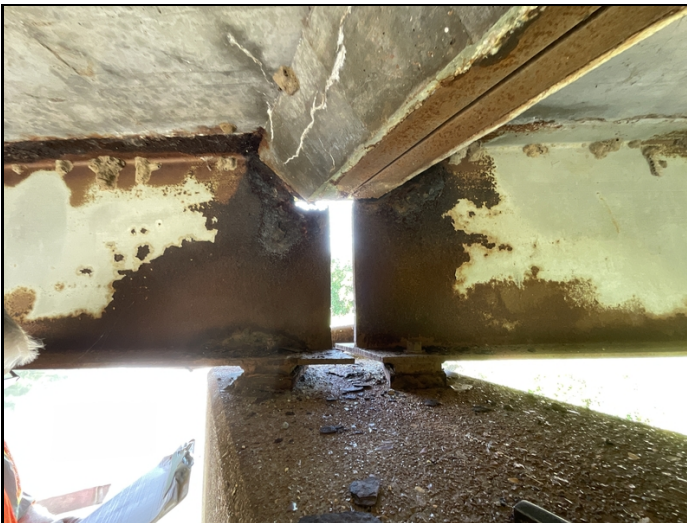
S3 & s4 b4 g1

Span 3 bent 4 girder 1 has a 5" x 2" hole in web below haunch increased in size 2022.

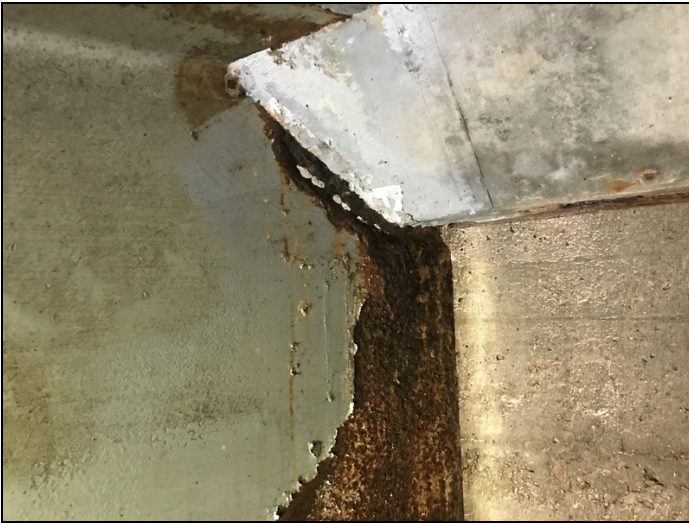
Span 5 bent 6 girder 2

***Span 5 bent 6 girder 2 has a 5" x 1" hole in web near haunch.

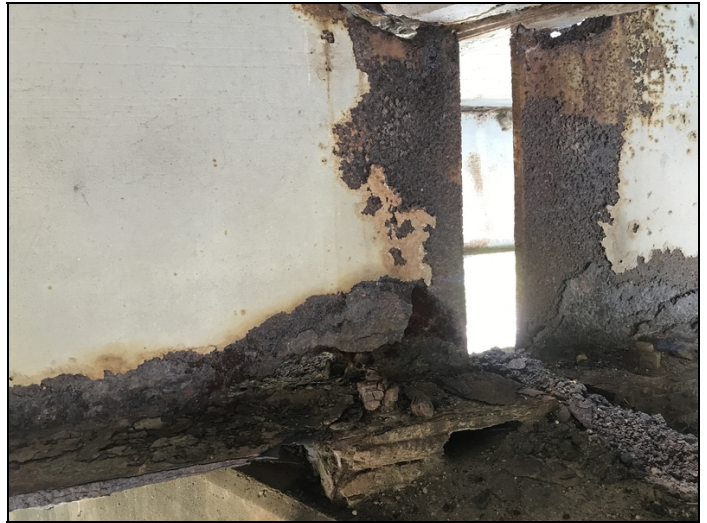
Span 2 bent 3 girder 3 has a 4" x 7" hole in web below haunch. Bottom of web has a 9" x 3.5" hole 5.5" from end. Left bottom flange has heavy section loss near bearing. Right flange has a 2.5" x 2" hole in bottom flange with heavy section loss surrounding area.

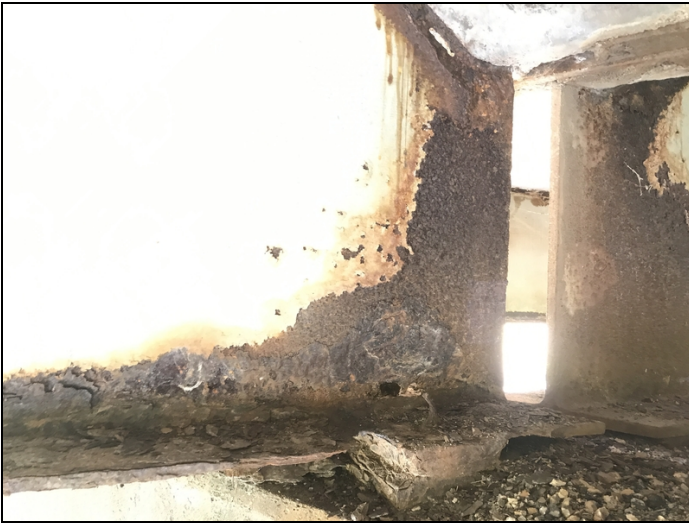
Span 4 bent 5 girder 2 has a 2" diameter hole in web below haunch. Bottom of web over bearing has a 4 1/2" x 1" hole with a 3/4" crack running from end of hole towards span. Right bottom flange has heavy section loss with a 3.5" x up to 4" hole in flange near bearing.

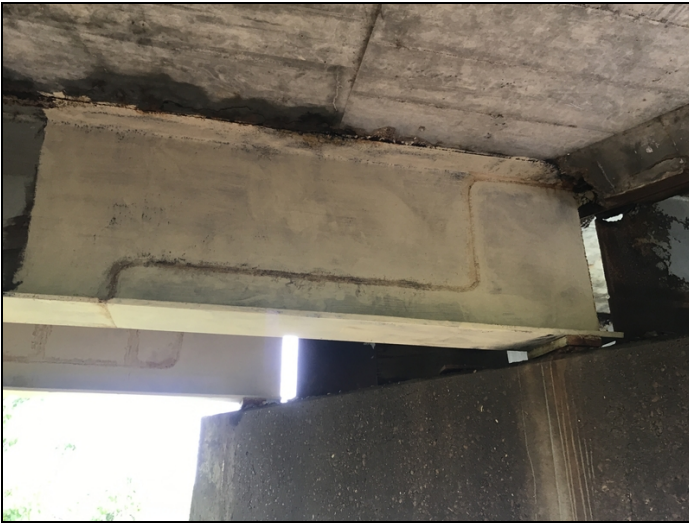
S5 b5 g4

***Span 5 bent 5 girder 4 has a 5" x 1.5" hole in web below haunch.

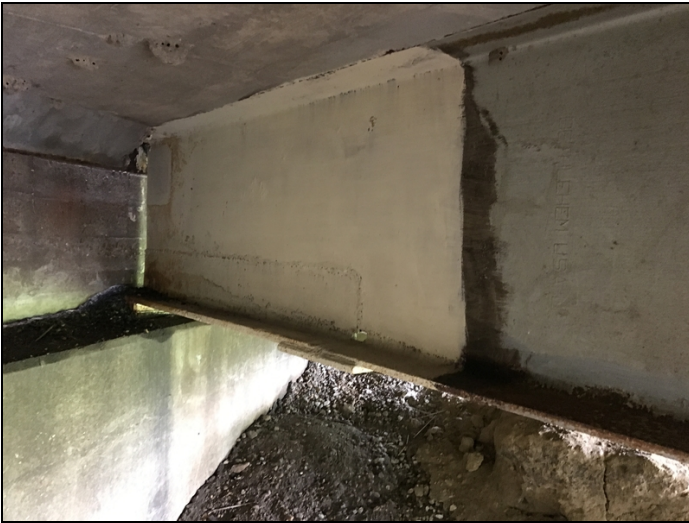
S5 b6 g3

***Span 5 bent 6 girder 3 has a 3" x 1" hole in web below haunch.

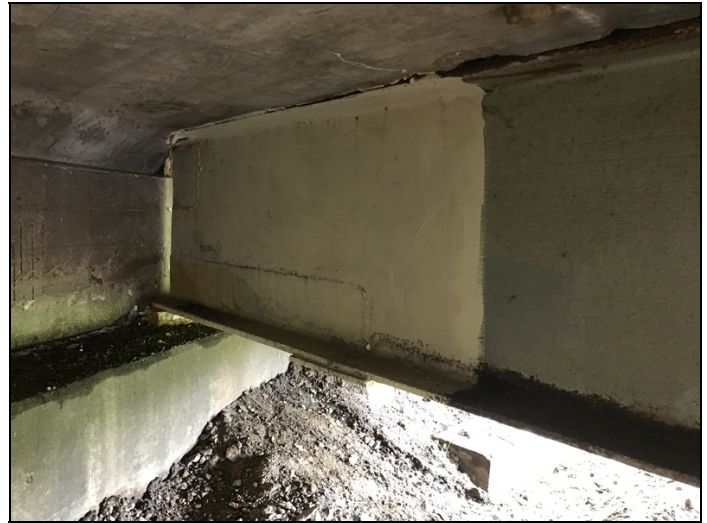
S5 b6 g4

***Span 5 bent 6 girder 4 has a 2" x 1" hole in web near haunch.

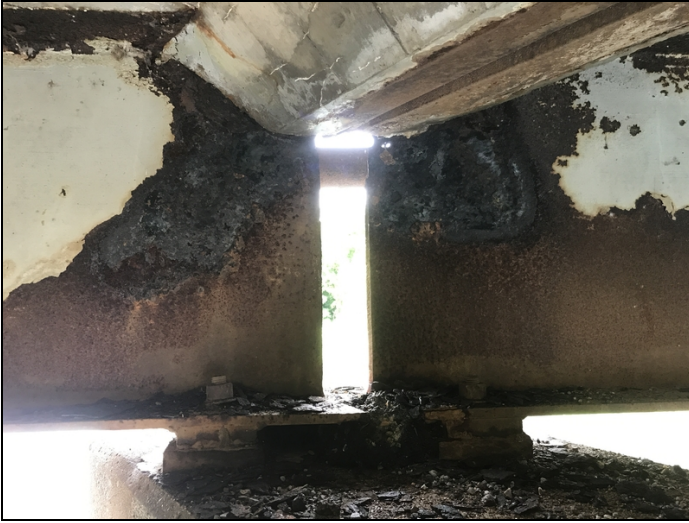
S2 b3 g1 & s3 b3 g1

Span 2 bent 3 girder 1 has a 14" x 9" area of heavy section loss at haunch.

Span 3 bent 3 girder 1 has a 12" x 12" area of heavy section loss near haunch and a 2" diameter hole.

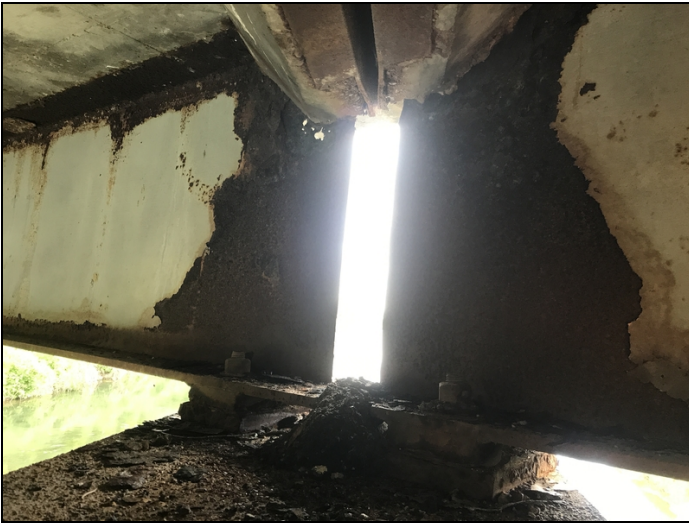
S3 b3 g5

Span 3 bent 3 girder 5 has a 4" x 1" hole in the top of web near haunch.

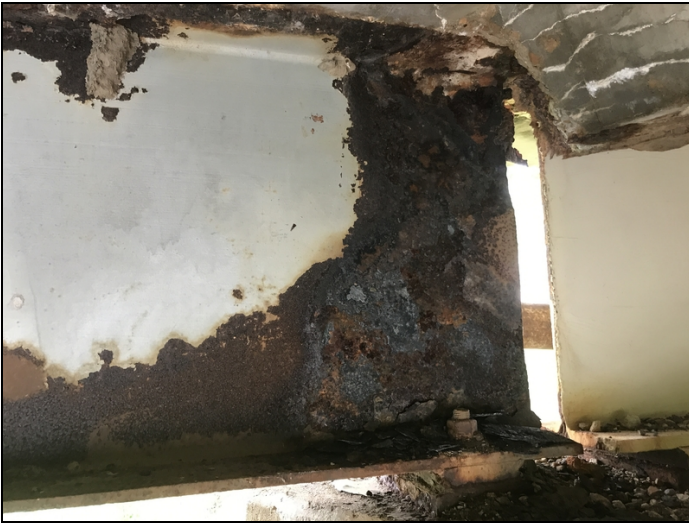
S4 b5 g1

Span 4 bent 5 girder 1 has 14" of heavy section loss along end of web.

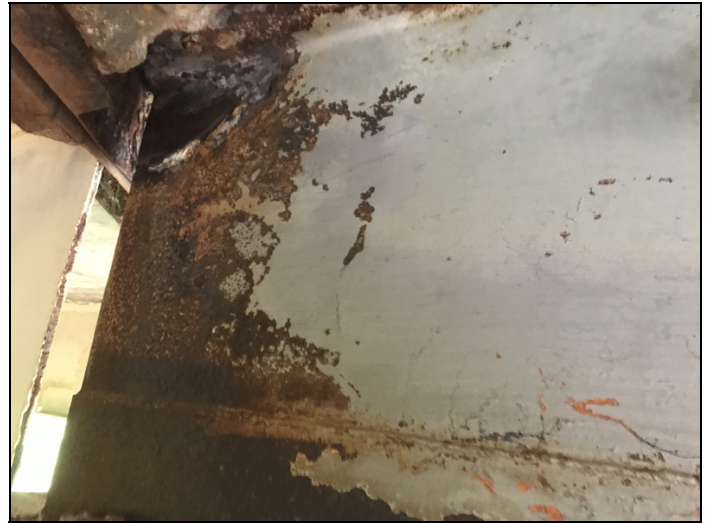
S4 b5 g4

Span 4 bent 5 girder 4 has a 4" x .5" hole in web below haunch. Bottom of web has been T-spliced.
