Asset #02907(Routine)

SH 135-02- LM 0.01 over DITCH NO 1

Location: POINSETT CO LINE

Team Lead: James Adams, Inspection Date: 11/14/2022

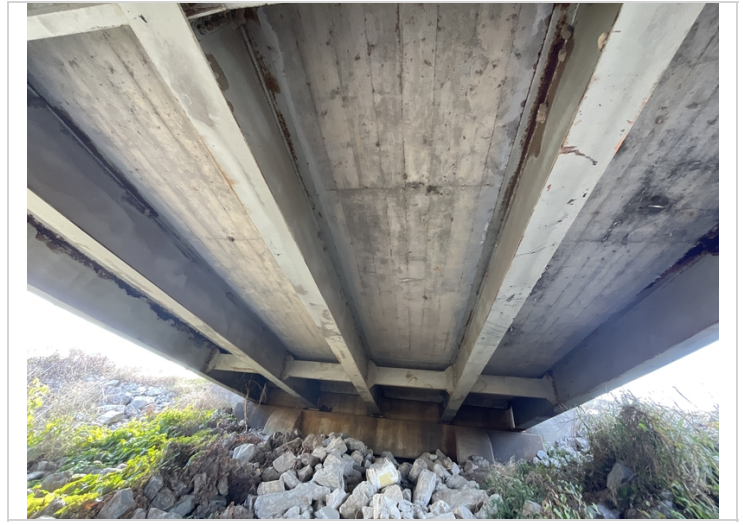
Concrete soffit has a few minor cracks, some with efflorescence & a few areas of exposed rebar.

Span 1 soffit

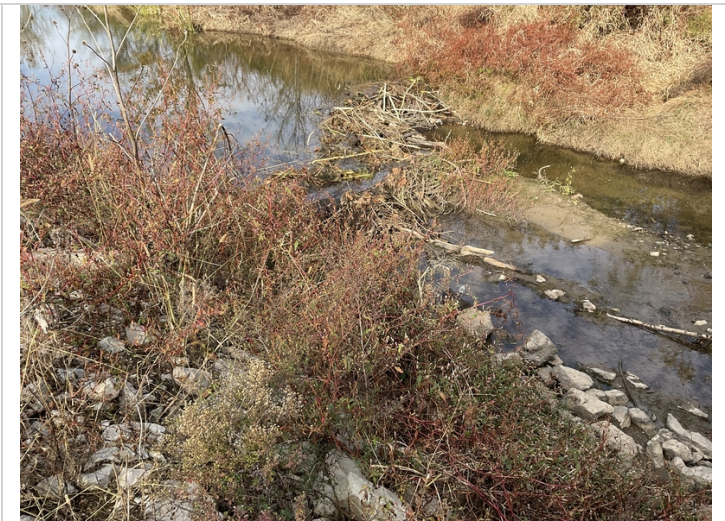
Beaver dam across channel upstream of bridge.

Beaver dam upstream 11-14-2022

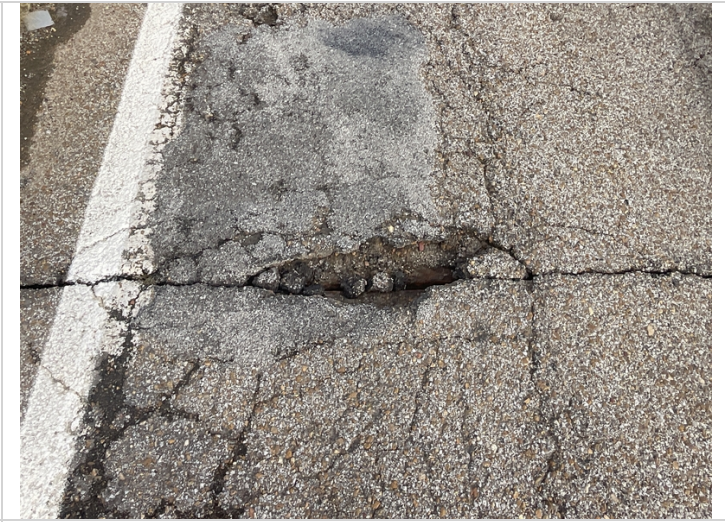
Bent 2 joint Southbound lane 11-14-2022

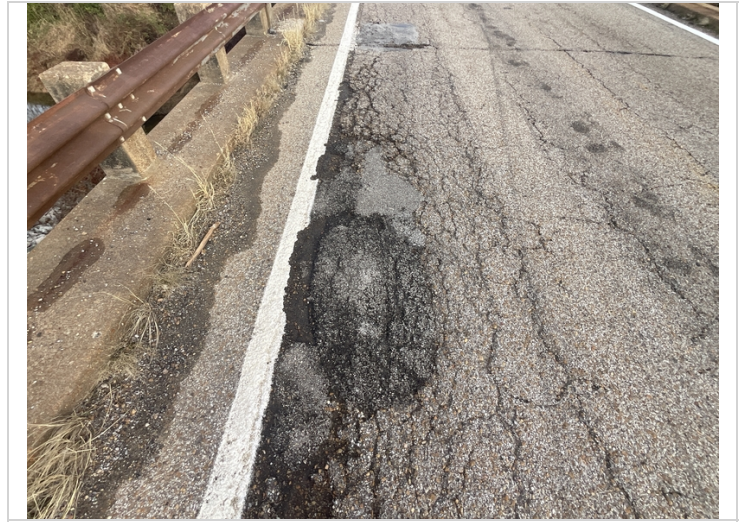
Spans 2 & 3 southbound lanes have areas of spalling & broken asphalt.

Span 1 Southbound lane 11-14-2022

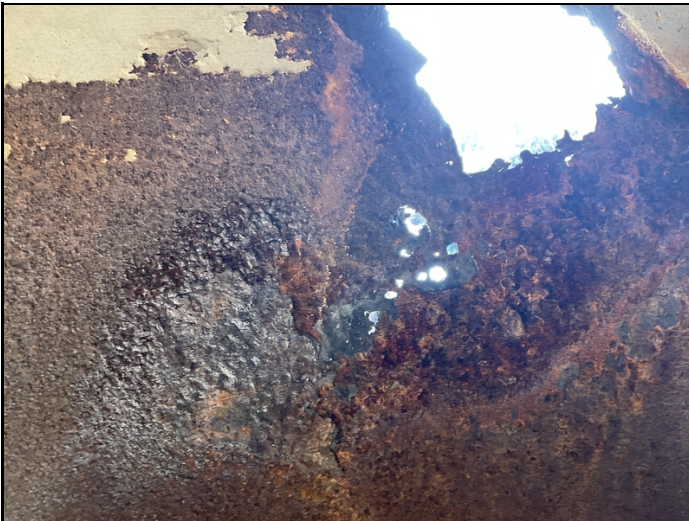
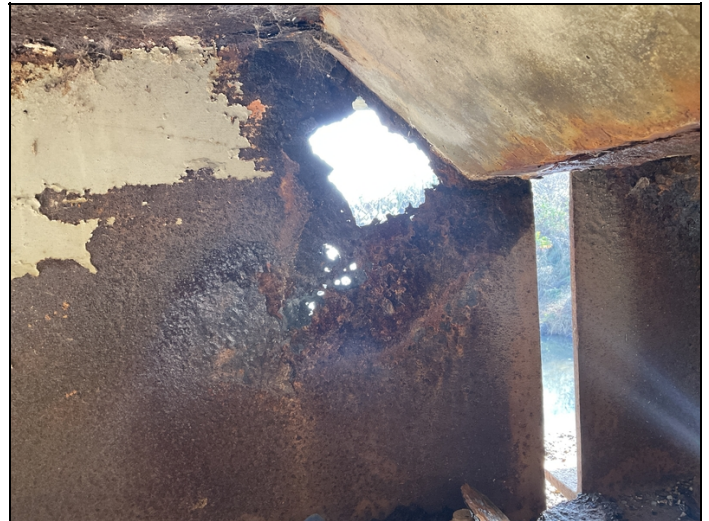
Span 3 bent 3 girder 5 has a 6in. x 5in. hole & a 5in. x 2in. area of holes in web below haunch. Bottom of web has 2ft. of moderate section loss on outside face.

Web of girder has begun to buckle.

Span 3 bent 3 girder 5 has a 6" x 5" hole & a 2in. x 5in. area of holes in web below haunch.  
Web has begun to buckle.  
Bottom of web has 2' of moderate section loss on outside face.

Span 3 bent 3 girder 5 photo 2/2 11-14-2022

Span 3 bent 3 girder 5 photo 1/2 11-14-2022

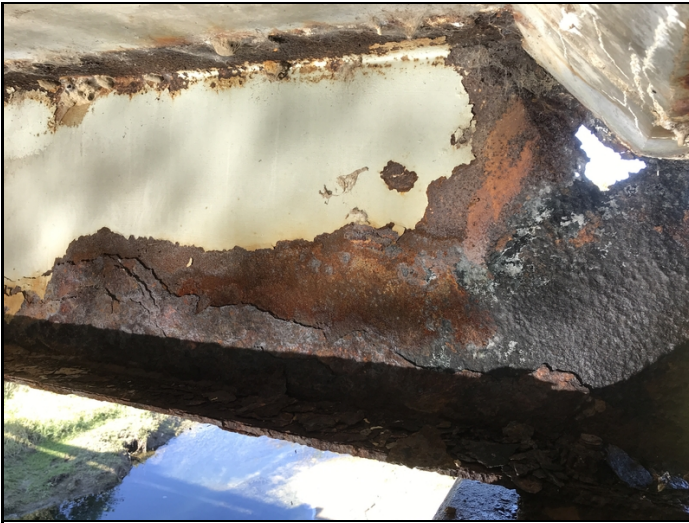
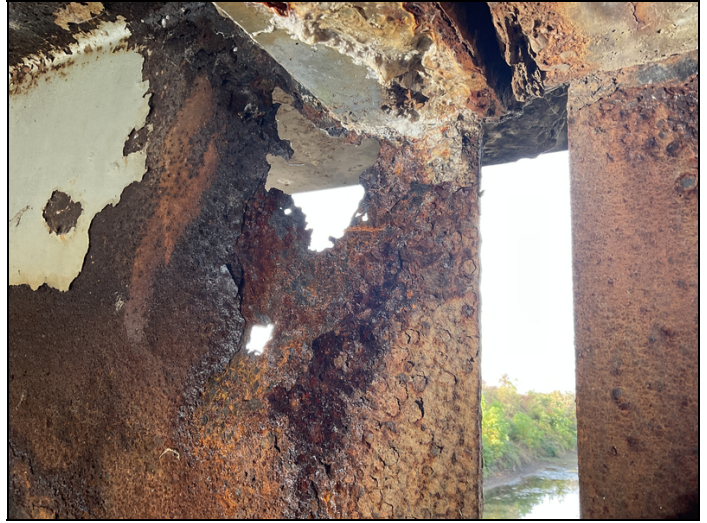
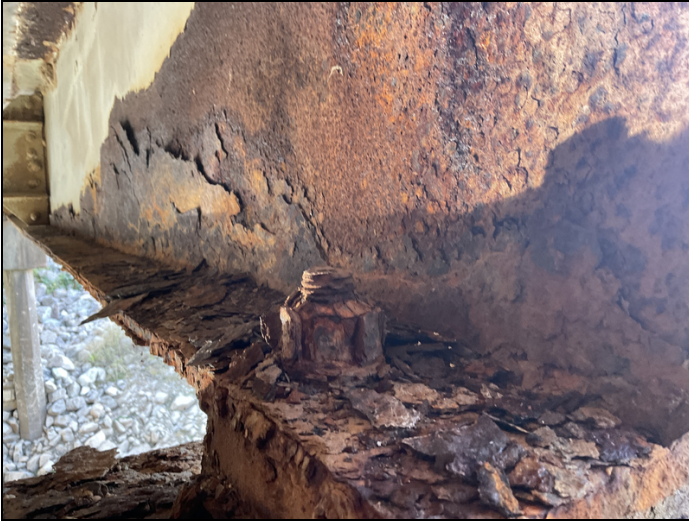
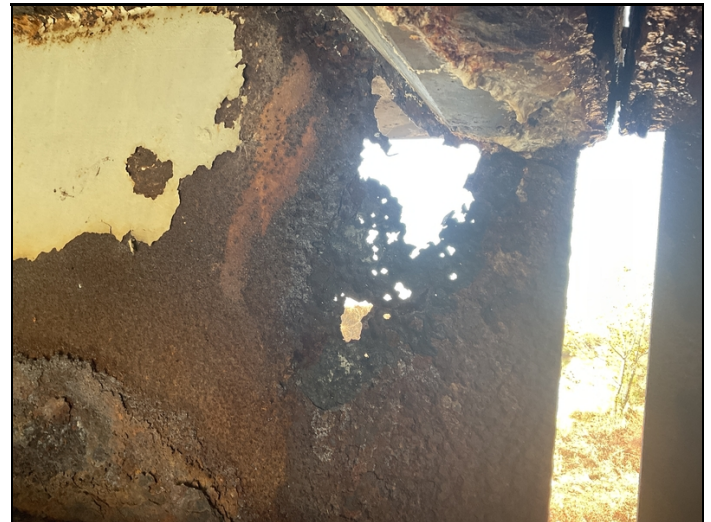
Span 2 girder 1 bent 3 haunch

Span 2 girder 1 bent 3

Span 2 bent 3 girder 1 has a 5" x 10" hole in web below haunch. Web has 1ft. of heavy section loss at end. Bottom of web and bottom flange have a 9ft. area of moderate section loss.

Span 2 bent 3 girder 1 11-14-2022

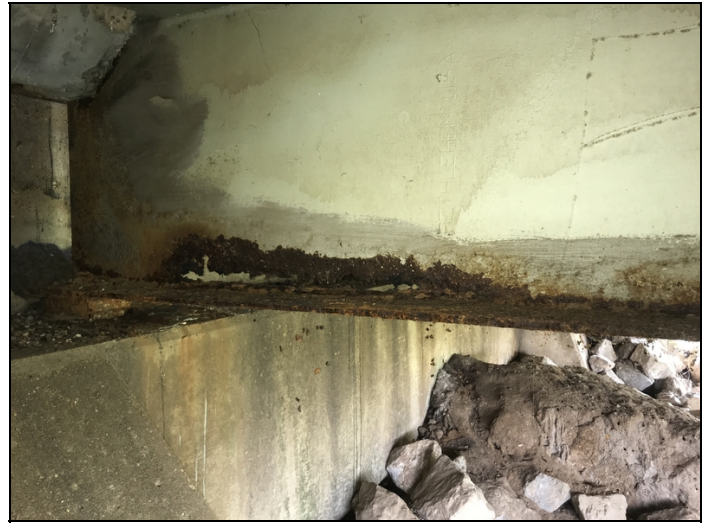
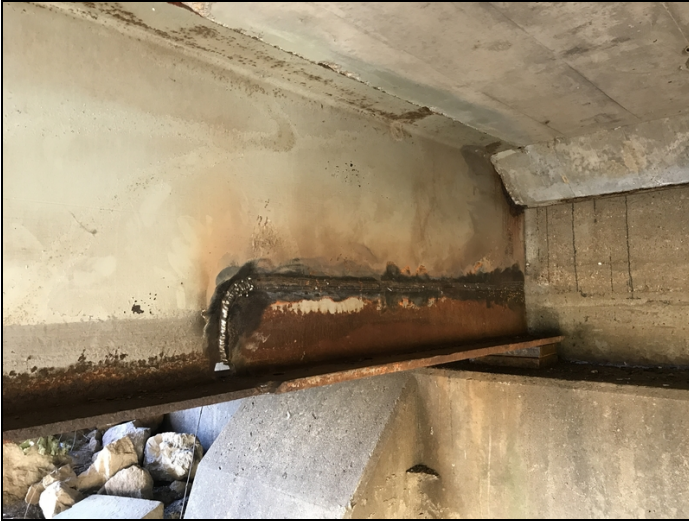
\*Span 3 bent 4 girder 2 has a 23" x up to 2.5" hole along bottom of web approx. 1' from end. Heavy section loss to bottom flange, beginning to knife edge.

Span 3 bent 4 girder 2 back side of 22" hole in bottom of web

Span 3 bent 4 girder 2 was t spliced in 2020.

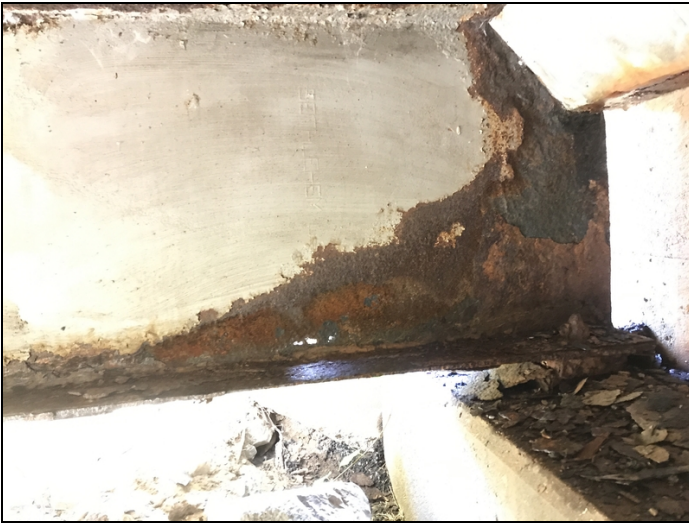
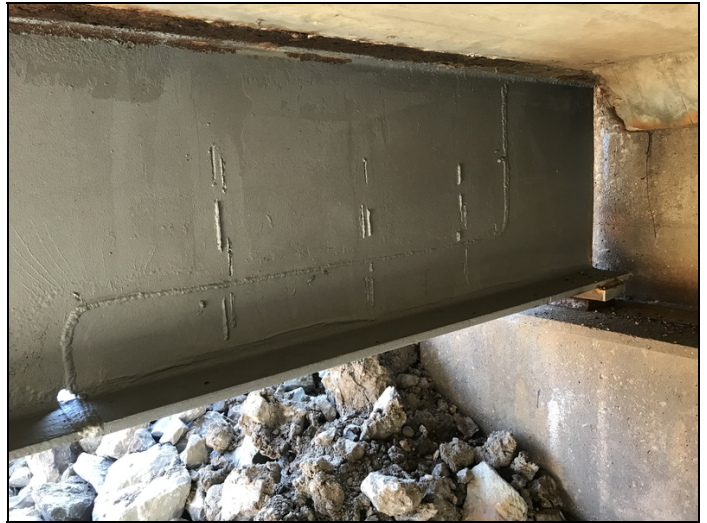
\*Span 1 bent 1 girder 5 has 3' of heavy section loss along bottom of web and bottom flange. Bottom of web has a 3" x 1" hole, 21" from end. Bottom flange is beginning to knife edge ahead of bearing.

Span 1 bent 1 girder 5 was t spliced in 2020.

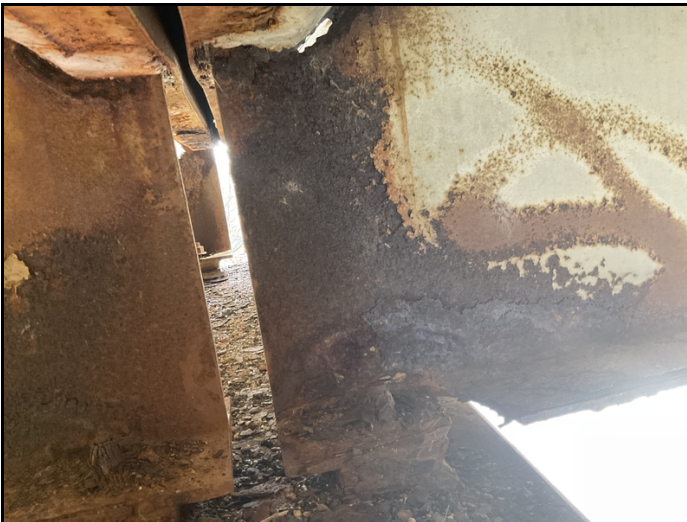
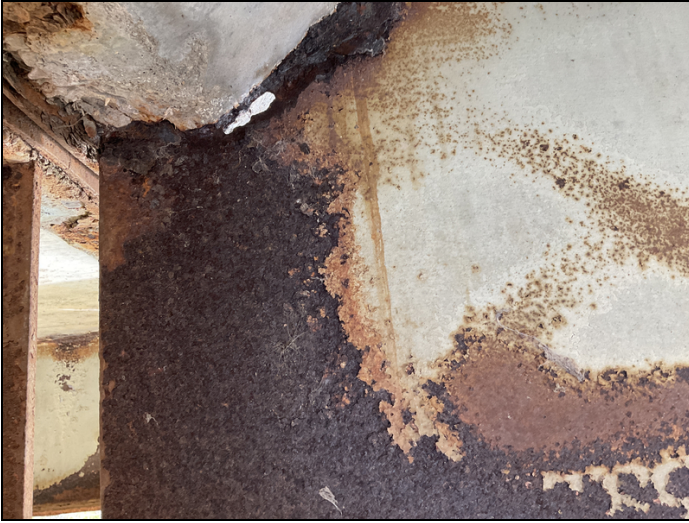
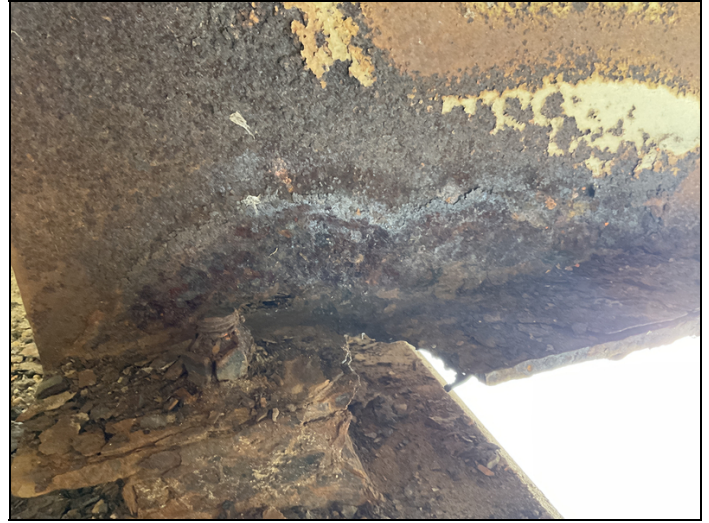
Span 2 girder 4 bent 3 11-14-2022

Span 2 bent 3 girder 4 has a 2in. x 1in. diameter hole in web below haunch. Left bottom flange has a 3in. x 4in. hole at bearing. Web over bearing has a 2in. x 1in. hole. Right bottom flange has measurable section loss.

Span 2 bent 3 girder 4 haunch

Span 2 girder 4 bottom flange

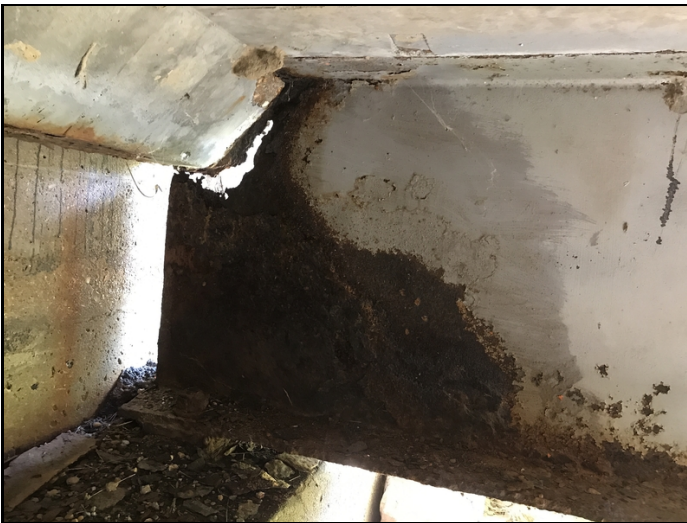
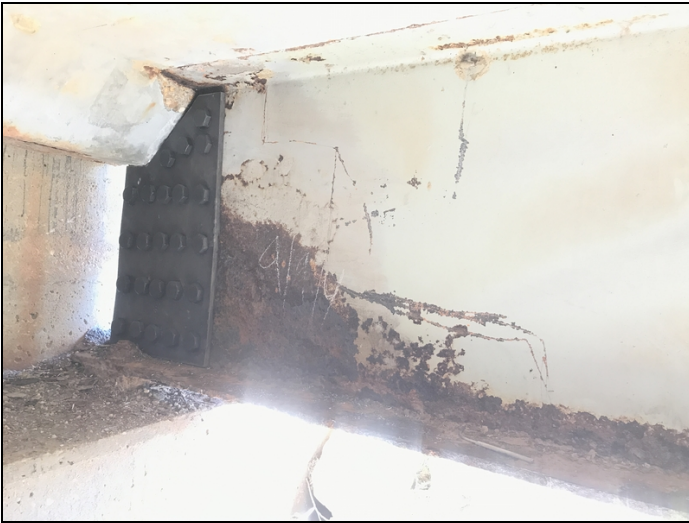
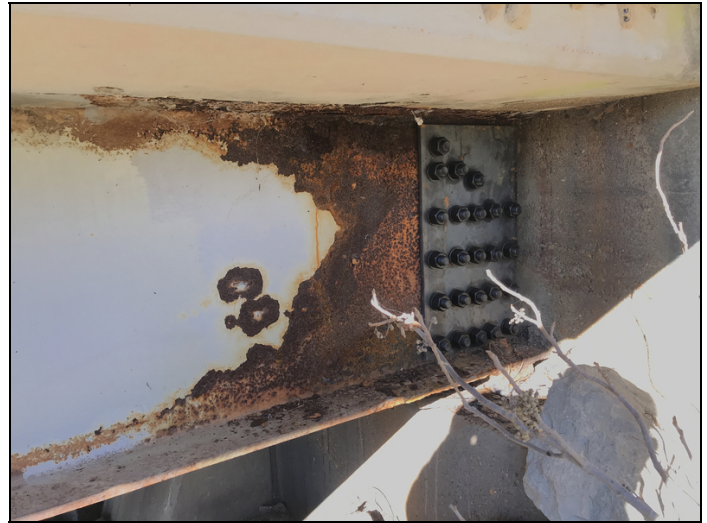
Span 3 bent 4 girder 5

\*Span 3 bent 4 girder 5 has a 11" x 2" hole in web below haunch. End of web has moderate section loss.

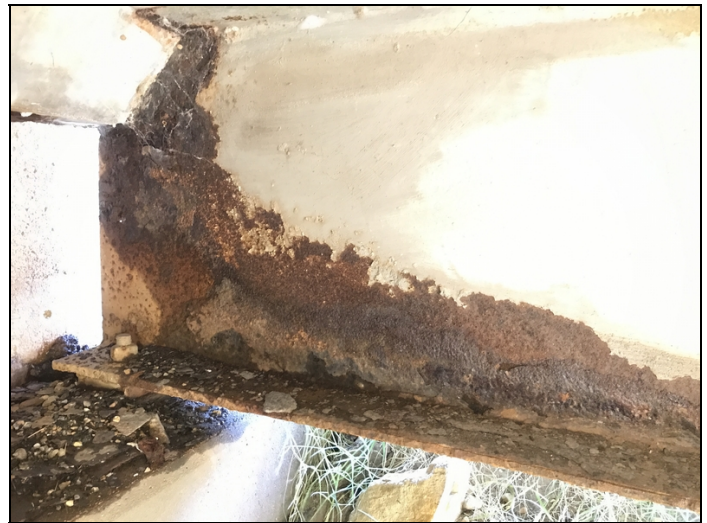
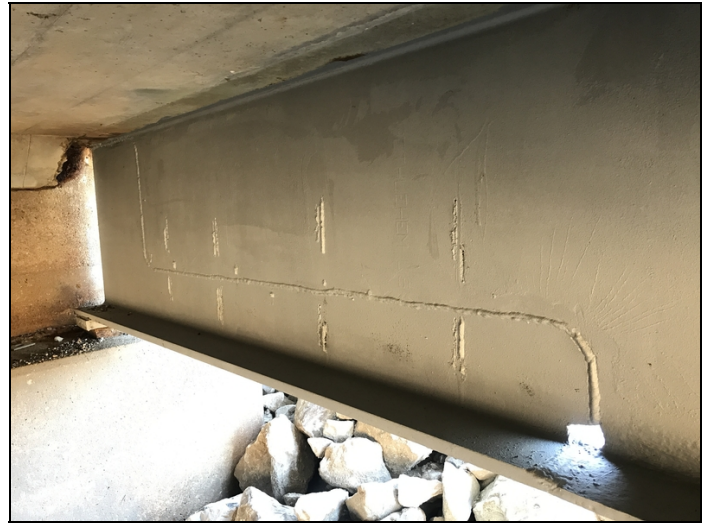
Span 1 bent 1 girder 1

\*Span 1 bent 1 girder 1 has minor to moderate section loss for 8.5' along bottom of web and bottom flange.

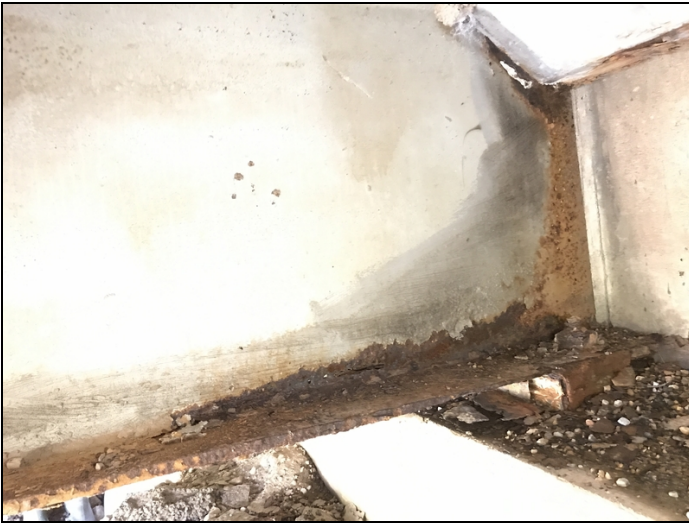
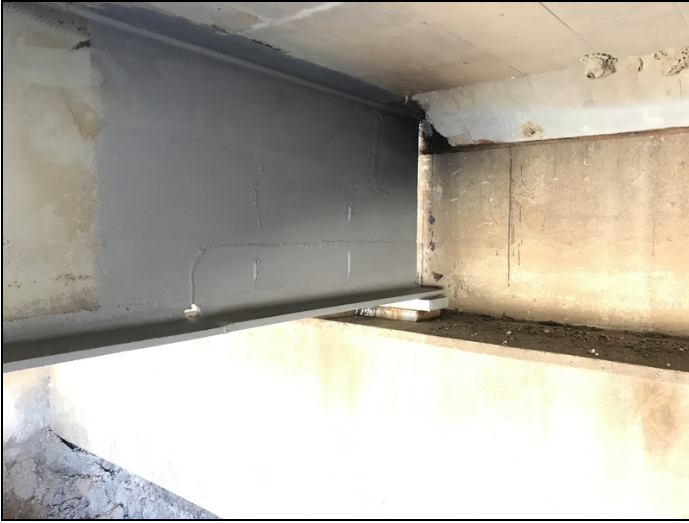
Span 1 bent 1 girder 3

\*Span 1 bent 1 girder 3 has a 3" x 1" hole in web below haunch and a 5.5" x 1" hole in bottom of web 16" from end. Bottom flange is knife edged with 1/8" remaining on edge near bearing.

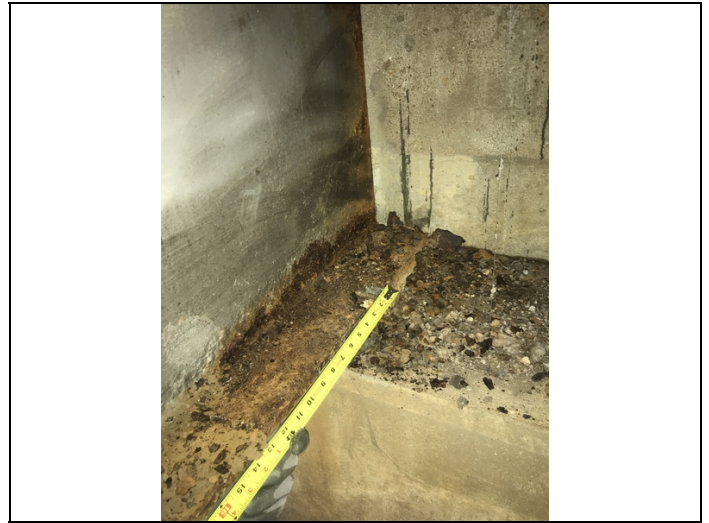
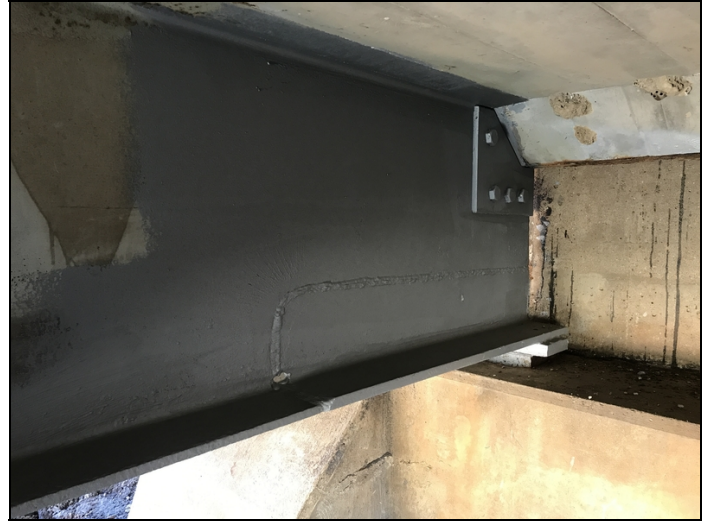
\*Span 1 bent 1 girder 4 has section loss for 2' along bottom of web and bottom flange. Lt bottom flange has a 4" x 2" hole in near bearing.

Span 1 bent 1 girder 4 hole in left side of bottom flange at  
with section loss at bottom of web

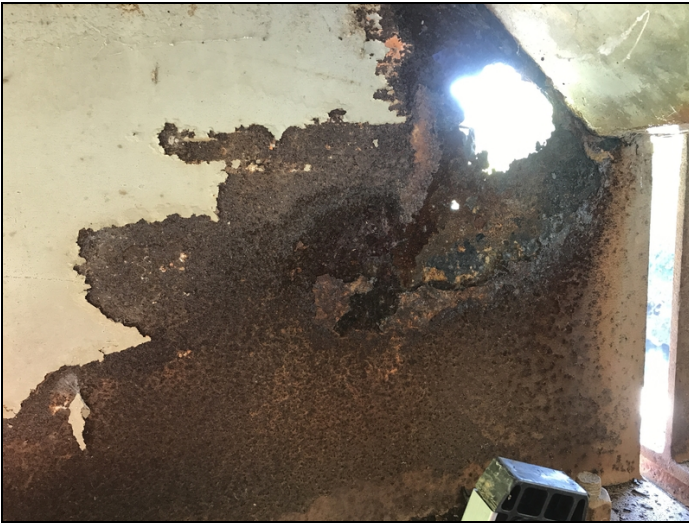
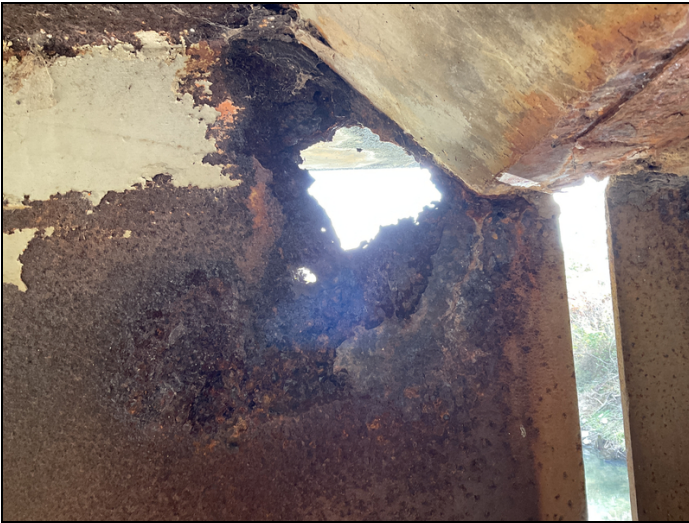
Span 3 bent 3 girder 5

\*\*Span 3 bent 3 girder 5 has a 6" x 5" hole & a 2in. x 5in. area of holes in web below haunch. MOVED TO CF PRIORITY.

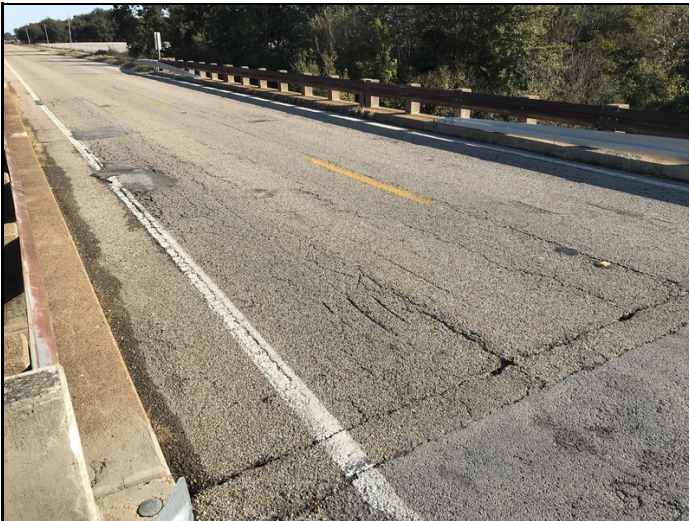
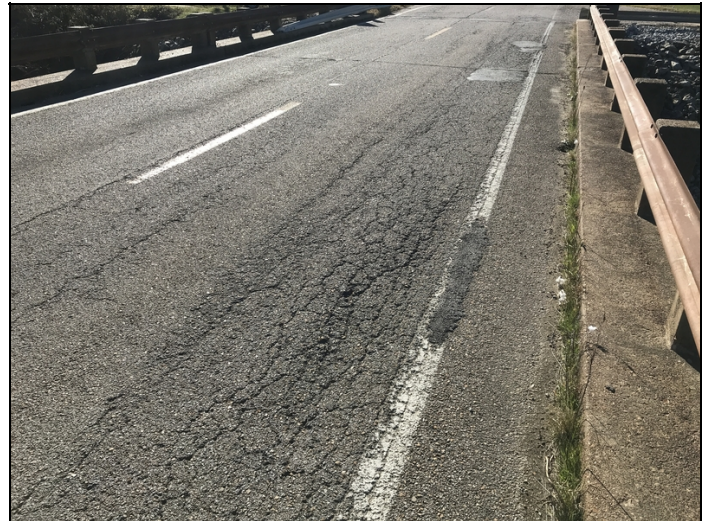
wearing surface

Wearing surface has a few transverse and longitudinal cracks, and a few areas of map cracking and patches in wheel path.

Spans 2 & 3 southbound lanes have areas of spalling & broken asphalt.

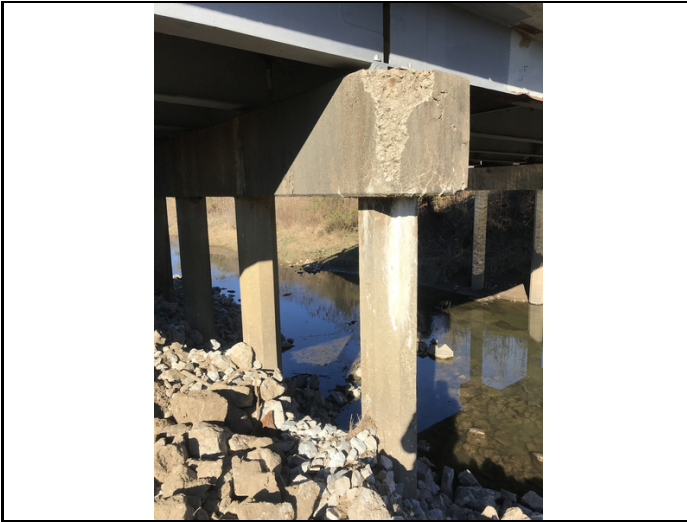
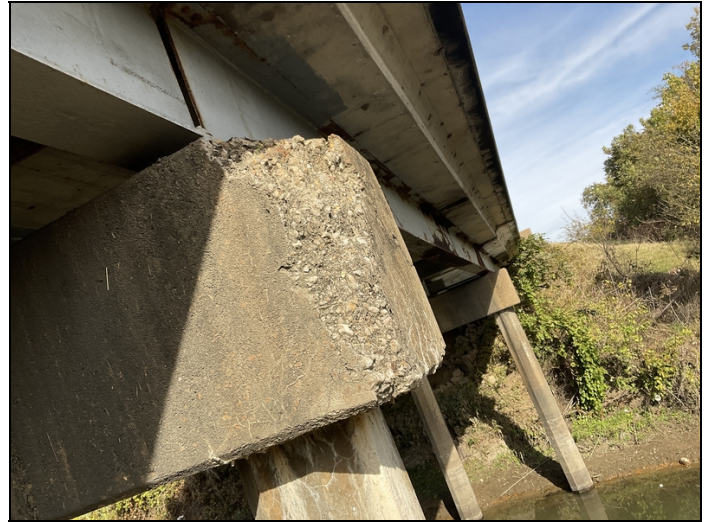
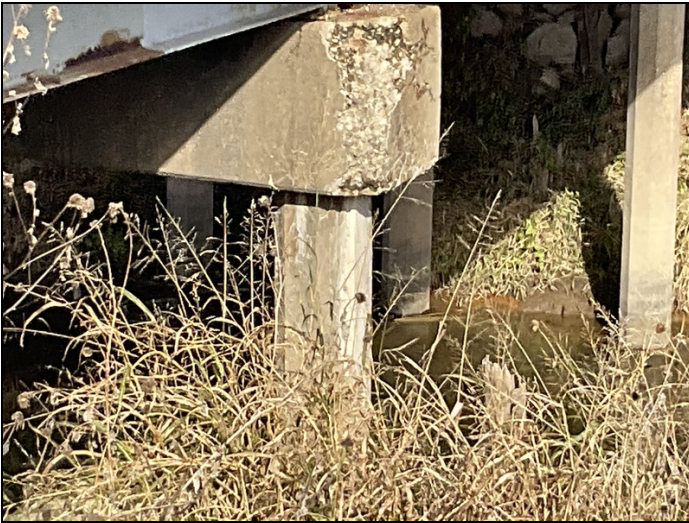
Bent 2 Rt

Bent 2 cap has 2' of deterioration with efflorescence and some rebar exposed on Rt end.

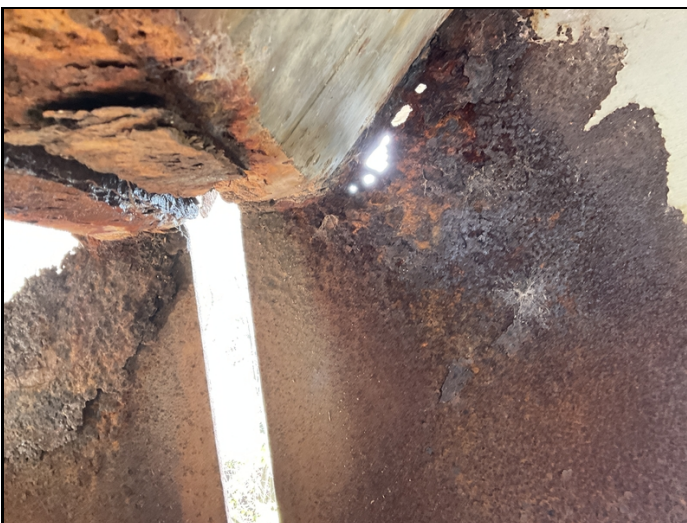
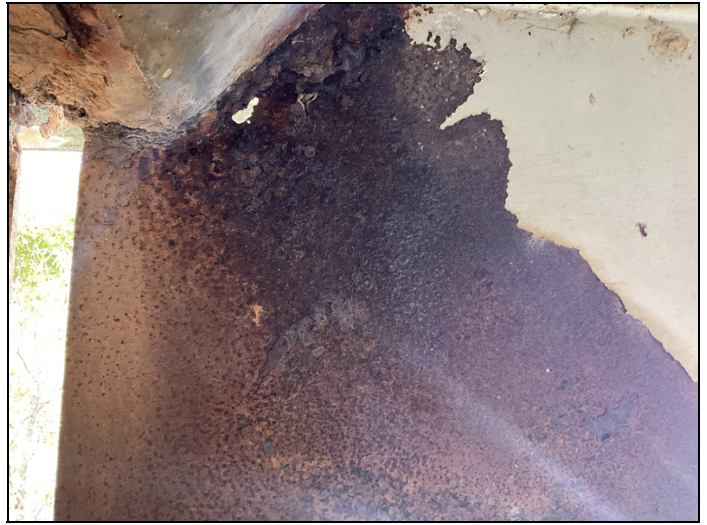
Span 2 girder 5 bent 3 11-14-2022

Span 2 bent 3 girder 5 has heavy section loss & a 5in. x 1in. hole at web below haunch.

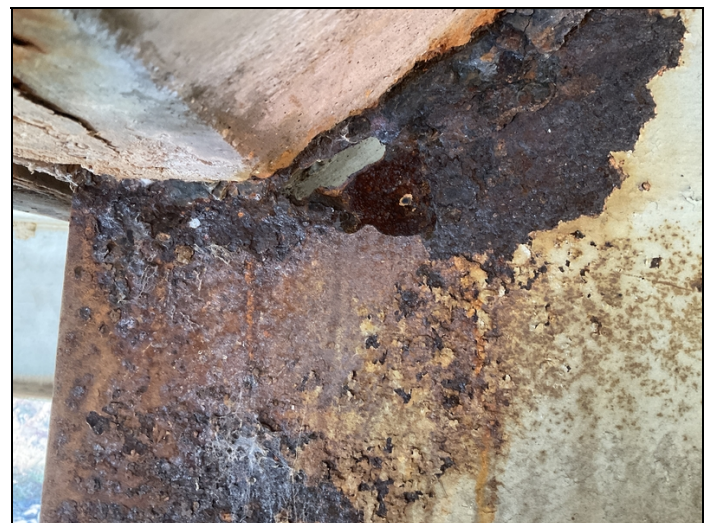
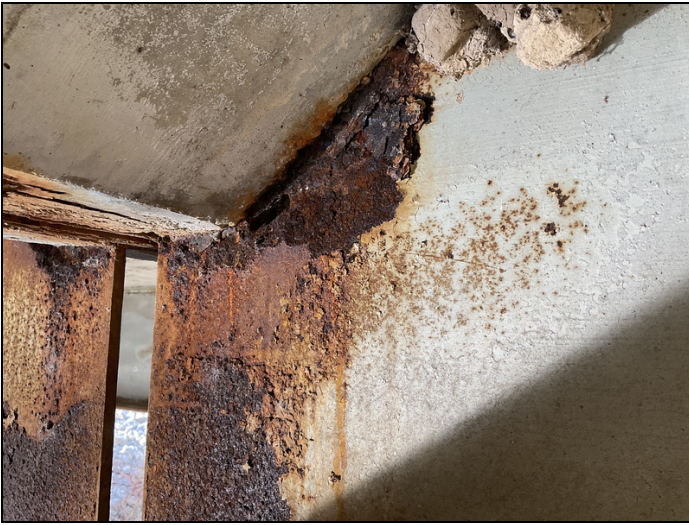
Span 3 bent 3 girder 3 11-14-2022

Span 3 bent 3 girder 3 has a 2in. x 1/2in. hole in web below haunch. 4ft. of bottom flange has rust with measurable section loss.

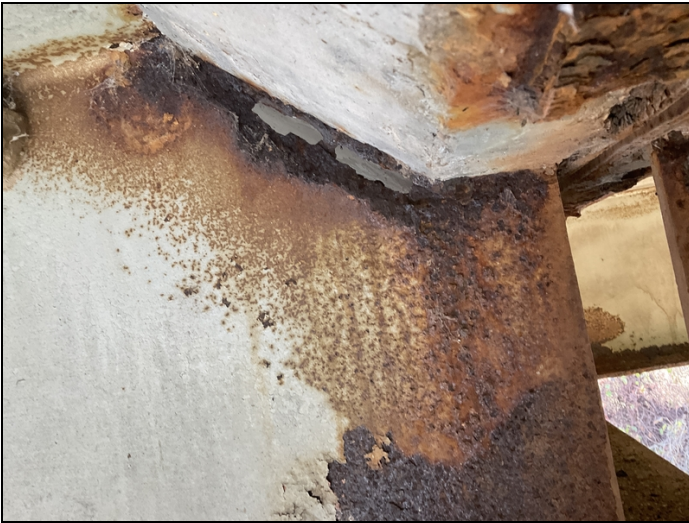
Span 2 girder 3 at bent 3 11-14-2022

Span 2 bent 3 girder 3 has a 5in. x 2in. hole in web near haunch.

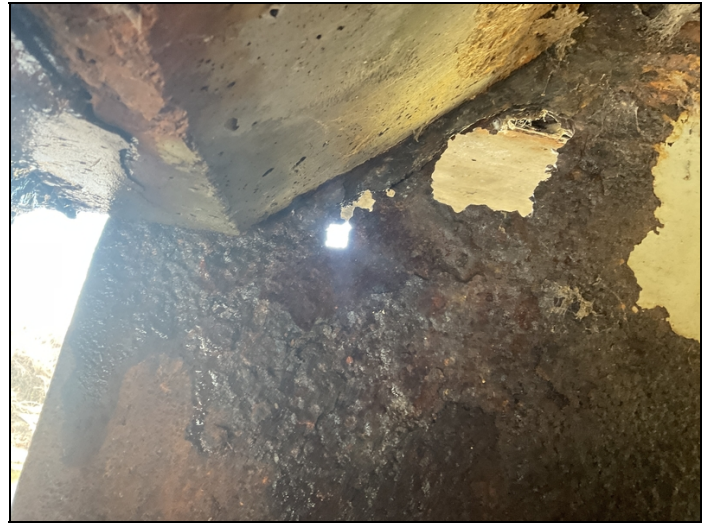
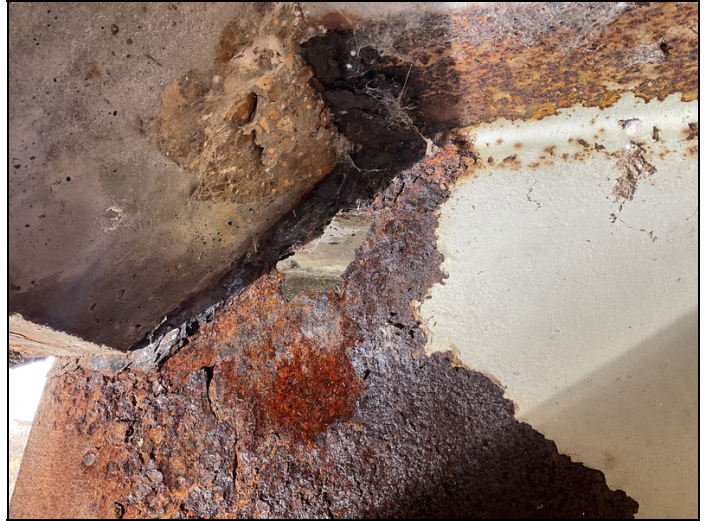
Span 3 bent 3 girder 1 11-14-2022

Span 3 bent 3 girder 1 has a 7in. x 2in. hole in web below haunch. Bottom of web and bottom flange have 8ft. of moderate section loss.

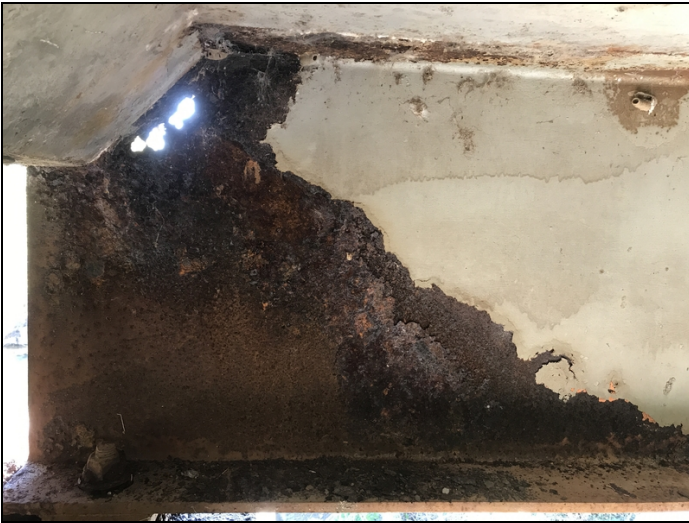
Span 1 bent 2 girder 5 web below haunch has a welded web splice.

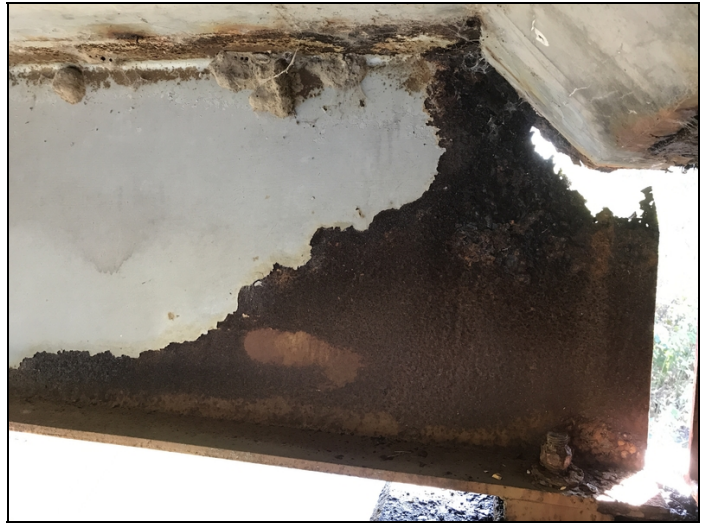
Span 2 bent 2 girder 5 web below haunch has a welded web splice.

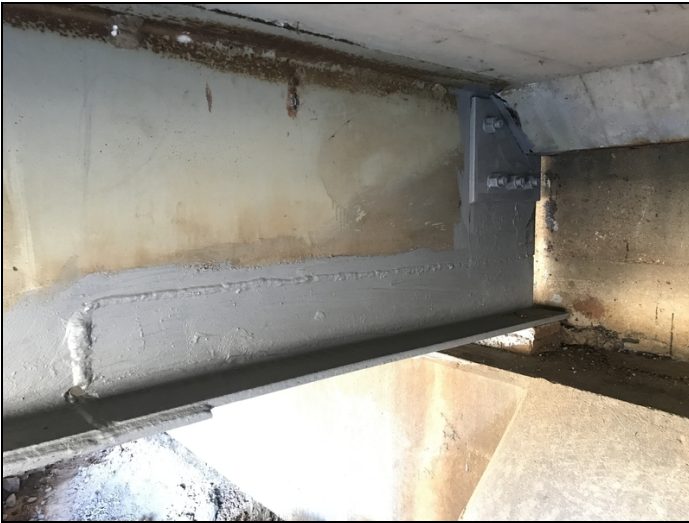
Span 1 bent 1 girder 2 has a bolted plate at web below haunch. Bottom of web has been t-spliced in the past.

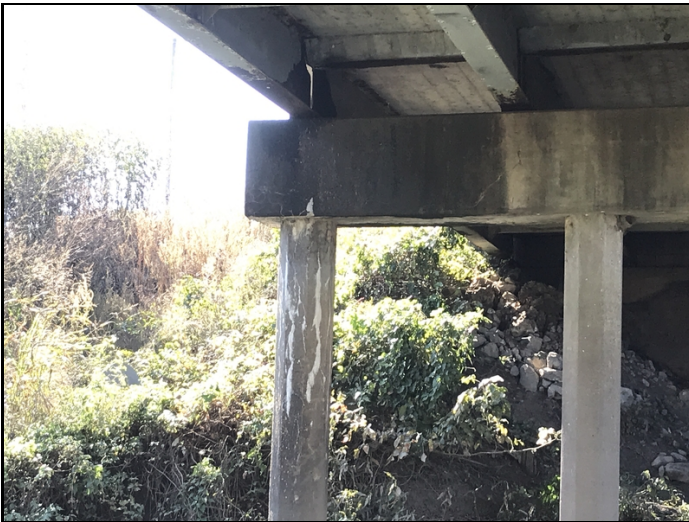
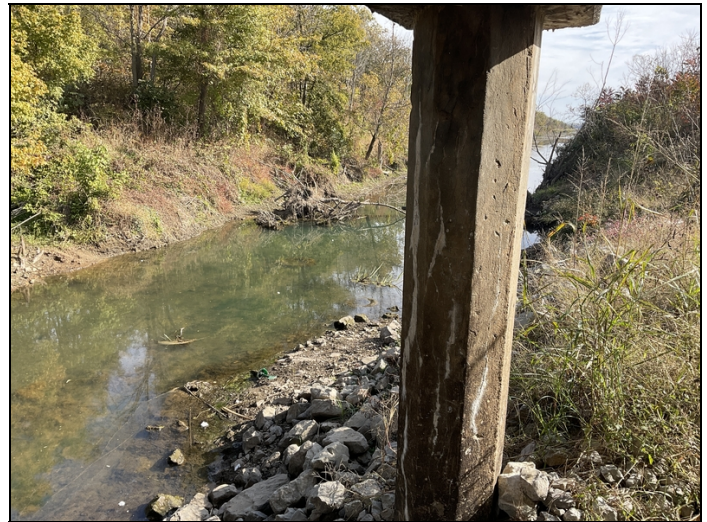
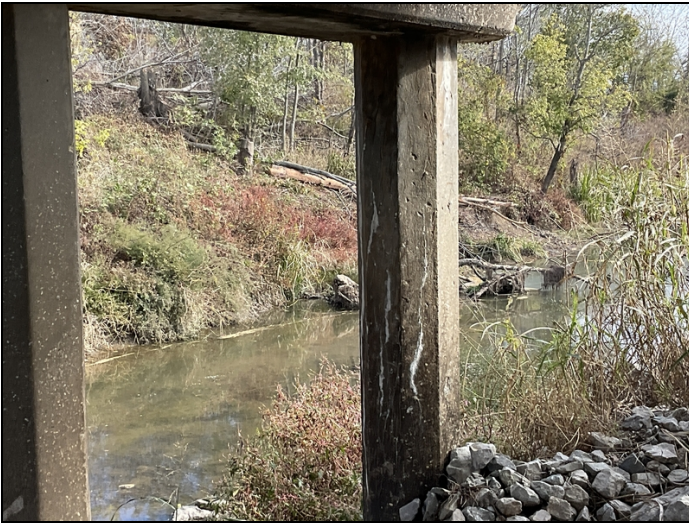
Bent 2 pile 4 has several vertical cracks with heavy efflorescence buildup.  
Bent 3 pile 4 has several vertical cracks.
