Asset #A2885(Routine)

SH 135-01- LM 2.67 over TYRONZA RIVER

Location: 2.43 M N JCT US 63 &SH135

Team Lead: Richard Jones, Inspection Date: 07/26/2023

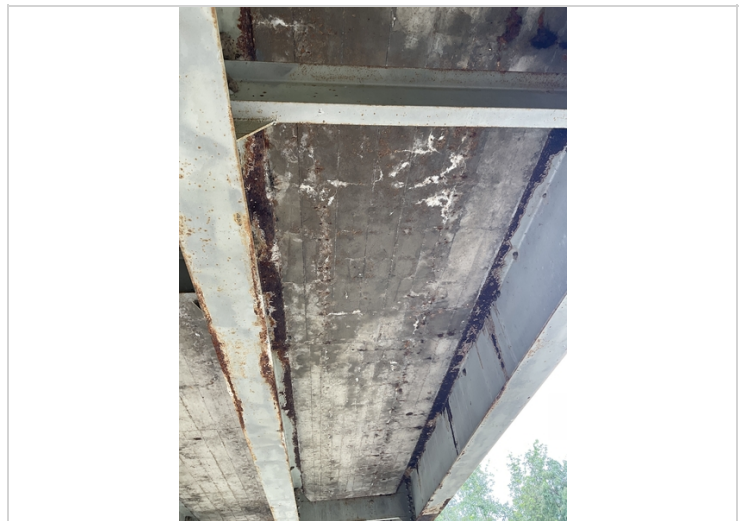
Span 4 bay 1

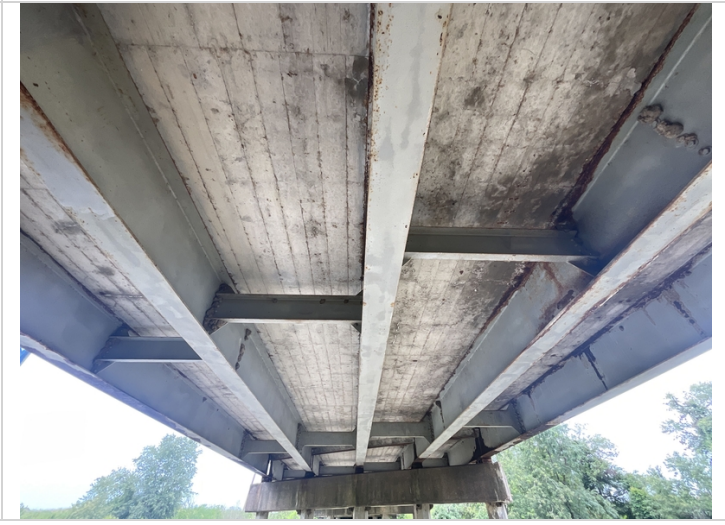
Soffit

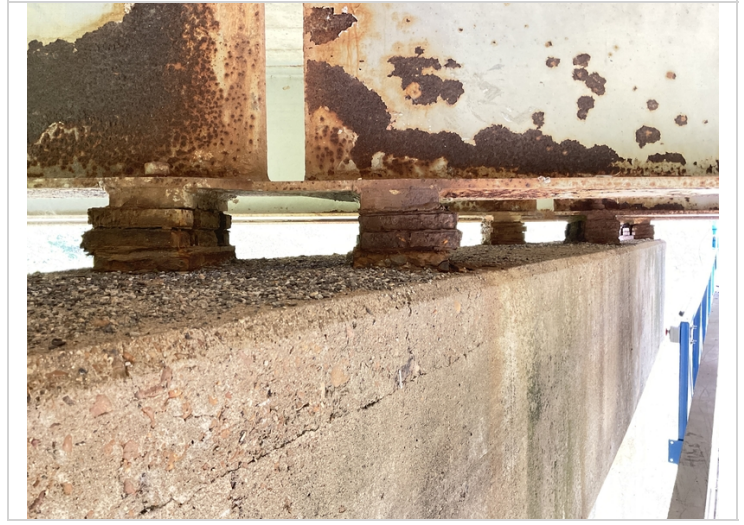
Typical bearing shims

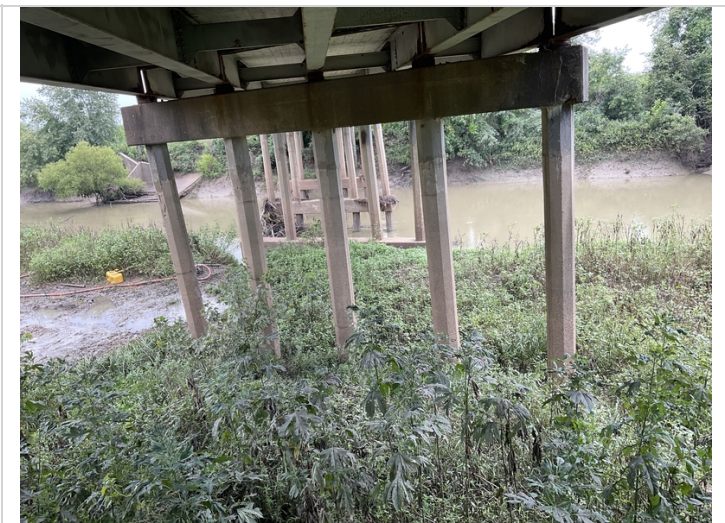
Piles out of plumb

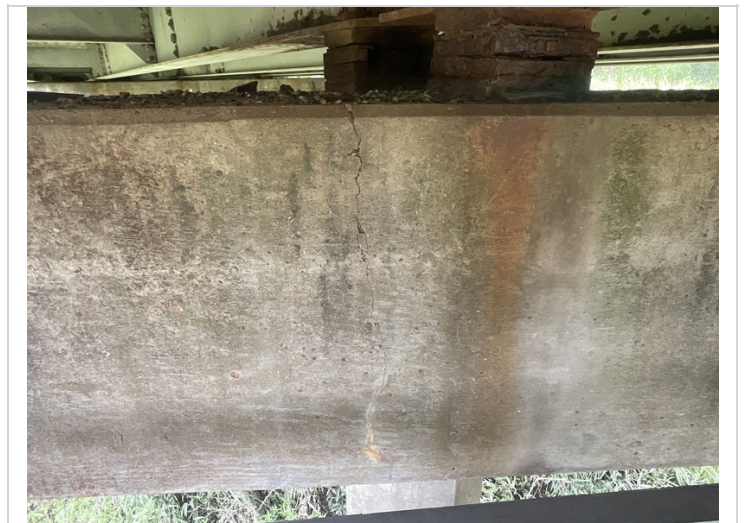
Typ settlement cracks

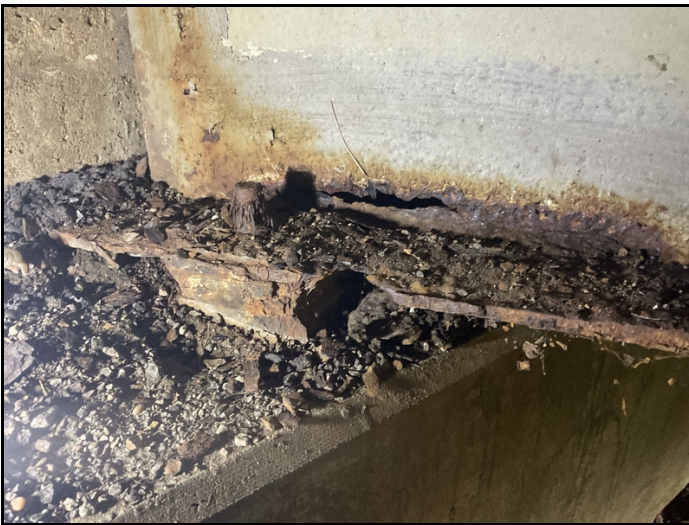
Span 1 bent 1 girder 4 has a 4" x 1" hole in web below haunch. Bottom of web has an 8" x 1" hole 5" from end of girder. Lt bottom flange is knife edged with a 13" x up to 3" hole along flange edge. Rt bottom flange is knife edged with a 3" x 2" hole adjacent to bearing.

Span 1 bent 1 girder 4
3" x 2" hole right bottom flange

Type of Work: T-Splice

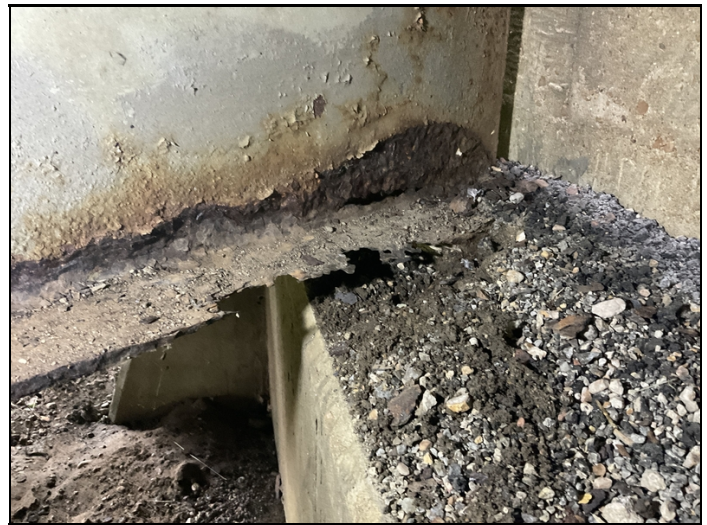
Span 1 bent 1 girder 4 - 8" x 1" hole at bottom of web 5"
from end. 13" x 3" hole left bottom flange.

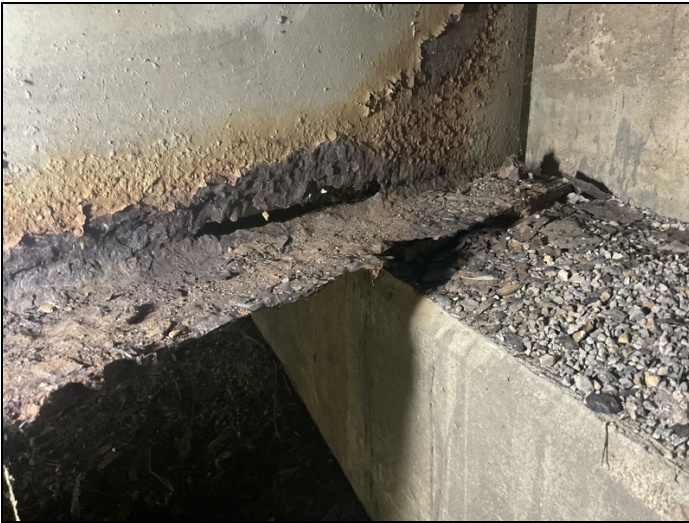
Span 7 bent 8 girder 3 has an 18" x 1" hole along bottom of web 9" from end of girder. Lt bottom flange is knife edged with a 6" x up to 3" hole adjacent to bearing. Rt bottom flange is knife edged with holes along outside edge.

Span 7 bent 8 girder 3 Rt
18" x up to 1" hole in bottom of web 9" from end of girder,
and a 4" x 2" hole in Rt bottom flange.

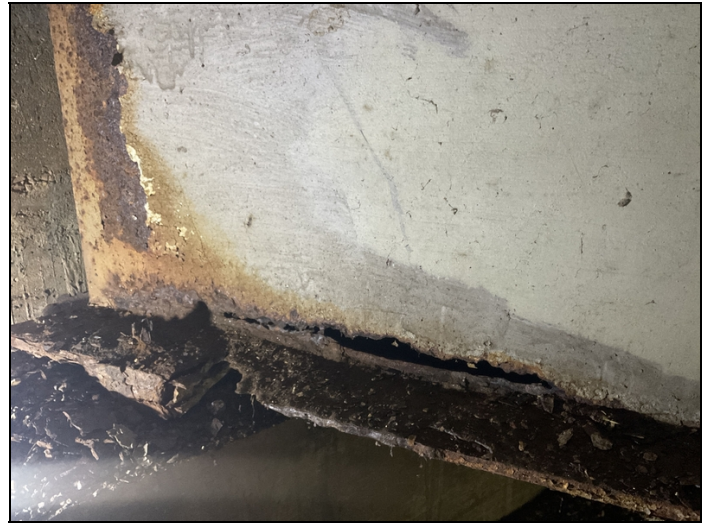
Span 7 bent 8 girder 3 Lt
18" x up to 1" hole in bottom of web 9" from end of girder,
and a 6" x 3" hole in Lt bottom flange.

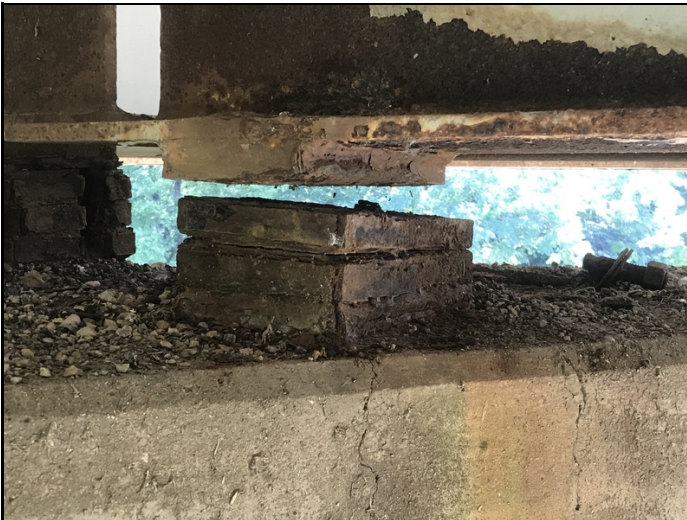
Span 3 bent 4 bearing 4 2019

Span 3 bent 4 bearing 4 shim plates are loose and moving under traffic.

Type of Work: Bearing Repair/Replacement

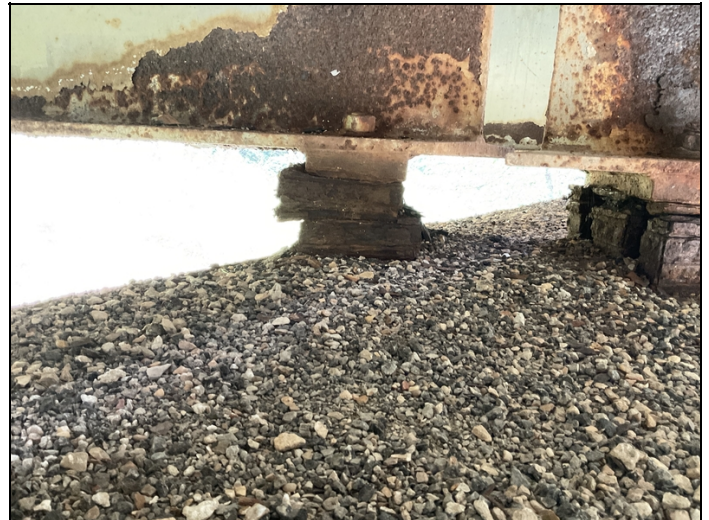
2023 - Span 6 bent 6 bearing 4

Span 6 bent 6 bearing 4 shims are shifting or out of alignment.

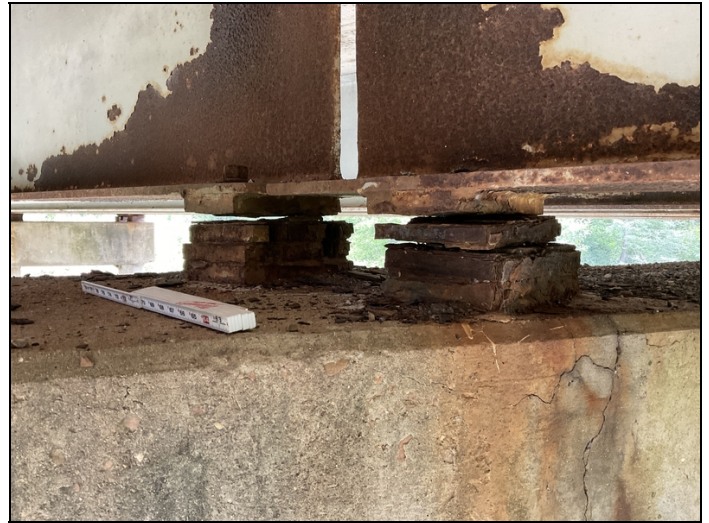
2023 - Bearing 2 over bent 4

Span 4 bent 4 bearing 2 has 1 plate missing.

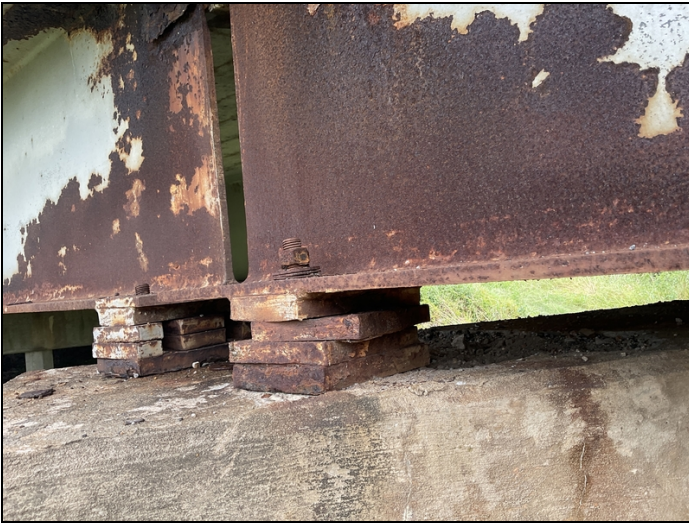
2023 - Span 5 bent 6 bearing 1 shims

Span 5 bent 6 bearing 1 shims are loose and rotating out.

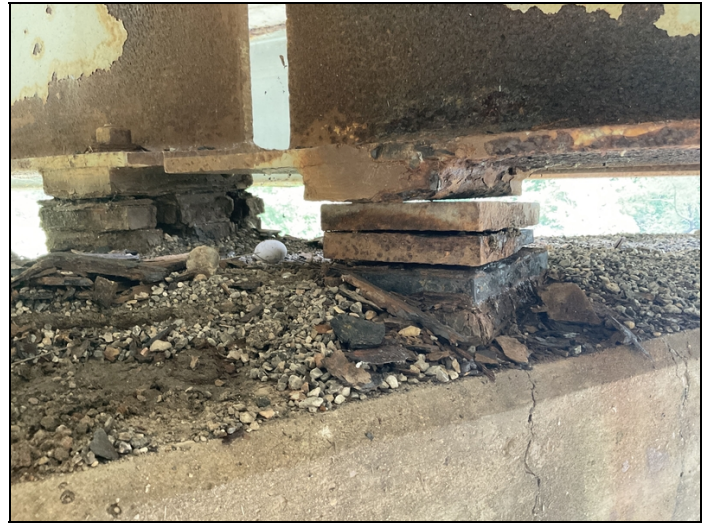
2023 - Span 4 bent 4 girder 4

Span 4 bent 4 bearing 4 shims are loose and moving under traffic.

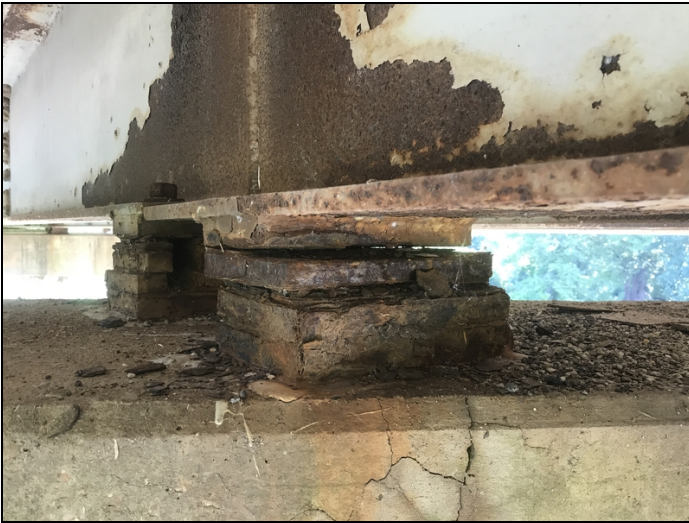
Span 3 bent 4 bearing 2 2019

Span 3 bent 4 bearing 2 shim plates are loose and moving under traffic.

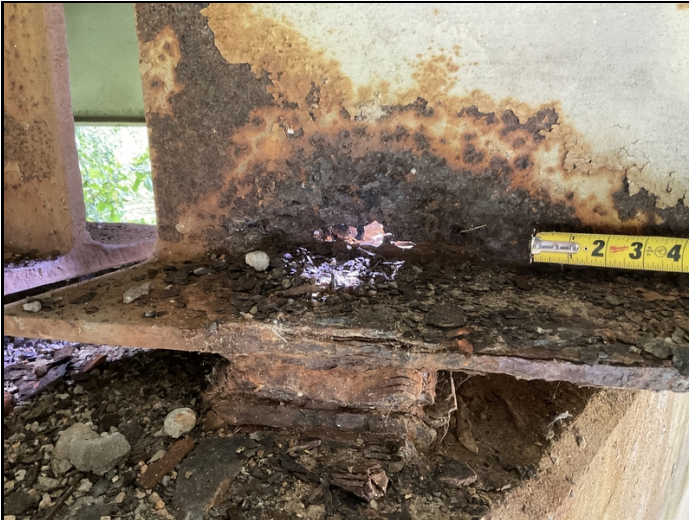
Span 6 bent 7 girder 3 has a 2.5" x 1" hole in bottom of web over bearing. Web has a 1/2" crack at end of hole running towards mid span.

Type of Work: T-Splice

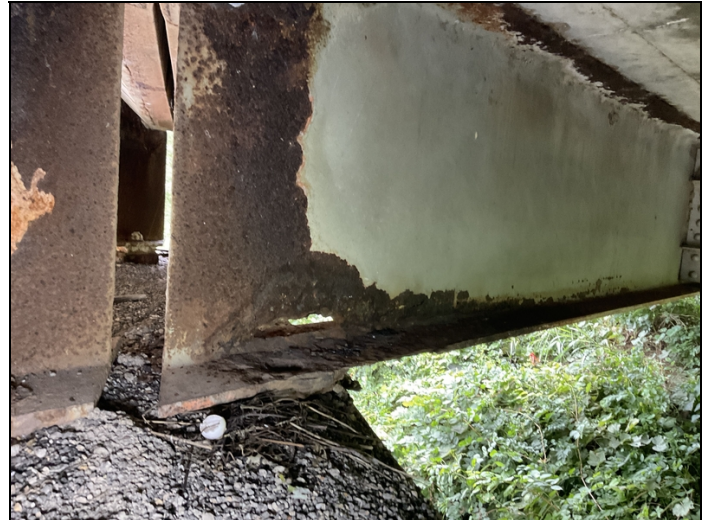
Span 1 bent 2 girder 4 has a 9" x 2" hole in bottom of web 6" from end. Bottom flange is knife edged for 1' adjacent to bearing.

Span 1 bent 2 girder 4
9" x 2" hole @ bottom of web 6" from end. Knife edge
bottom flange.

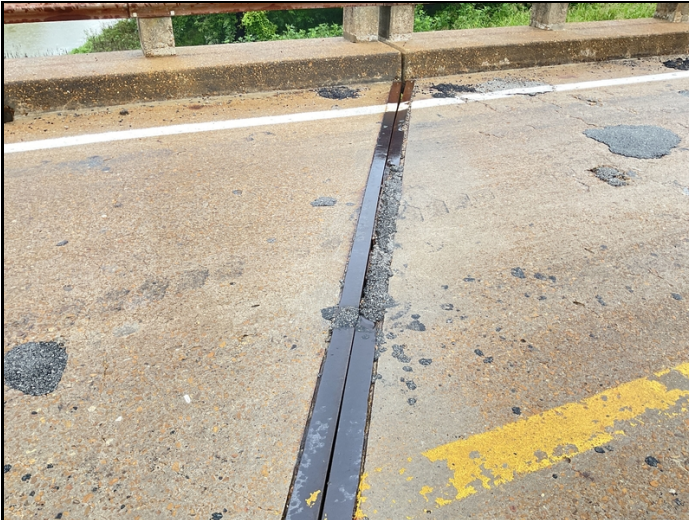
2023 - Bent 7 joint

Deck is spalled along several joints. Road irons are beginning to pull loose at bents 2, 5, and 7. (Bent 7 joint has 5' missing)

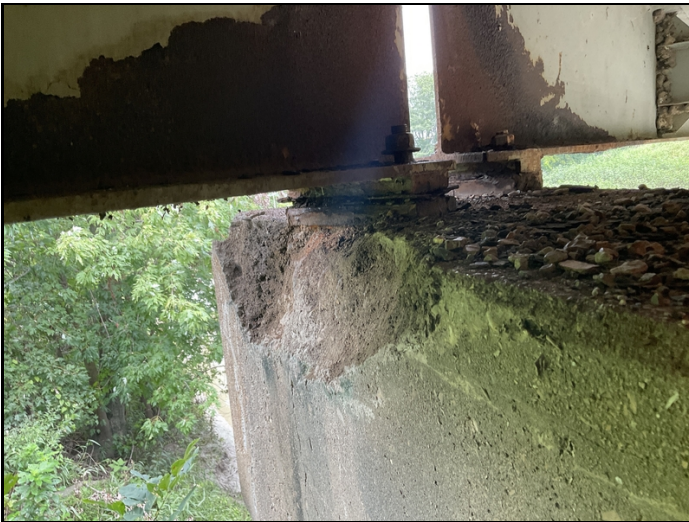
Bent 2 left

Caps at Bents 2 – 6 have several vertical and horizontal cracks, delaminated areas, and spalls with rebar exposed. Some piles have cracking/delaminations near bents.

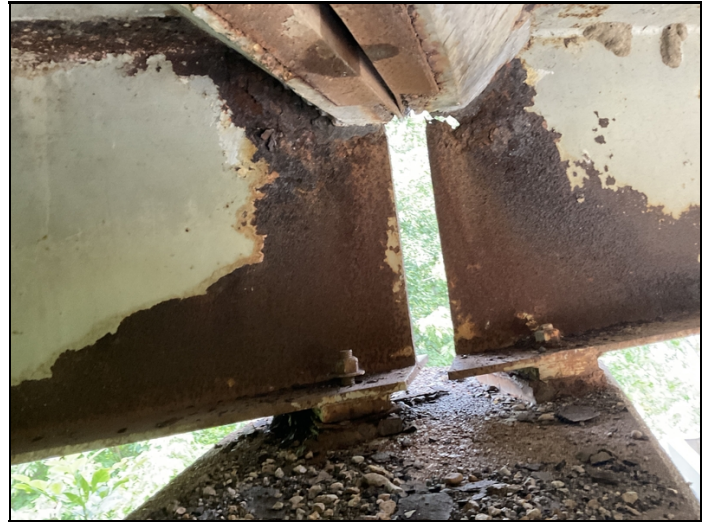
Girder 1 over bent 2

Girder ends have section loss, especially at web below haunch. See photos and element notes for specific locations.

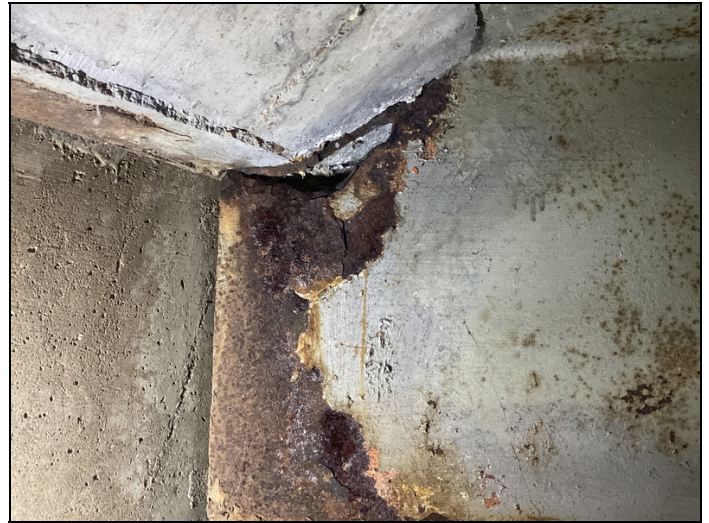
Span 1 bent 1 girder 2
9" x up to 2" hole @ haunch
