Asset #02884(Routine, Underwater type 2)
SH 135-01- LM 0.99 over DEAD TIMBER LAKE

Location: .99 MI N JCT OF US 63

Team Lead: Tim Myrick, Inspection Date: 04/07/2022

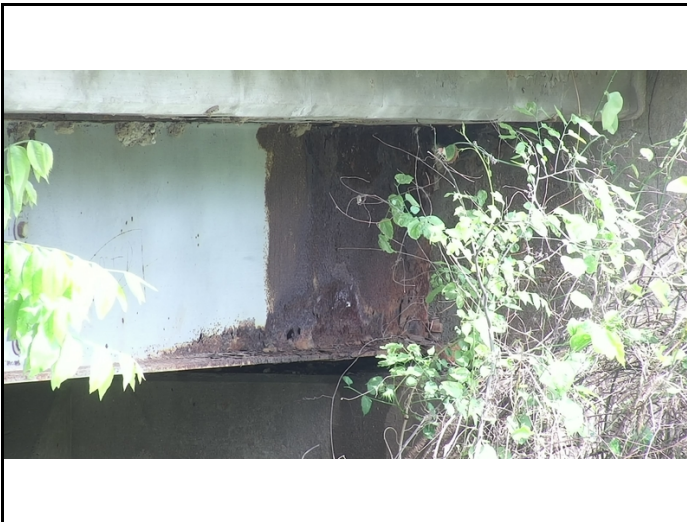
Span 5 bent 6 girder 5 has 2' of 1/8" section loss along bottom of web 2.5' from end 1" x 4" hole in web at web near bottom flange 3' back from Bt.6.
