Asset #02886(Routine)

SH 135-01-LM 6.03 over DITCH NO 47

Location: 3.0 MI N OF SH 118

Team Lead: Tim Myrick, Inspection Date: 09/19/2022

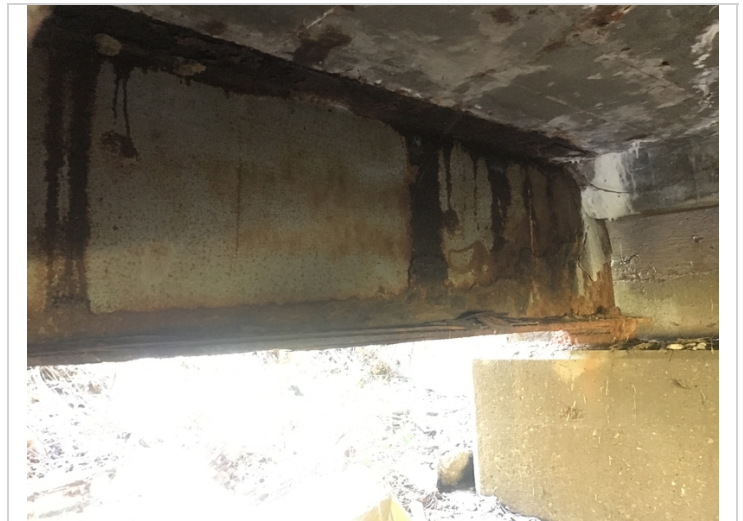
S1 b1 g5

*Span 1 bent 1 girder 5 has heavy section loss at web a 6' ft. x up to 1" area of along bottom flange Lt bottom flange is beginning to knife edge.

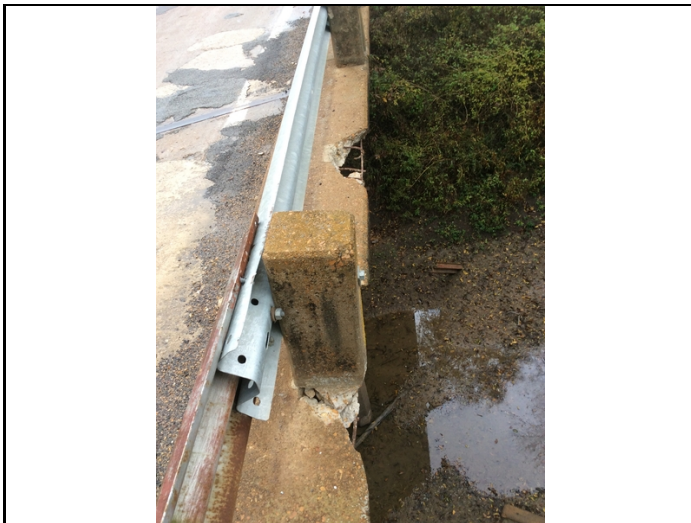
Right side of Span 3 Bridge Rail Post is broke with rebar exposed and 1 post missing with rebar exposed on overhang.

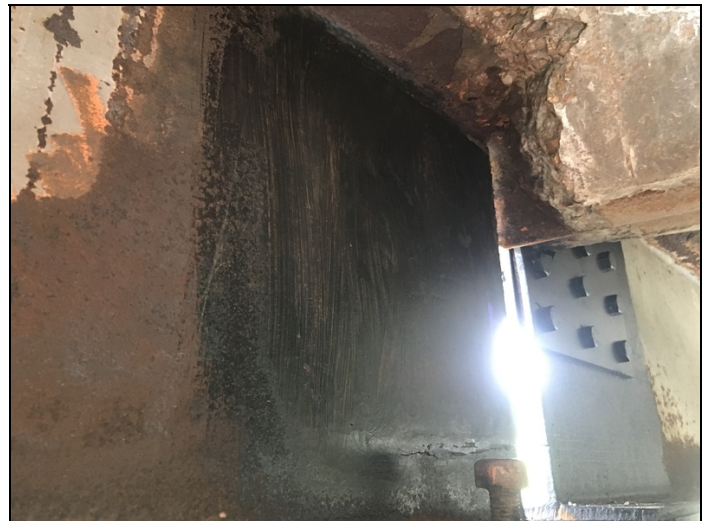
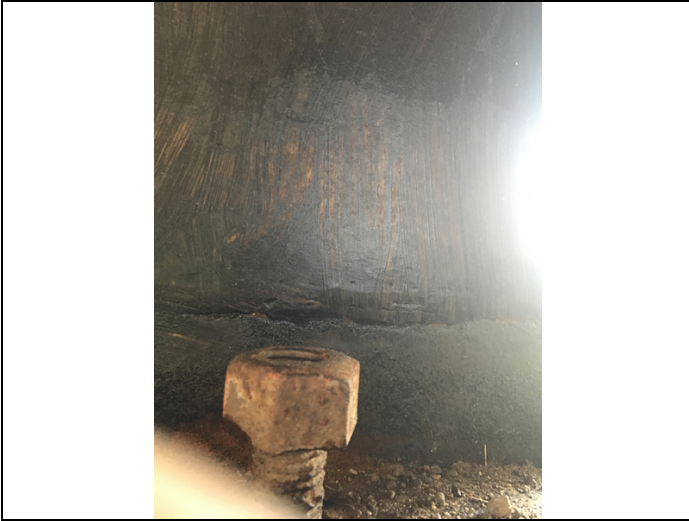
S3 b4 g1

Span 3 bent 4 girders 1, 3, and 4 - (floating with 1/4" gap at bearing)

Inspection 9-16-2021 for girder repairs made to superstructure by State Heavy Bridge crew. CCP

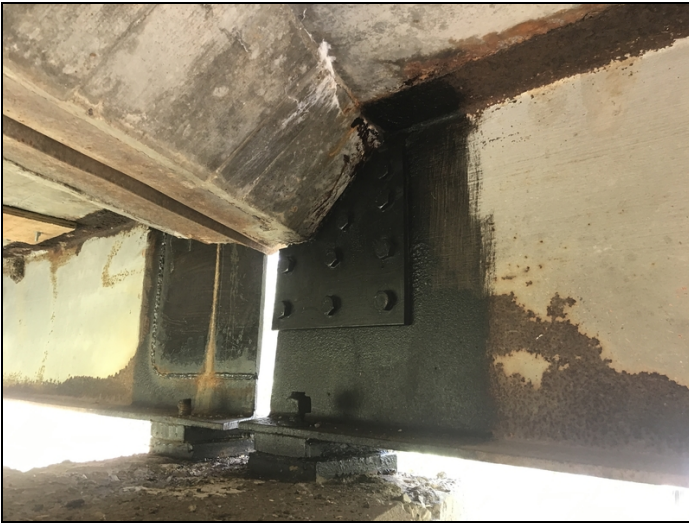
S3 b4 g5

*Span 3 bent 4 girder 5 has heavy section loss at web below haunch and out of plane bending.

Inspection 9-16-2021 for girder repairs made to superstructure by State Heavy Bridge crew. CCP

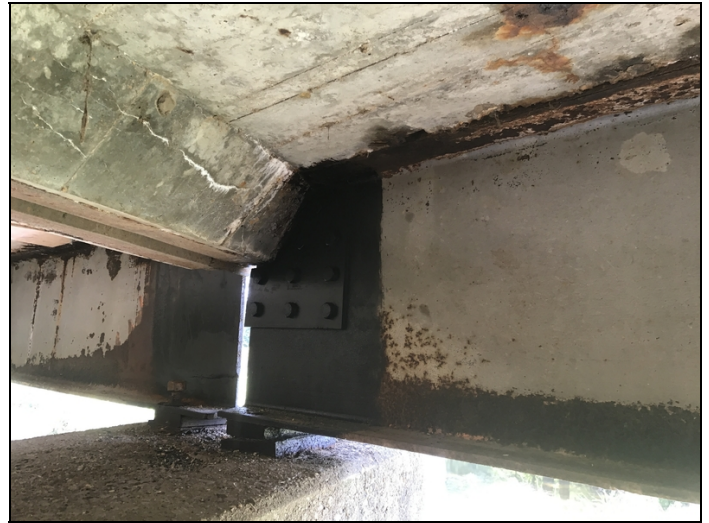
S4 b4 g1

*Span 4 bent 4 girder 1 has heavy section loss in web below haunch.

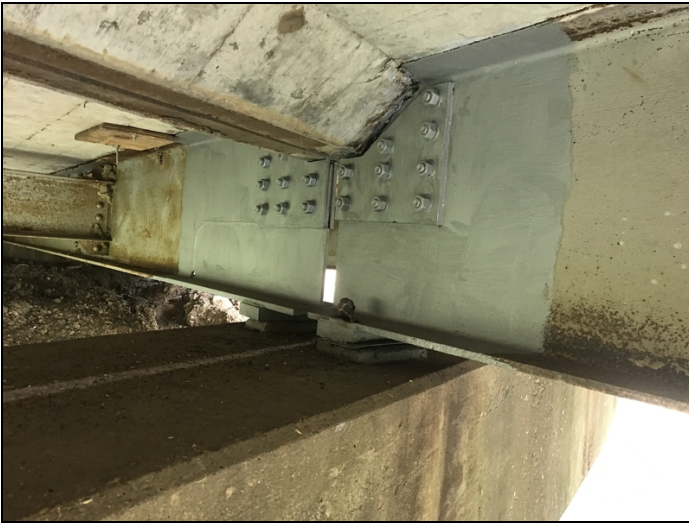
S4 b5 g3 & s5 b5g3

*Span 4 bent 5 girder 3 is moving under traffic.

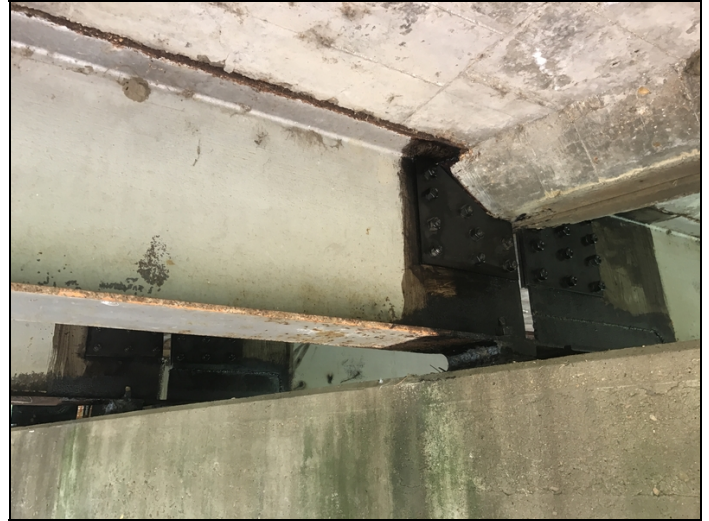
S3 b3 g3

- *Span 3 bent 3 girder 3 has a 4in. x 1in. hole in web below haunch.
- *Span 3 bent 3 girder 4 left bottom flange has heavy section loss at bearing with a 3 in. x 1 in. hole near haunch.

Inspection 9-16-2021 for girder repairs made to superstructure by State Heavy Bridge crew. CCP
