Asset #07019(Routine)

SH 135 over I-555

Location: JCT SH 135 & I-555

Team Lead: Tim Myrick, Inspection Date: 05/10/2021

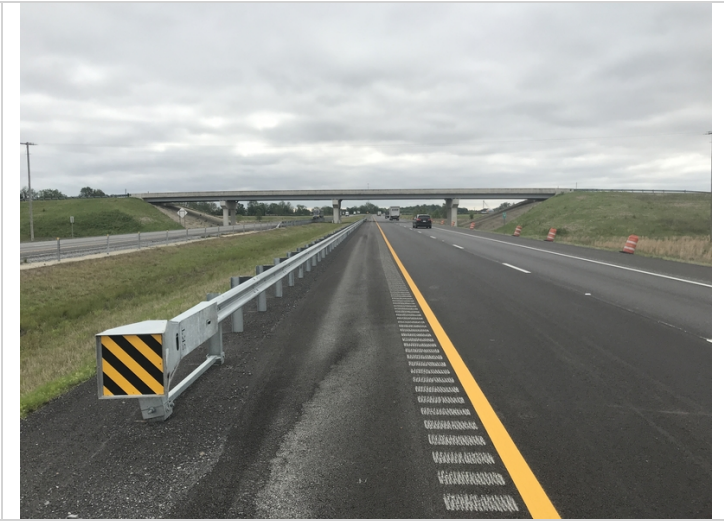
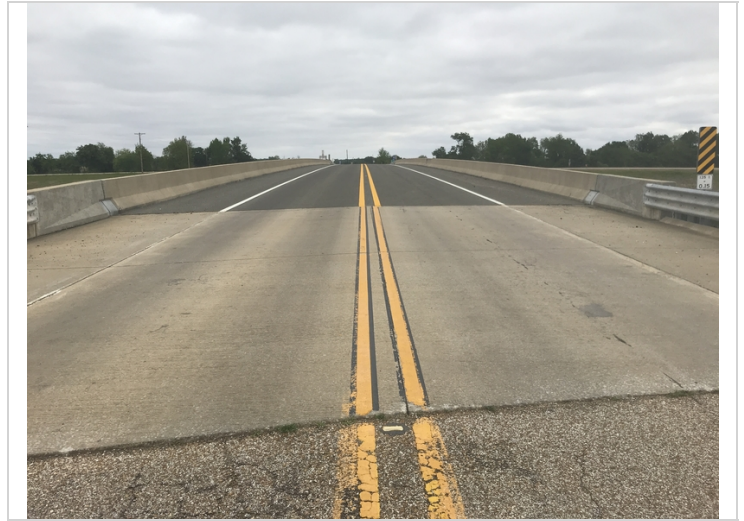
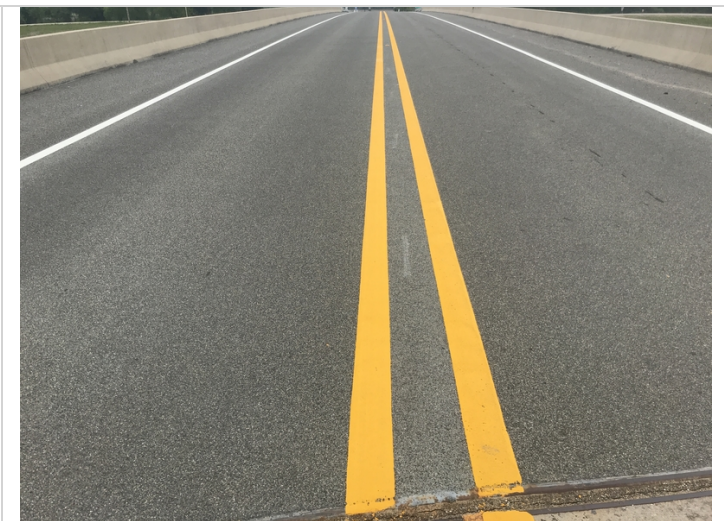
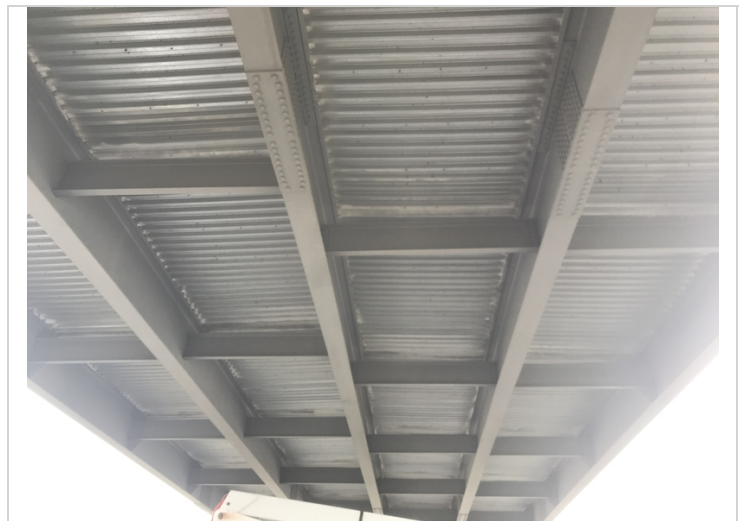
Both bridge ends have up to 3" roadway settlement, especially near drop inlet.

Type of Work: Repair (General)

copy to Poinsett Crew for review
