Asset #A2885(Routine, Underwater type 2)

SH 135-01- LM 2.67 over TYRONZA RIVER

Location: 2.43 M N JCT US 63 &SH135

Team Lead: Tim Myrick, Inspection Date: 05/17/2022

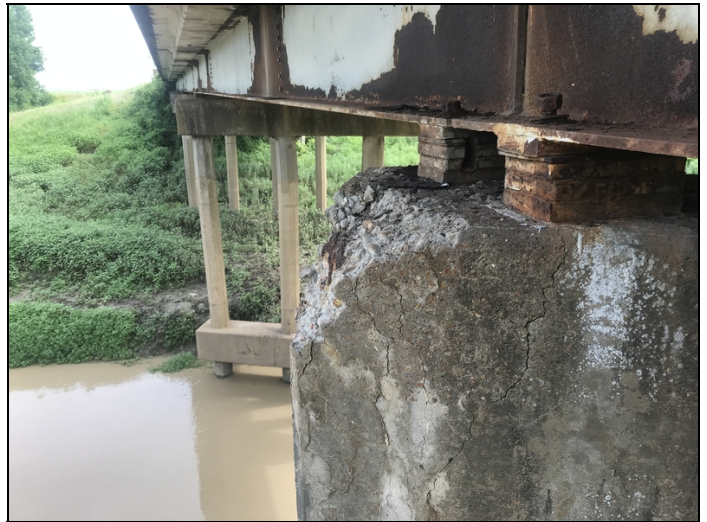
B4 left end

Cap has 1' of exposed rebar under bearing 3. left end has a spall with 1' of exposed rebar and 1' of cracks/delamination.

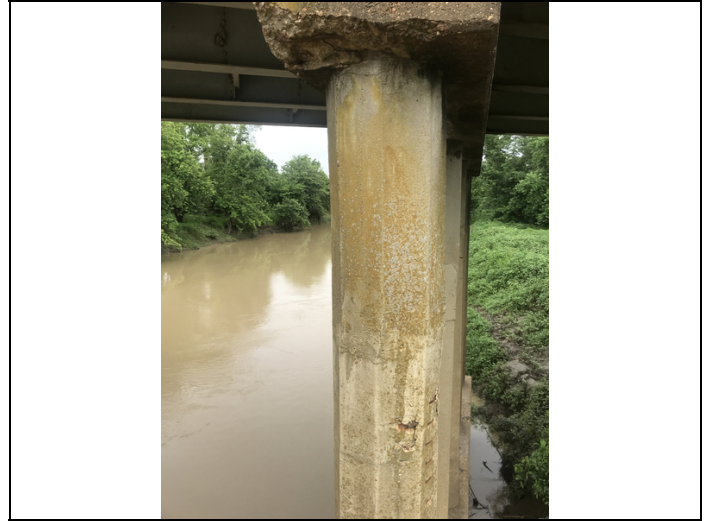
B5 right & p5

Cap has a spall with 1' of rebar on right end.

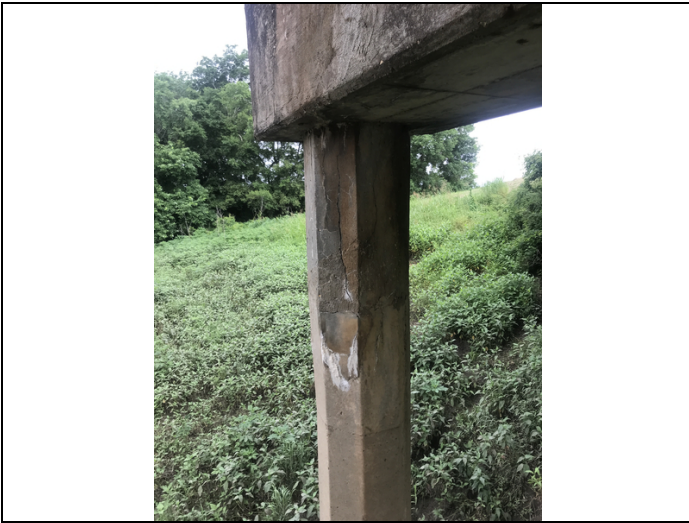
B6 p1

Bent 6 pile 1 has cracks, delaminated areas, and efflorescence.

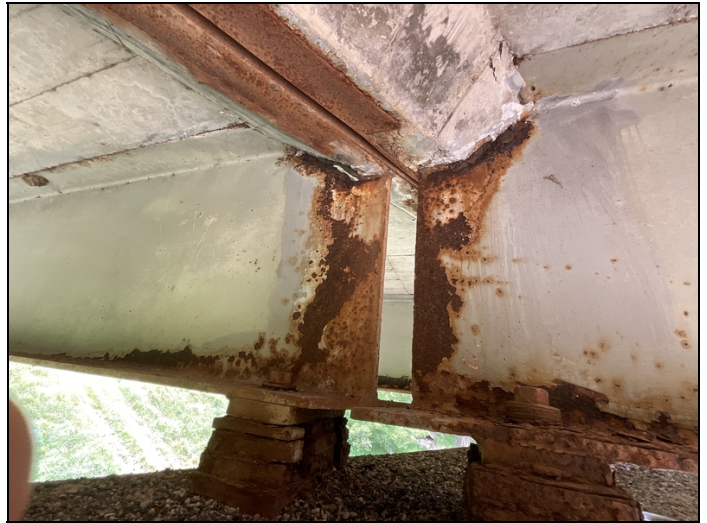
S5 & s4 b5 g4

Span 5 bent 5 girder 4 has 5"x1" hole in web haunch.

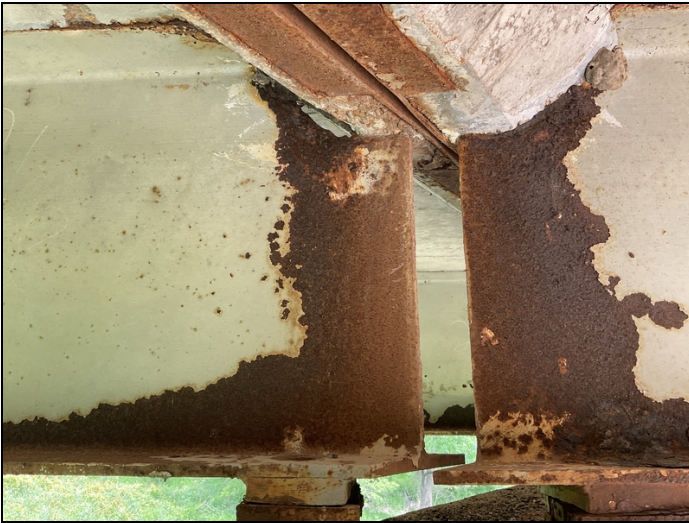
S5 & s4 b5 g2

Span 5 bent 5 girder 2 has a 5" x 1" hole in web below haunch.

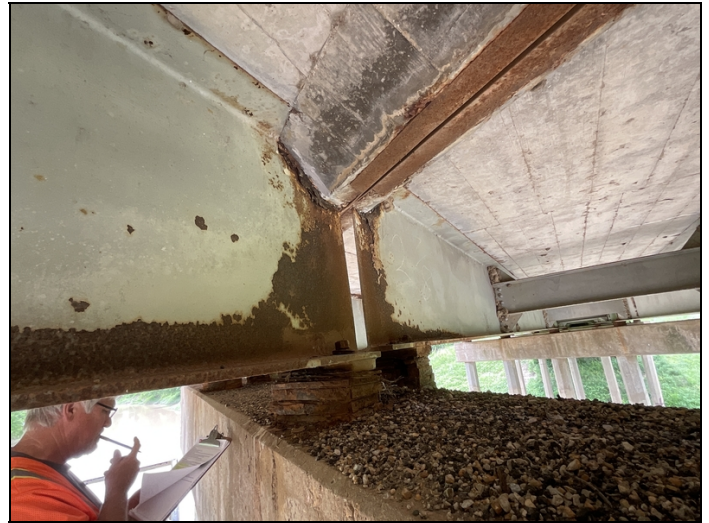
S3 & s4 b4 g3

Span 4 bent 4 girder 3 has a 3 " diameter hole in web below haunch.

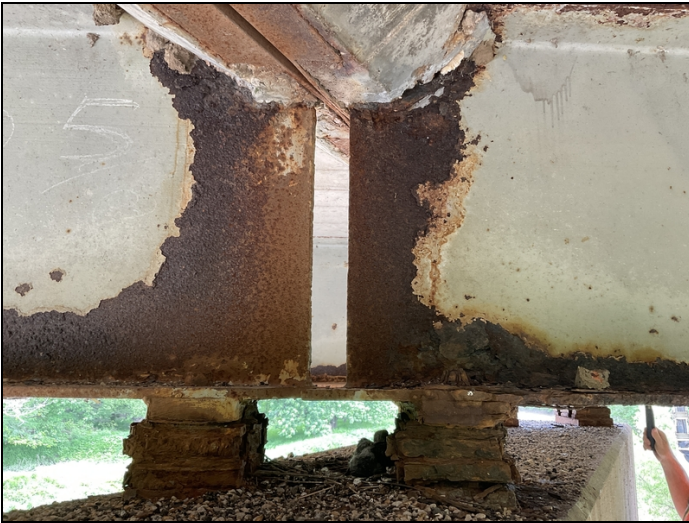
S3 & s2 b3 g4

Span 2 bent 3 girder 4 has a 5" x 1" hole in web below haunch. Bottom of web has some section loss over bearing.

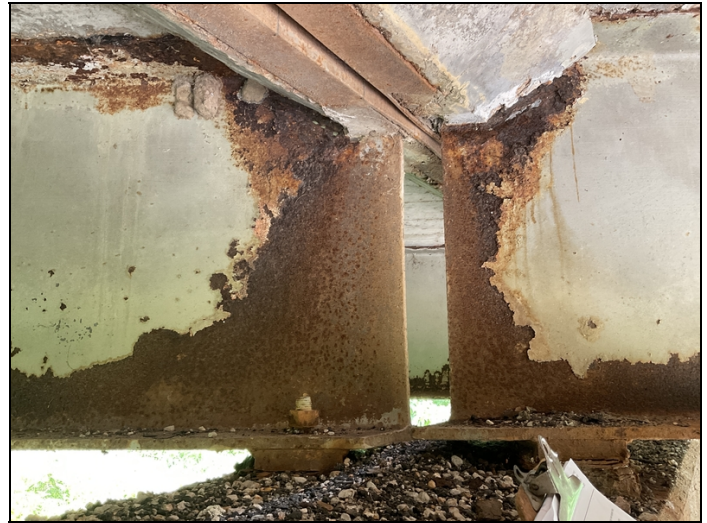
S1 & s2 b2 g3

Span 1 bent 2 girder 3 has a 3" diameter hole in web at haunch.

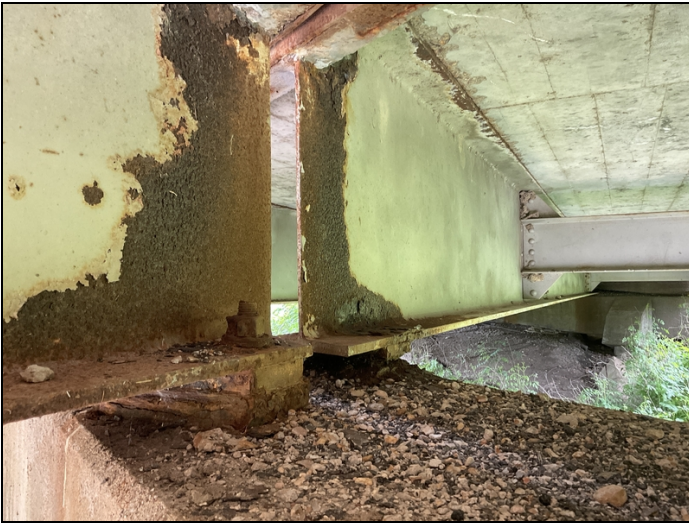
S1 b2 g2

Span 1 bent 2 girder 2 has pin hole at haunch.

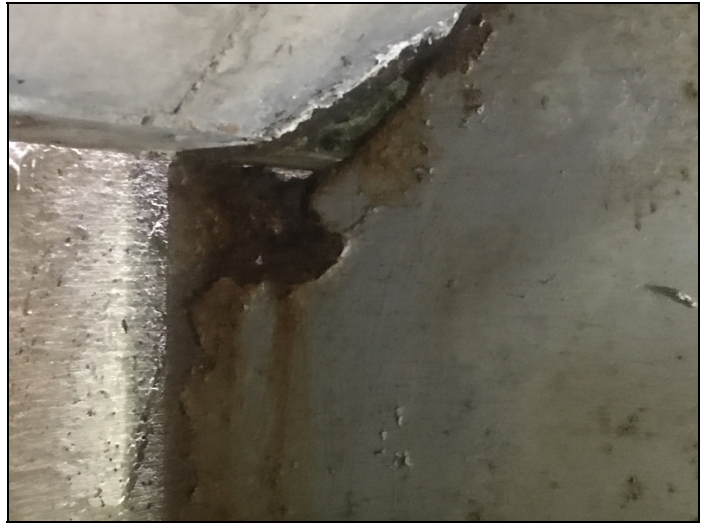
Span 1 Bent 1 girder 2 2019

Span 1 bent 1 girder 2 has a 8" x 2" hole in web below haunch. Bottom of web has been T-spliced. Girder is moving under traffic.

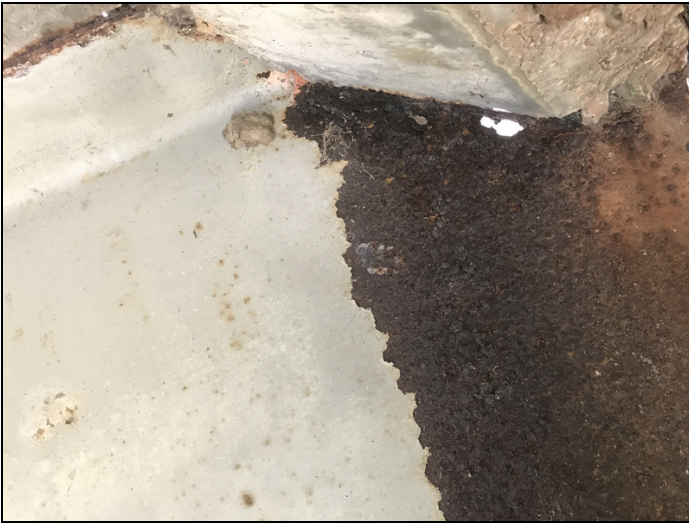
Span 4 bent 4 girder 2 has a 4" x 1" diameter hole in web below haunch.

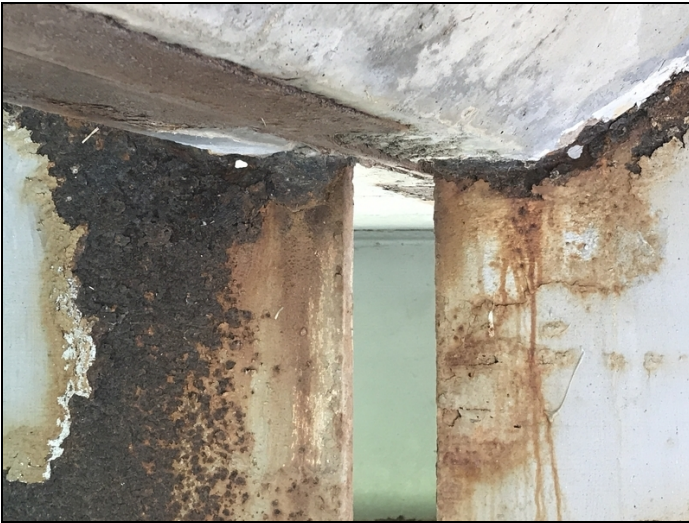
Span 4&5 bent 5 girder 3

Span 4 bent 5 girder 3 has a ½ " diameter hole in web near haunch.

Span 5 bent 5 girder 3 has a ½ " diameter hole in web near haunch.

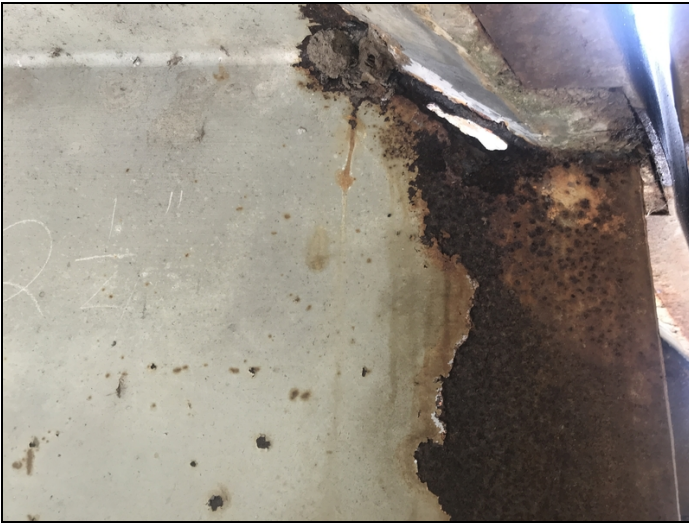
S4 b4 g4

Span 4 bent 4 girder 4 has a 4.5" x 1" hole in web below haunch.

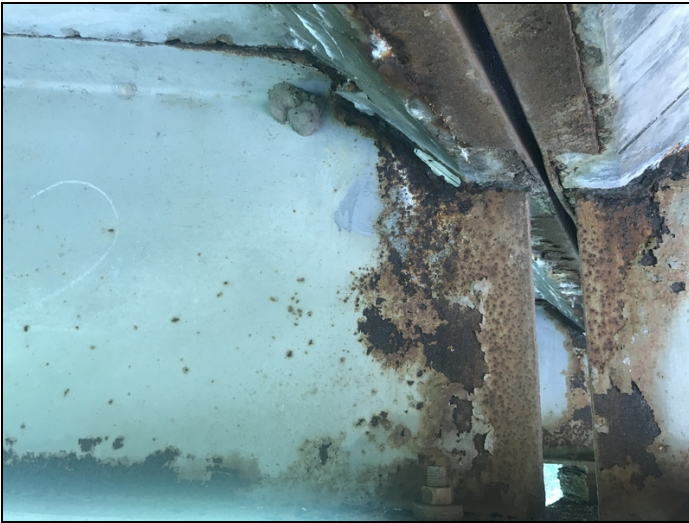
S6 b6 g2

Span 6 bent 6 girder 2 has a 4"x 1" hole in web below haunch.

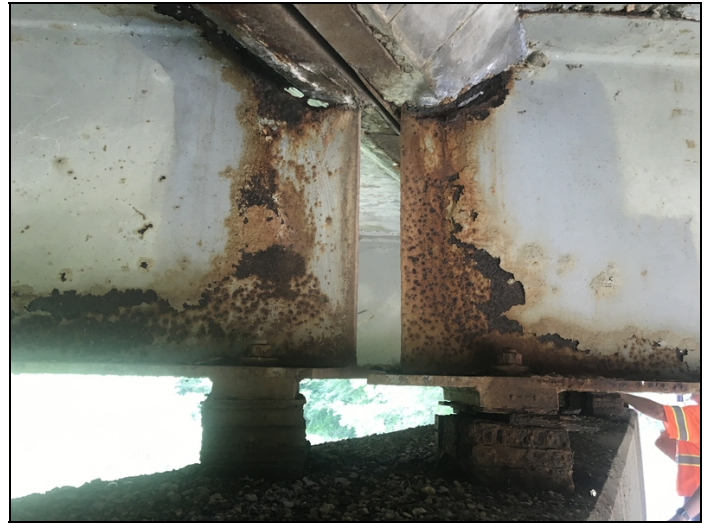
S5 b6 g3 & s6 b6 g3

Span 6 bent 6 girder 3 has a 3" x 1/2" hole in web below haunch.

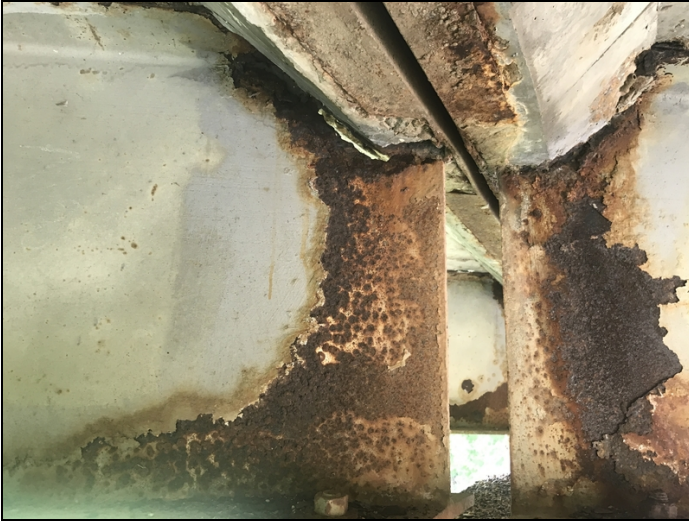
S6 b6 g4

Span 6 bent 6 girder 4 has a 6" x 1" hole in web below haunch and shims are shifting or out of place.

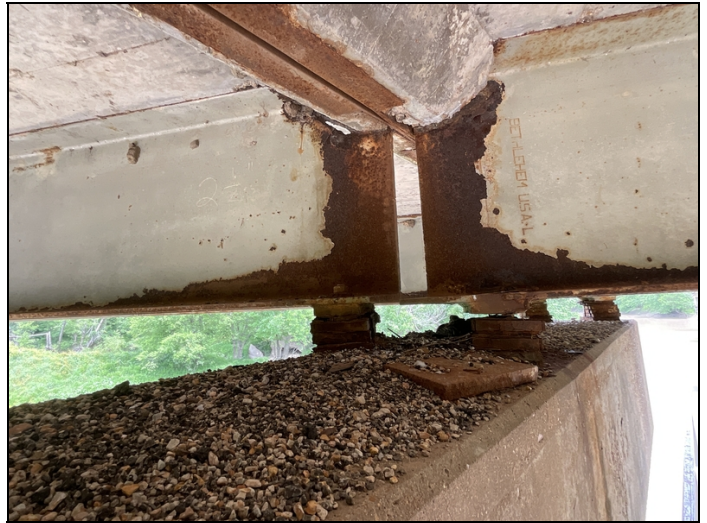
S3 b4 g4

Span 3 bent 4 bearing 4 shim plates has fallen out, both anchor bolts are missing.

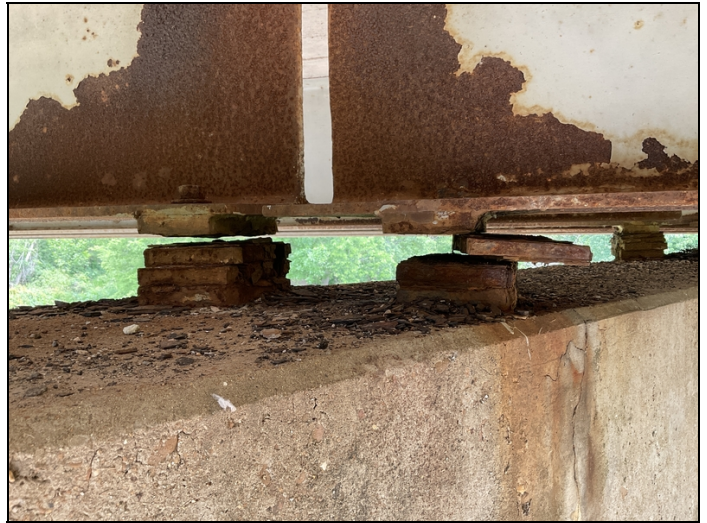
S3 b4 g2

Span 3 bent 4 bearing 2 shim plates are loose, both anchor bolts are missing and sliding out on span 4 side also.

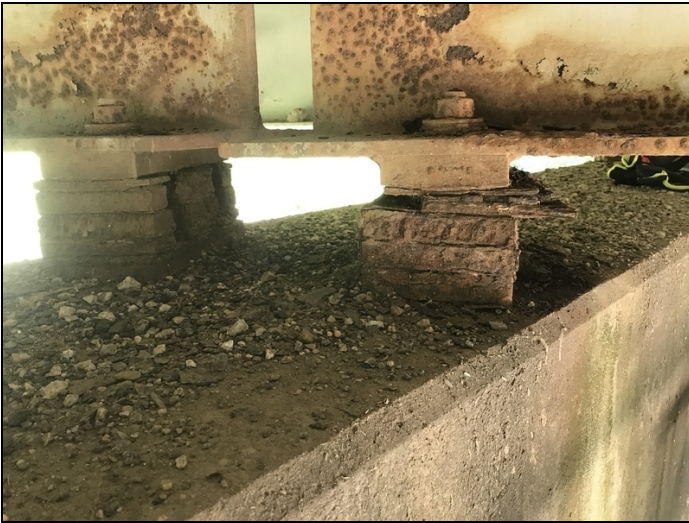
Span 5 bent 6 bearing 3 shim is sliding out and a 3" x 1/2" hole at haunch.

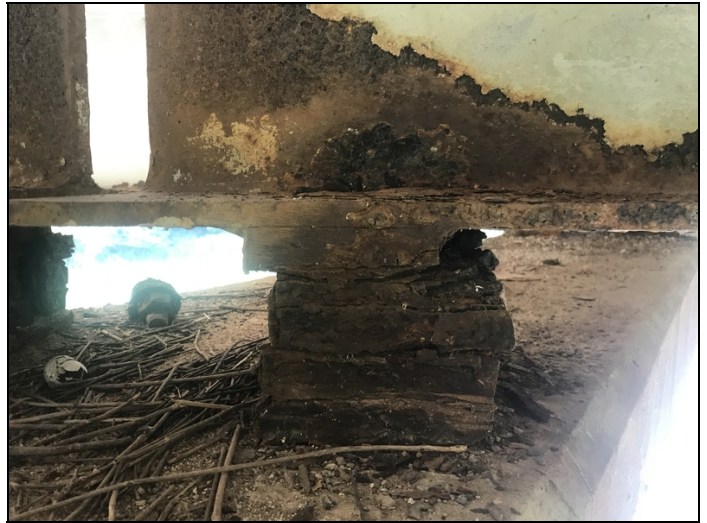
S2 b3 g3

Span 2 bent 3 girder 3 bearings are beginning to slide out.

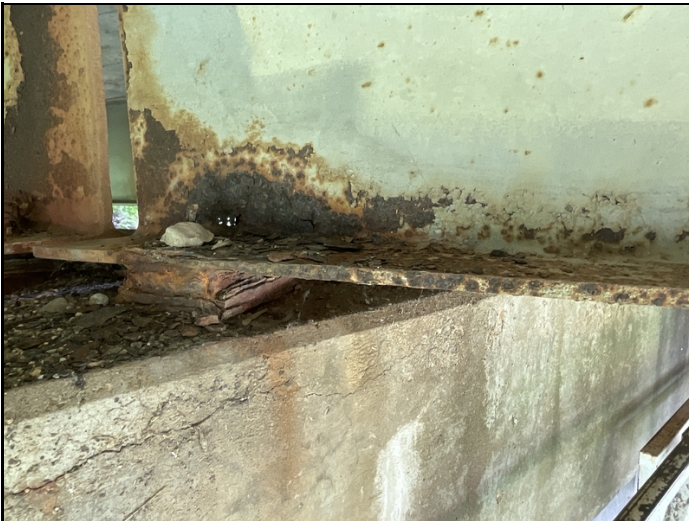
S6 b7 g3

Span 6 bent 7 girder 3 has moderate section loss along bottom of web over bearing with a 2" x 1" in hole in web near bottom flange.

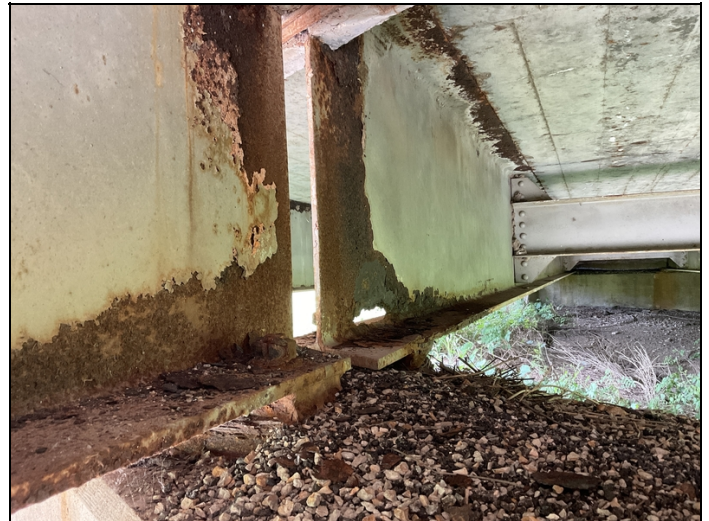
S1 b2 g4

Span 1 bent 2 girder 4 has a 7 ½" x 2" hole in bottom of web 7" from end.

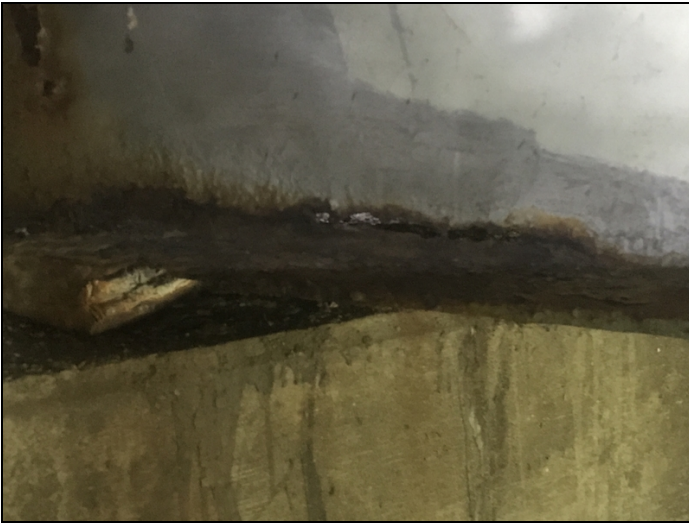
Span 7 bent 8 girder 3 2019

Span 7 bent 8 girder 3 has a 9" x 1" hole in bottom of web 16" from end of girder in right flange.

Bottom flange has a 5" x up to 2" hole near bearing in left flange.

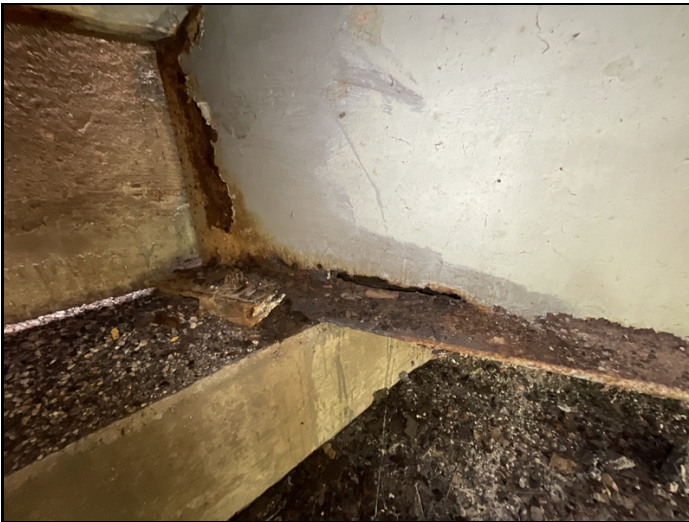
G3

Span 7 bent 8 girder 3 has a 10" x 1" whole in bottom of web 16" from end of girder and a 5" diameter whole in left side of bottom flange and 3" x 1" whole in right side bottom flange.
