| FRACTURE CRITICAL BRIDGE MEMBER INSPECTION | | |

BRIDGE INSPECTION REPORT

Dist 01 Co 48-MONROE

Bridge 01253

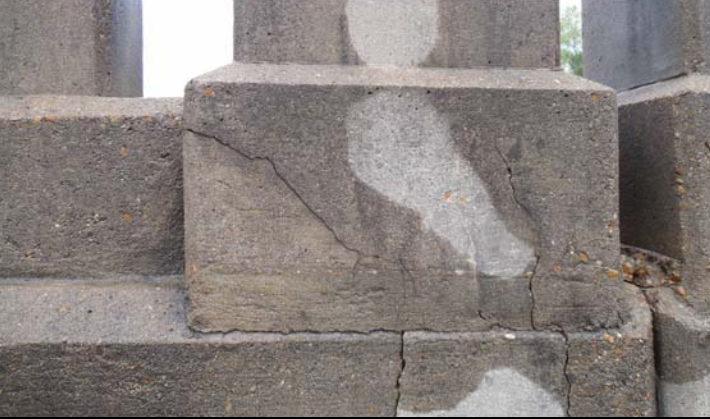
The bridge rail has numerous areas of collision damage scattered throughout the approach spans. Many of the terminal posts at the end of each span were cracked horizontally at the base.

Many of the terminal posts at the end of each span were cracked horizontally at the base. Cracks range in size from 1/16" to 1/4"

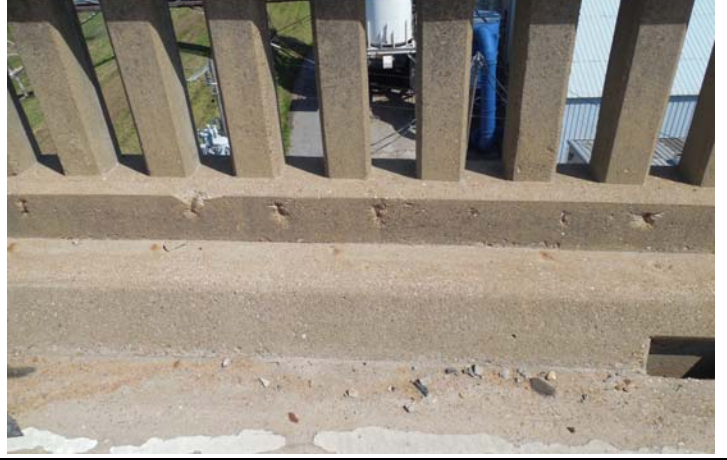
Shallow spalls with rebar exposed scattered throughout.

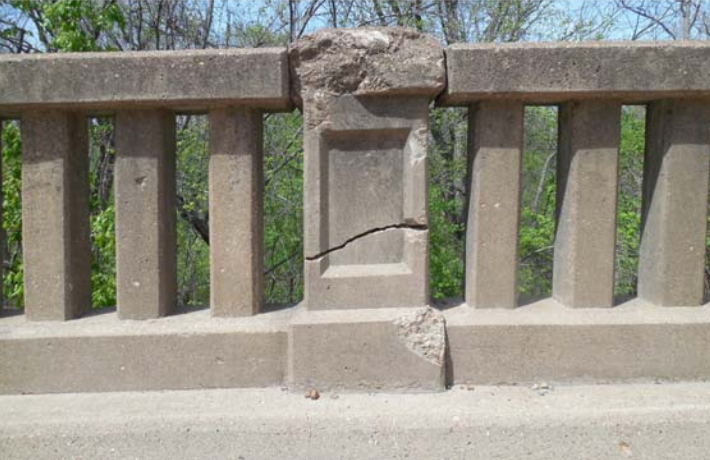
The bridge rail has numerous areas of collision damage scattered throughout the approach spans.

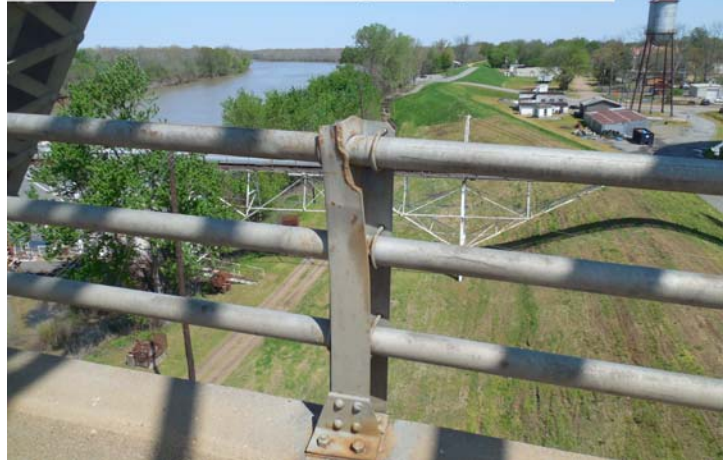
PP 0 - PP 5, Rt: Minor collision damage to the metal bridge rail posts.

Main Span, PP 0 - PP 5, Rt: Minor collision damage to the metal bridge rail posts.

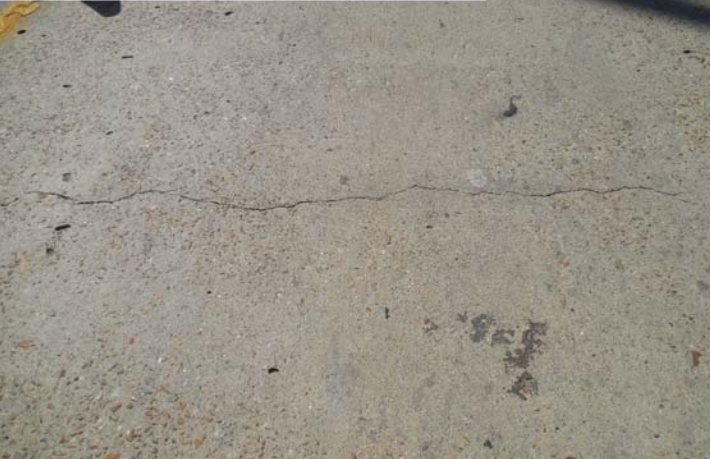
The deck has numerous unsealed transverse cracks in all spans.

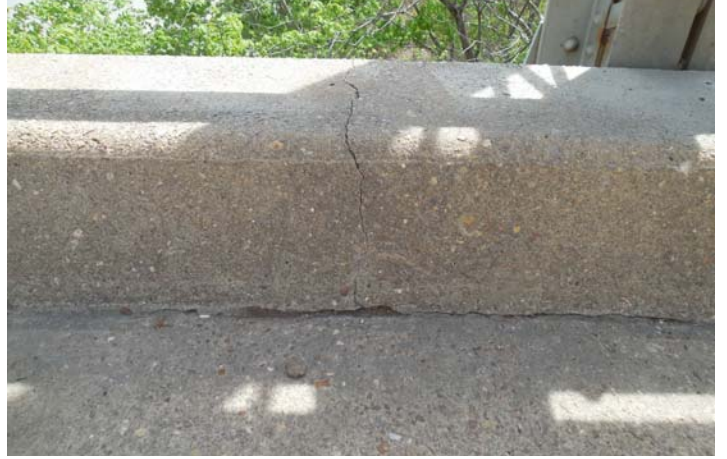
The curbs have vertical hairline cracks and spalls in all spans.

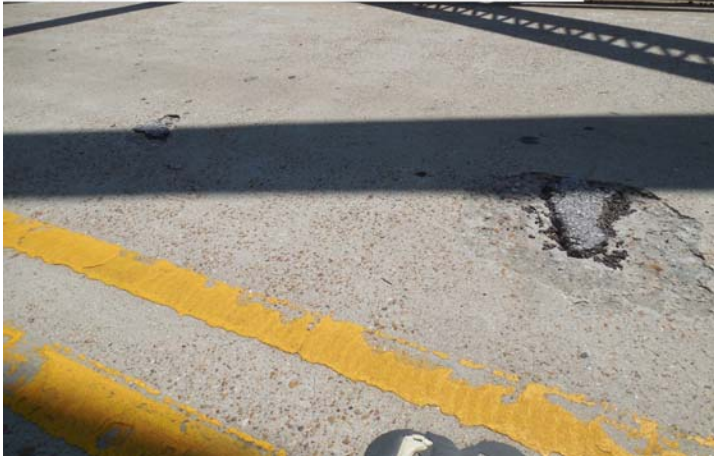
The deck has numerous shallow spalls with rebar exposed scattered throughout.

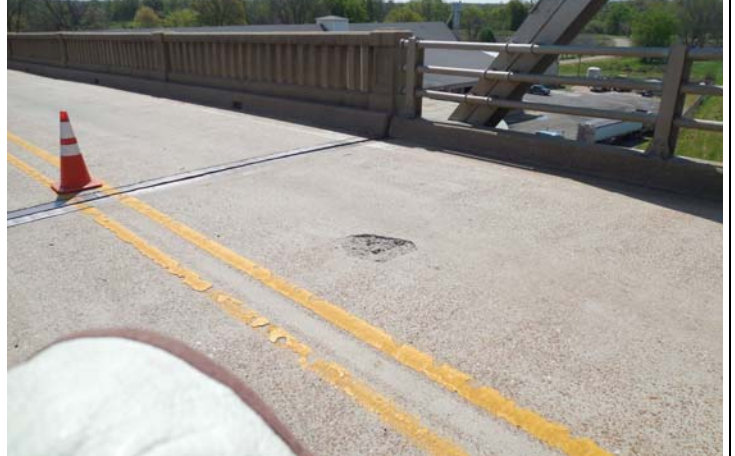
The deck has numerous shallow spalls with rebar exposed scattered throughout.

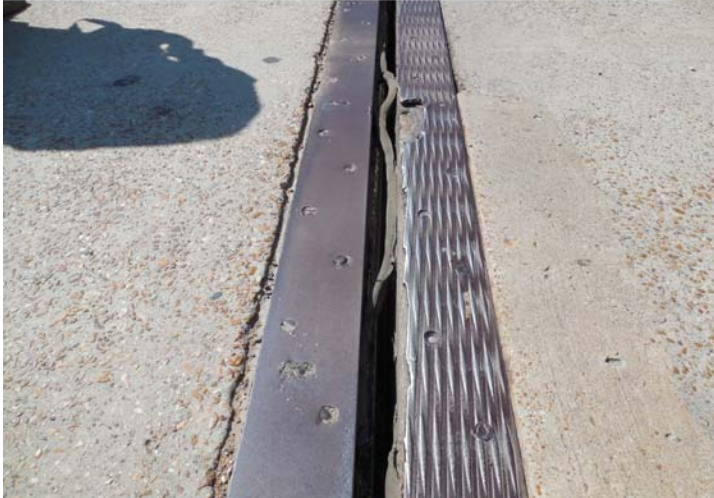
PP 0, L14, L22 & L36: Joint material has failed.

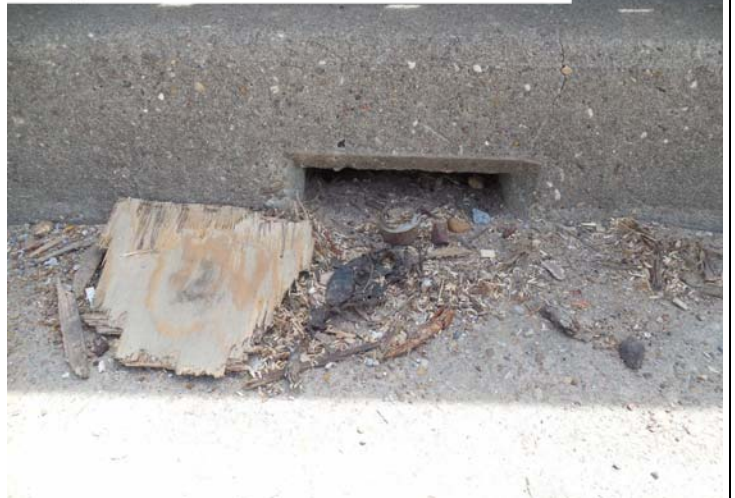
Many are filled with debris. Vegetation growing from debris.

Many of the drains are filled with debris.

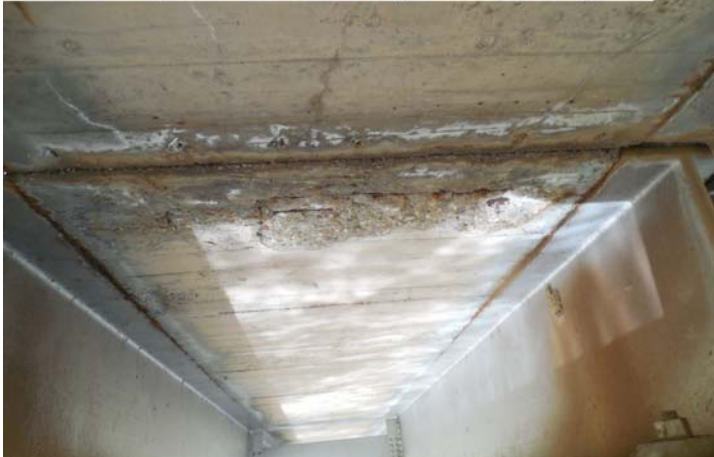
Bt. 41: Joint is open with no joint material installed. Spall with rebar exposed below joint.

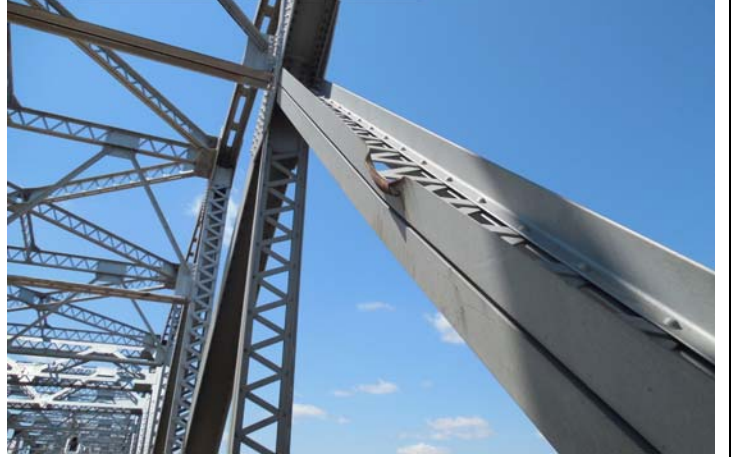
Active corrosion and pack rust to the bottom of the diagonals at the connection to the bottom chord in numerous locations throughout.
Collision damage scattered throughout the truss.
PP10, Rt: Collision damage. Flange of the diagonal is torn.

PP10, Rt: Collision damage. Flange of the diagonal is torn.

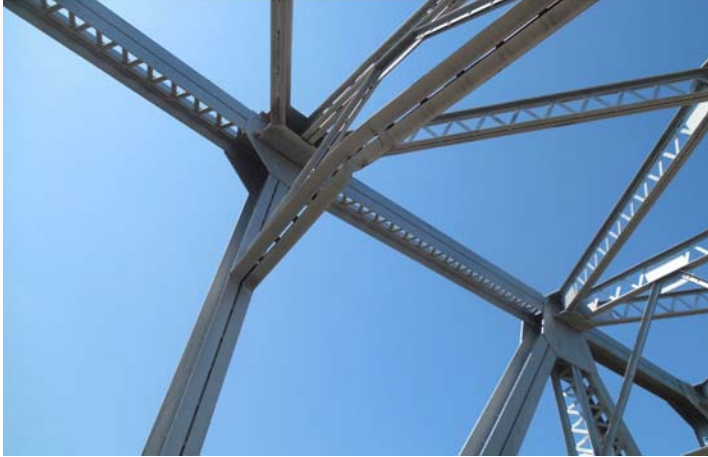
U2-U4, U12-U24, U31-U34: Sway bracing is bent from impact with over-height loads.

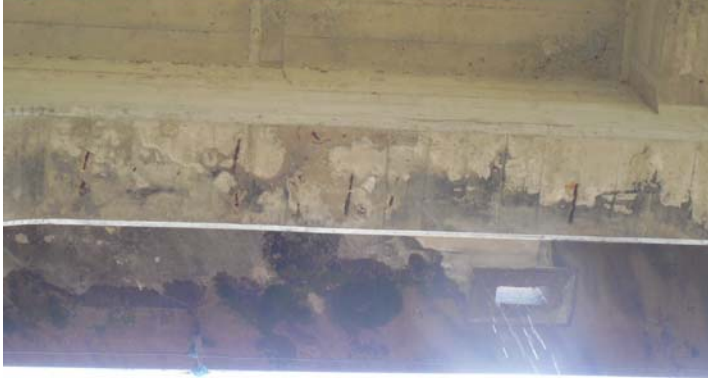
Girder 1, Numerous shallow spalls with rebar exposed on bottom face.

Span 16, Girder 1: Numerous shallow spalls with rebar exposed on bottom face.

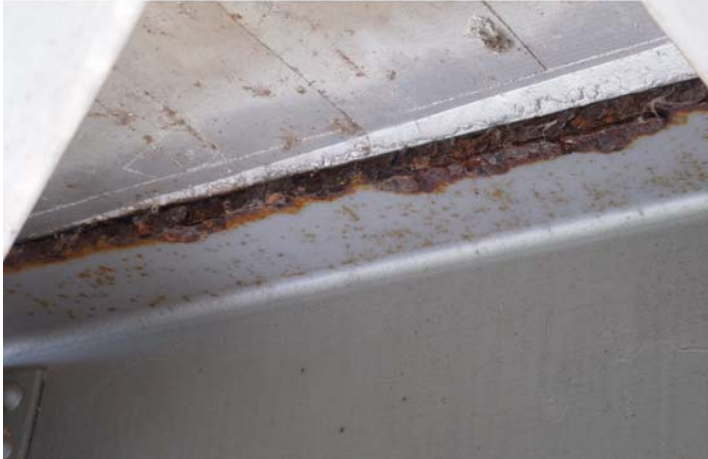
PP11, Lt: Corrosion and pack rust to the top flange of the floorbeam. Section loss to 3/16".

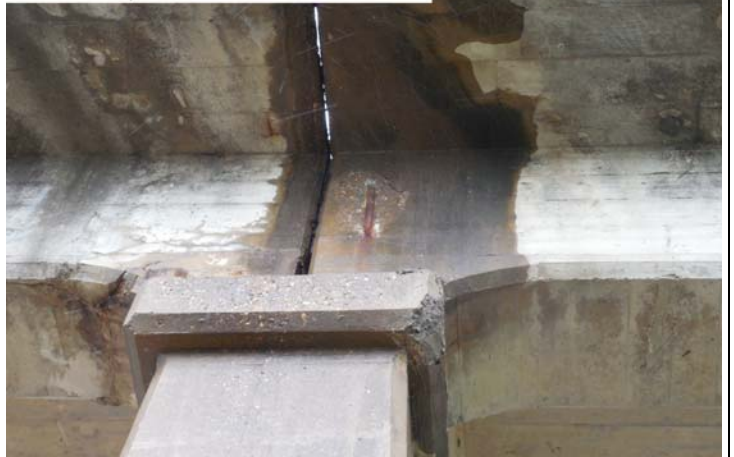
Bt. 6, Girder 1: Spall with rebar exposed above column.

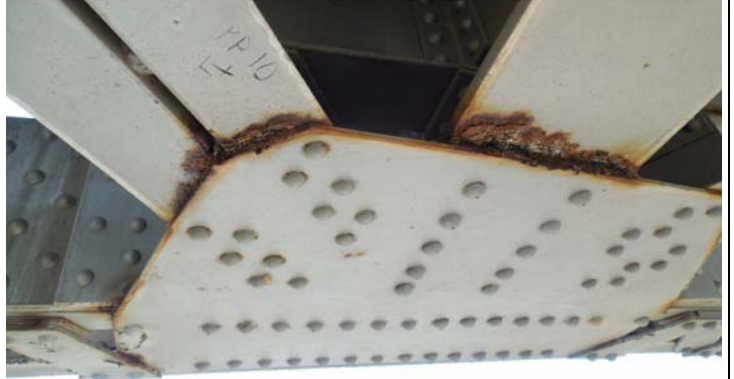
Gusset plate connections: Active corrosion and pack rust with holes corroded through the ends of the laterals at the connection with the lower chord. Typical condition throughout thru-truss.

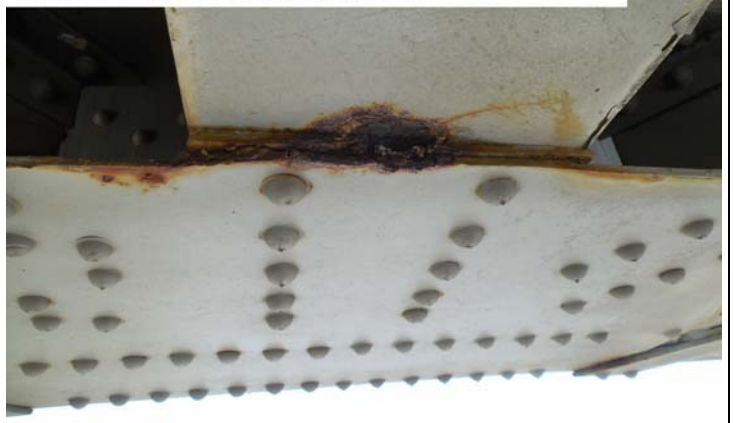
PP12, Lt: Section loss to the bottom flange of the floorbeam at gusset plate connection. Typical condition throughout.

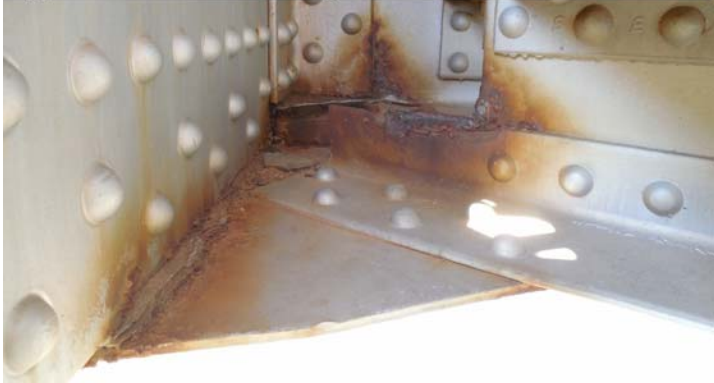
Gusset plate connections: Active corrosion and pack rust with holes corroded through the ends of the laterals at the connection with the lower chord. Typical condition throughout thru-truss.

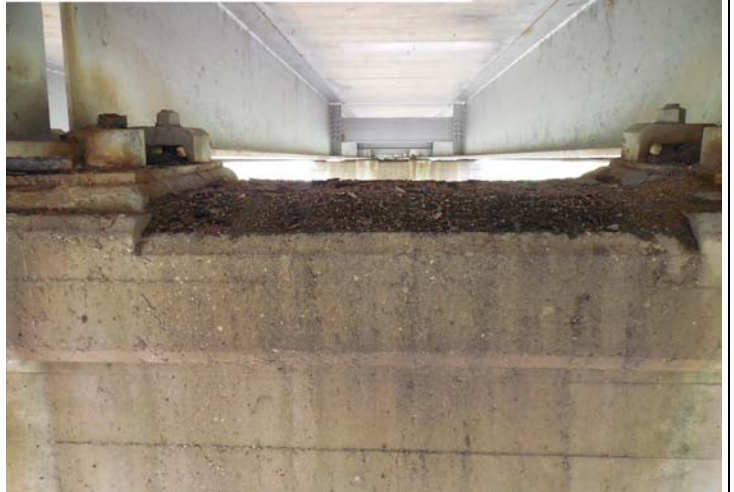
Caps have heavy debris at joints

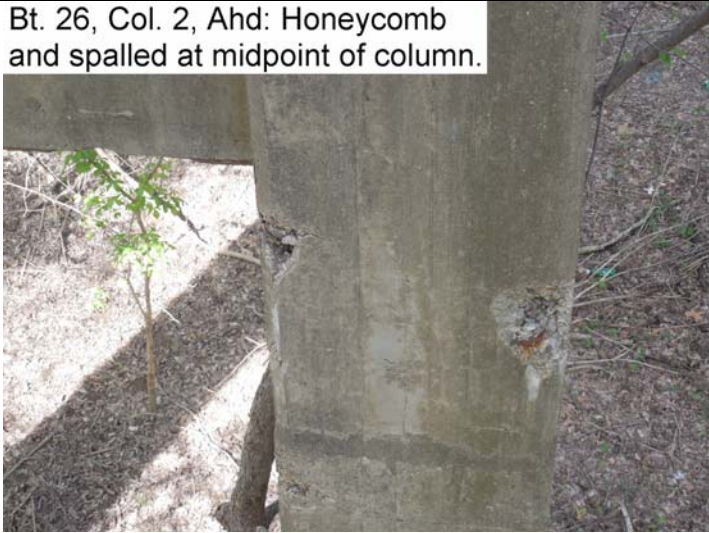
Bt. 26, Col. 2, Ahd: Honeycomb and spalled at midpoint of column.

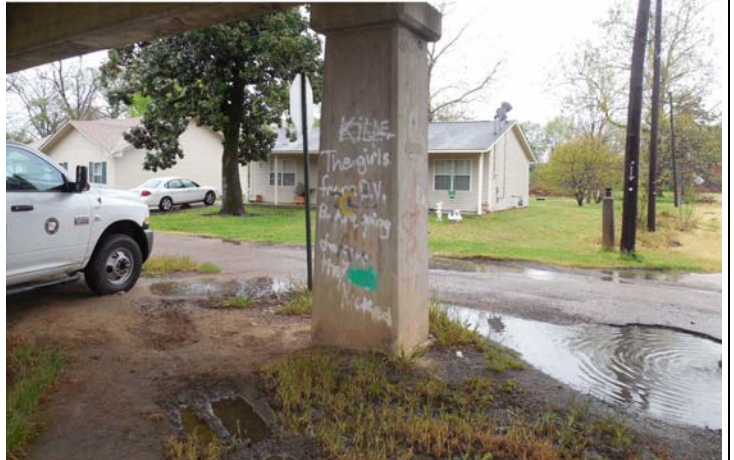
North abutment and approach spans have graffiti on columns in numerous locations.

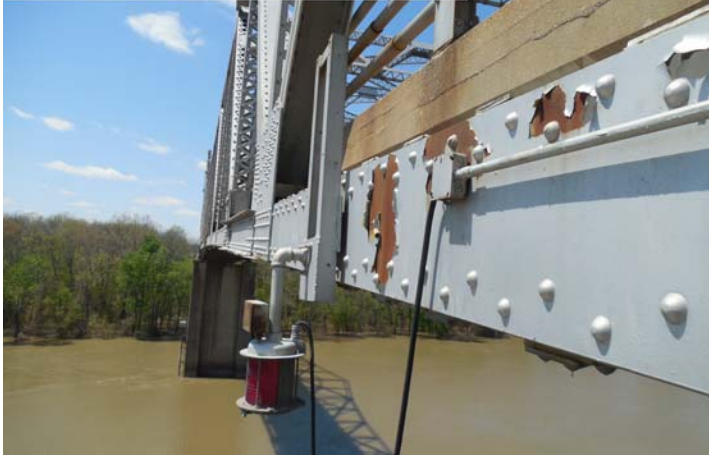
PP12, Lt: Paint peeling. Typical in scattered locations throughout.

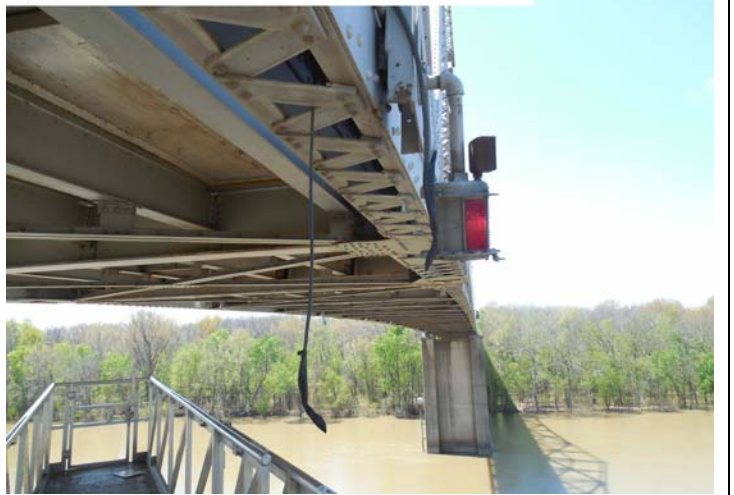
Typical condition of the bottom chord.

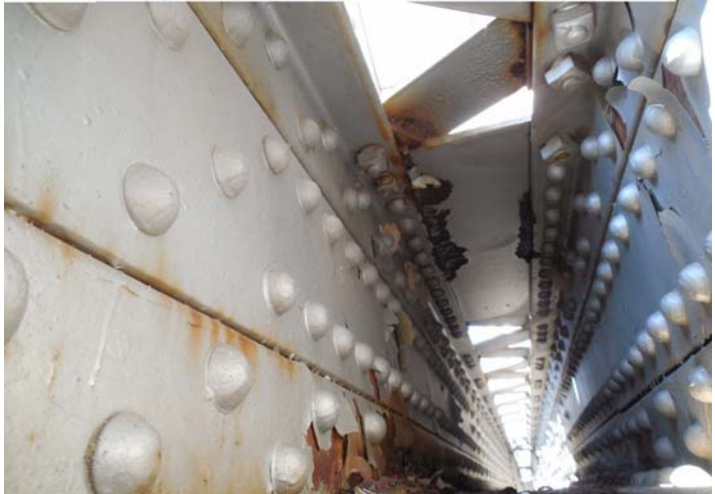
PP10, Lt: Typical condition inside bottom chord.

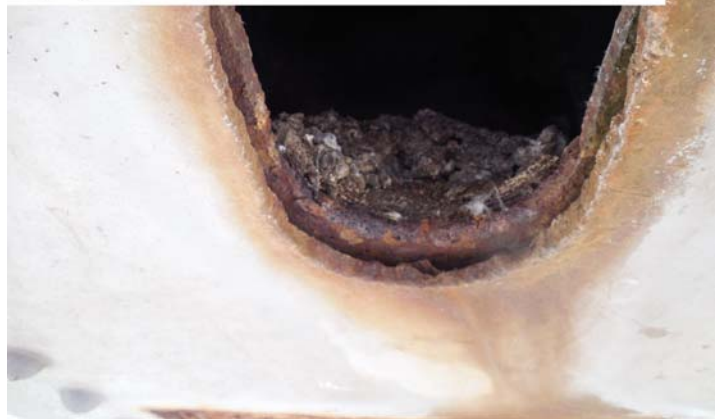
PP14 & 22, Lt. & Rt: Wind locks are heavily corroded and have moderate to heavy amounts of pigeon dung inside.

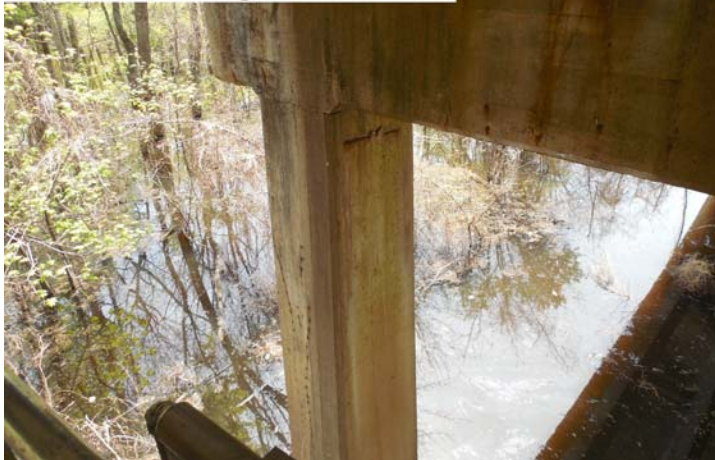
Bt. 49, Col. 1: Spalls with rebar exposed 1.5' long on side face.

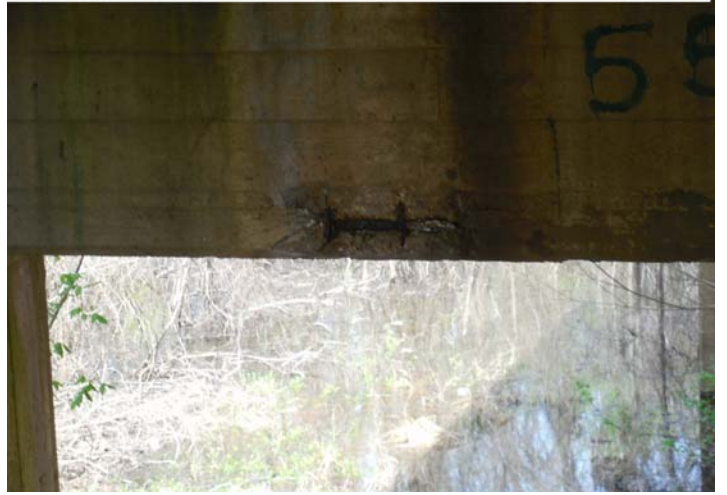
Bt. 55, Ahd: Cap has a 1' spall with rebar exposed.

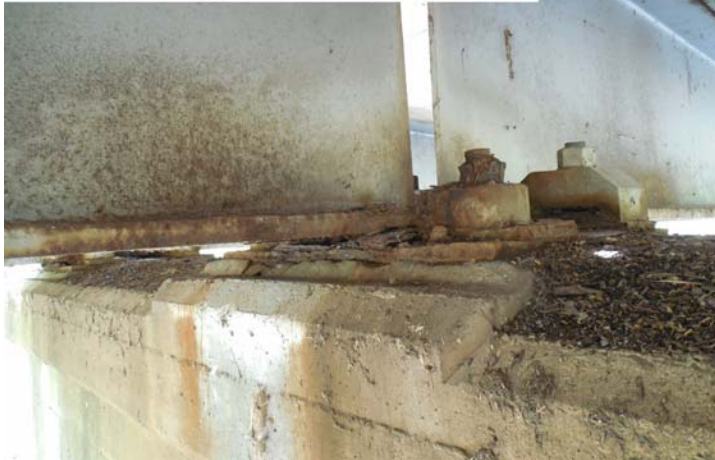
Bt. 43, G2: 1/2" Up to 50% section loss at bottom flange at bearing area.

Bt. 43, G2: ½" Up to 50% section loss at bottom flange at bearing area.

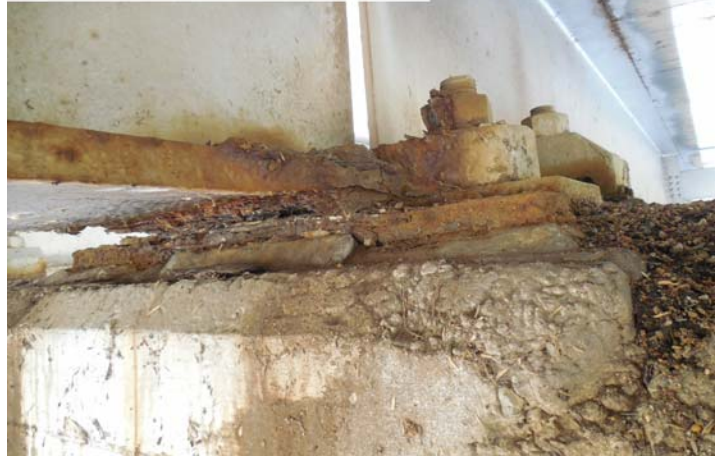
Bt. 50, G2: 1/2" Section loss at bottom flange at bearing area.

Bt. 50, G2: ½" Section loss at bottom flange at bearing area.

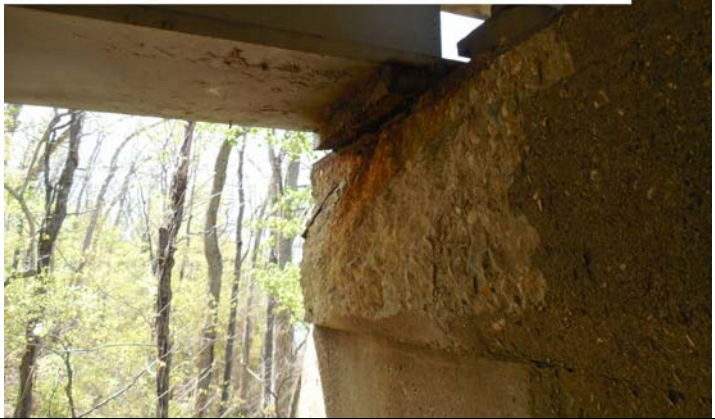
Bt. 34, Bk, Girders 1- 4: Girders are slipping off bearing pads.

Bt. 34, Bk, G1: Large spall with rebar exposed below bearing plate.

Bt 34, Bk, G1: Girder is slipping off bearing pad. Typical of G1 - G4 at this bent. Large spall with rebar exposed below bearing plate

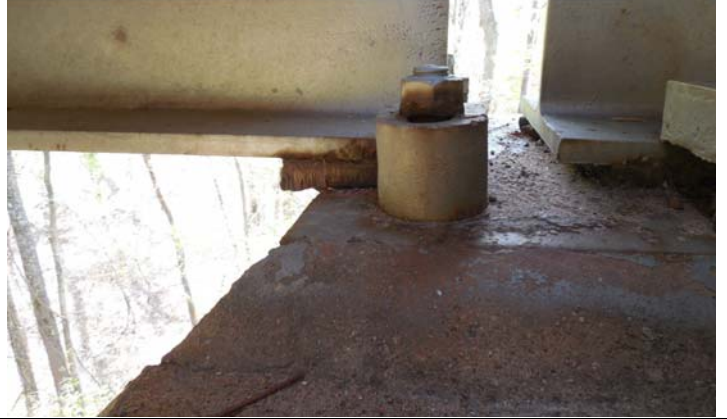
Bt 34, Bk, G1: Girder is slipping off bearing pad. Typical of G1 - G4 at this bent. Large spall with rebar exposed below bearing plate
