Bridge Inspection Report

**B1253
US 79
over
WEST OLD WHITE RIVER**

Structure Number: B1253

Facility Carried: US 79

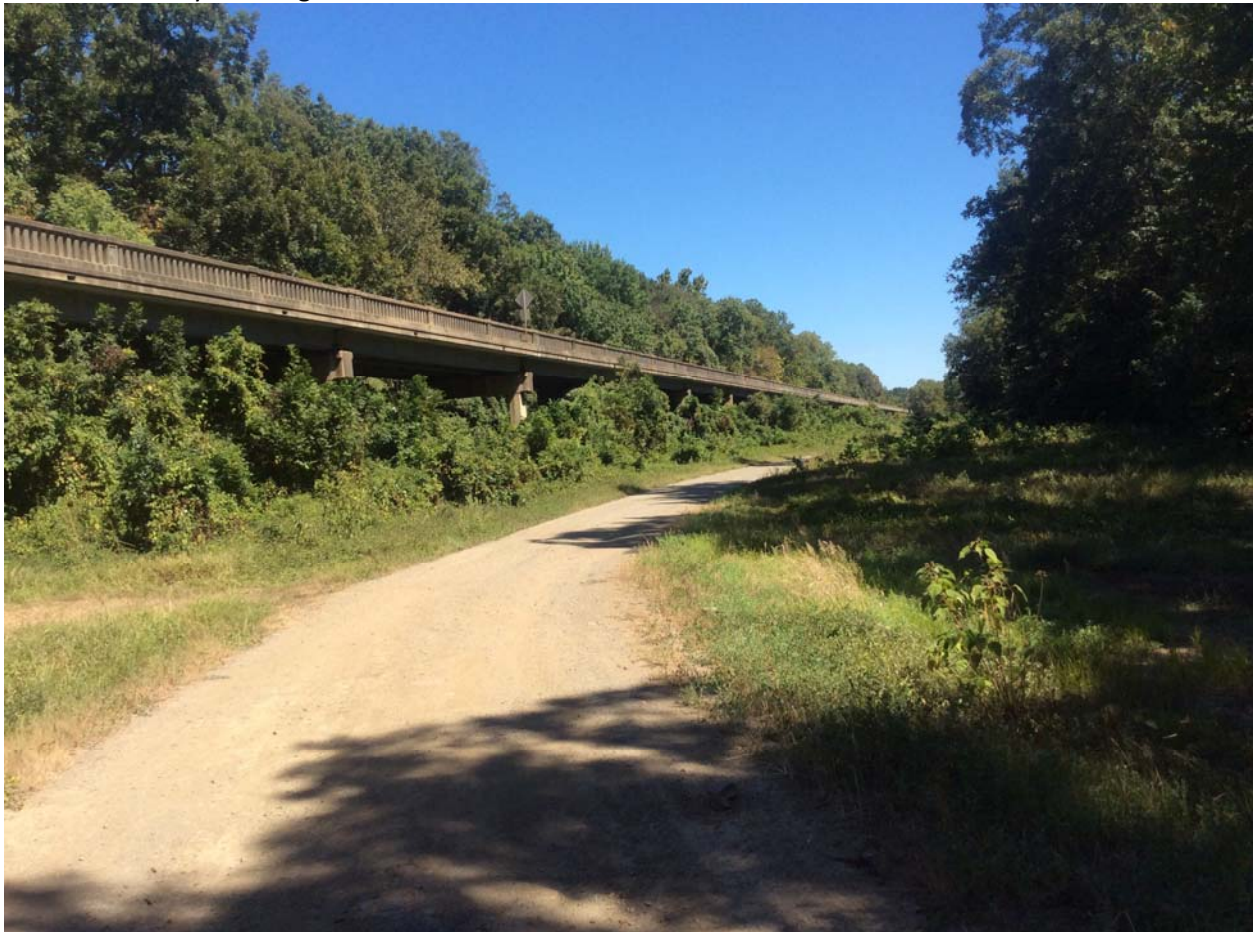
Note: No overlay on bridge deck
