# Bridge Inspection Report

05771  
US 79  
over  
UPRR

Structure Number: 05771

Facility Carried: US 79

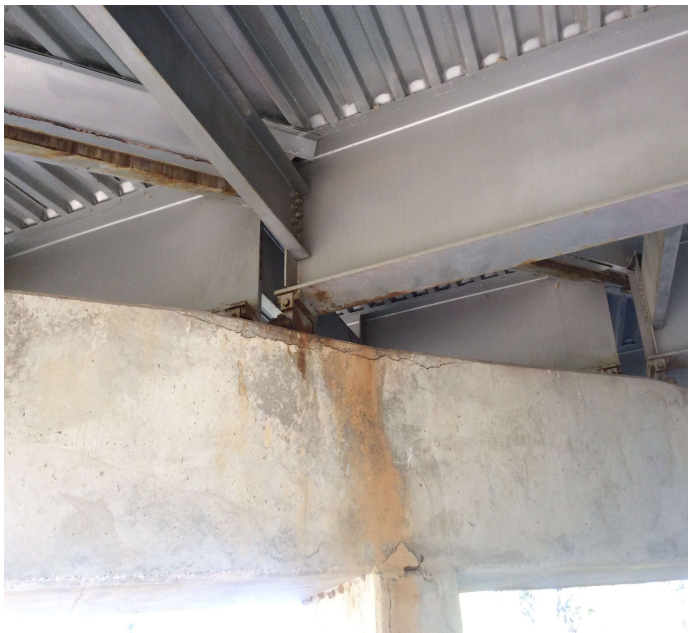
BENTS #4&5 AHEAD FACE HAVE TRANSVERSE CRACKS AT TOP

PHOTO 1      Description      Bent #5 cap ahead face 4' transverse crack at top over column #2

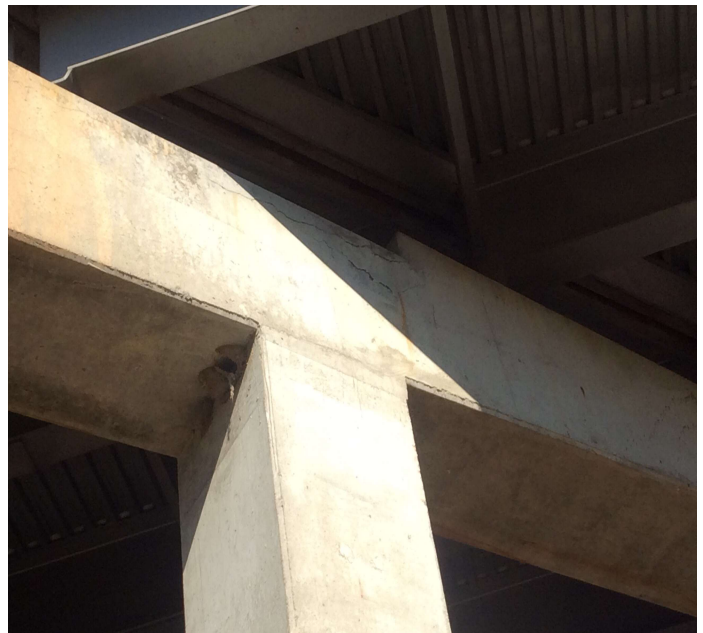
PHOTO 2      Description      Bent #4 cap ahead face at column #3 transverse cracks (4'in length)

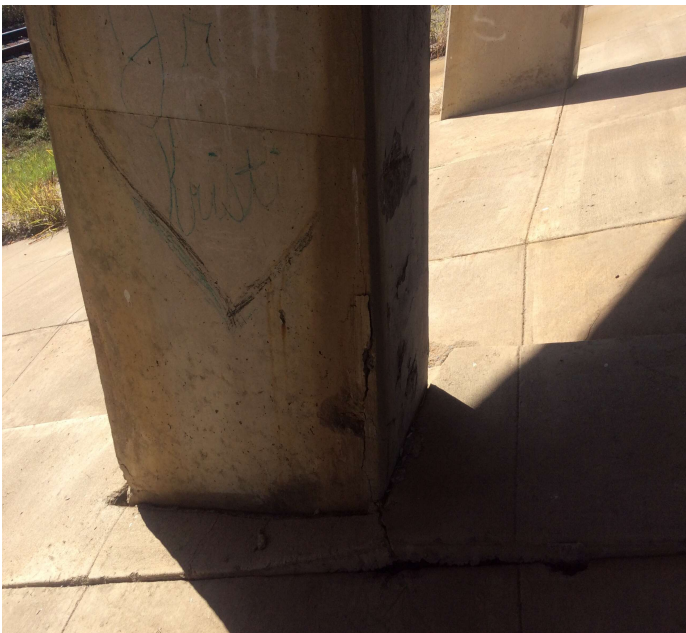
PHOTO 1    Description    Bent #2 column #3

BENT #2 COLUMN #3 BACK FACE IS CRACKED AND DELAMINATED WITH EXPOSED REBAR

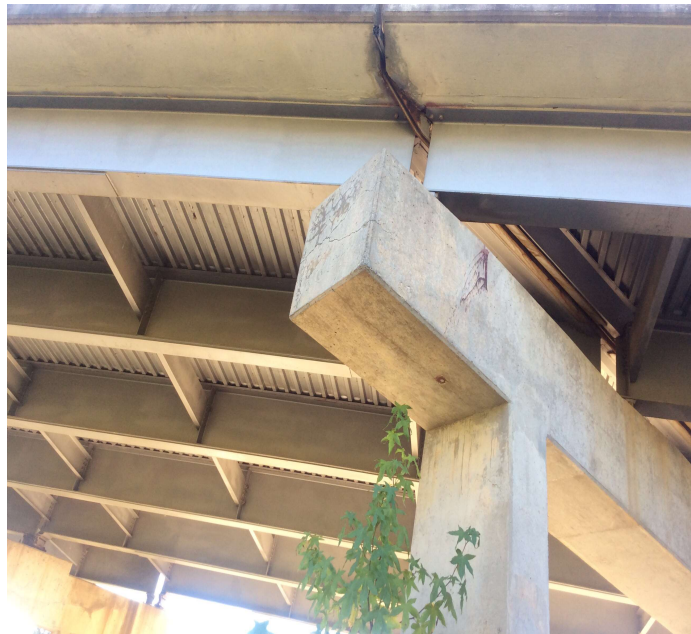
PHOTO 1      Description      Bent #2 cap left end

CAPS HAVE MAP CRACKING, DELAMINATIONS, SPALLS IN THESE AREAS.

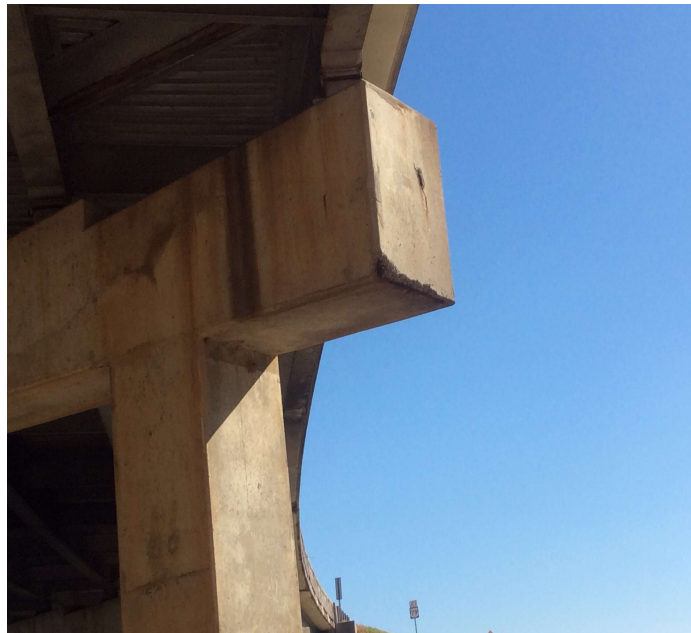
PHOTO 3      Description      Bent #3 cap right end spalled with exposed rebar

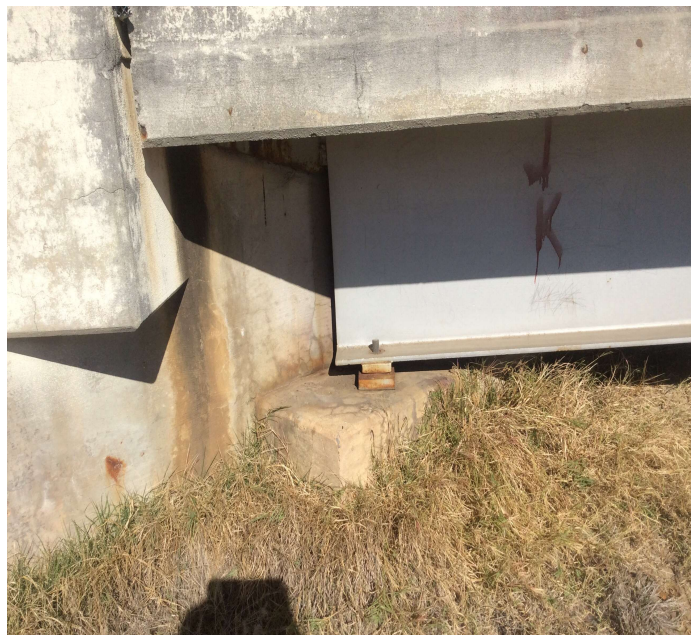
BT. #1 GRD. #6  
ANCHOR NUT MISSING

PHOTO 1      Description      Bent #1 girder #6 outside anchor bolt nut missing

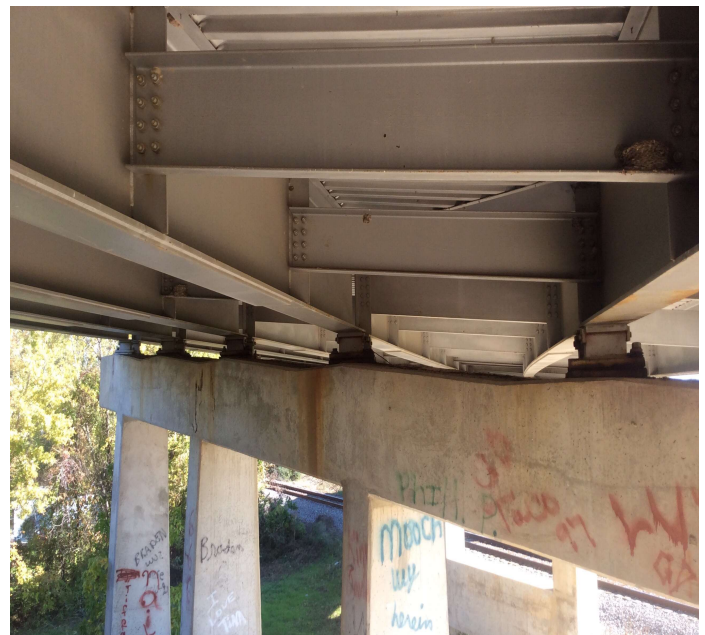
SPAN # 1 BENT # 2  
GIRDERS # 2,3,5  
ANCHOR BOLTS ARE BROKEN OFF

PHOTO 2      Description      Span #1 bent #2 girders #2,3,5 have anchor bolts broken off

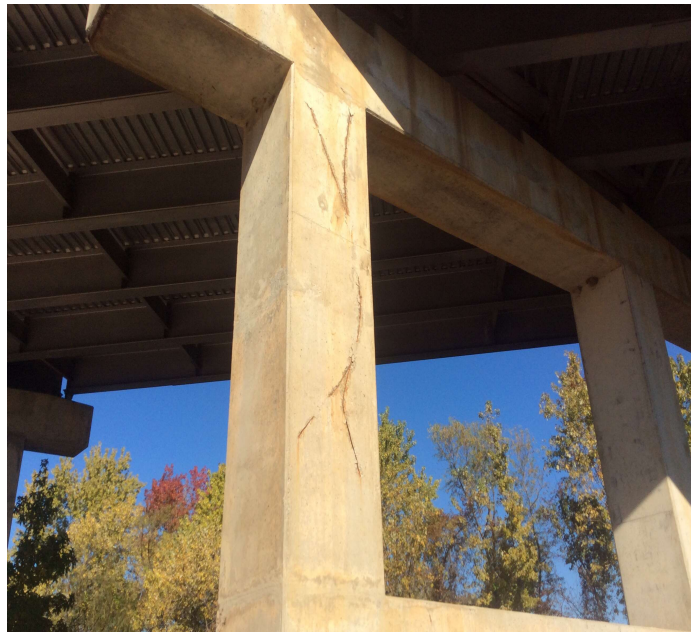
PHOTO 1      Description      Bent #3 column #3 ahead face

COLUMNS HAVE AREAS OF EXPOSED REBAR  
DUE TO POOR CONCRETE COVERAGE.

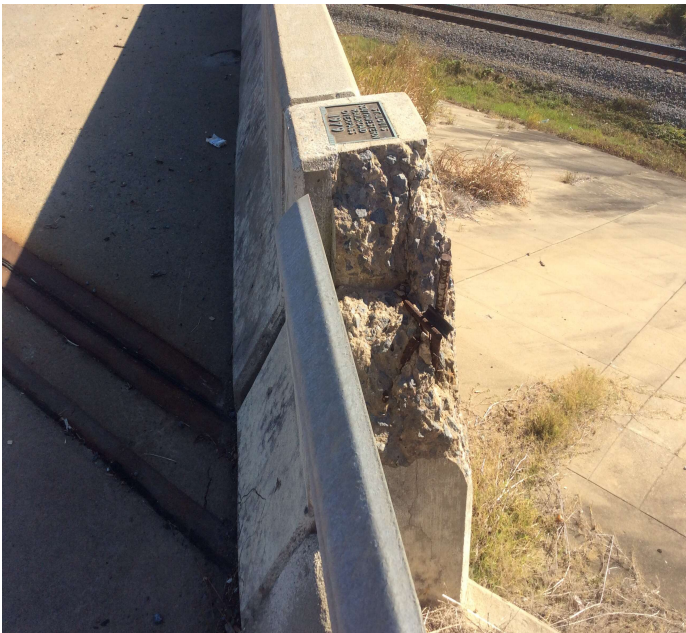
PHOTO 1      Description      Abutment #1 right end post

END POST HAS COLLISION DAMAGE

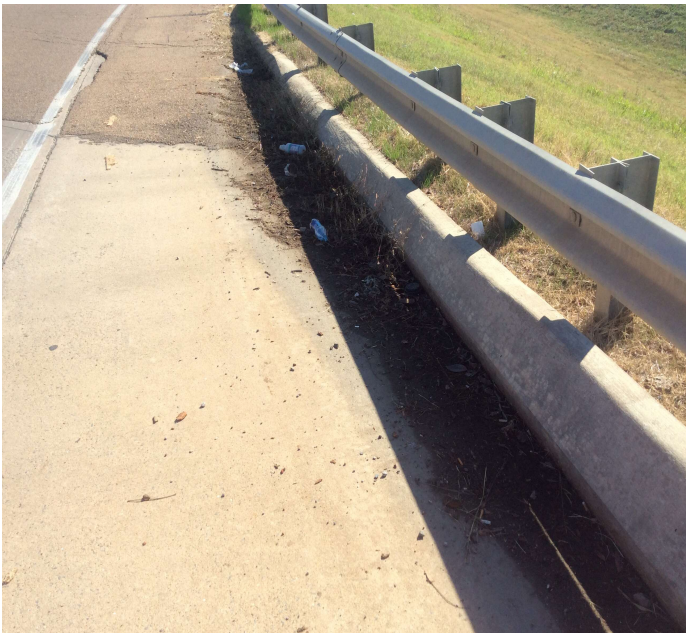
PHOTO 1      Description      Abutment #2 right approach gutter

GUTTER IS FULL OF DIRT CAUSING WATER  
TO BACK UP ON APPROACH GUTTER.

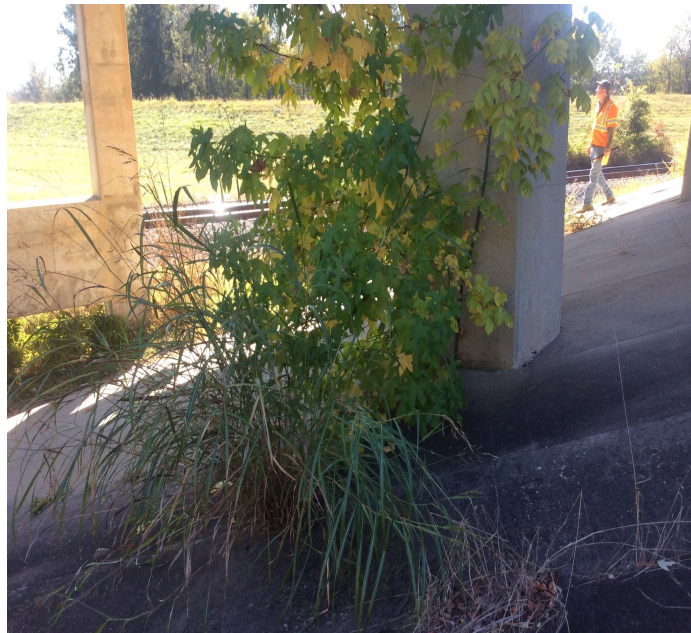
SLOPE HAS TWO TREES GROWING THROUGH CONCRETE.

PHOTO 1      Description      Abutment #1 trees growing up in slope pavement

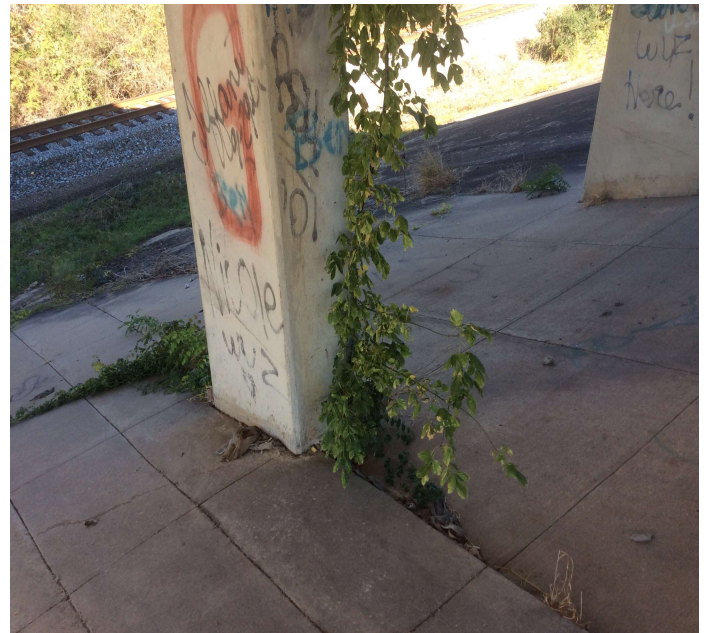
PHOTO 2      Description      Tree growing up in slope pavement abutment #2
