# Bridge Inspection Report

**07077  
US 79  
over  
CYPRESS CREEK**

Structure Number: 07077

Facility Carried: US 79

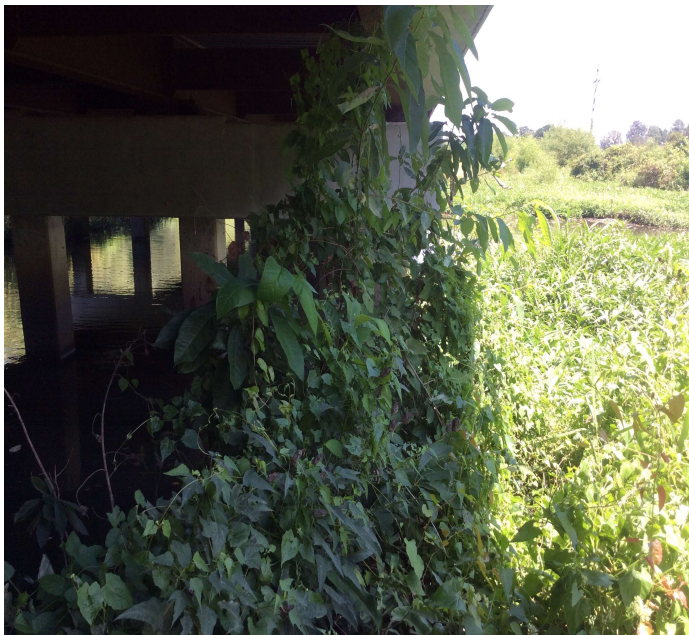
Vegetation growing beside and under bridge span #1 left and right side

PHOTO 1      Description      Vegetation span #1 right side

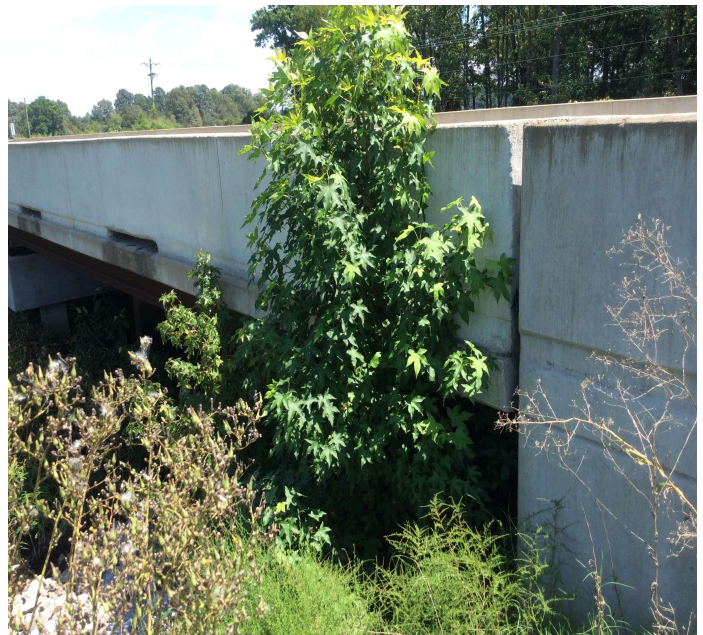
PHOTO 2      Description      Vegetation abutment #1 left side
