Bridge #01101(Record Change, Fracture Critical)

US 70 Cache River over CACHE RIVER

Team Lead: Keith Harris **Inspection Date:** September 21, 2020

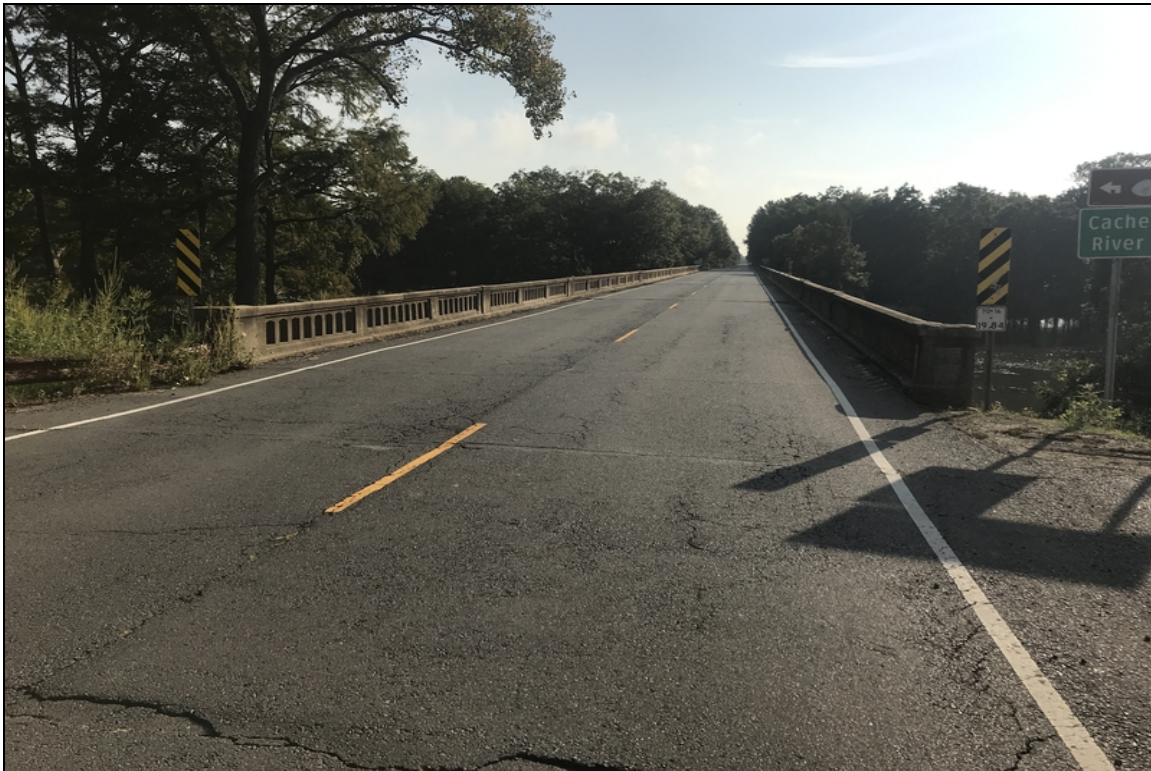
Approach

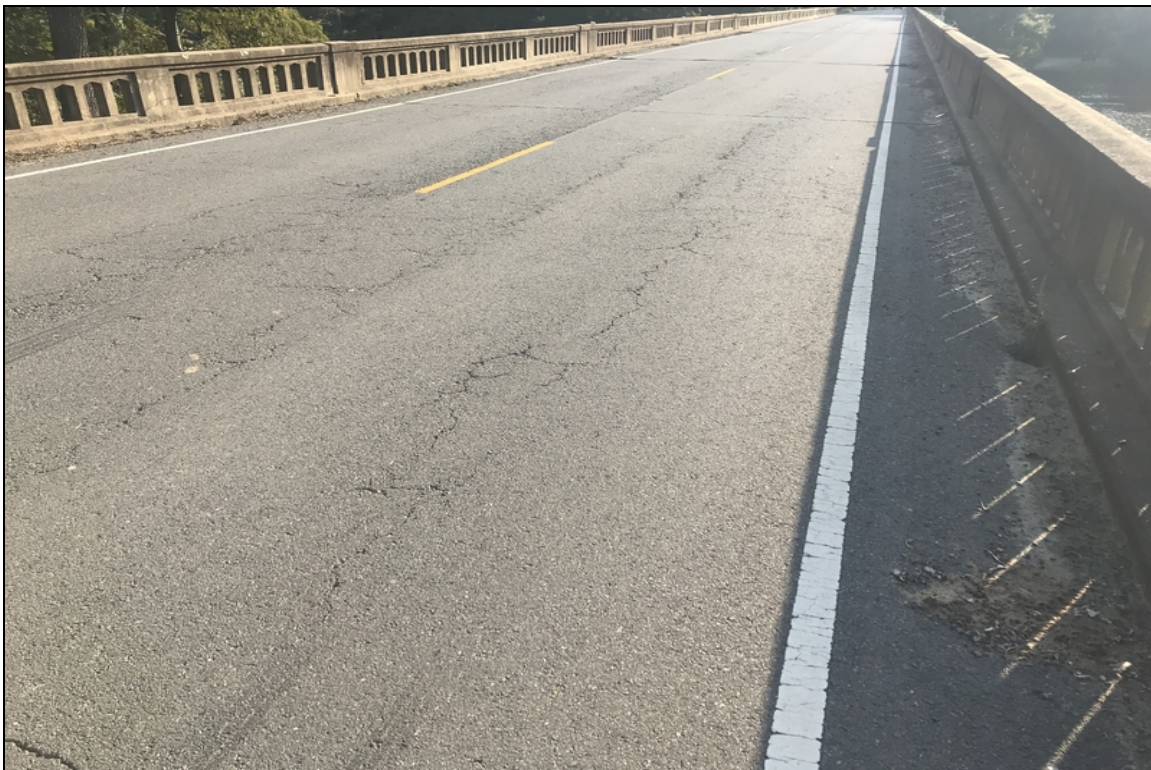
Deck overview

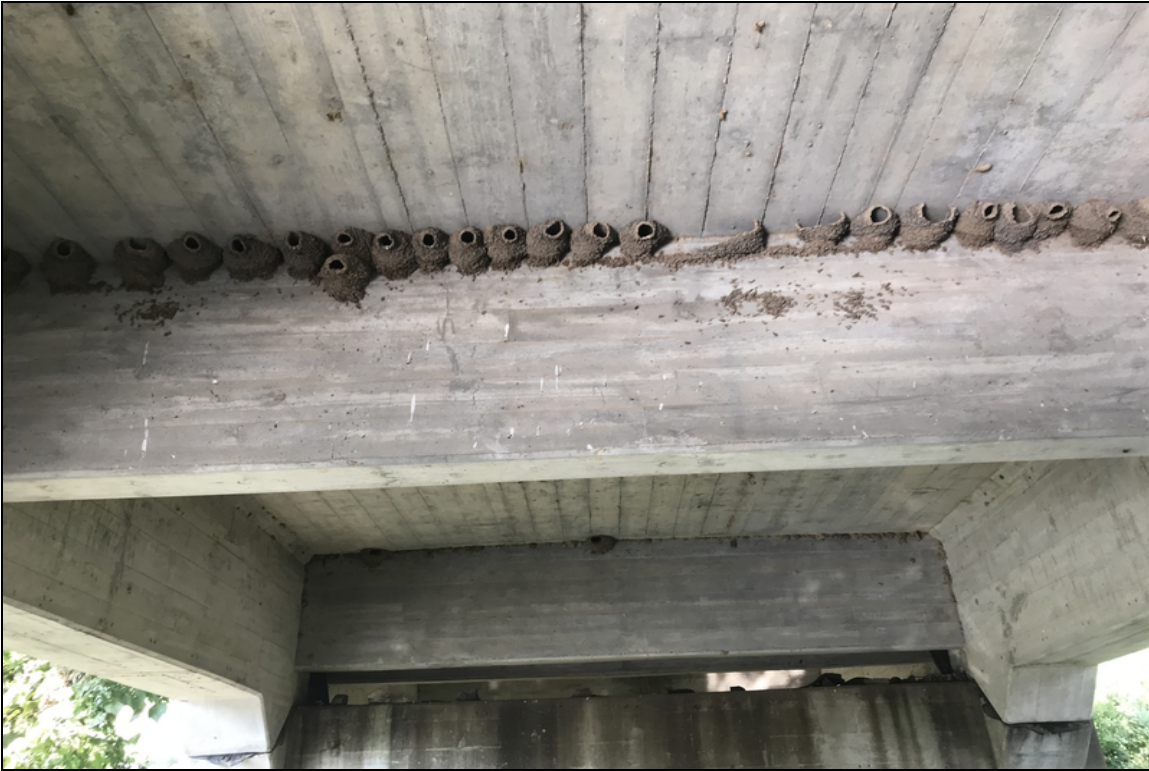
Approach soffit view

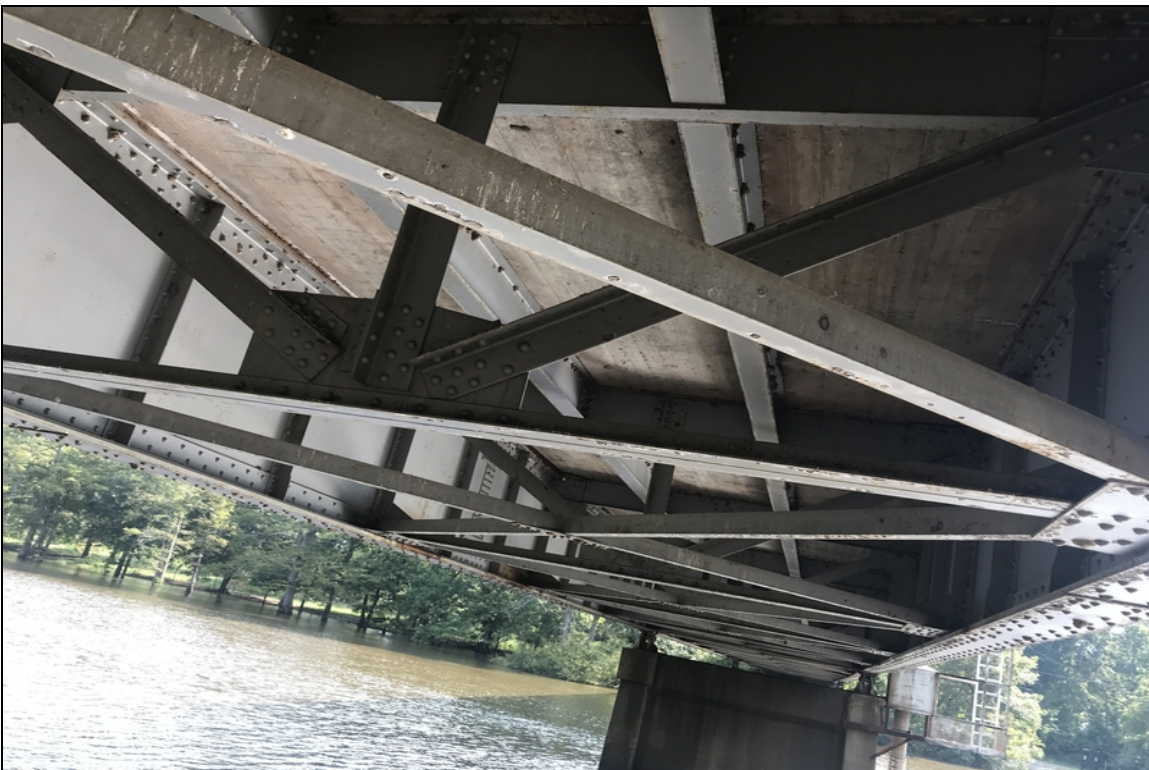
Main soffit view

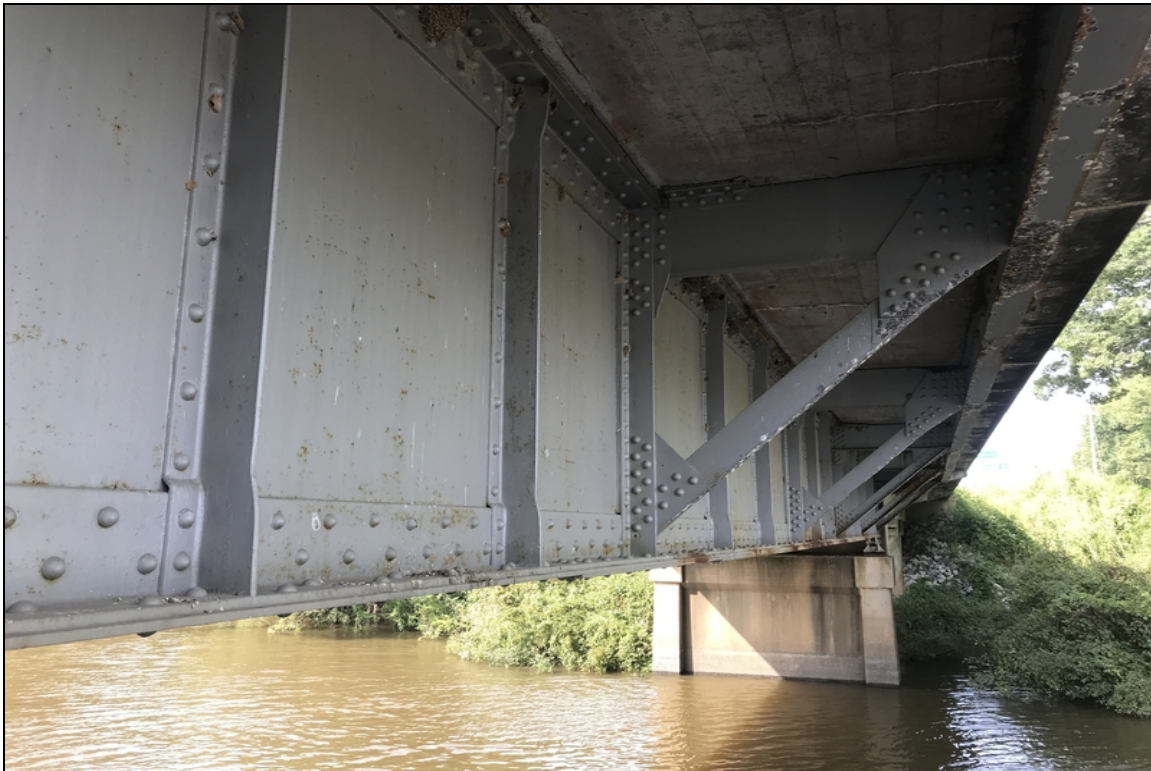
Span 3 typical paint condition

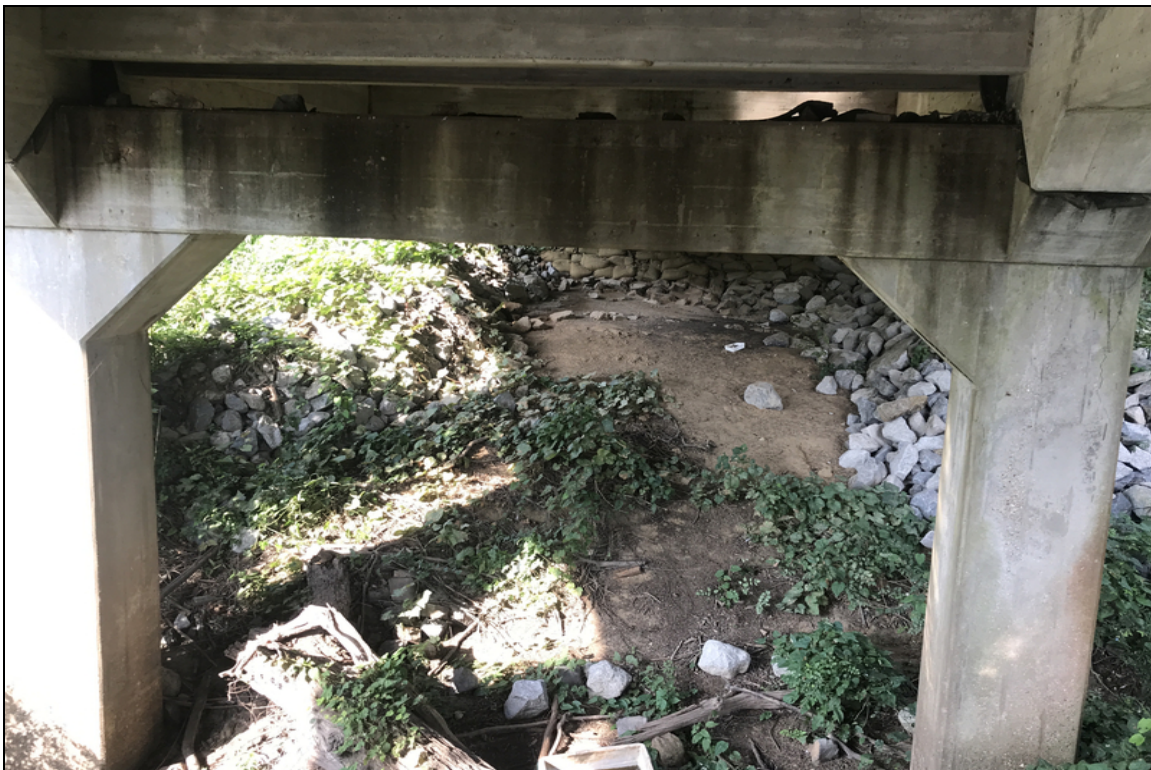
(205)							
Both columns at bent 2 have vertical cracks. 0.050 inch avg. Column 1 at bent 7 has spall with exposed rebar. Column 2 at bent 7 has a small delam right side. Column 1 at bent 8 has spall with exposed rebar on back face. Column 2 at bent 8 has delam on back face.							
210	Reinforced Concrete Pier Wall	LF	72	0	29	43	0
1090	Exposed Rebar	LF	7	0	0	7	0
1190	Abrasion/Wear (PSC/RC)	LF	65	0	29	36	0

Bent 2 spall with exposed rebar on cap, cracks in both columns.

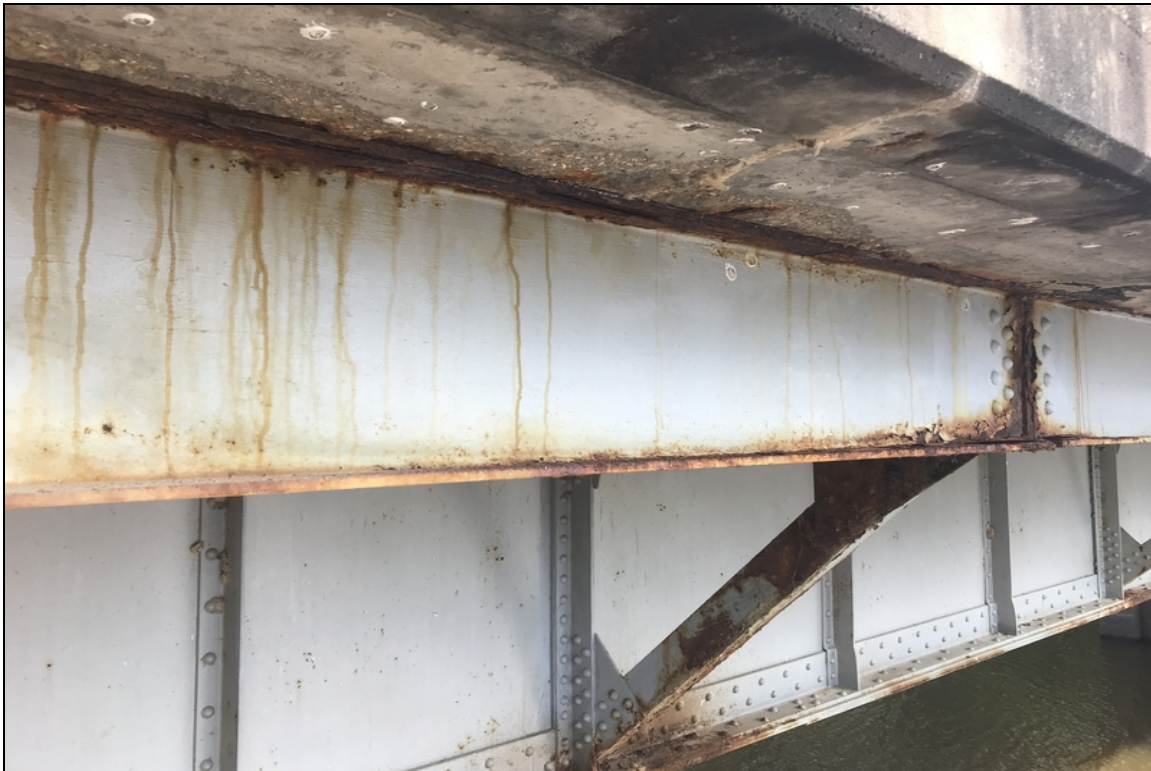
Span 5 outside stringer corrosion

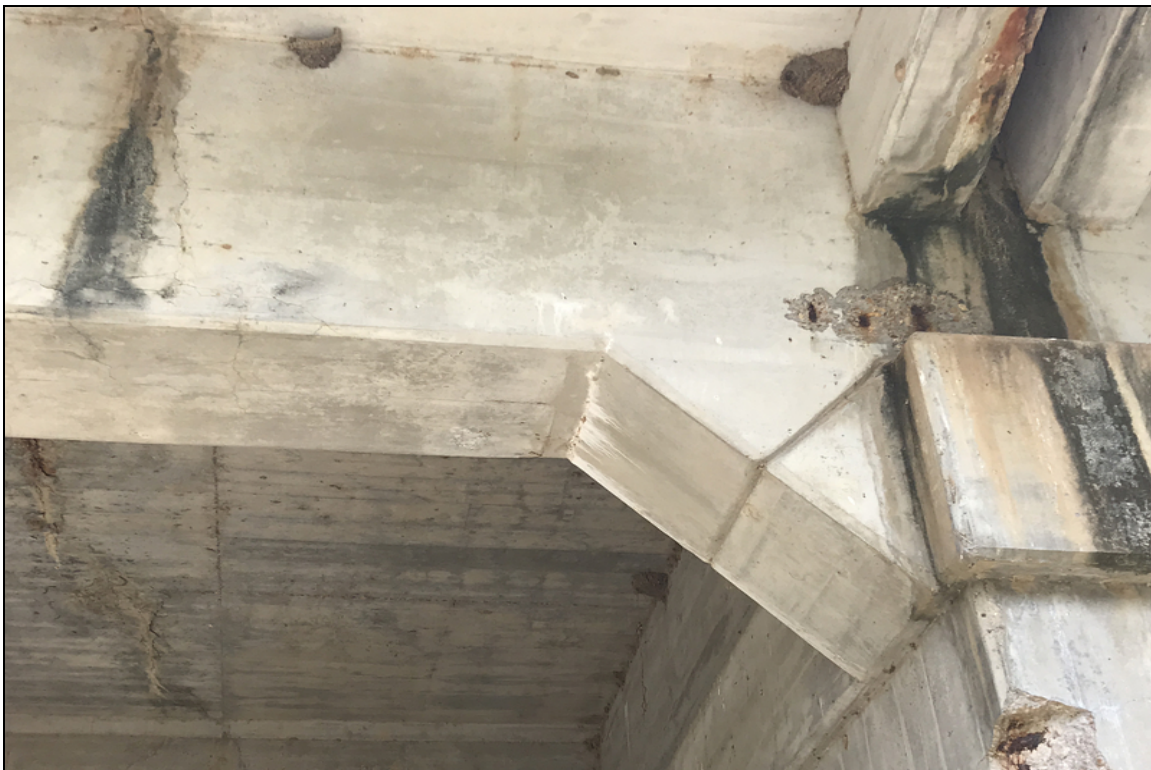
(110)							
Span 7 girder 2 at bent 8 spall with exposed rebar on right side. Flex cracks in the legs of spans 1,2,6,7,&8. Span 7&8 have small spalls on both girders from traffic impact							
113	Steel Stringer	LF	1215	278	250	687	0
1000	Corrosion	LF	922	0	250	672	0
1020	Connection	LF	15	0	0	15	0

Span 7 girder 2 at bent 8 spall with exposed rebar on right side.

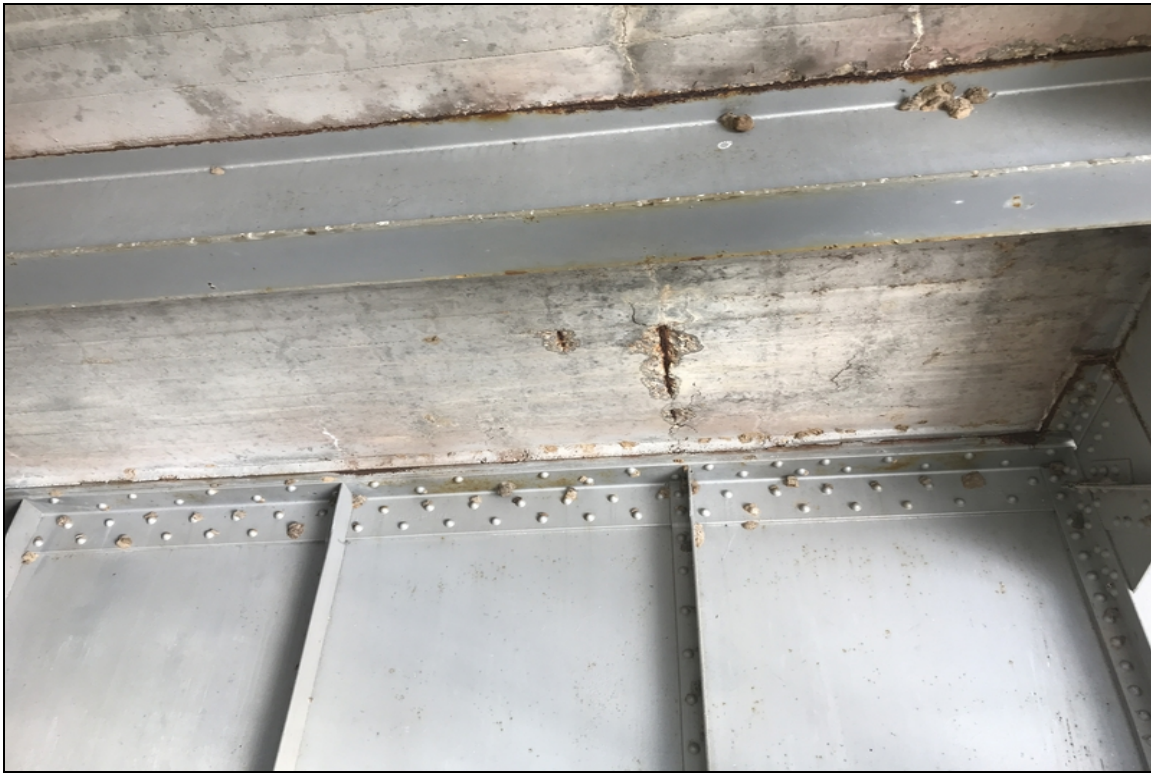
(12)							
Span 3, 4 and 5 have Spalls with exposed rebar on the soffit and cracks with rust stains and efflorescence.							
16	Reinforced Concrete Top Flange	SF	6107	5895	38	174	0
1080	Delamination/Spall/Patched Area	SF	38	0	38	0	0
1090	Exposed Rebar	SF	29	0	0	29	0
1120	Efflorescence/Rust Staining	SF	145	0	0	145	0
510	Wearing Surfaces	SF	5400	2457	2943	0	0
3210	Delam/Spall/Patched Area/Pothole	SF	27	0	27	0	0
3220	Crack (Wearing Surface)	SF	2916	0	2916	0	0

Exposed rebar on soffit span 3

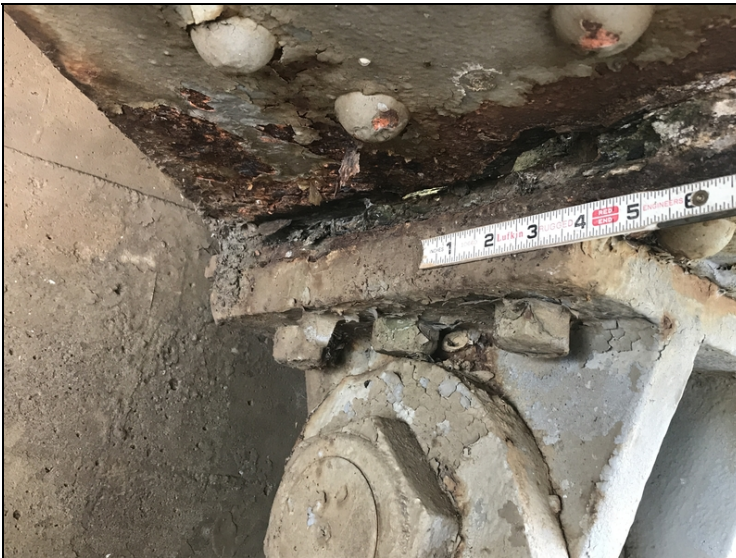
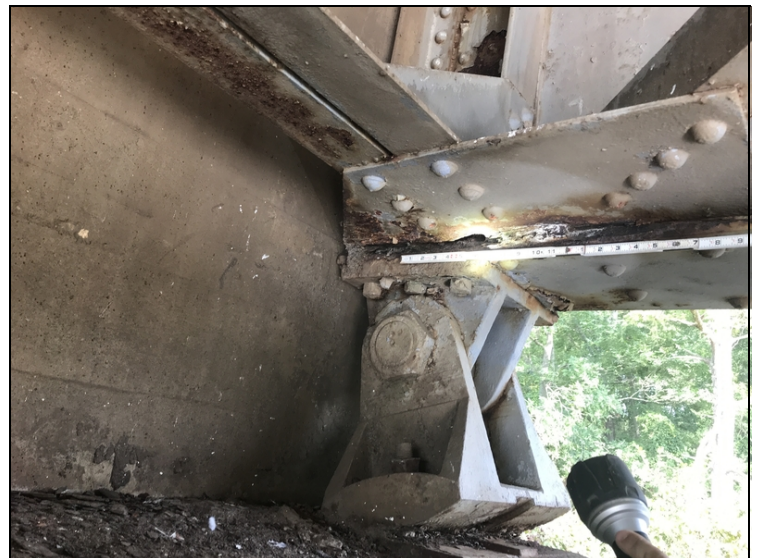
Pier 1, Span 3, girder1, 6"x1" hole in gusset plate were lateral bracing ties in above bearing 1.

Date Reported: 09/21/2020
Priority: B - Pressing; 6 month completion goal
Type of Work: Repair
Status: Open
Component:

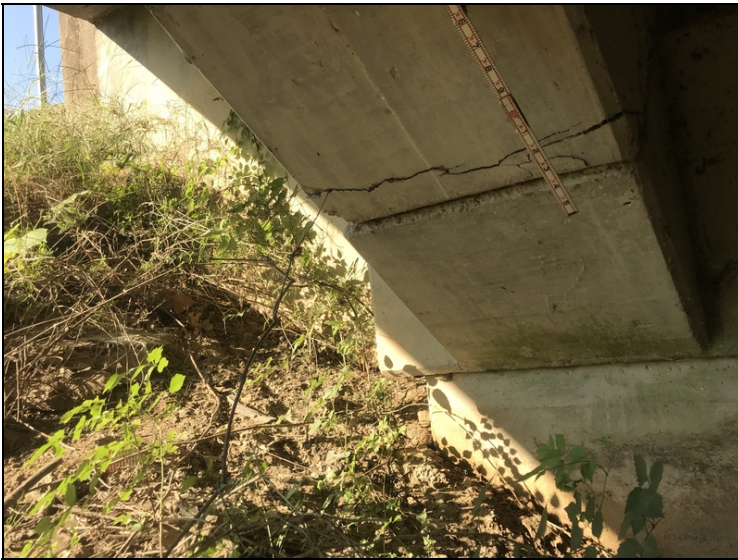
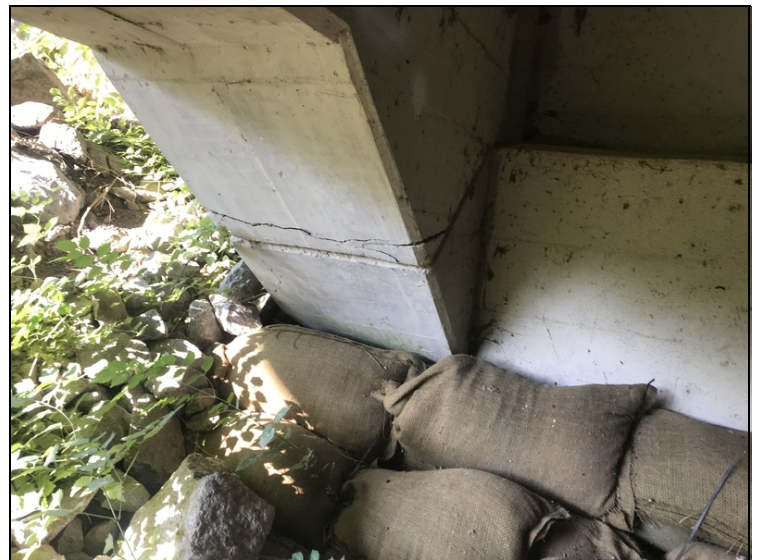
Bent 1, span 1, girder 2: Transverse crack in the girder near the cap.

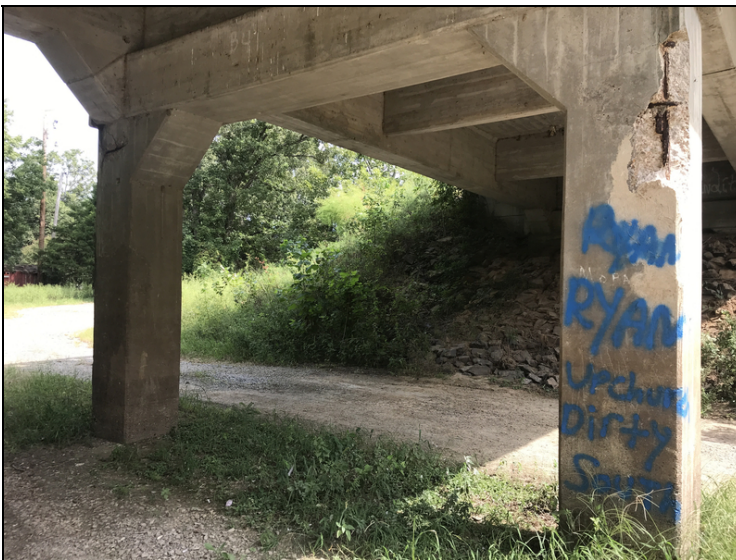
Bent 8, column 1 and 2: large spall with exposed rebar.

Bent 8 column 1 & 2 large spalls with exposed rebar

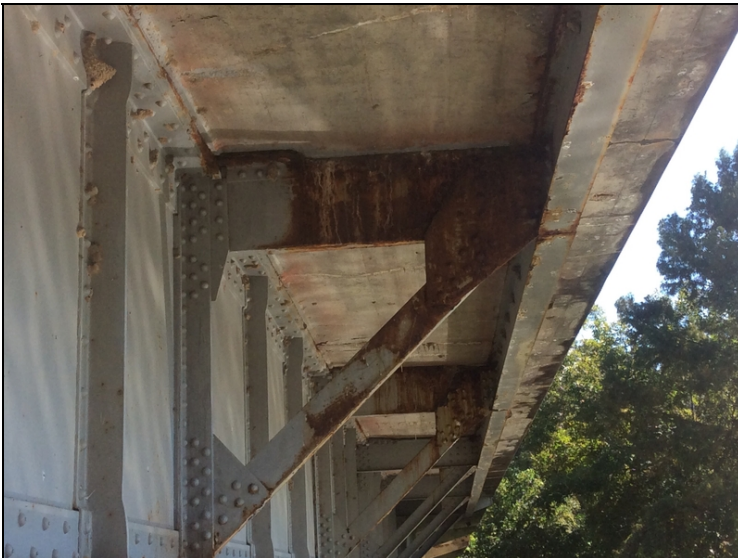
Spans 3,4 & 5 the stringer and floor beams have active rust with moderate pitting. The corrosion is more common on the stringers and floor beams on the out side of girders at soffit overhangs.

Span 5 right of girder 2 active rust on the cantilevered floor beams.

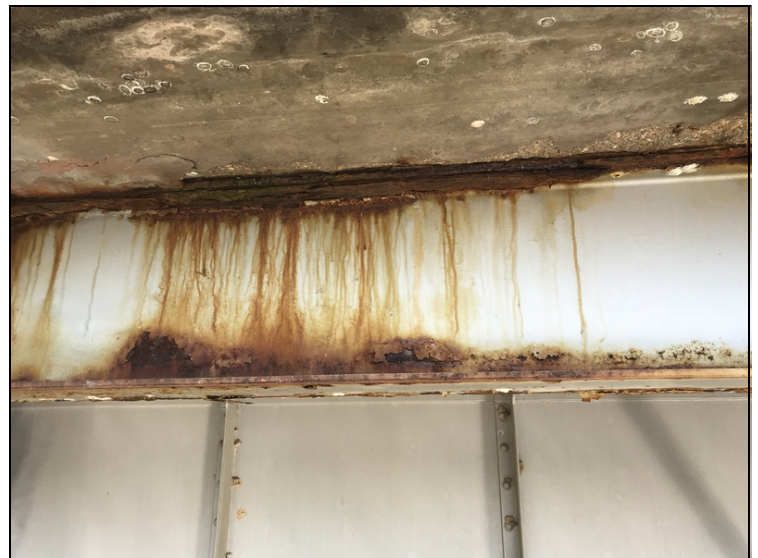
Span 4, stringer 4: top flange with laminating rust and lower web with measurable section loss. (8' from pier 2 joint)

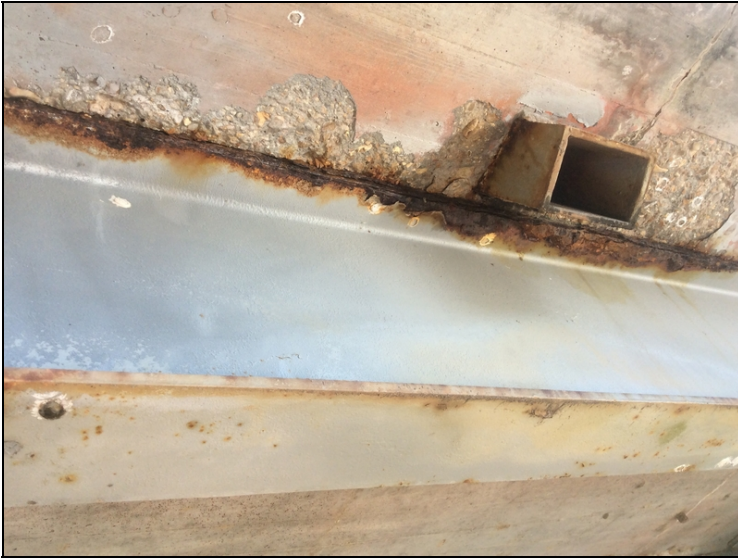
Span 3 right side stringer 4 active rust to top flange at scupper drain.

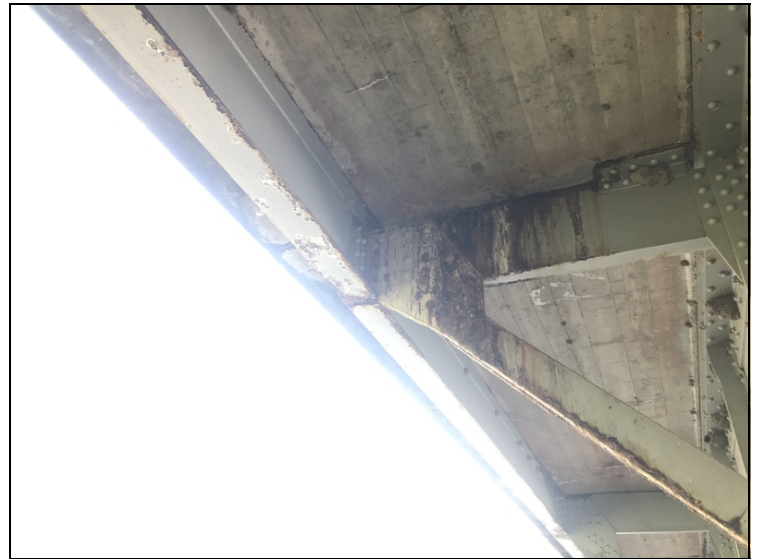
Span 3 left of girder 1 active rust on the cantilevered floor beams.

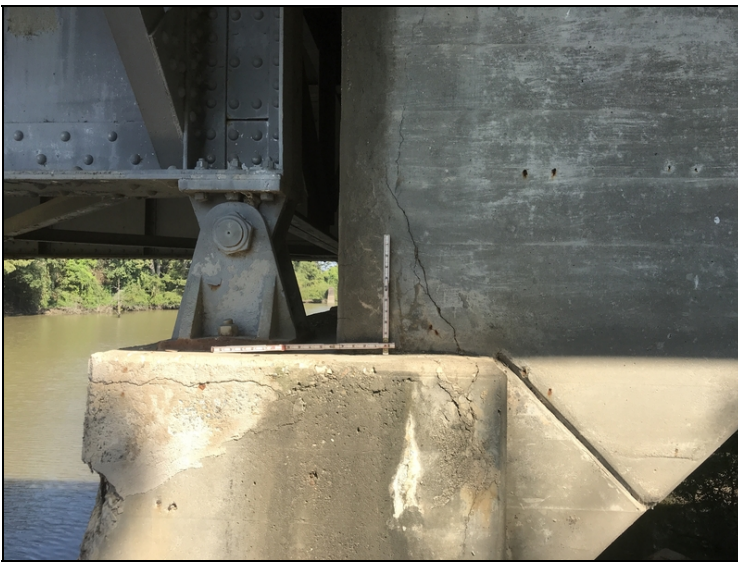
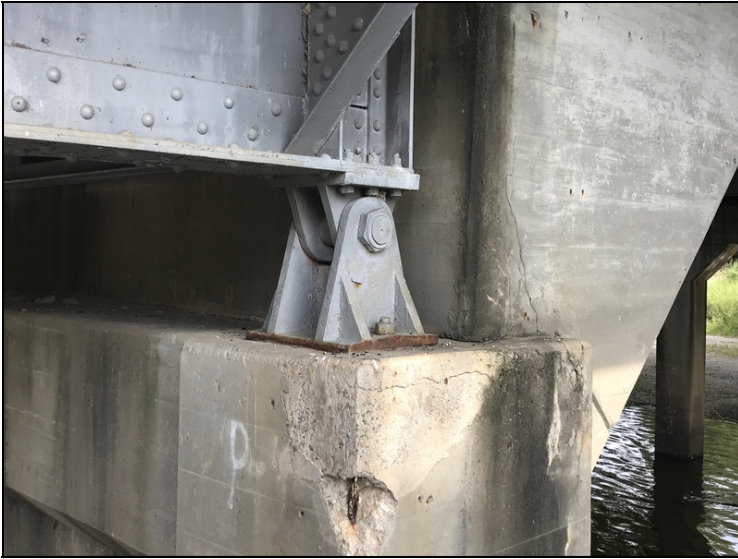
Right side pier 4: diagonal crack in the step up of the cap, also the main cap below.

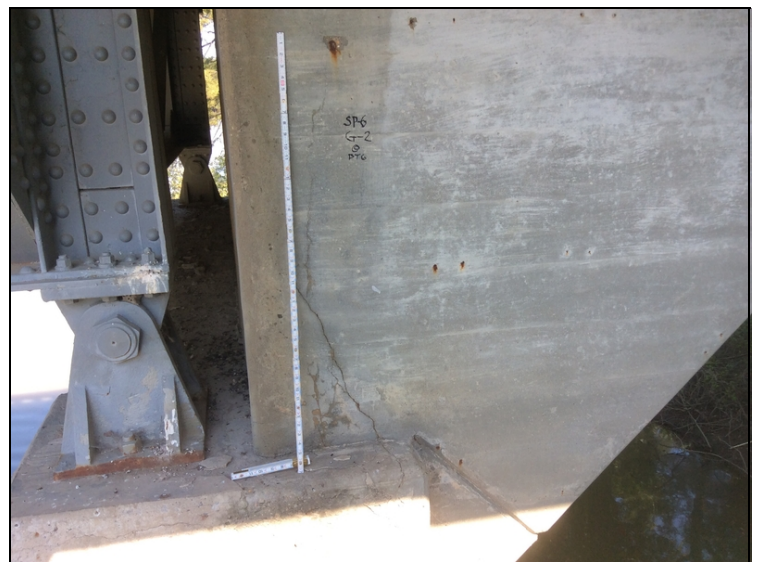
Span 6, girder 2
Cracking at the end of the girder.

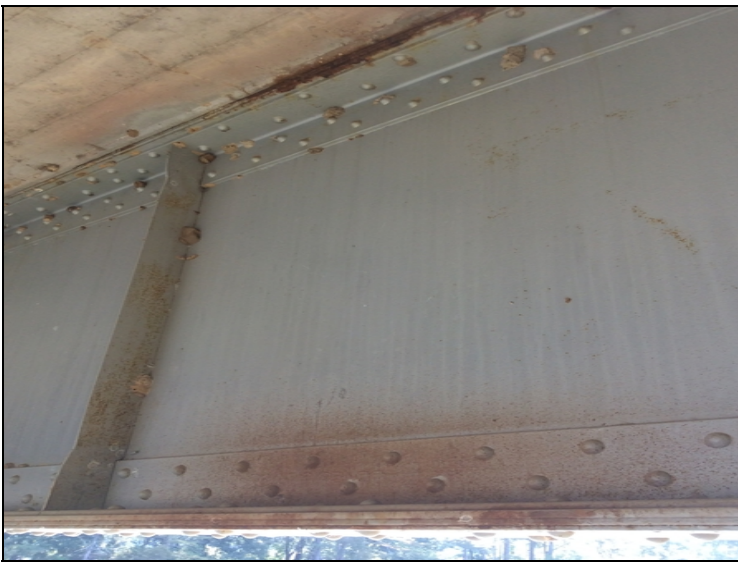
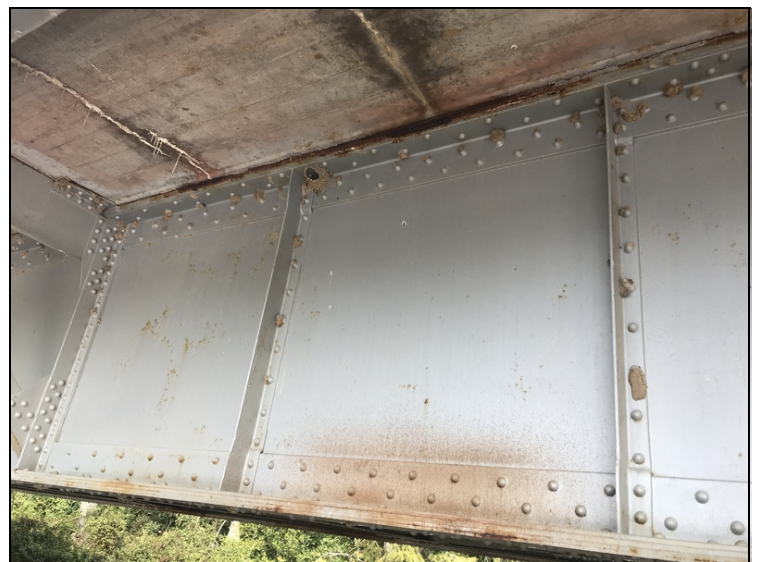
The top flanges of the main girders have active corrosion due to deck cracking. The rust "washes" out during rainy conditions, staining the sides of the girders.

Span 3, right girder left face.
Deck cracking is allowing water to rust the top flange and "wash out" on the web and bottom flange.

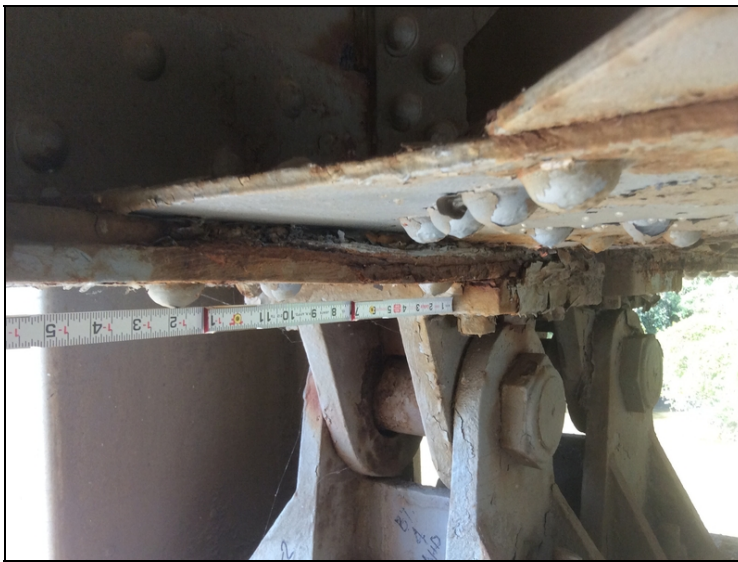
Span 4, girder 2 at bent 4 on the left side.
Pack rust has deformed the bottom flange near the bearing.

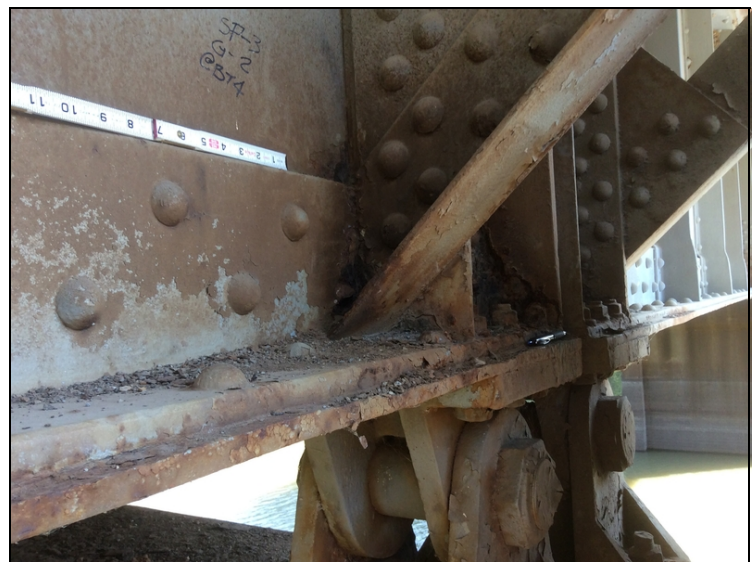
Span 3, girder 2, right side at bent 4.
The web plate is pitted to 1/8 inch at the diagonal brace and the end vertical stiffener.

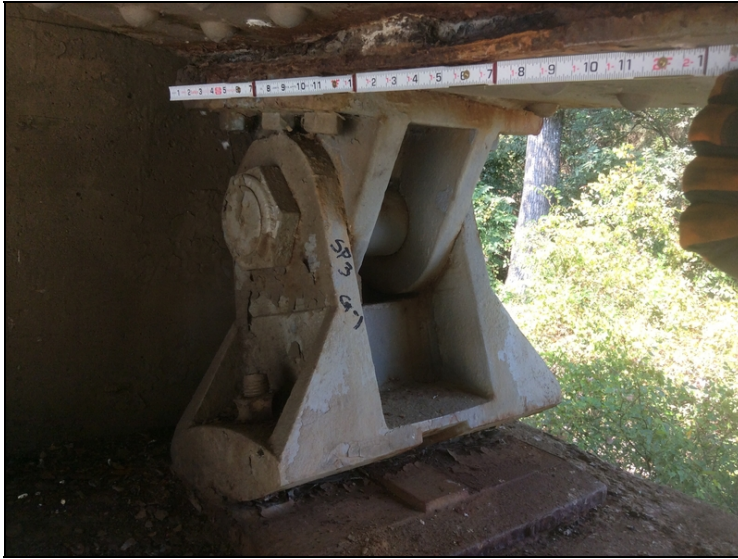
Span 3, girder1

The left edge of the bottom flange at the bearing is corroded down approx. 1/4"

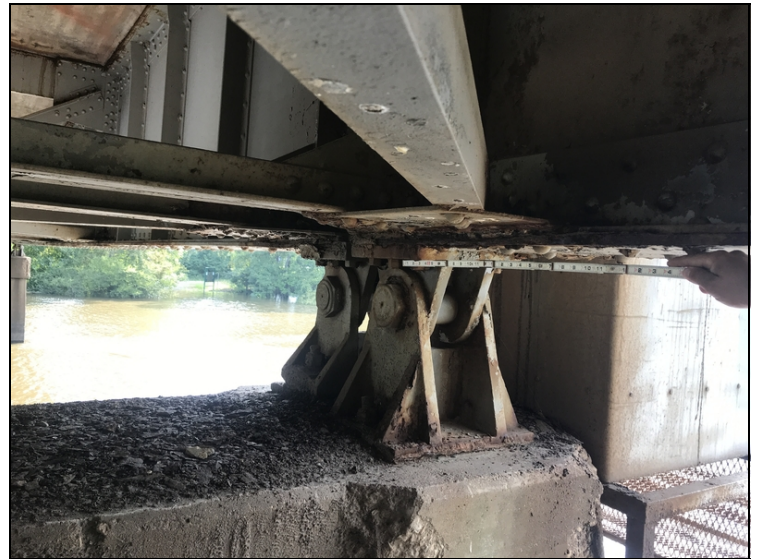
Span 3, girder 2, left side at bent 4.

The web plate and bottom flange have active corrosion with section loss up to 1/8"

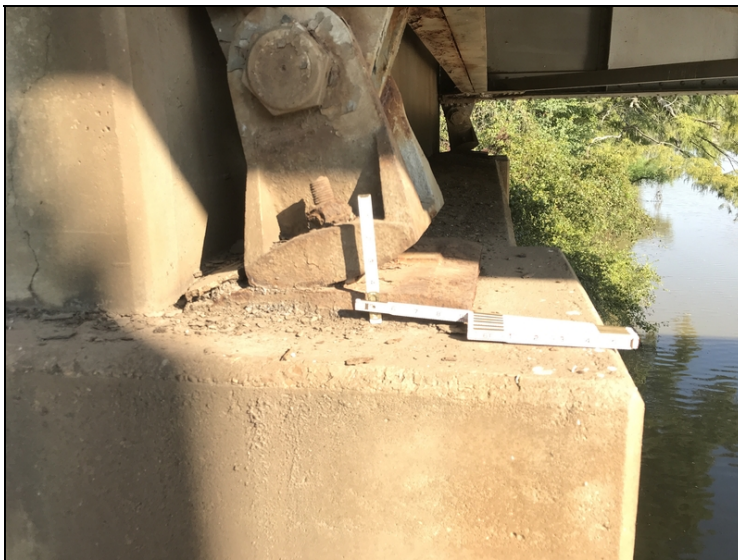
The moveable bearings at Bent 3 & 5 under the main span are fully rotated. See photos

Pier 1: both right and left bearing are fully rotated back.

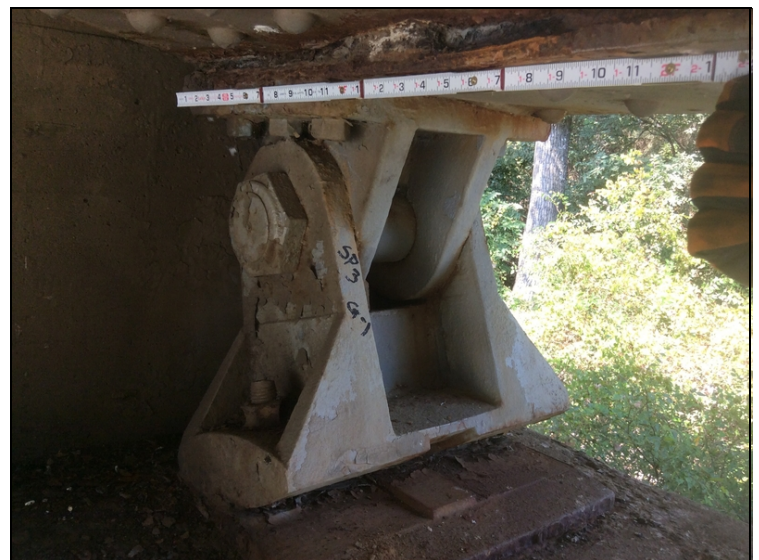
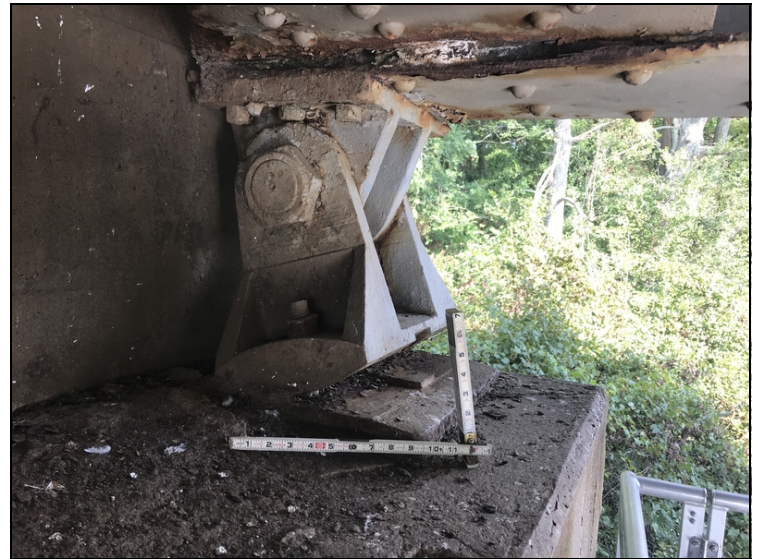
Span 3, girder1
The left edge of the bottom flange at the bearing is corroded down approx. 1/4"

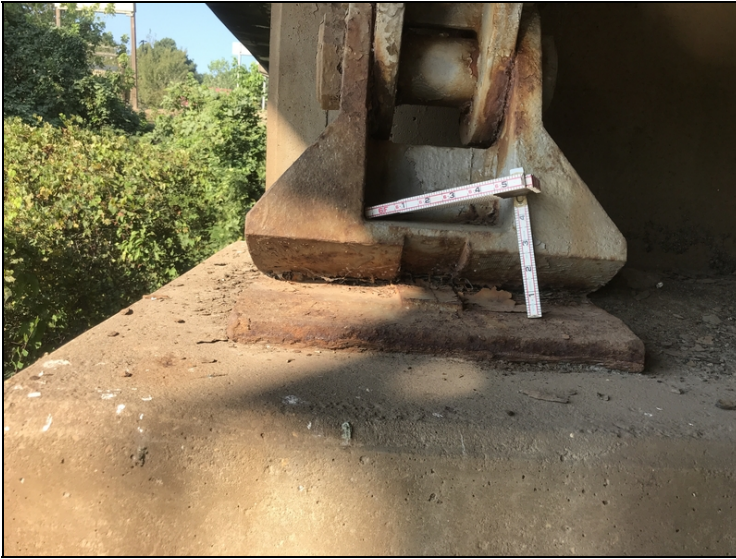
Pier 1, span 3, girder 2: right bearing fully rotated back. Girder 2 bearing in similar condition

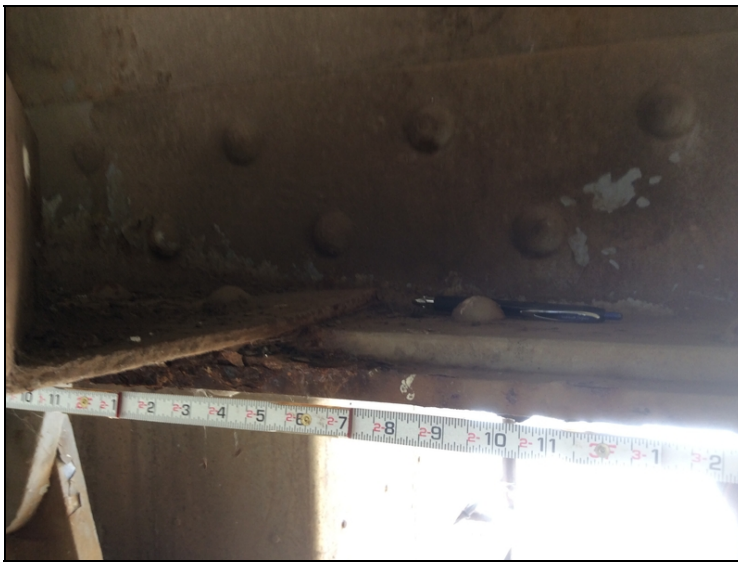
Girder 2, three feet back from bent 4.
Pack rust has developed between the diagonal brace gusset plate and the top of the bottom flange.

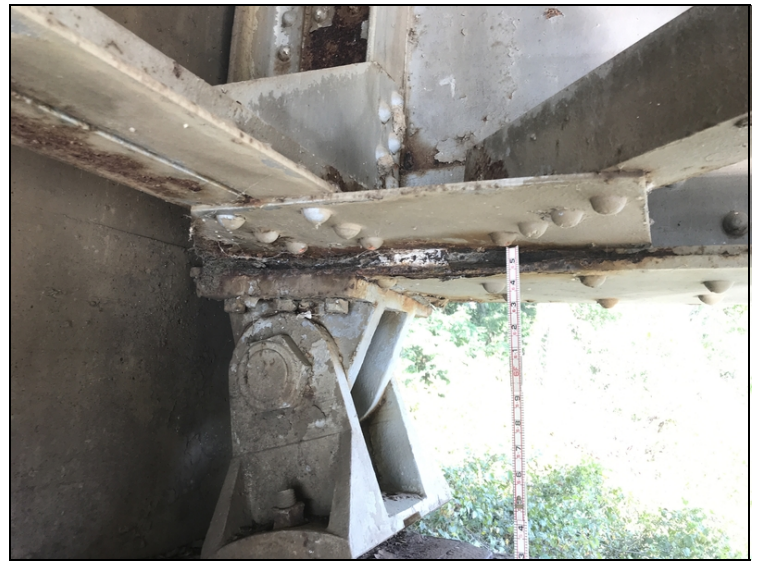
Pier 1, girder 1: pack rust between bottom flange and gusset plate above bearing. This is a common condition at all piers near the bearings

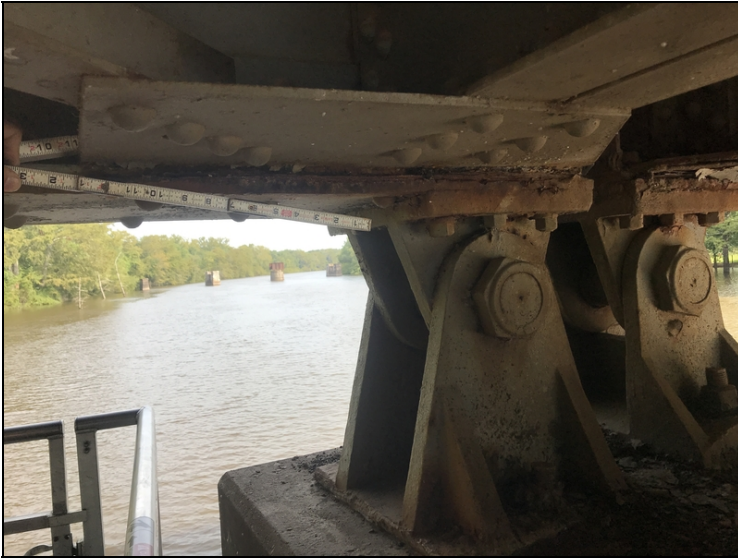
Pier 2 , Girder 1, span 3 Pack rust has developed between the diagonal brace gusset plate and the top of the bottom flange.

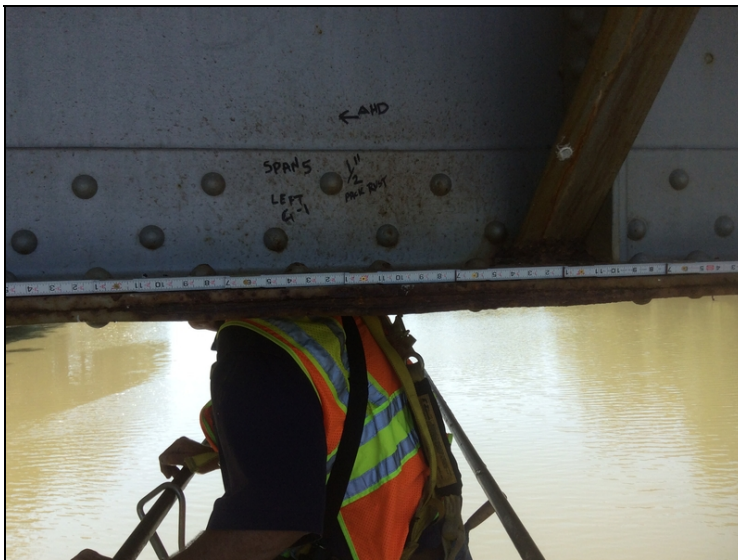
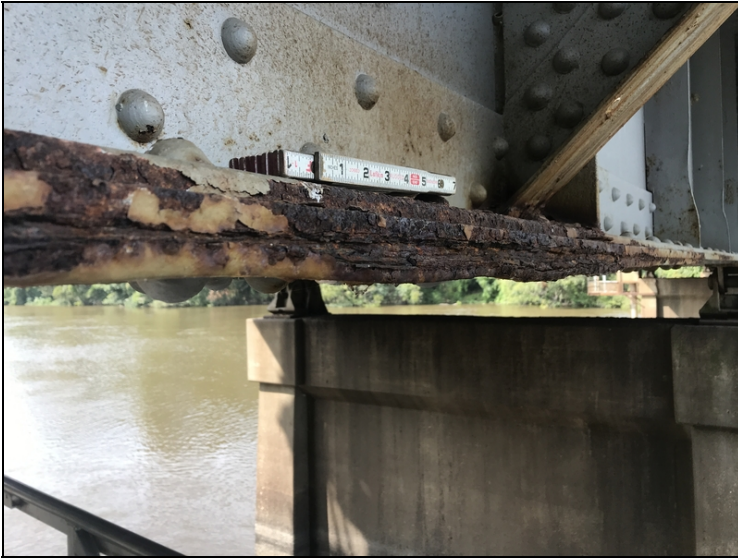
Span 5 girder 1, left side
1/2" of pack rust between the plates of the bottom
flange,
Approx. 20 feet ahead of bent 5.

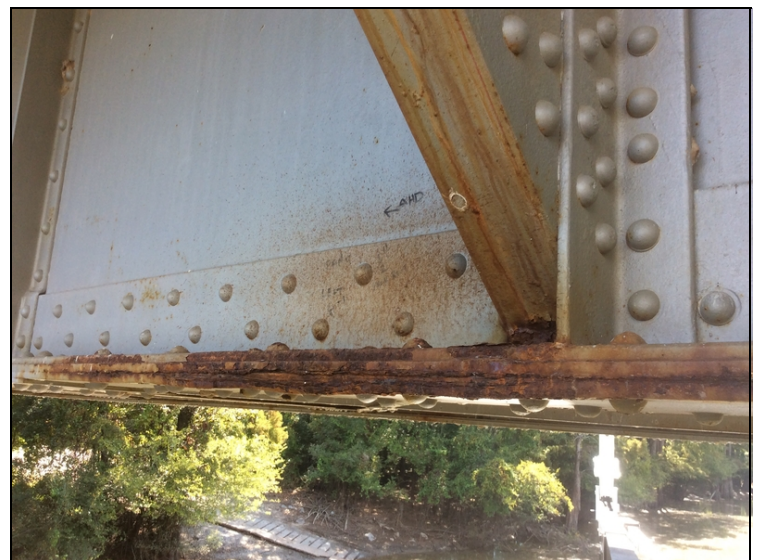
Span 5, girders 1 pack rust has deformed bottom flange at riveted built up section. See photo.

Span 5, girders 1 pack rust has deformed bottom
flange at riveted built up section.

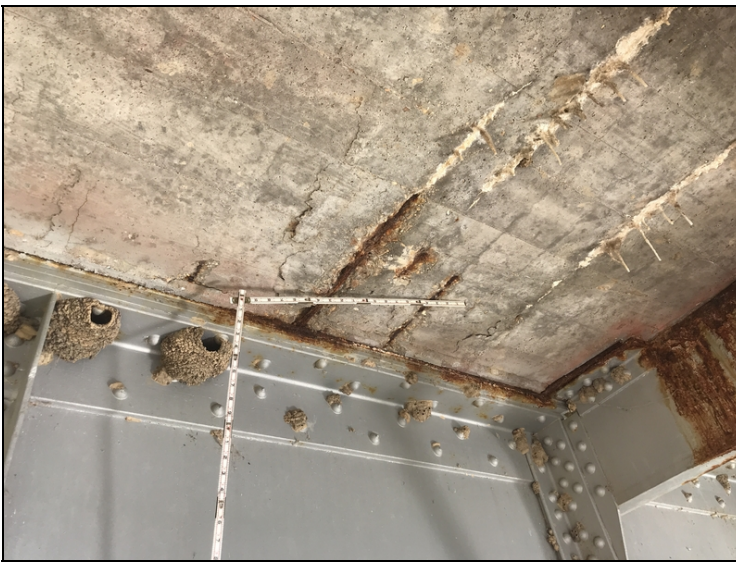
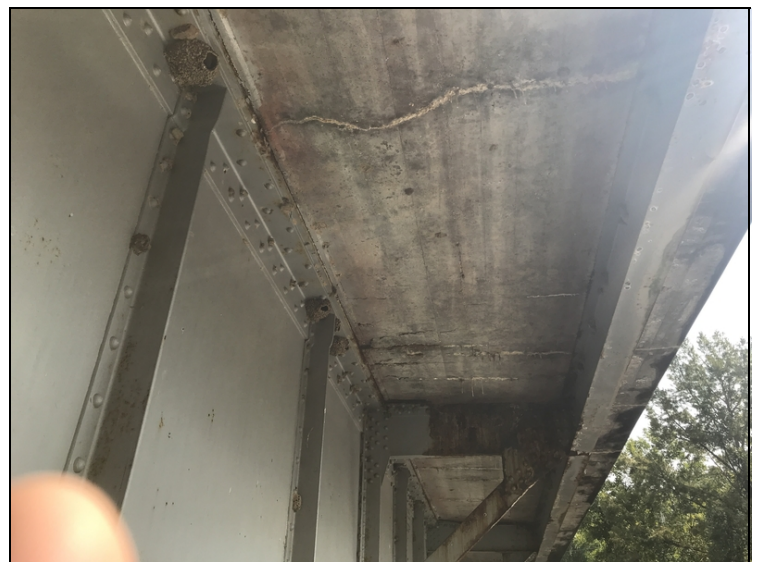
The soffit (bottom of the deck) of spans 3,4 and 5 have transverse cracks with rust stains and efflorescence build up, spalls and spalls with exposed rebar.

Span 5 right of girder 2: spalls with exposed rebar and transverse cracks with heavy efflorescence build up. Common deficiency at this span

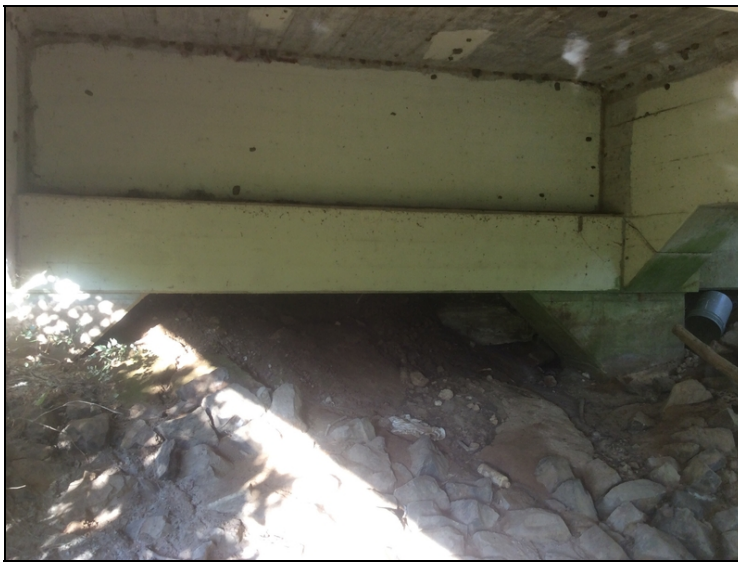
Both of the abutments (spill through abutments) have active erosion due to storm water run off.

Abutment 1 erosion.

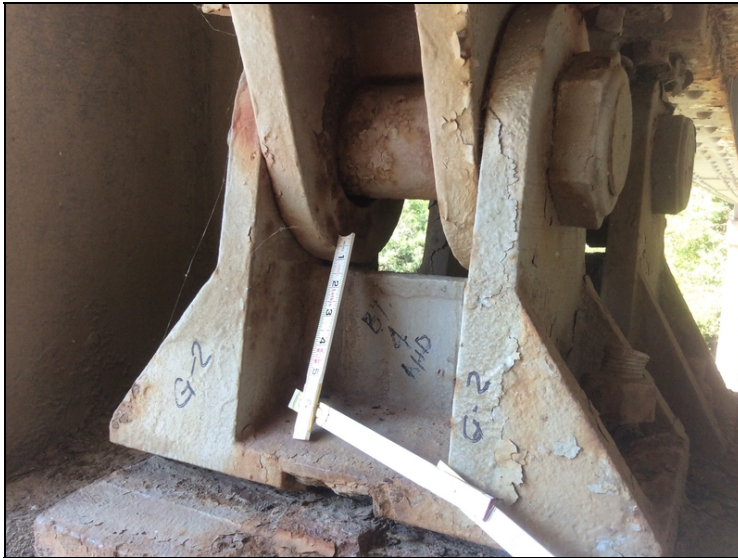
Bent 4, girder 1, the bearing pin is worn 1/8" deep
Bent 4 girder 2, the bearing pin is worn 1/4" deep.
Bent 6 girders 1 and 2 the bearing pins are worn 1/16" deep.

Looking back at the moveable bearing of girder 2
at bent 4.
The pin is worn (saddled) approx. 1/4 inch deep.

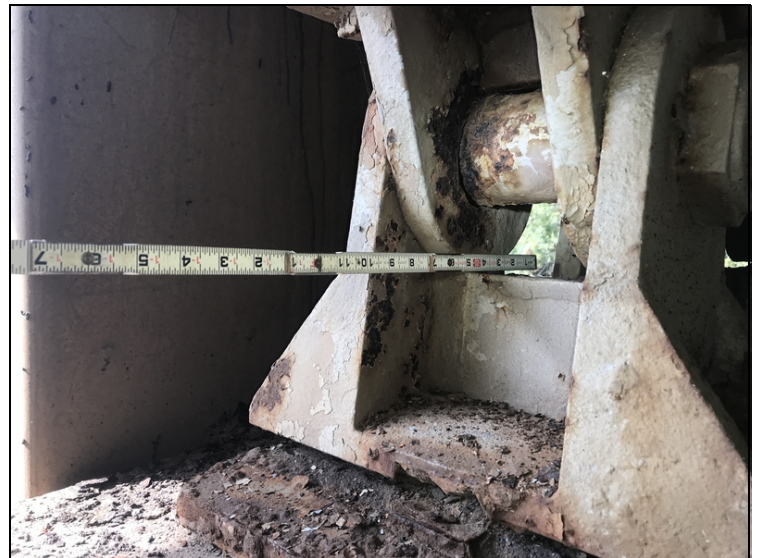
Bent 4, girder 1, the bearing pin is worn 1/4" deep
