Bridge #01101(Record Change, Fracture Critical)

US 70 Cache River over CACHE RIVER

Team Lead: Keith Harris **Inspection Date:** September 21, 2020

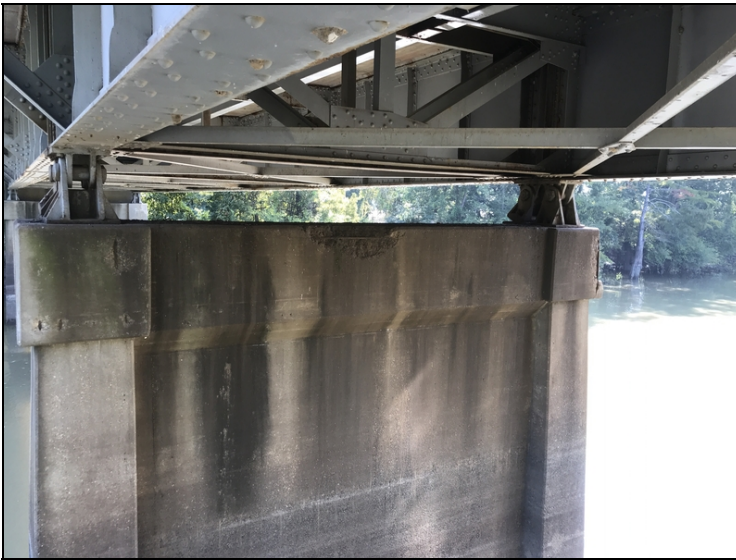
Backside of pier 3 cap has spalls with exposed rebar

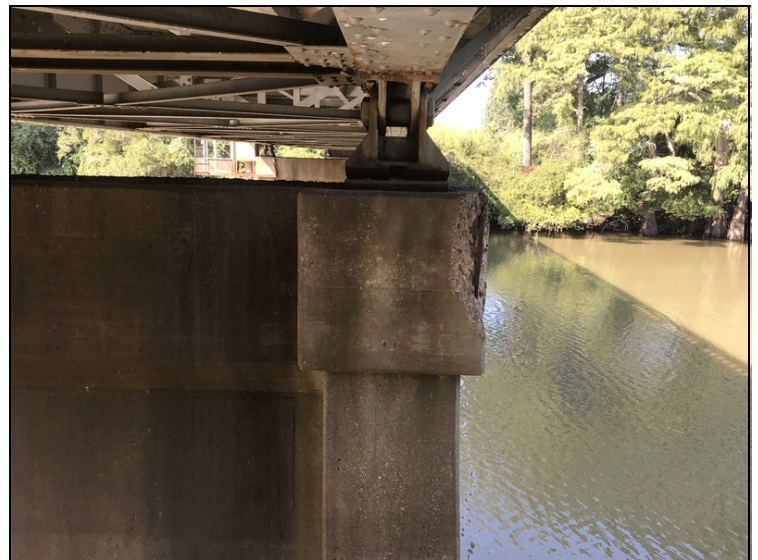
Ahead side of pier 3, left side: large spall with exposed rebar

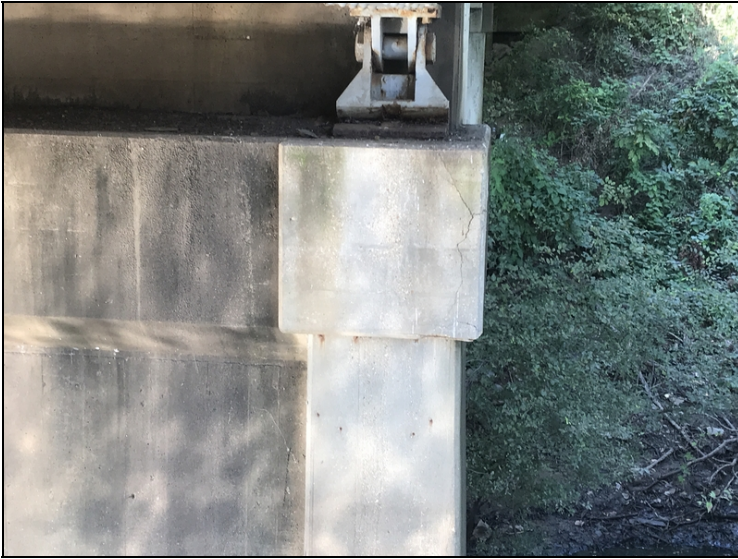
Ahead Pier 1, under girder 1: vertical crack under bearing

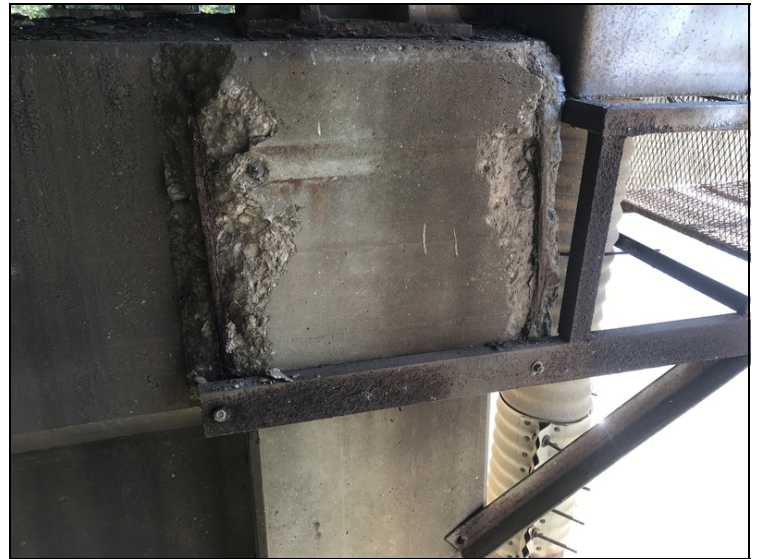
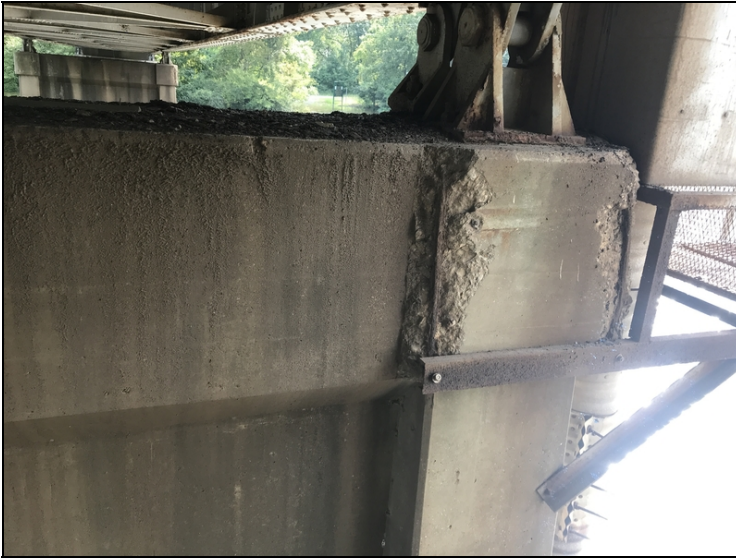
Back side pier 2, under girder 2: spalls with exposed rebar that has section loss. USGS river gauge is bolted to the cap and the bolts are loose.

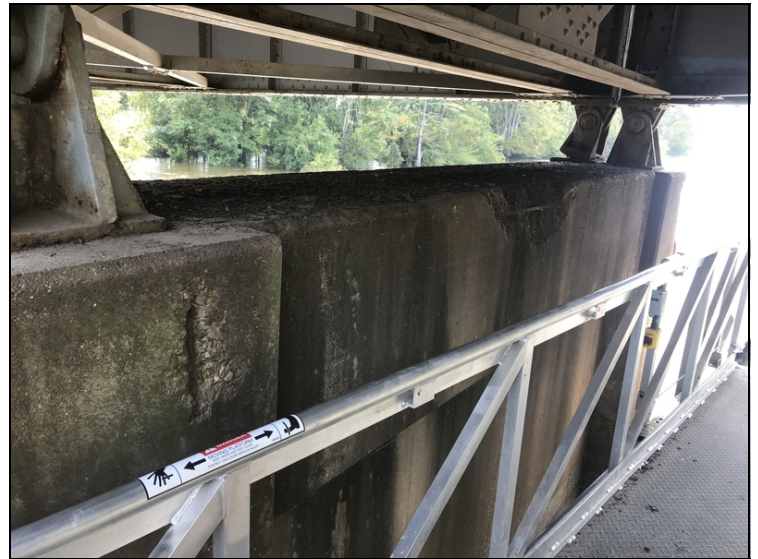
Pier wall 3 cap spalls with exposed rebar
