Bridge #01111(Routine, Underwater type 2)

Us-70/Sec-17/L5.25 over Bayou Devieu River

Team Lead: Myron Futrell Inspection Date: April 14, 2020

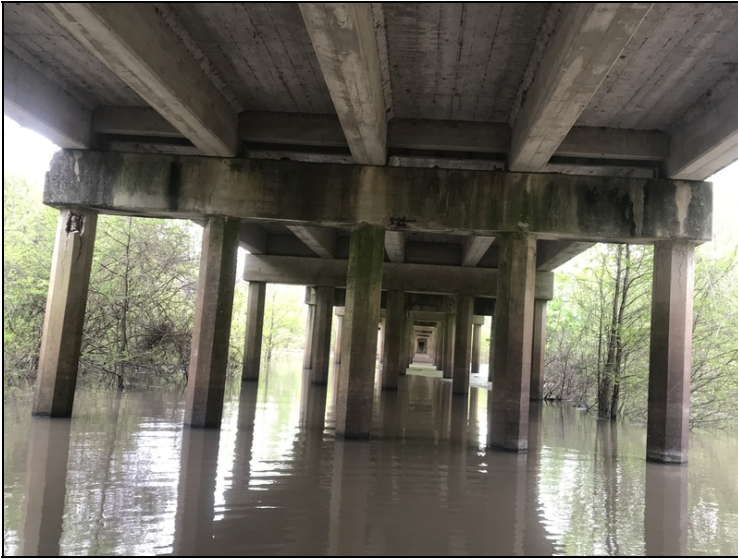
Bent #3 cap back face 6" from top has longitudinal crack between girders #1 through #4.

Bent 3 cap back face.

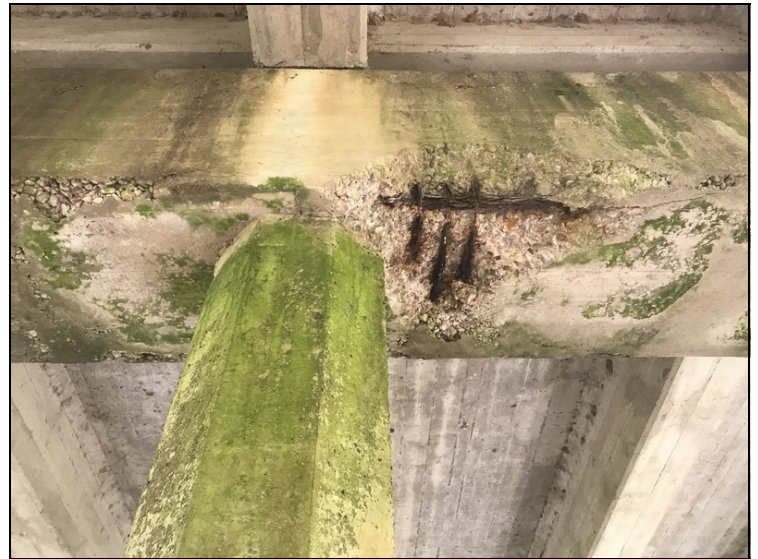
Bent #3 cap has a 2' spall on bottom at pile #3 with exposed rebar with 50% section loss.

Bent #3 cap bottom face at pile #3.

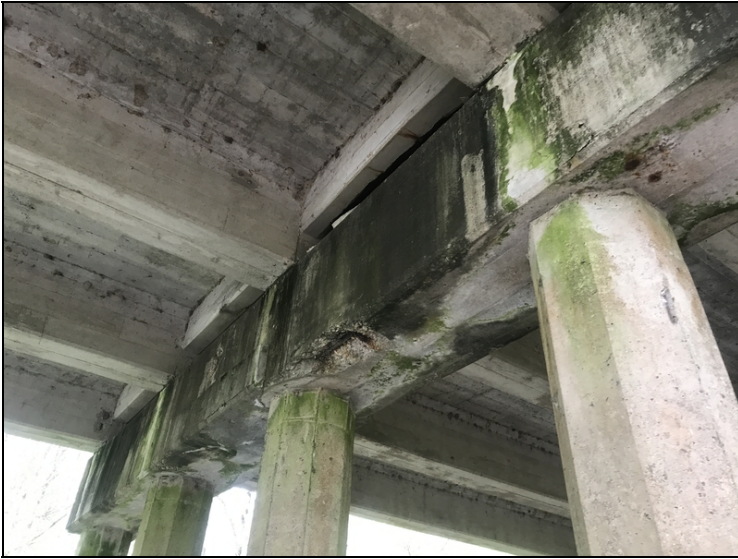
Bent #5 cap in center on bottom has two foot spall with exposed rebar with 10% section loss.

Bent #5 cap bottom face between piles #2 and #3.

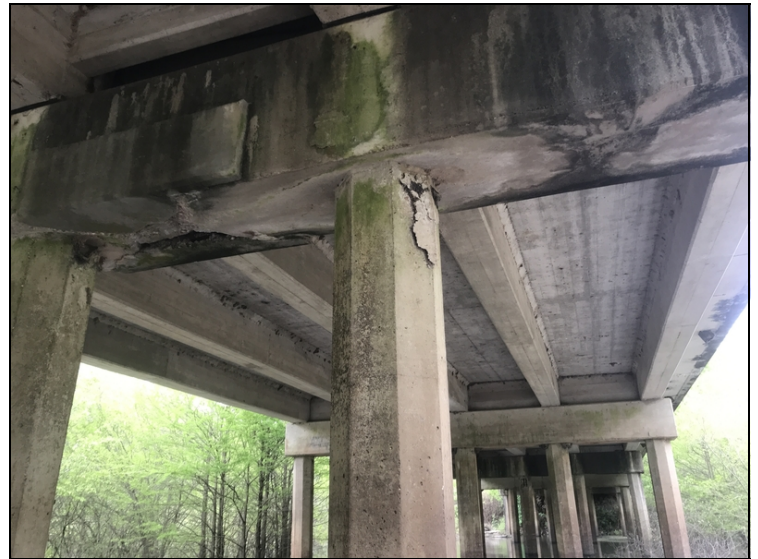
Bent #17 pile #4.

Bent #17 pile #3 has one foot spall at top with exposed rebar with 15% section loss with cracks extending down three feet from top.  
Bent #17 pile #4 has cracks extending down 2' from top and 1' delamination with 6" spall with exposed rebar with 20% section loss at top.  
Bent #17 pile #5 has a 6" spall with rebar exposed with 10% section loss with cracks extending down 2' from spall.  
Bent #19 pile #3 has a one foot spall at top with exposed rebar with 15% section loss.  
Bent #21 pile #2 is spalled, cracked, and delaminated with exposed rebar with 10% section loss.

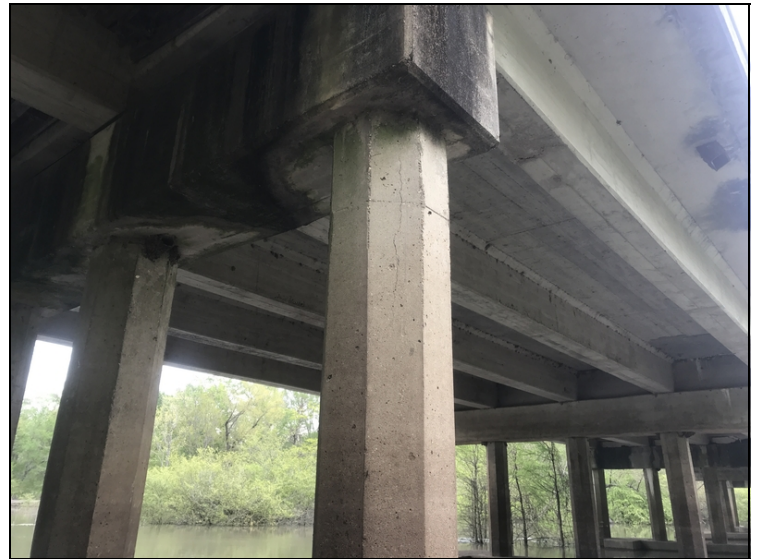
Bent #7 pile #5 has 3' of cracking near top.

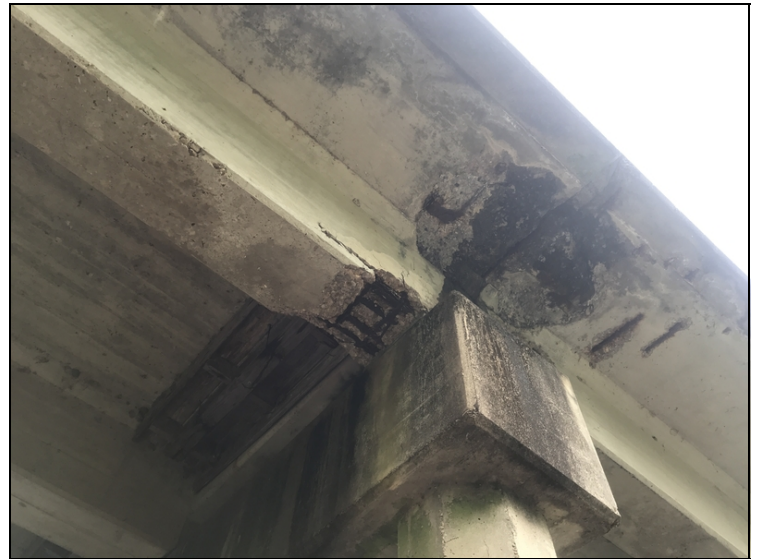
Span #6 girder #5 at bent #7 last one foot bottom of girder is spalled with exposed rebar with 20% section loss.

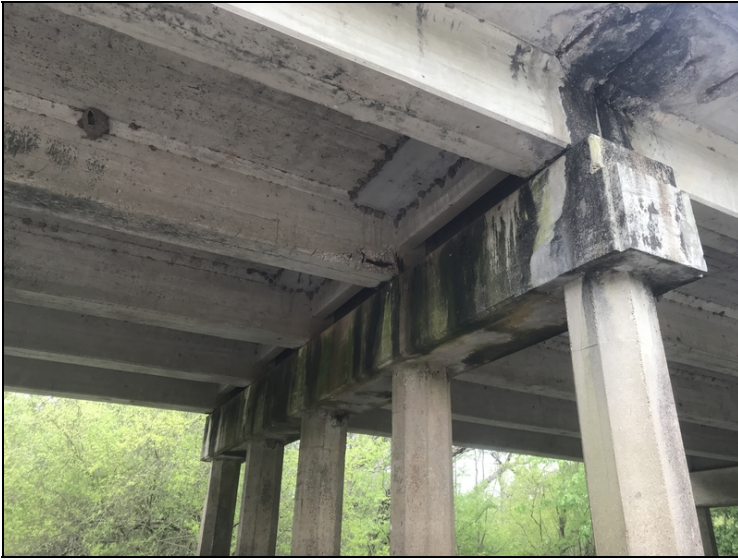
Span #7 bent #7 girder #2 has 3' of spalling with 1' exposed rebar with 20% section loss.

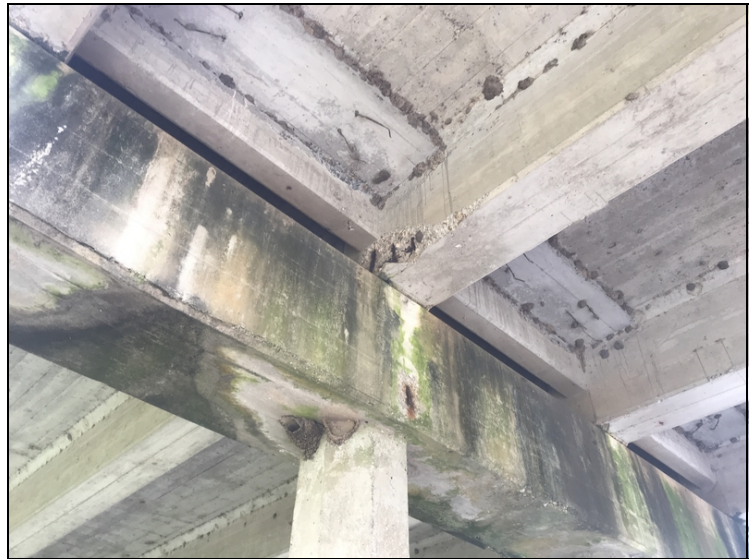
Span #7 girder #4 at bent #7 has a two foot spall with 1' exposed rebar with 20% section loss on right side.

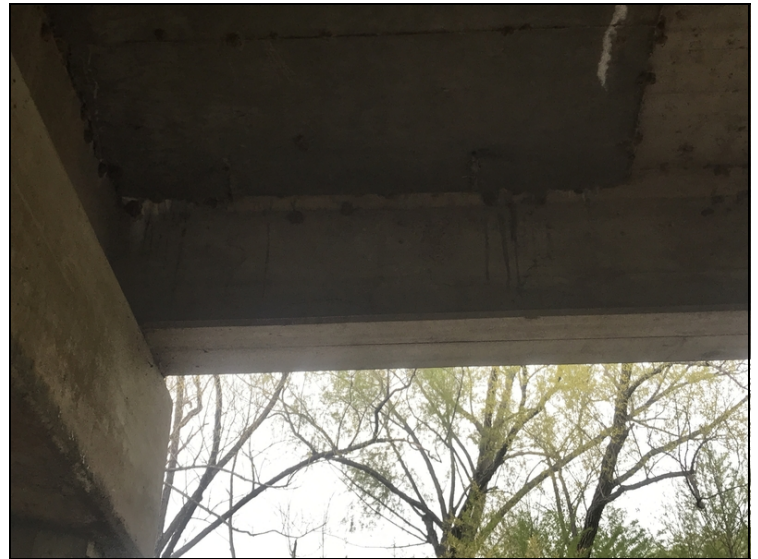
Span #14 girder #1 has a two foot delamination three feet ahead of bent# 14 on right side.

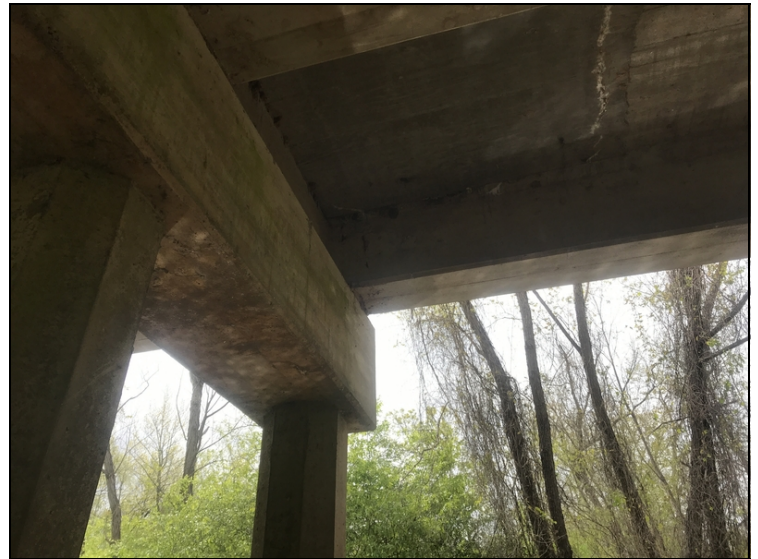
Span #13 girder #5 at bent #14 has 1' exposed rebar with 5% section loss.

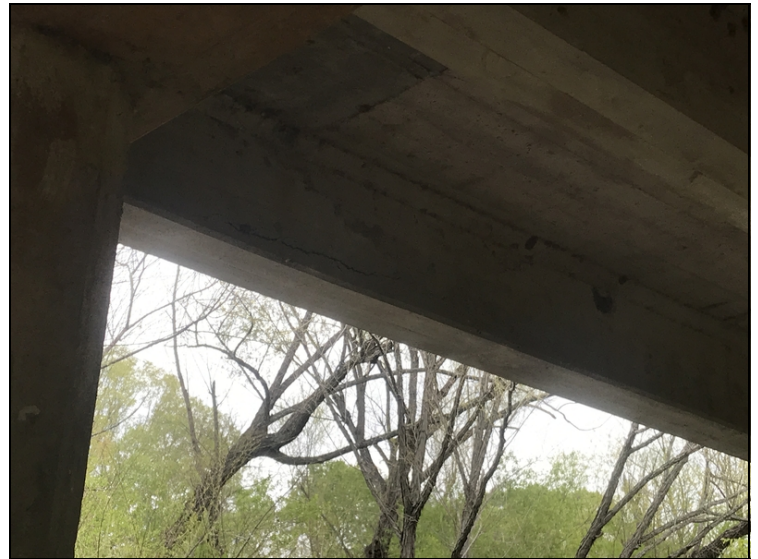
Span #12 girder #1 first ten feet from bent #12 has delamination.

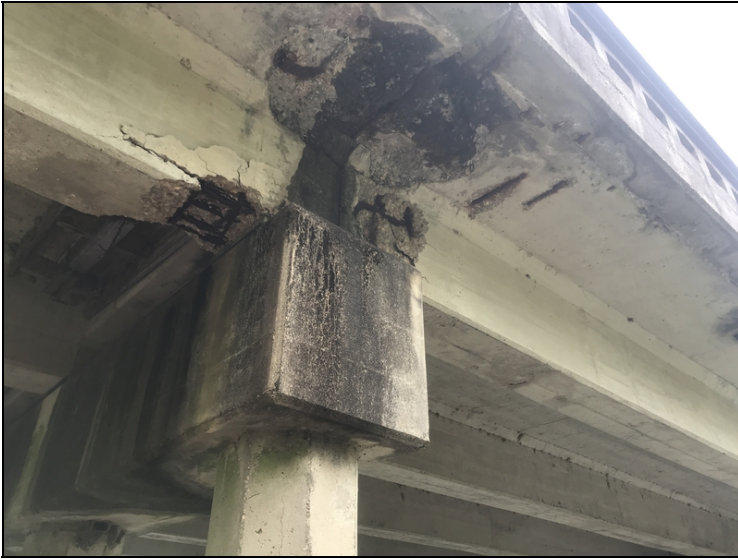
Span #7 girder #5 at bent #7 has a 2' spall on right side at bearing with rebar exposed with 20% section loss.

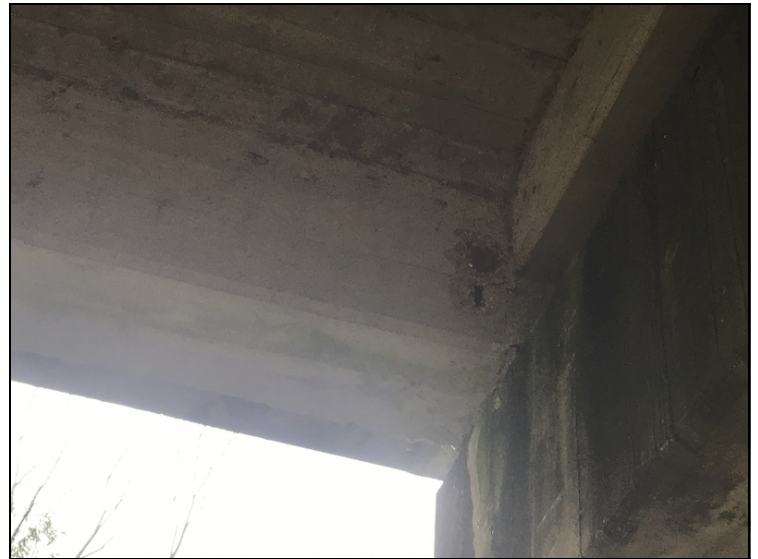
Span #5 girder #5 at bent #5 has a 1' spall on left side with exposed rebar no section loss.

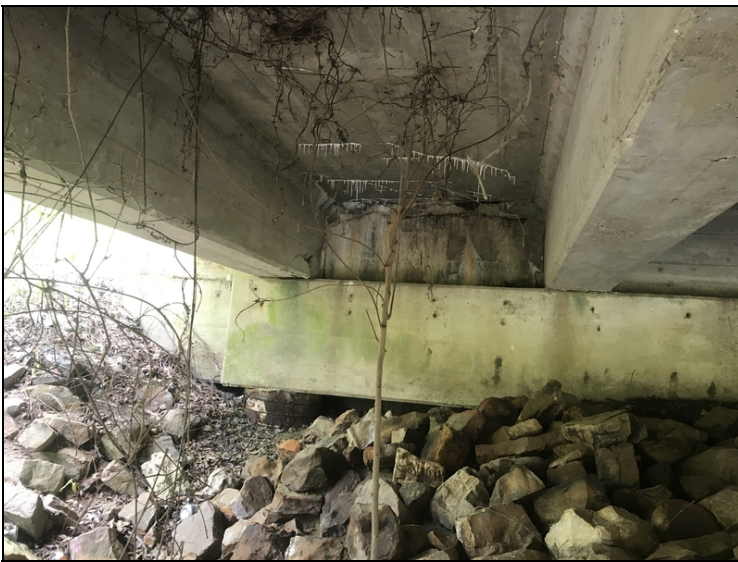
Abutment #1 back wall between girders #4 and 5.

Abutment #1 cap is undermined by erosion on right 6' up to 1' exposing one pile.

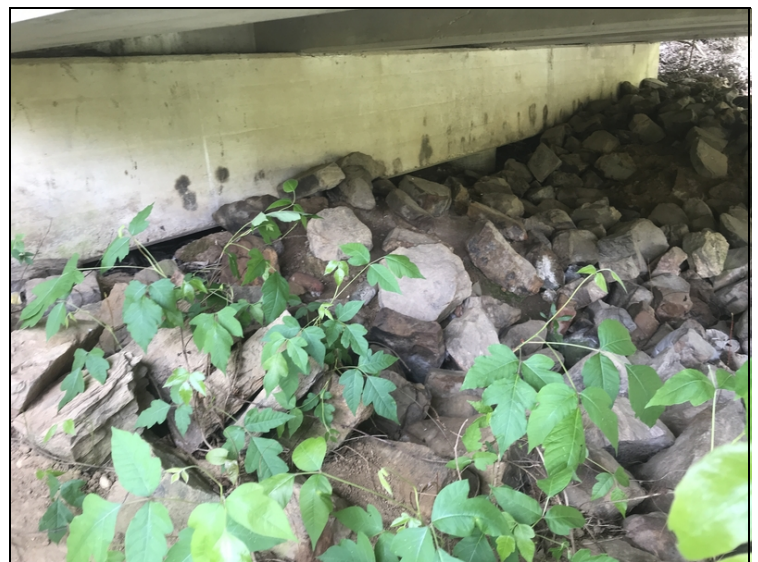
Abutment #2.

Abutment #2 cap is undermined by erosion in center up to six inches exposing one pile.

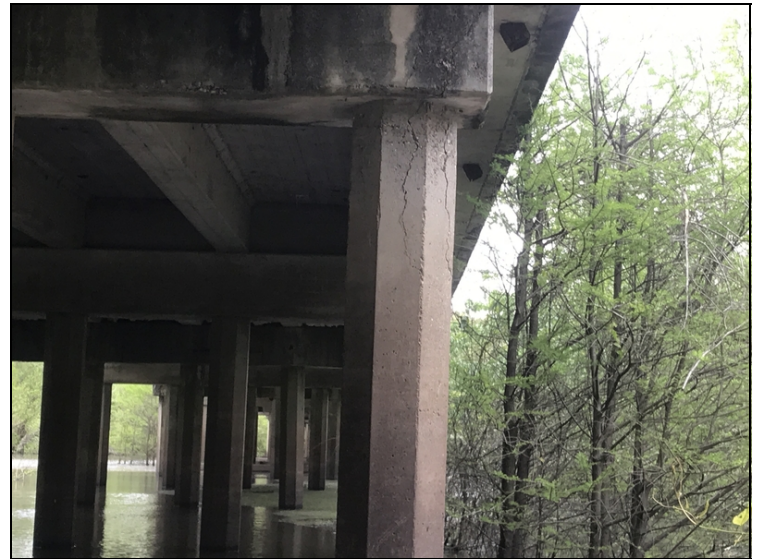
Bent #3 pile #5.

Bent #3 pile #5 is cracked at top.

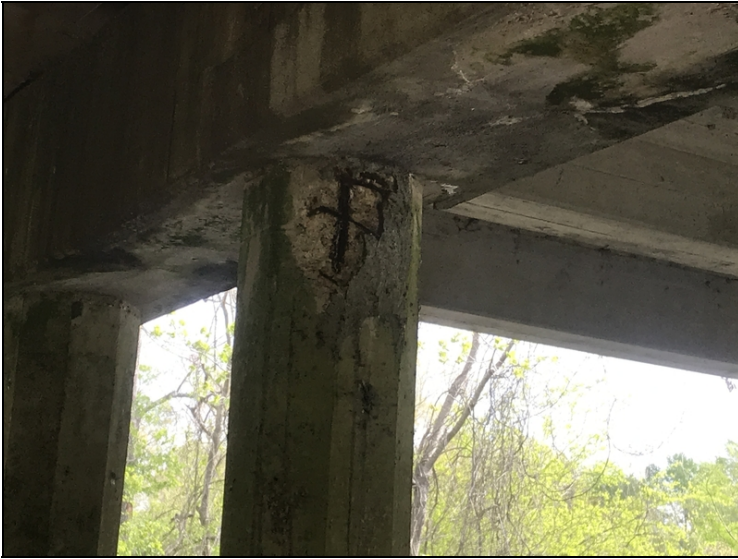
Bent #5 pile #3 1' spall at top with exposed rebar with 10% section loss.

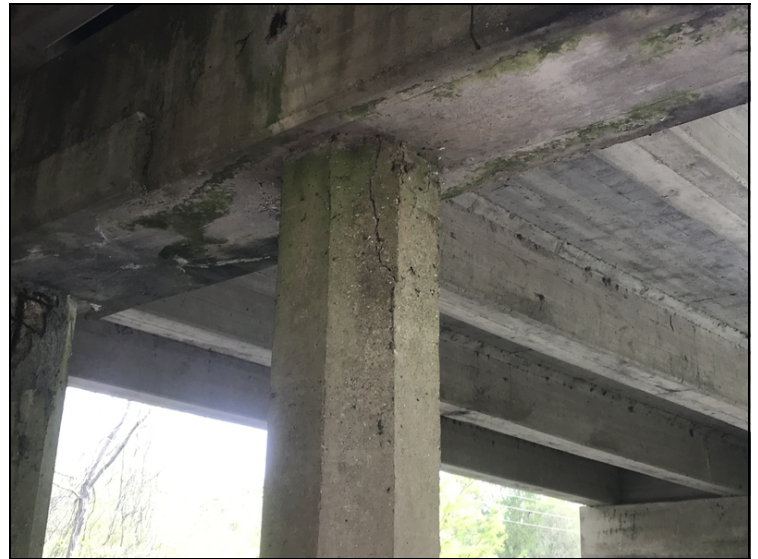
Bent #5 pile #4 1' delamination at top.

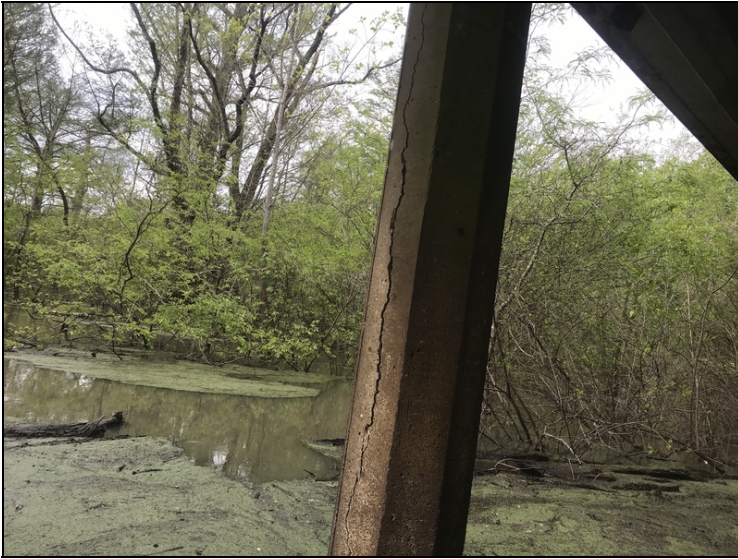
Bent #5 pile #5.

Bent #5 pile #5 is cracked on ahead face extending down 10'.

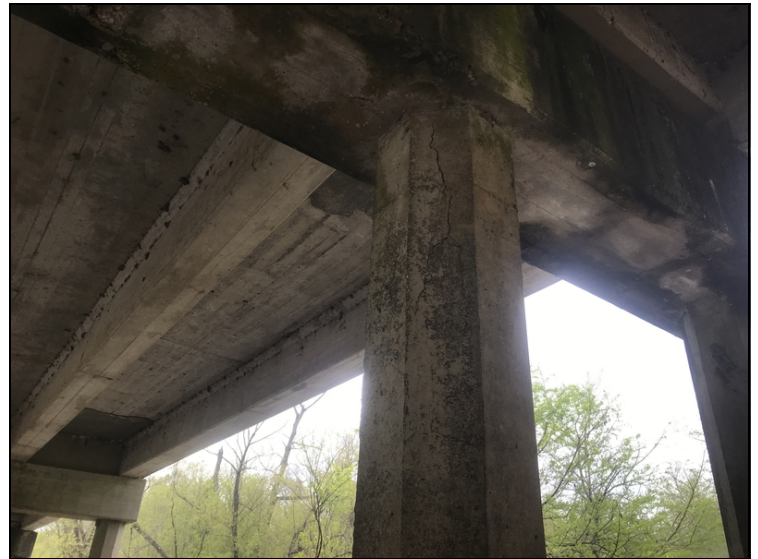
Bent #9 pile #4 cracked 3' near top.

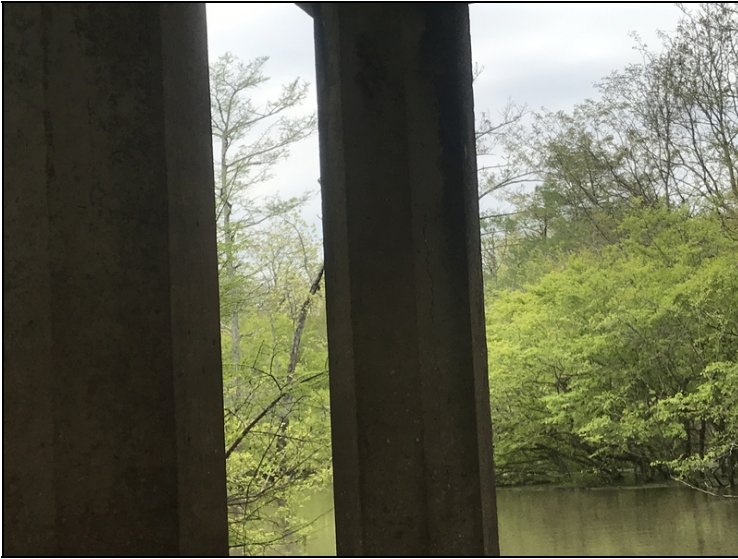
Bent #9 pile #5 cracked 6' near top.

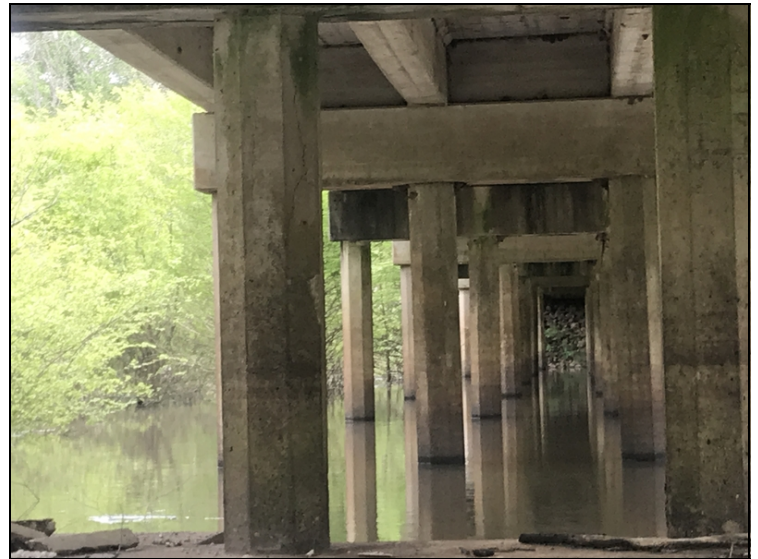
Bent #15 pile #2.

Bent #15 piles #2, 5 each have cracks extending down for three feet from top.

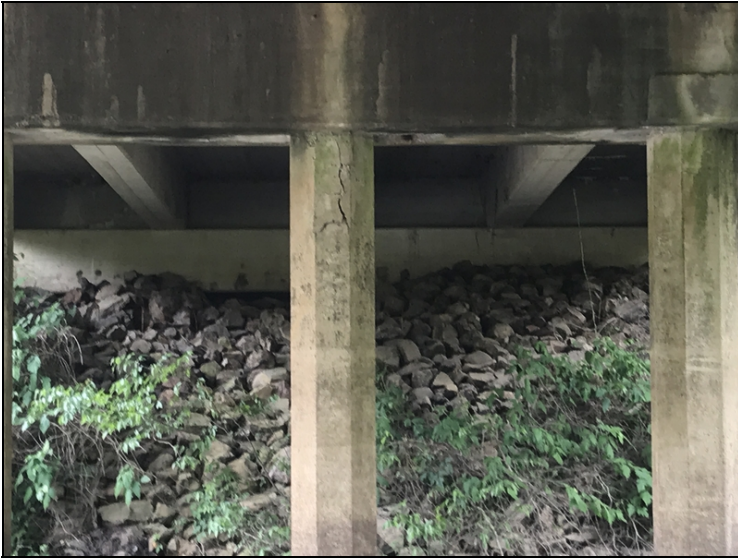
Bent #21 pile #3.

Bent #21 pile #3 has a two foot delamination near top on back face.

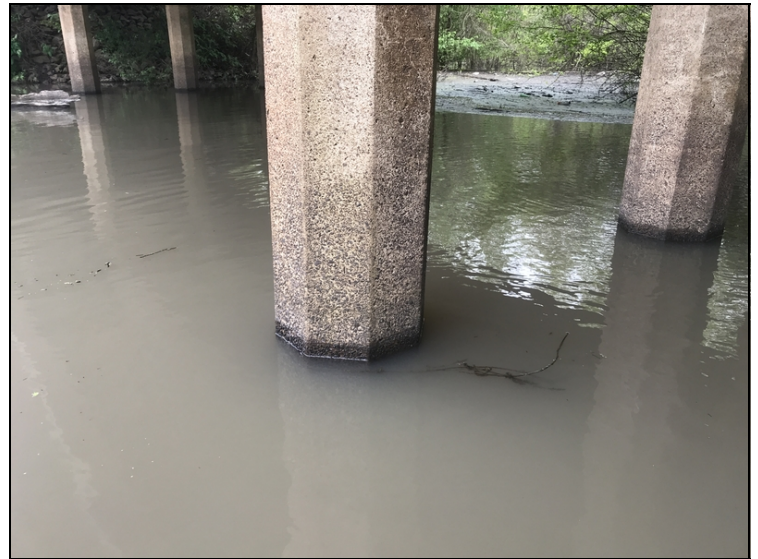
All piles have light abrasion.

Typical abrasion on piles.

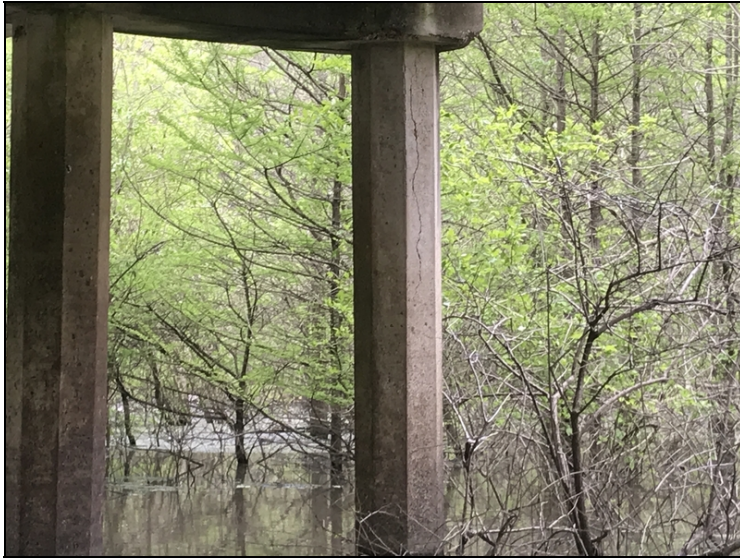
Bent #19 pile #5.

Bent #19 piles #1, 2, 4, 5 are cracked on back side extending down up to 6' from top.

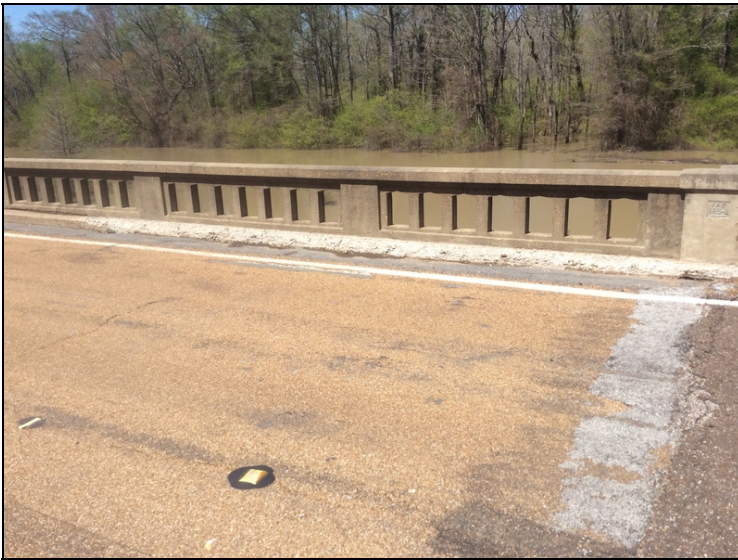
Deck curbs have multiple areas full length of bridge with spalling and deterioration exposing aggregate.

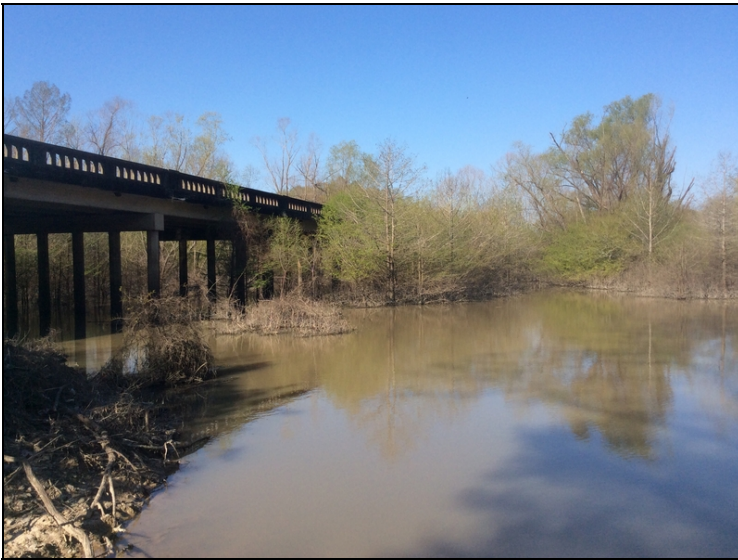
Trees and vegetation are growing beside and under bridge and onto roadway.

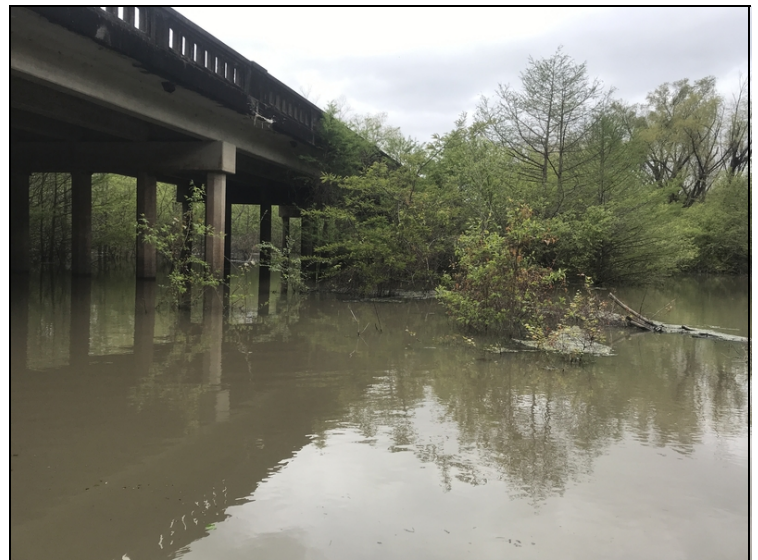
Trees and vegetation growing beside and under bridge.

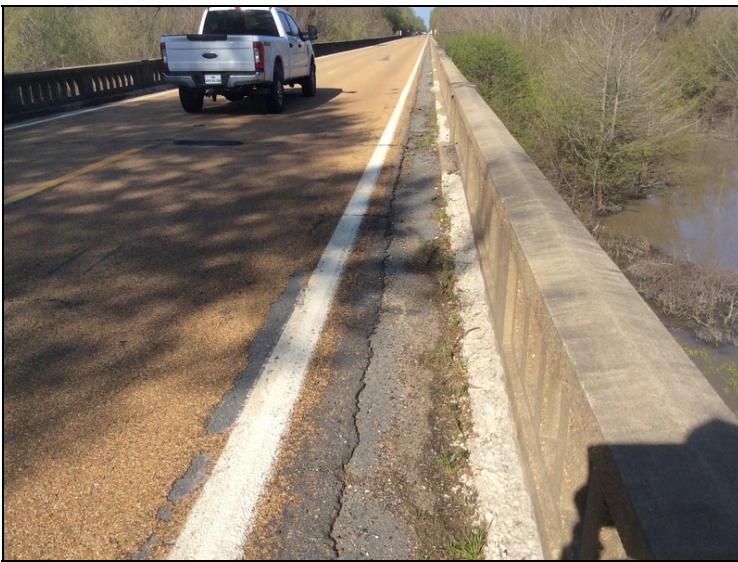
Gutters have vegetation growing in them.

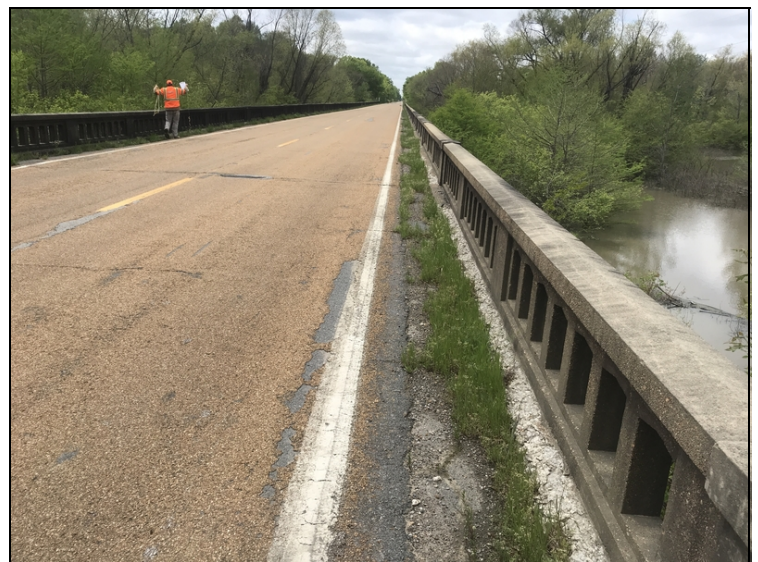
Dirt and vegetation in gutters.

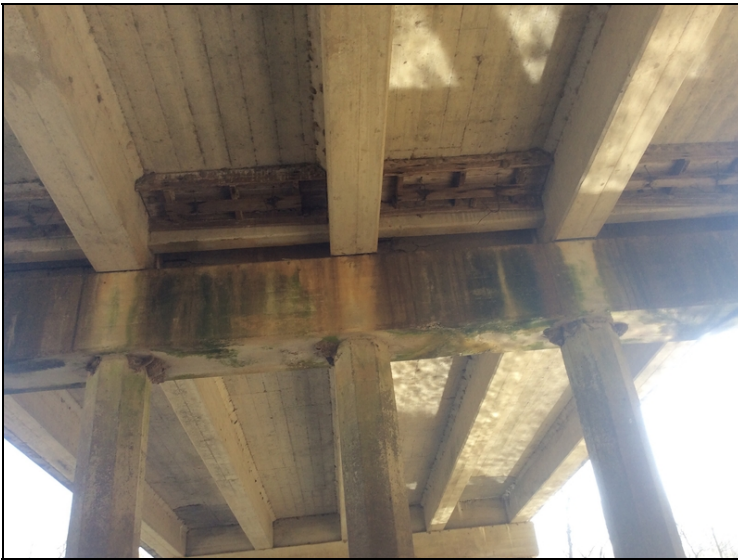
Span #6 at bent #7 soffit between each girder has forms left in place.
