Bridge Inspection Report

07069
US 49/SEC-8/L6.96
over
I-40 SEC 43

IDENTIFICATION		INSPECTIONS	
(1) STATE CODE	056 - Arkansas	(90) INSPECTION DATE	10/24/2017
(8) STRUCTURE NUMBER	07069	(91) DESIGNATED INSPECTION FREQUENCY	24

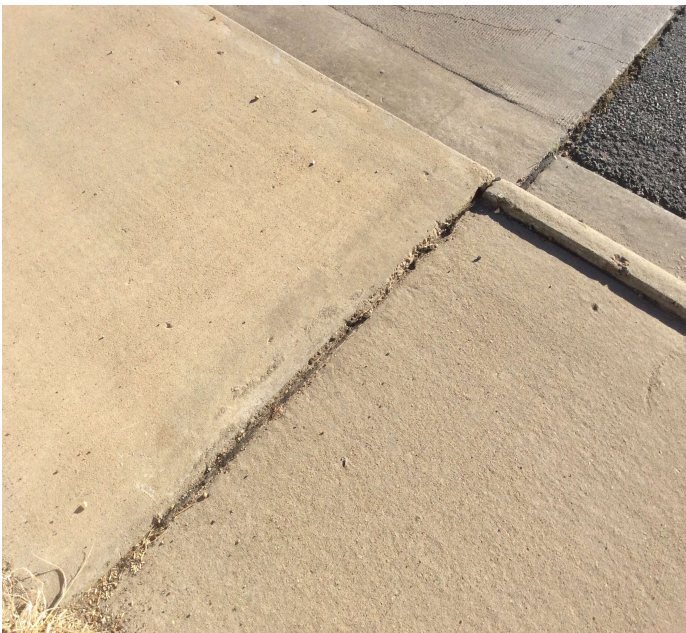
Abutment #2 right, abutment #1 left sidewalks have settled 1" at bridge end.

PHOTO 1 Description Abutment #2 right sidewalk has settled 1" at bridge end.

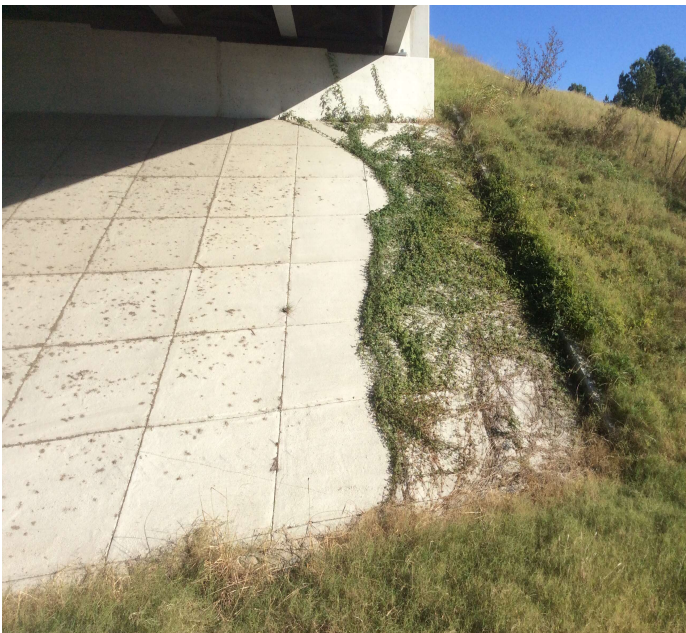
Abutment #1 concrete slope on left side has vines growing on it.

PHOTO 1 Description Abutment #1 concrete slope on left side has vines growing on it.

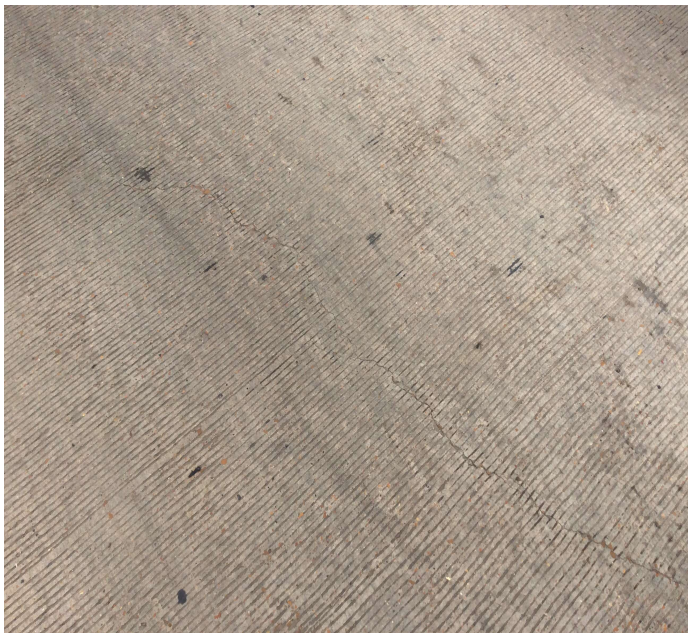
Each approach slab has several open and sealed cracks up to 1/16" wide.

PHOTO 1 Description Typical longitudinal cracks abutment #2 approach slab spaced 6'+-

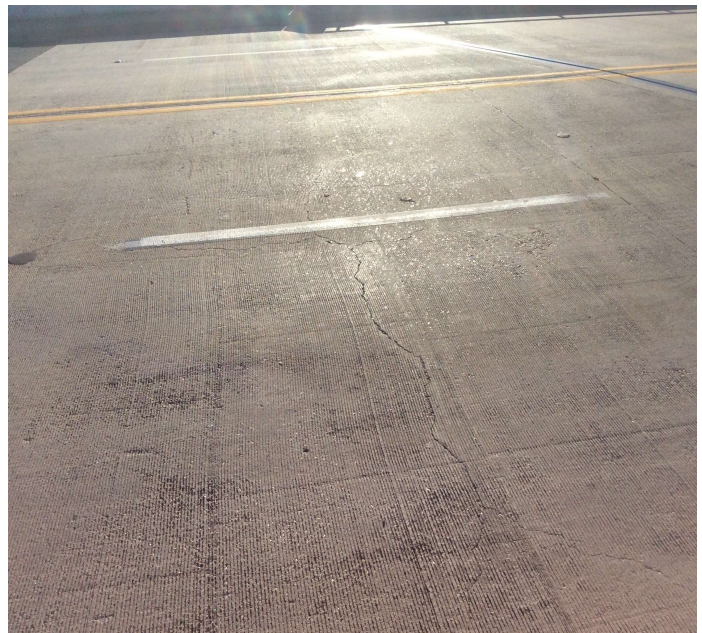
PHOTO 2 Description Typical approach slab cracks.

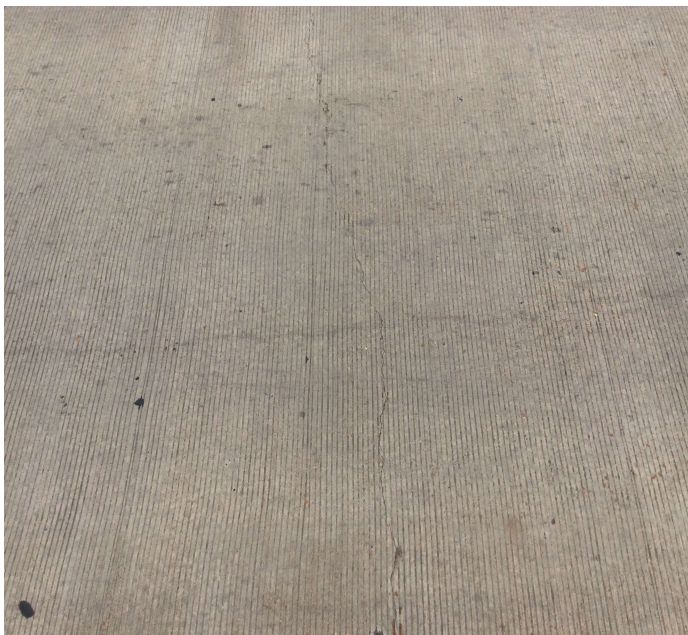
Each span has unsealed longitudinal cracks with various spacing.
Each span has unsealed transverse cracks spaced 4'.

PHOTO 1 Description Typical transverse deck cracks spaced 4' +- all spans.

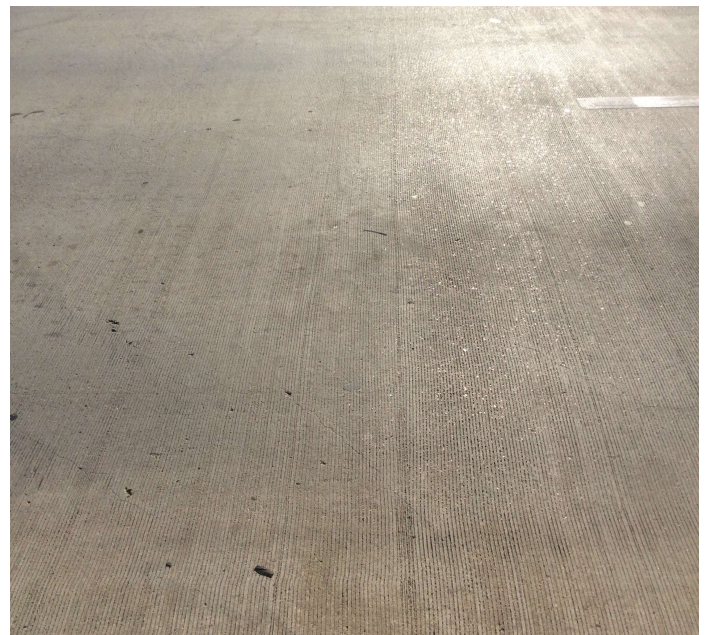
PHOTO 2 Description Typical deck cracks.
