Asset #M1829(Routine, Underwater type 2)

Sh118/Sec-3/L10.60 over Chatman Branch

Team Lead: Drew Melton, Inspection Date: 03/02/2023

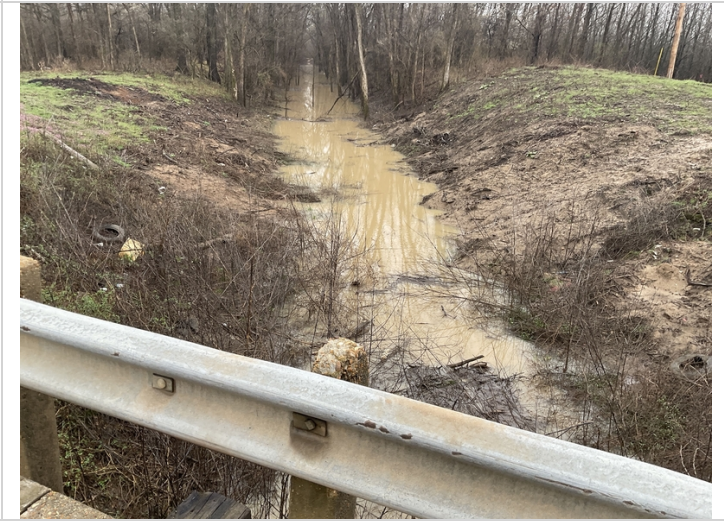
Channel left side

Channel banks have some protection with channel alignment off a little. Channel has large vegetation growing in it and debris restricting water flow.

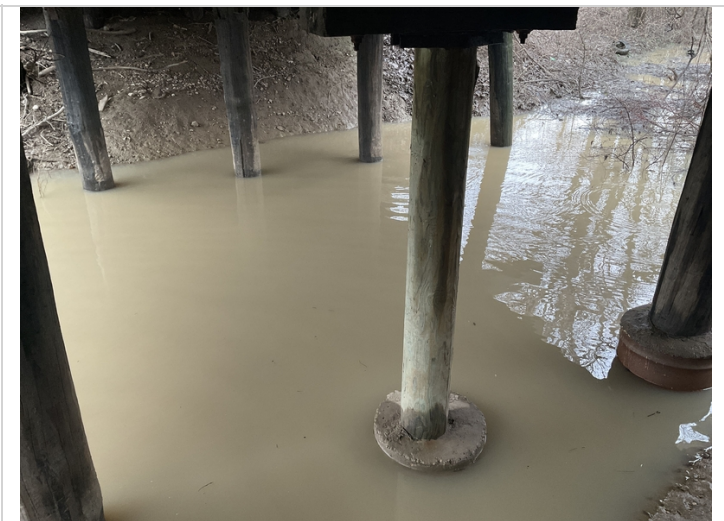
Typical channel under bridge

03/02/2023 lowered channel from 7 to 5 due to large amounts of debris and vegetation growing in channel restricting water flow.

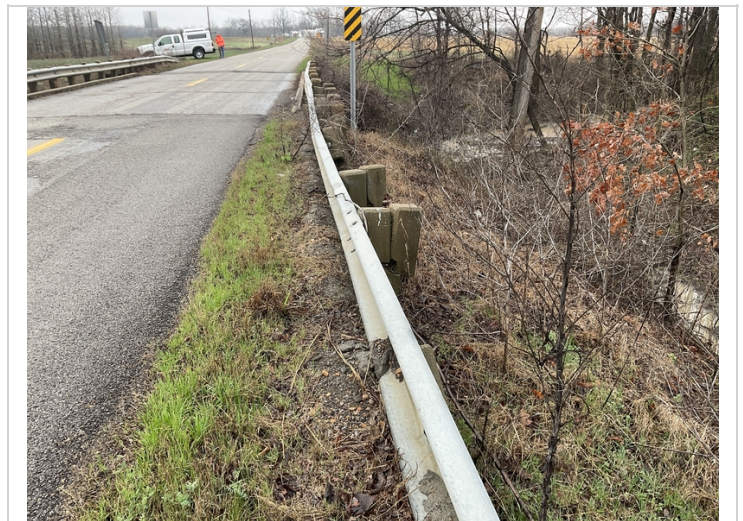
Abutment #1 right approach rail has several posts broken with minor collision damage to rail.
Abutment #2 right, left approach rail has minor collision damage.
Abutment #2 right and left side approach shoulders are eroded underneath approach roadway

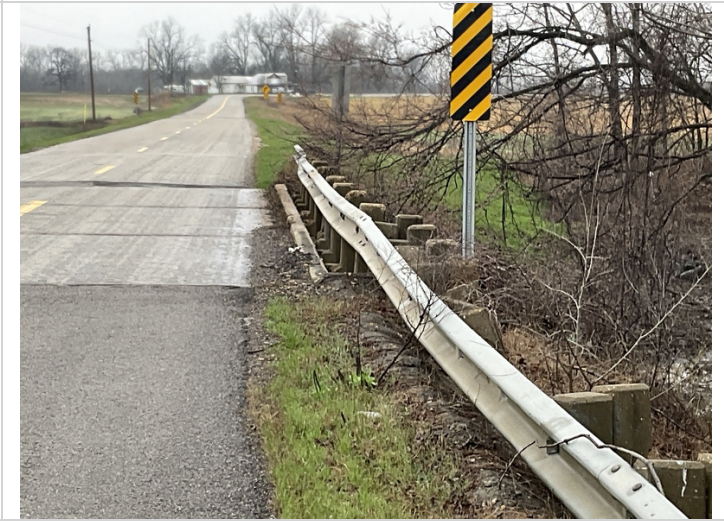
Right side there is a tree limb hanging into the bridge rail.

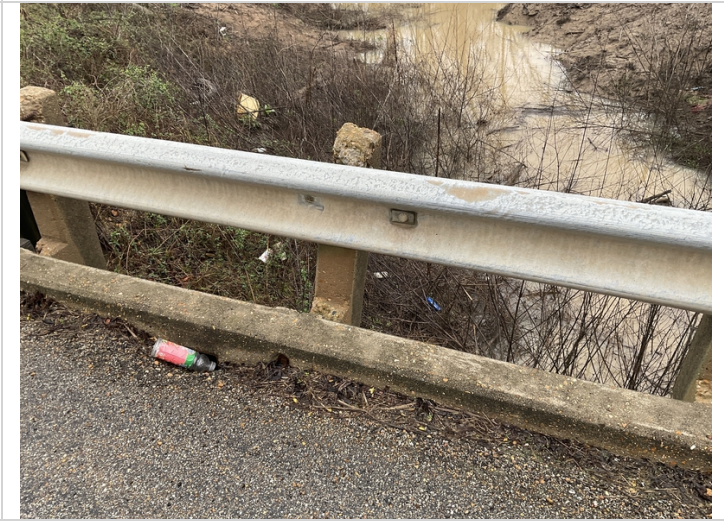
(330) Bridge rail posts on both sides are spalled at top and bottom connection bolts with exposed rebar no section loss and rail is leaning outward. Bridge rail has minor dent and digs full length. Span #1 left side, third post not connected. Span #2 right side, first rail post not connected. Span #3 left side, last rail post not connected.

Span #1 left side, third post not connected.

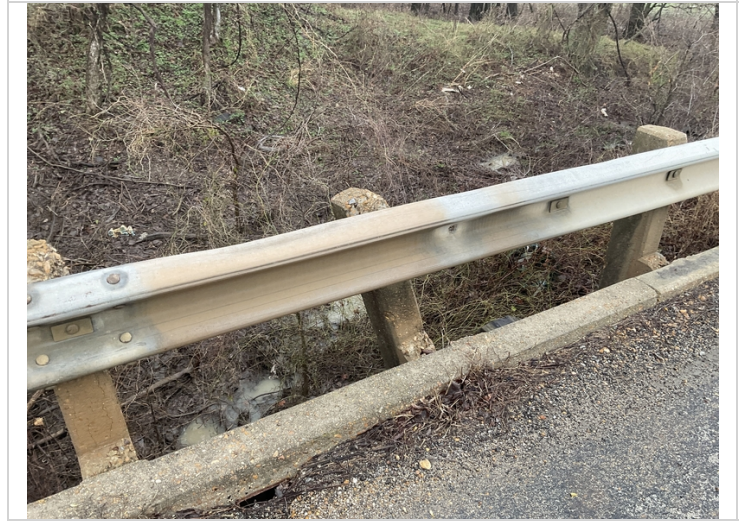
Span #2 right side, first rail post not connected.

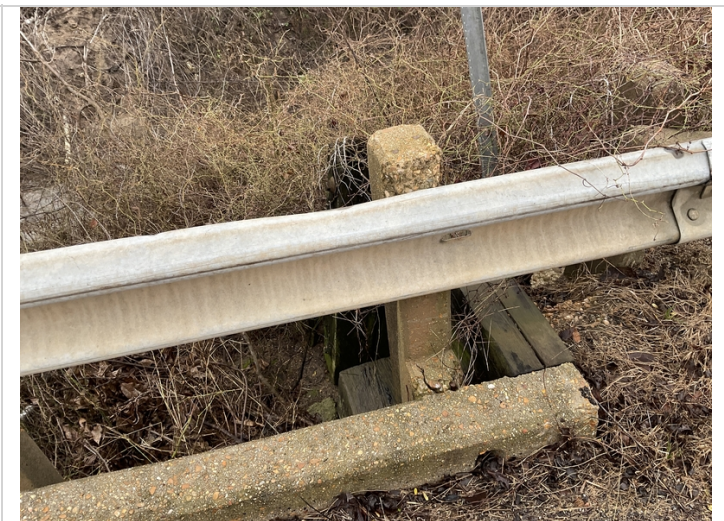
Span #3 left side, last rail post not connected.

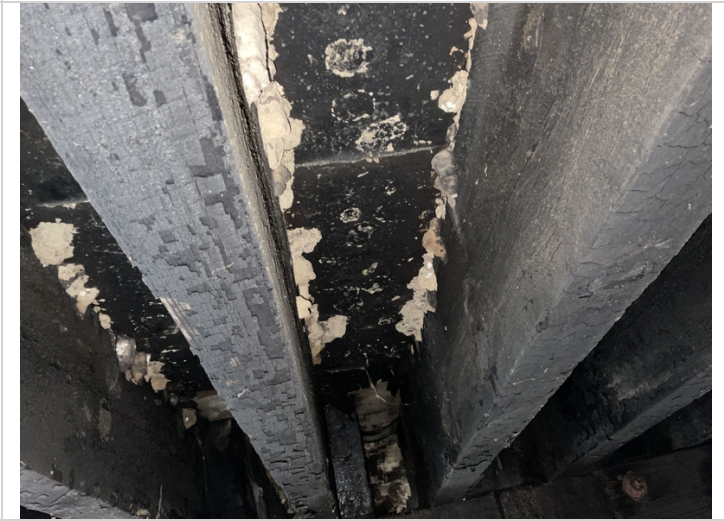
Typical soffit-under surface

3/16/2020 lowered deck form 7 to 6 due to fire damage to soffit-under surface.

Deck has an asphalt wearing surface with fire damage to soffit-undersurface.

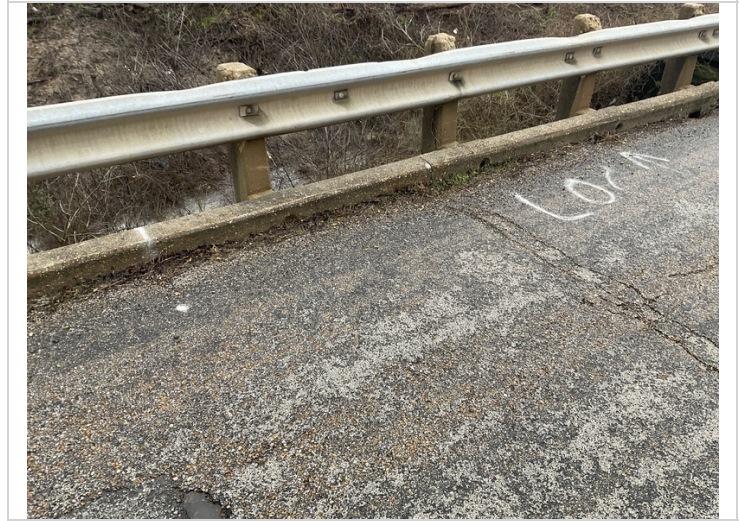
Typical debris in gutters

Gutters are full of dirt and debris with vegetation growing in them.

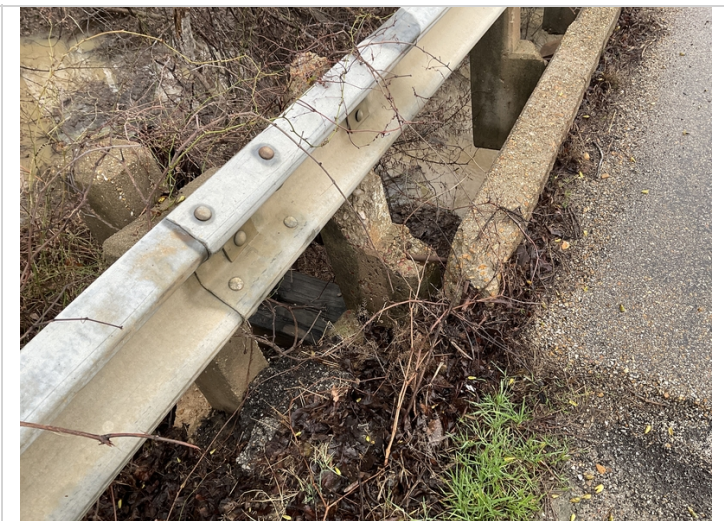
Span #3 right curb spalled 1' with exposed rebar with no section loss at abutment #2.

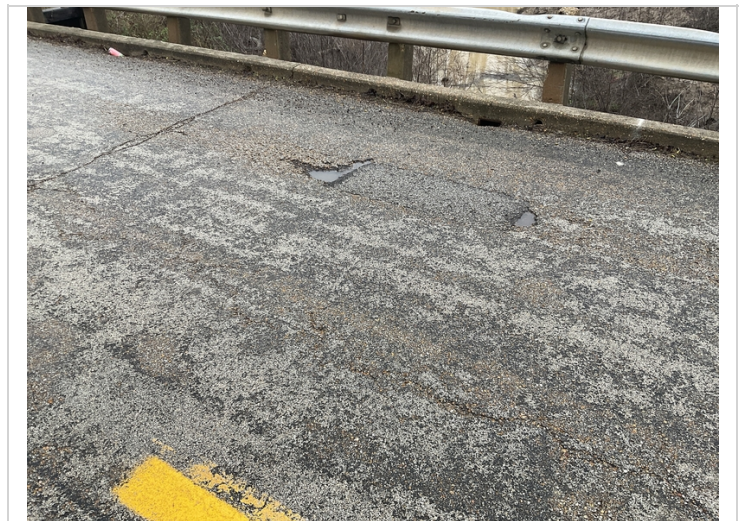
Span #2 right lane has a one foot spall in asphalt wearing surface that has been repaired and a two foot repaired spall in wearing surface. These repairs are being to fail with 2 small shallow spalls in repaired area.

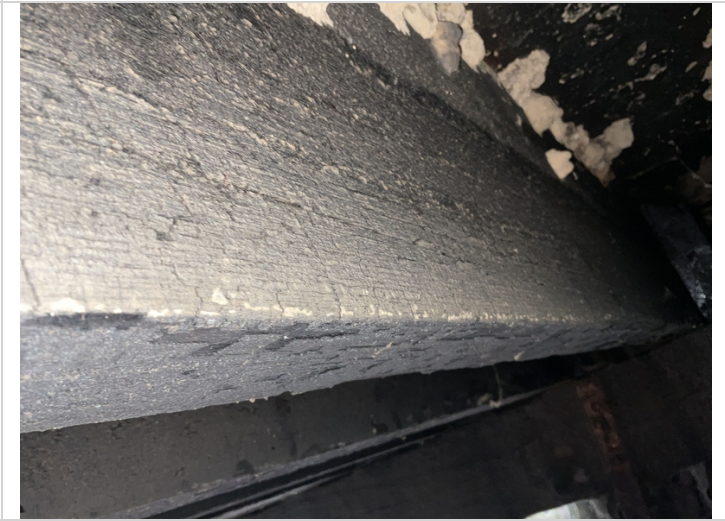
Typical girder fire damage

Superstructure is in fair condition with fire damage with some section loss with some girders having some cracks.

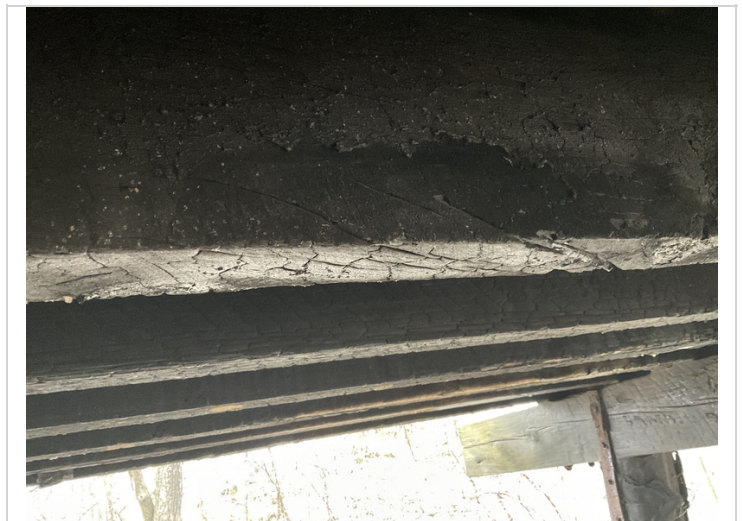
Span #3 girder #14 has diagonal crack across bottom face extending into girder three inches near center span.

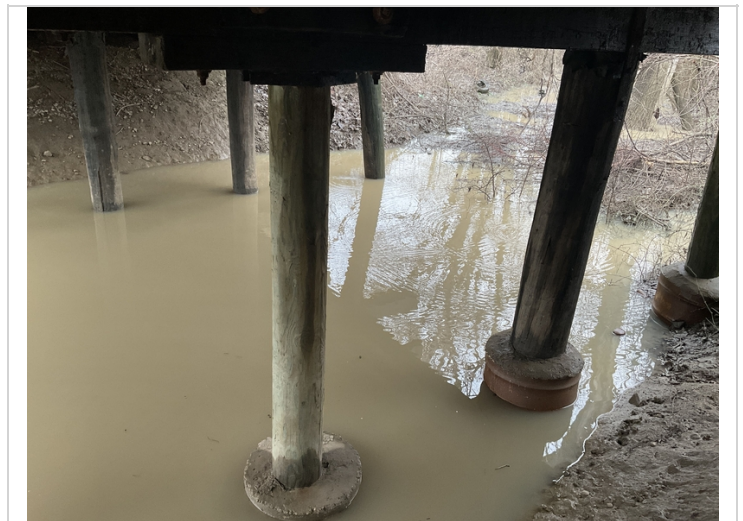
Typical spliced and encased piles

03/02/2023 raised substructure from 4 to 5 to due bad piles being spliced and encased in concrete.

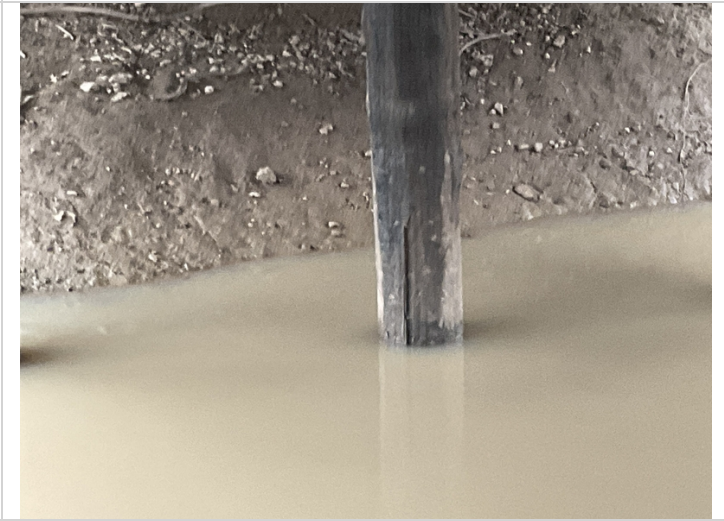
Bent #3 pile #3 has a moderate shake near bottom back side.

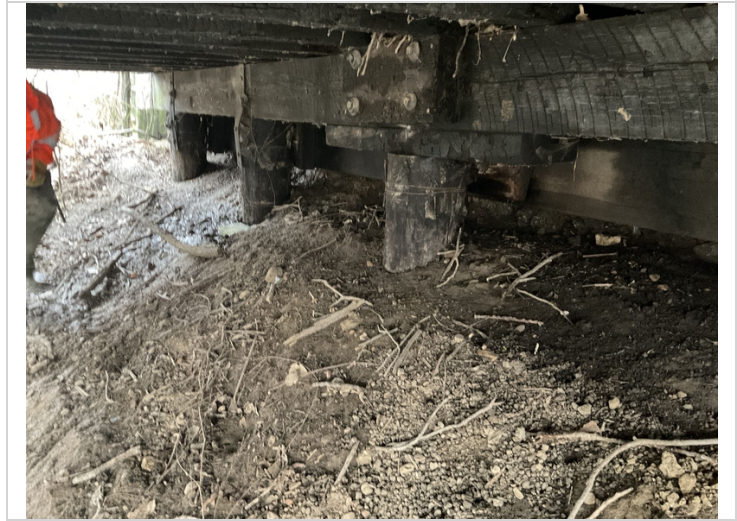
Bent #4 pile #3 has minor outer shell decay near ground approximately minor section loss.

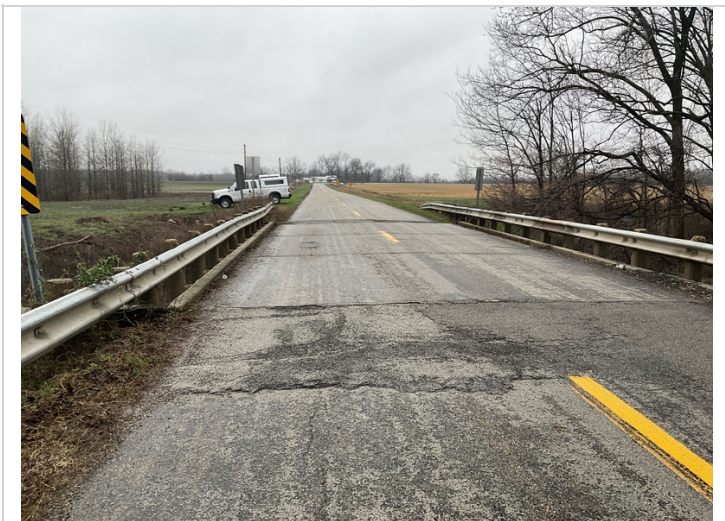
No log mile signs in place should read 10.60

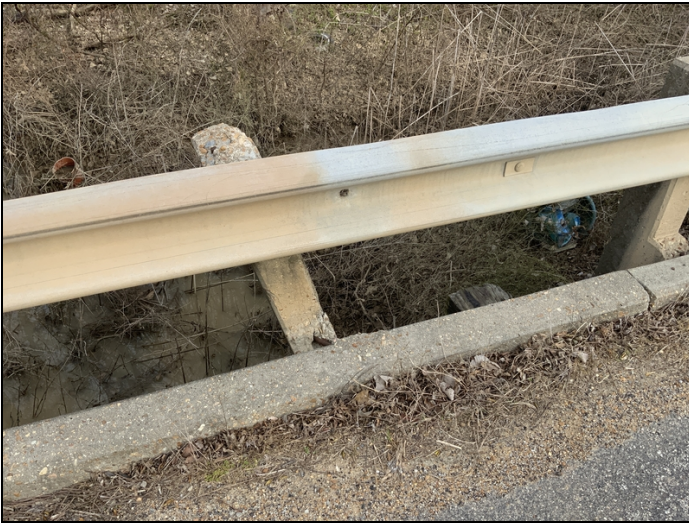
Typical missing rail post bolt.

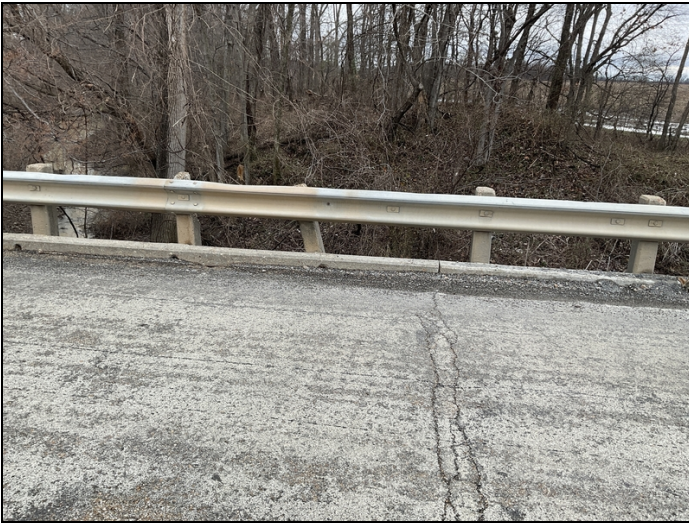
Span #2 first rail post not connected

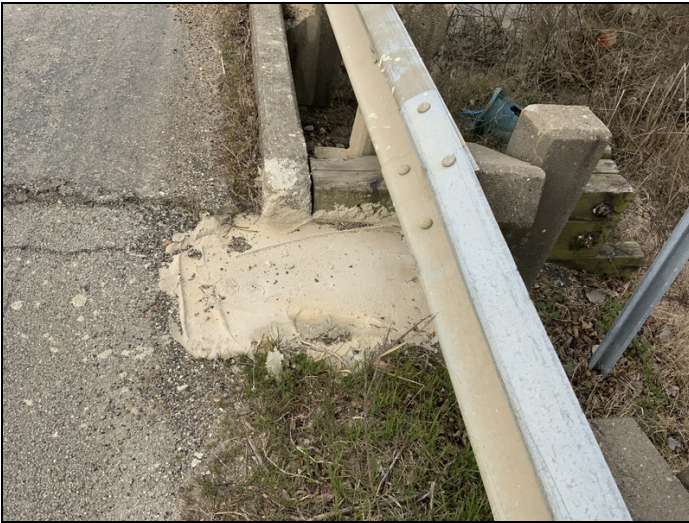
3/22/2021-Abutment #1 right approach shoulder has been repaired at time of inspection.

Abutment #1 right approach shoulder repair.

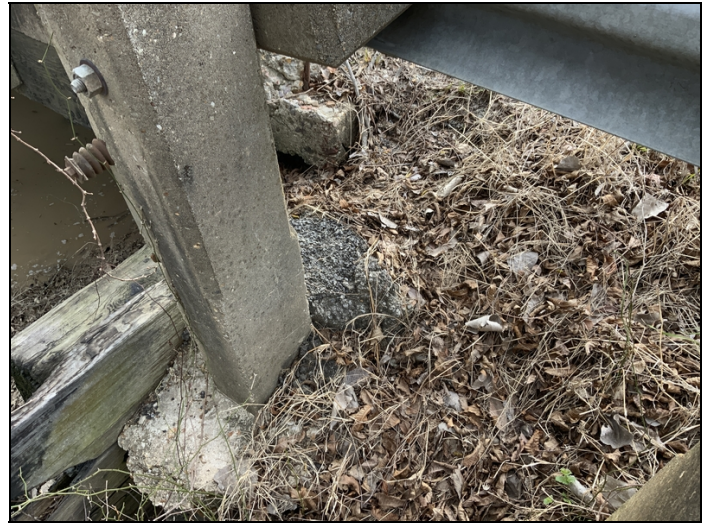
Erosion at abutment #2 right side.

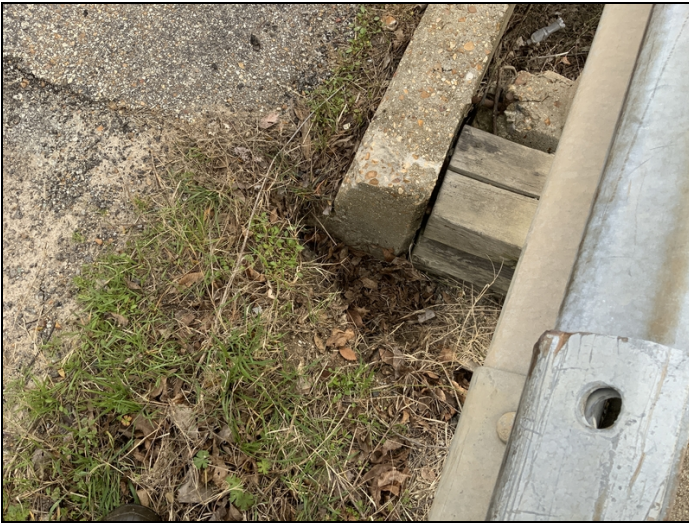
Erosion at abutment #2 left side.

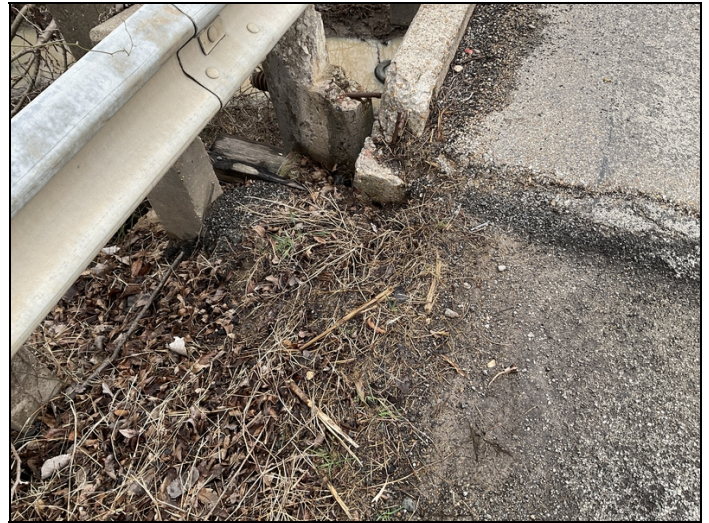
Abutment #2 right and left side approach shoulders are eroded underneath approach roadway.

Erosion at abutment #2 right approach shoulder

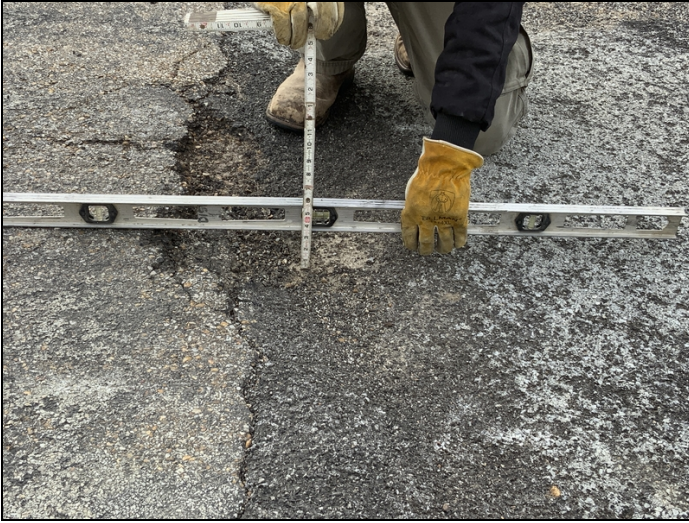
Abutment #2 timber backwalls are decayed with voids behind backwalls allowing abutment #1 roadway to settle up to 2" and abutment #2 roadway to settle up to 3 1/2"

Abutment #2 approach roadway settlement.

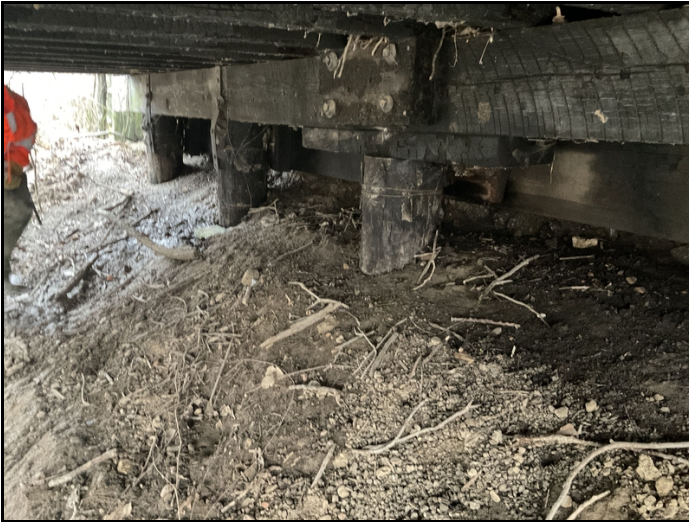
Bent #4 pile #3 has minor outer shell decay near ground approximately minor section loss.

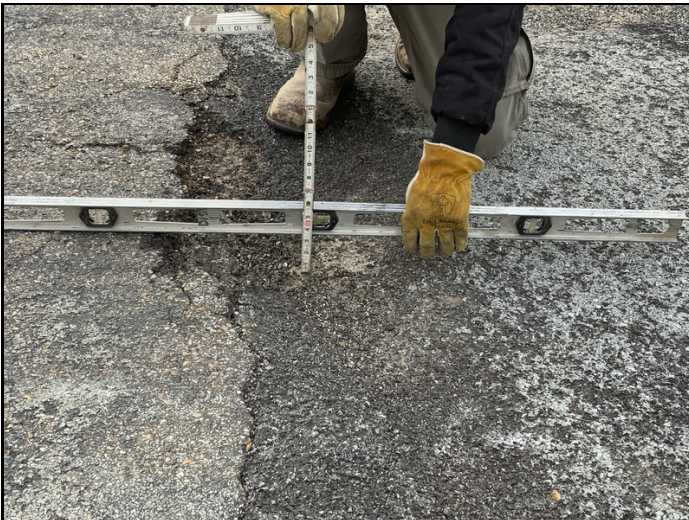
Abutment #1 roadway has settled up to 2" and abutment #2 roadway has settled up to 3 1/2"

Abutment #2 approach roadway settlement.
