Asset #M3876(Routine)

Sh-50/Sec-4/L-8.42 over Ditch Number 9

Location: 8.42 Mi Ne Of Jct Us 64

Team Lead: Drew Melton, Inspection Date: 04/11/2023

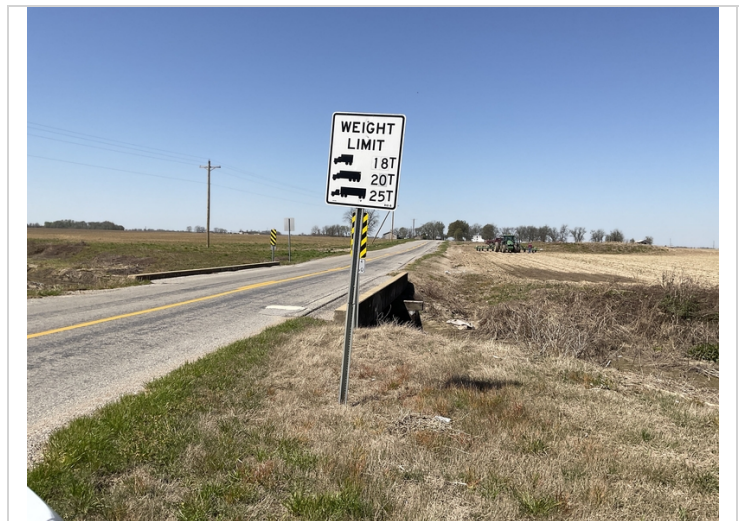
Abutment #2 posting

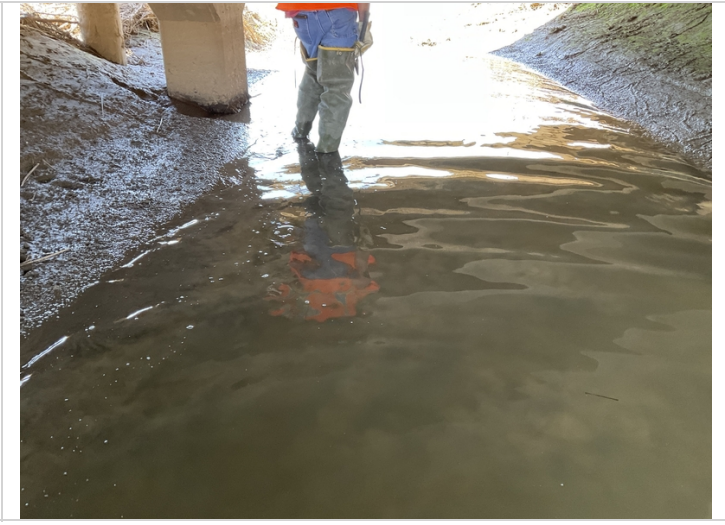
Channel banks have some vegetation with areas of minor to moderate erosion. Channel is aligned fair at best with bridge structure. Channel has little to no restrictions to water flow.

Channel under bridge

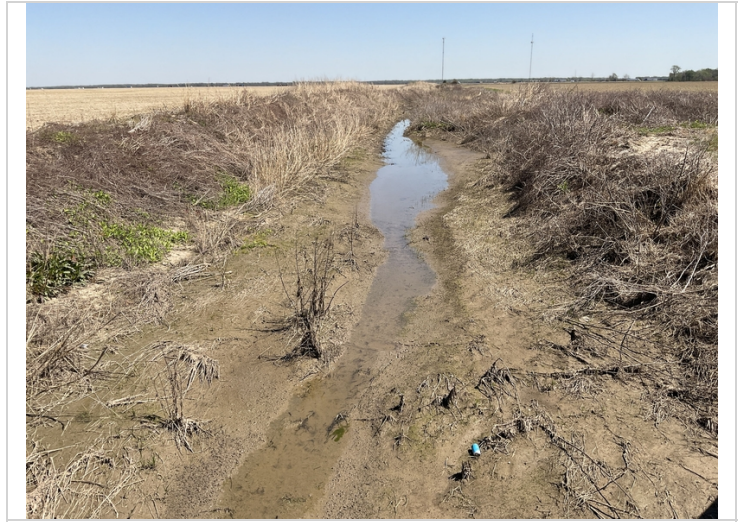
Channel left side

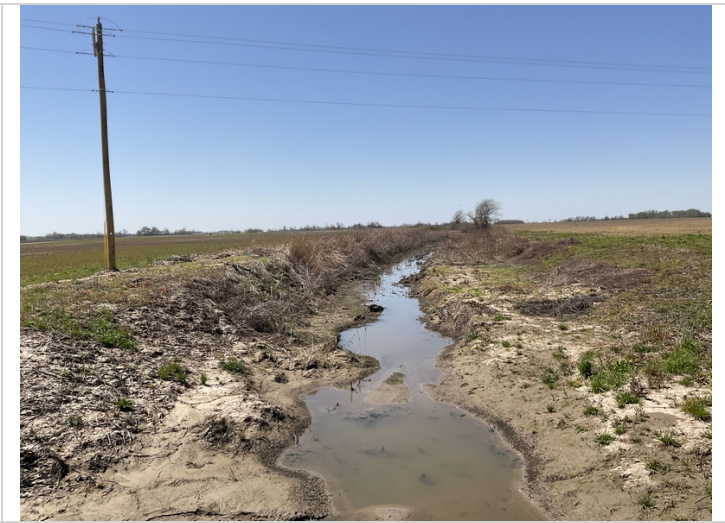
Channel right side

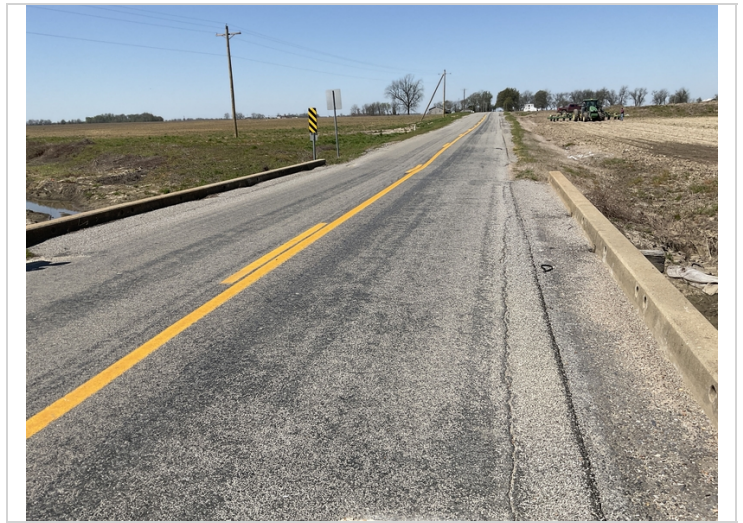
Typical deck

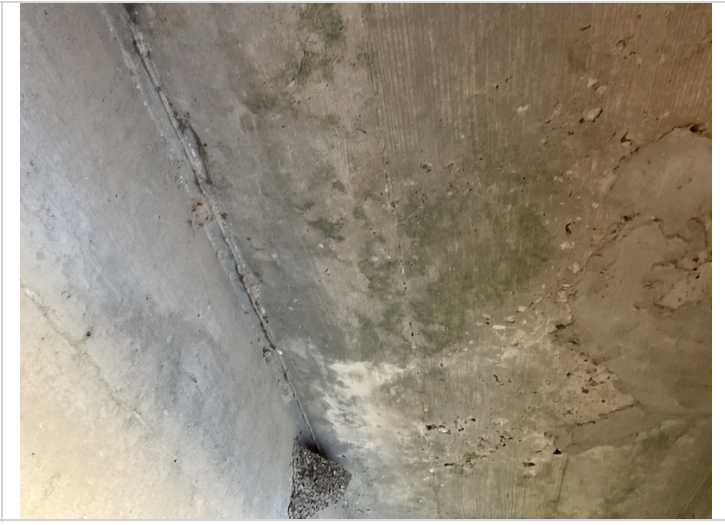
Typical soffit-under surface original bridge

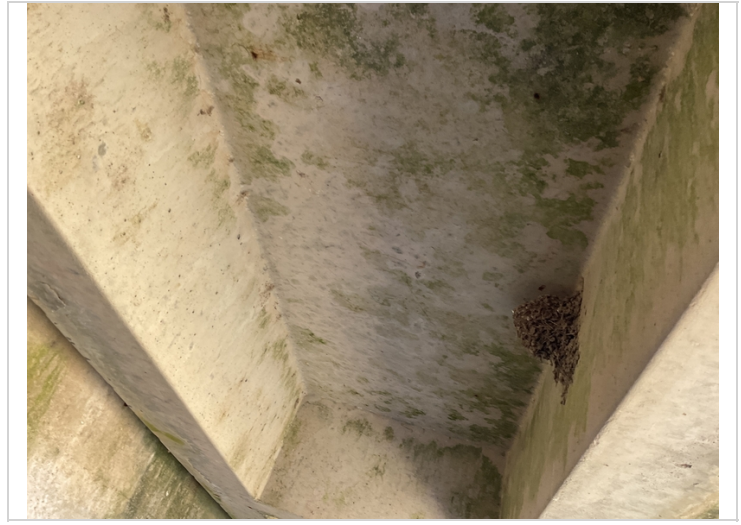
Typical soffit-under surface for extensions

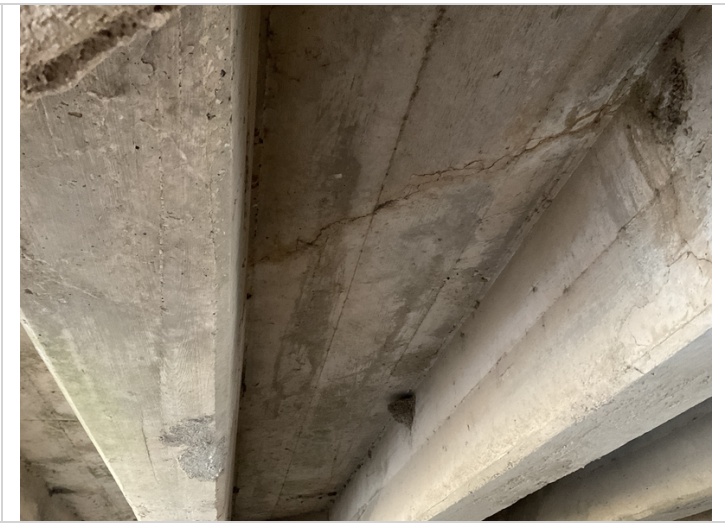
Typical transverse soffit-under surface crack in span #2

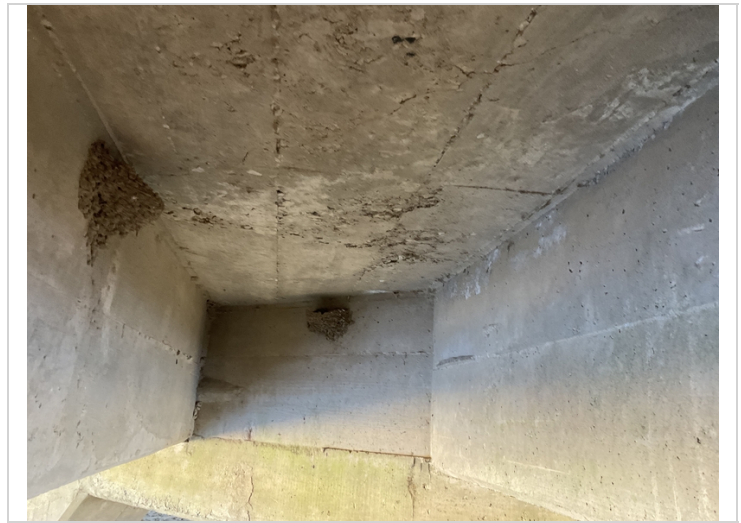
Span #1 & 2 girders are cracked vertically & transversely approx. 3' east & west of bent #2 cracks extend up stem and across soffit-under surface and continue from girder #2 to girder #

Span #1 & 2 girders are cracked vertically & transversely approx. 3' east & west of bent #2 cracks extend up stem and across soffit-undersurface and continue from girder #2 to girder #7.

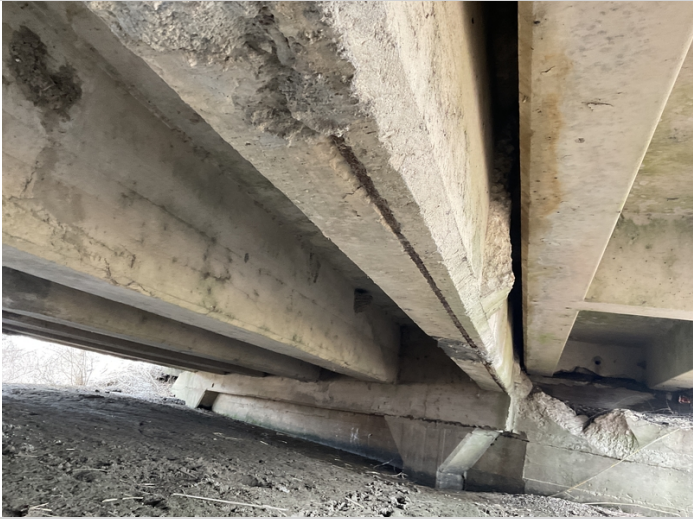
Exposed rebar in span #1 girder #7 bottom face

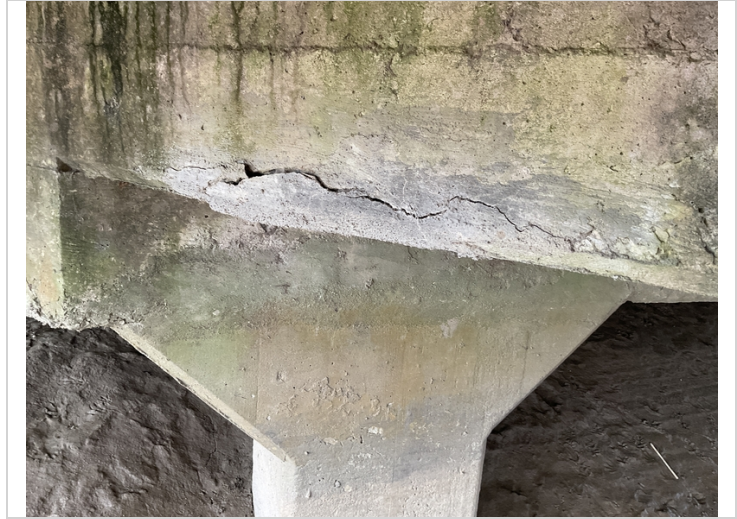
Span #1 girder #2 has 2' long delaminated area at bent #2

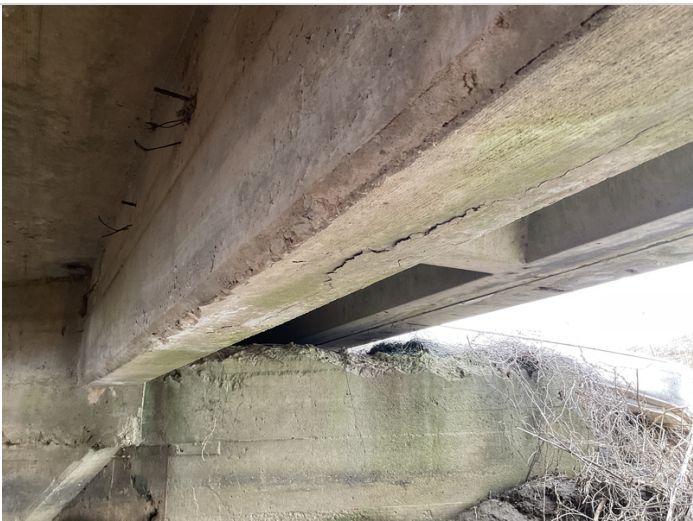
Span #1 girder #2 has 3' long delaminated area on bottom face mid span.

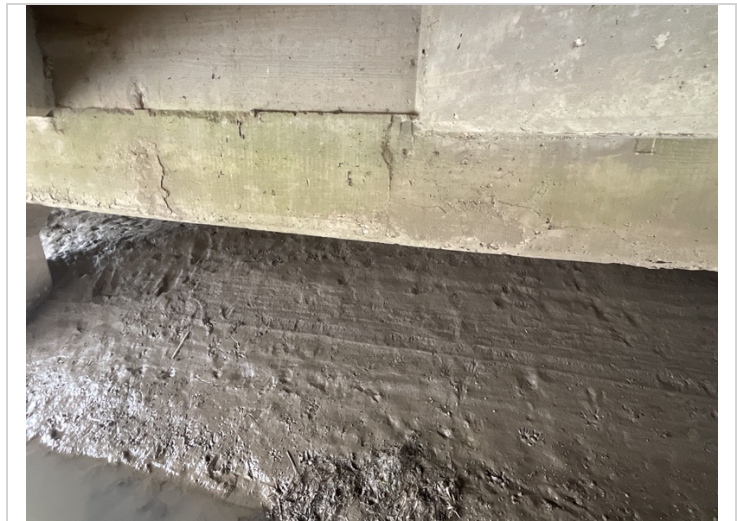
(234) Bent #2 cap back face has 2' of delaminated areas between girders #3,4.							
235	Timber Pier Cap	LF	17	0	8	9	0
1140	Decay/Section Loss	LF	9	0	0	9	0
1160	Crack (Timber)	LF	8	0	8	0	0

Bent #2 cap back face has 2' of delaminated areas between girders #3 and 4.

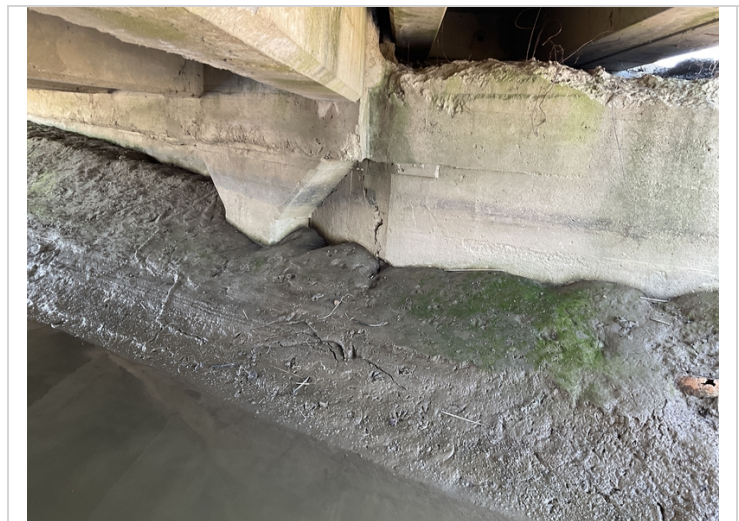
(215) Concrete wings only holding dirt back has lots of areas of spalling on top. Abutment #1 by left column has cs3,cs4 vertical crack.							
216	Timber Abutment	LF	32	0	17	15	0
1140	Decay/Section Loss	LF	15	0	0	15	0
1160	Crack (Timber)	LF	17	0	17	0	0

Abutment #1 by left column has cs3,cs4 vertical crack.

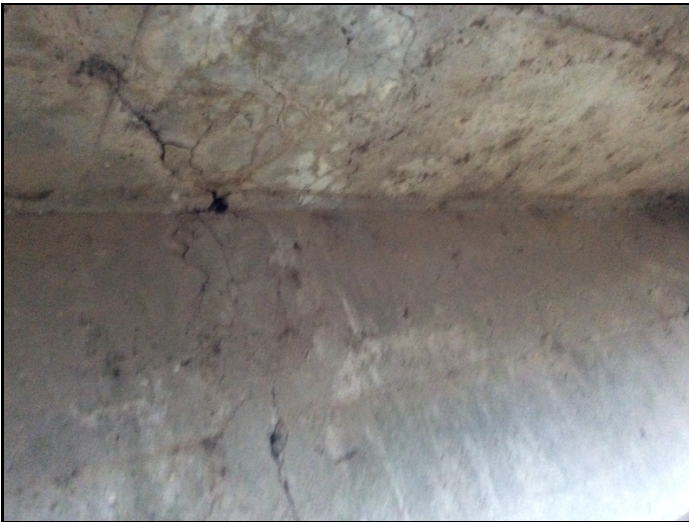
Typical crack up side of t beam into soffit.

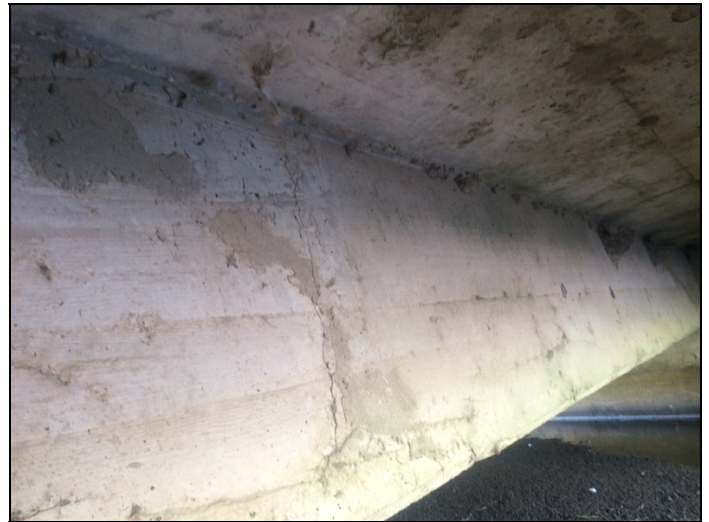
Typical crack in stem and soffit span #2.

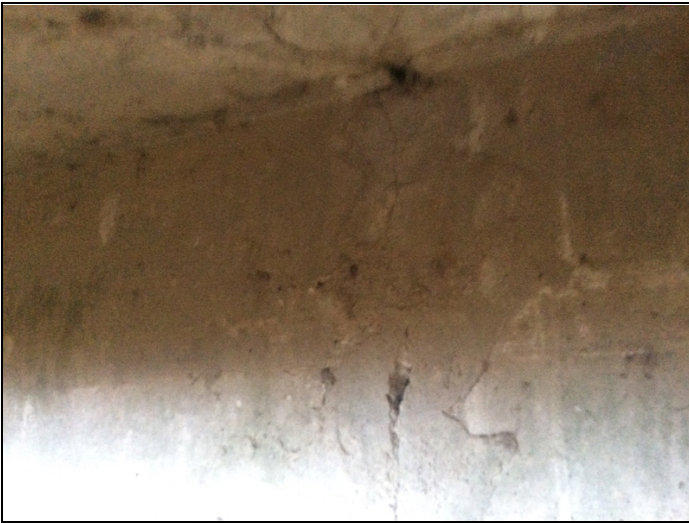
Typical crack in stem and soffit span #1.

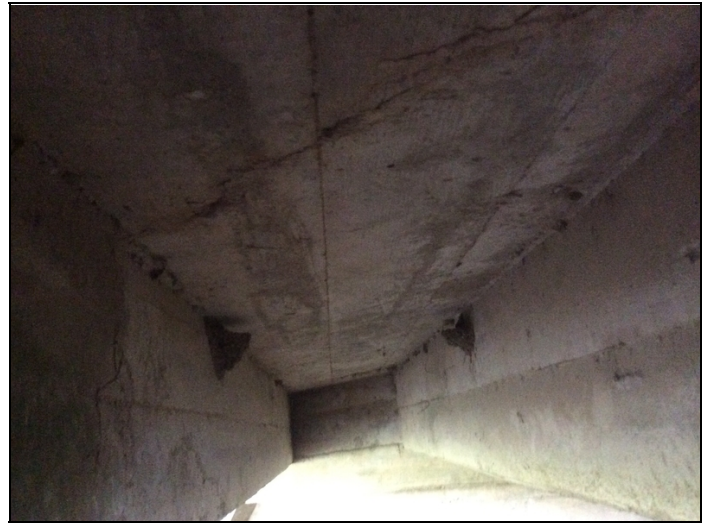
Typical soffit to girder crack.

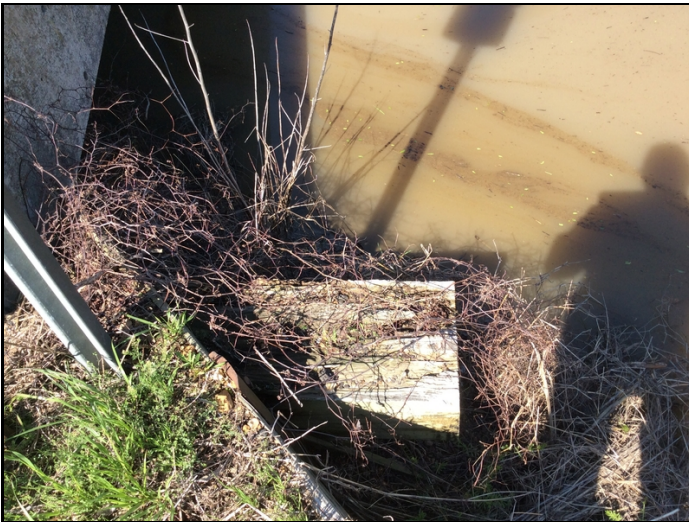
Abutment #1 right and left timber caps are decayed on top with 30% section loss.
Abutment #2 left timber cap is decayed on top with 15% section loss.

Abutment 2 left end of cap.

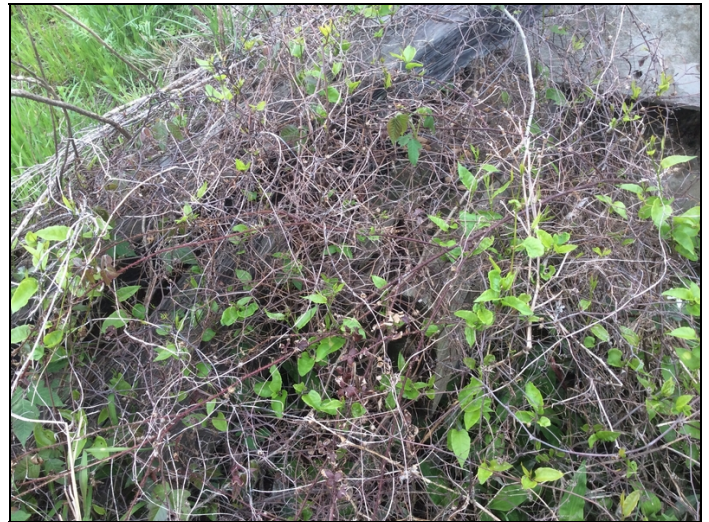
Abutment 1 right side timber cap.
