Asset #03832(Routine)
Sh-357/Sec-1/L5.38 over Drainage Ditch #20

Location: 5.38 Miles North Sh 50

Team Lead: Myron Futrell Inspection Date: 01/11/2024

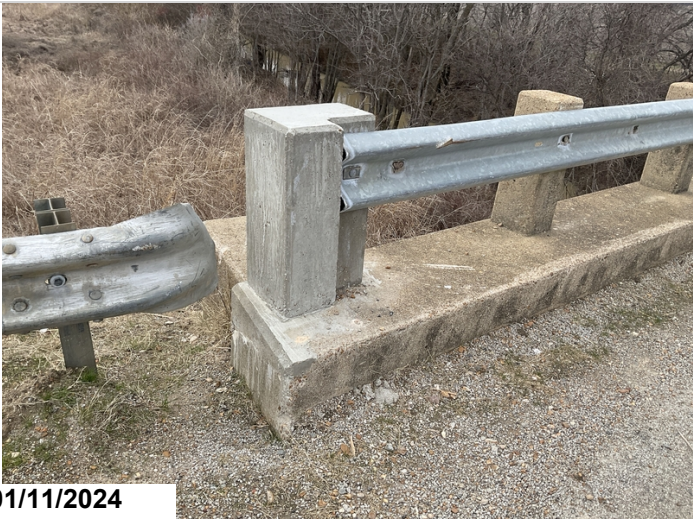
Abutment #1 left side first rail post has been replaced.

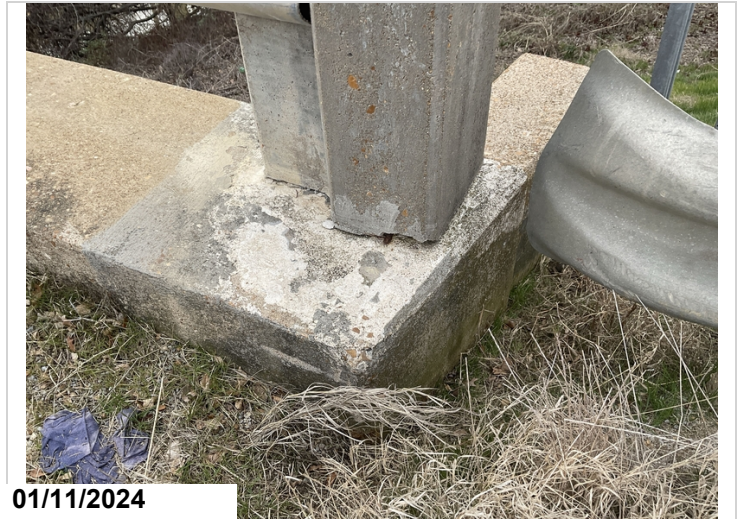
Attached #2 left end post broken loose at bottom with exposed

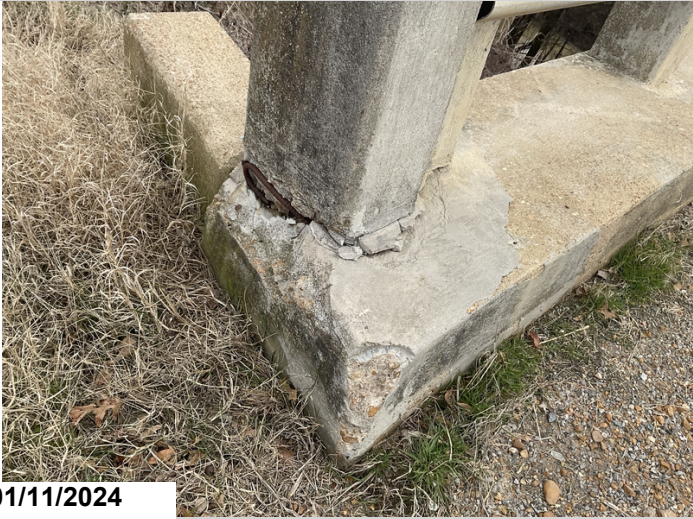
Abutment #2 right end post broken at bottom with exposed rebar and curb spalled

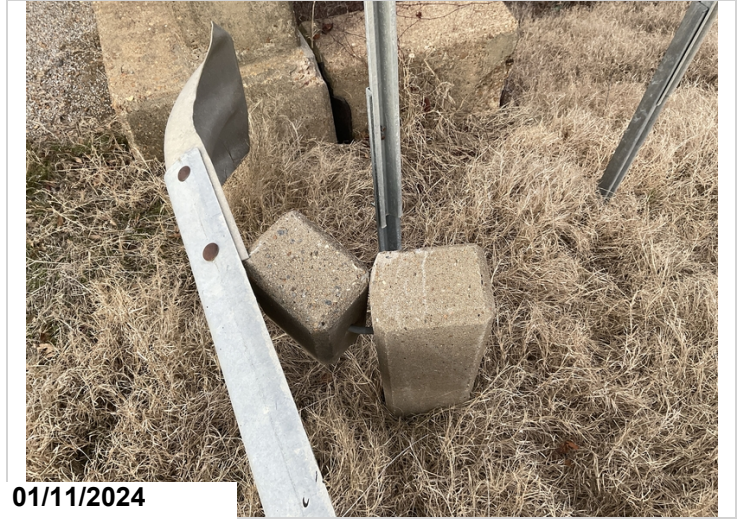
Last approach rail post misaligned and loose alignment abutment #1 right side

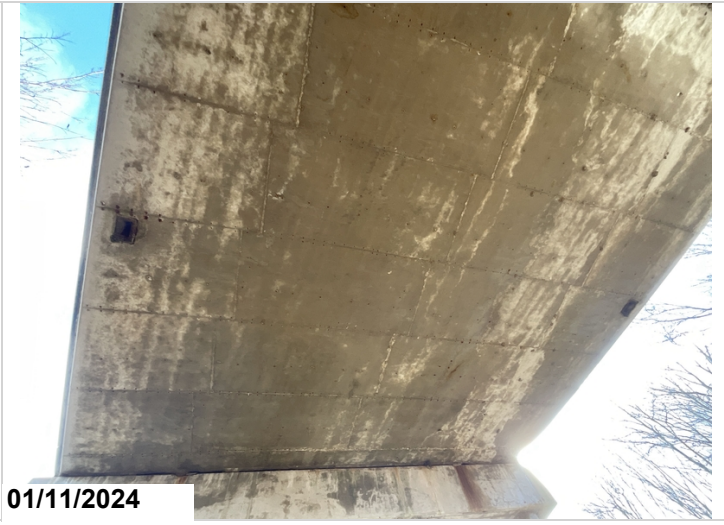
Deck is a voided slab with an ACHM overlay and is in overall good condition. Sides of slab have vertical hairline cracks spaced at roughly 8" to 12". Soffit / underside of slab has multiple CS2 longitudinal and transverse cracks each span, some with efflorescence and rust staining. ACHM overlay is cracked and spalled at joints.

Span #3 soffit / underside of deck

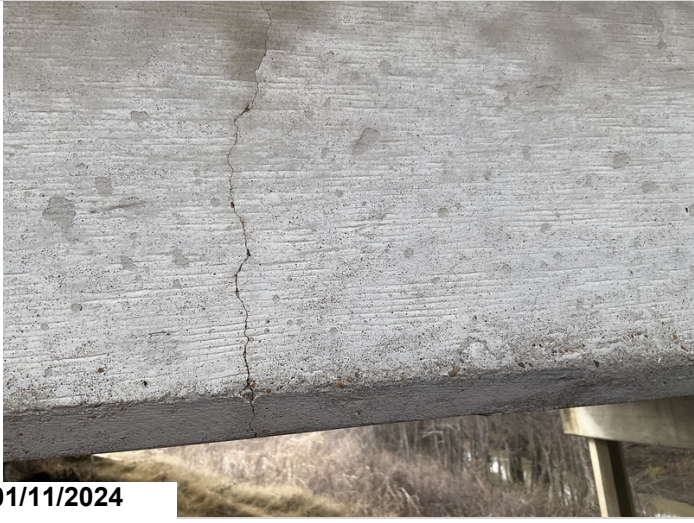
Typical vertical crack in side of slab

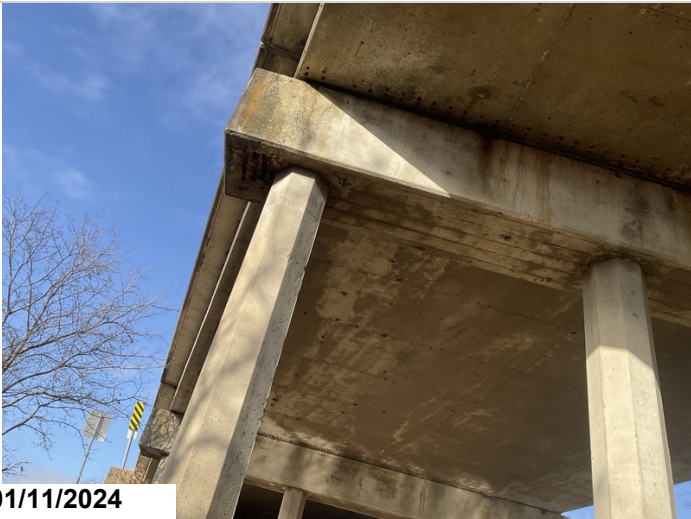
Reinforced concrete substructure is in overall satisfactory condition. Concrete caps have several shallow spalls with exposed rebar. Bent #3 piles have light to moderate abrasion with no loose aggregate.

Typical exposed rebar on caps

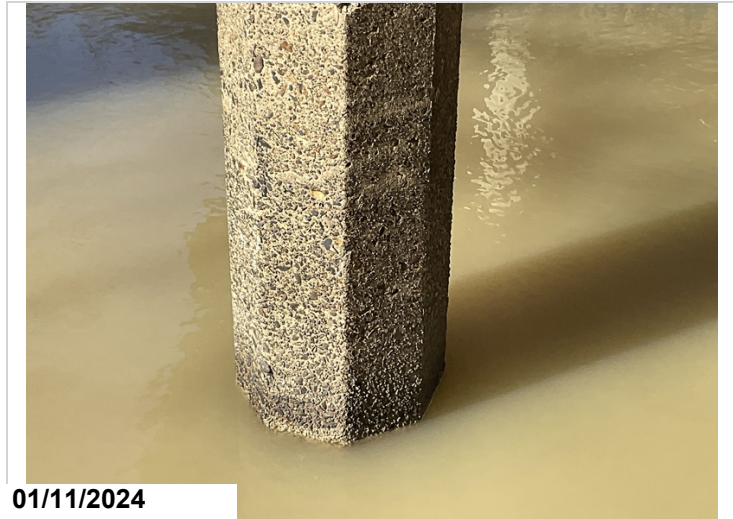
(227) Bent #3 piles have light scaling with no loose aggregate on bottom 3'.							
234	Reinforced Concrete Pier Cap	LF	84	67	0	17	0
1080	Delamination/Spall/Patched Area	LF	5	0	0	5	0
1090	Exposed Rebar	LF	8	0	0	8	0
1130	Cracking (RC and Other)	LF	4	0	0	4	0

Typical abrasion on bent #3 piles

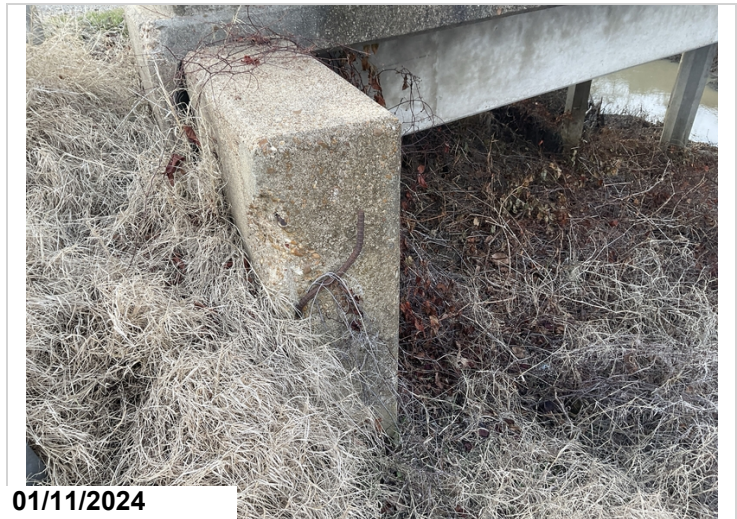
(215) Abutment #1 cap right side has 1' spall with exposed rebar with moderate section loss. Abutment #1 right wing has spall with one foot of exposed rebar.							
227	Reinforced Concrete Pile	EA	12	8	4	0	0
1190	Abrasion/Wear (PSC/RC)	EA	4	0	4	0	0

Abutment #1 right wing spalled with exposed rebar

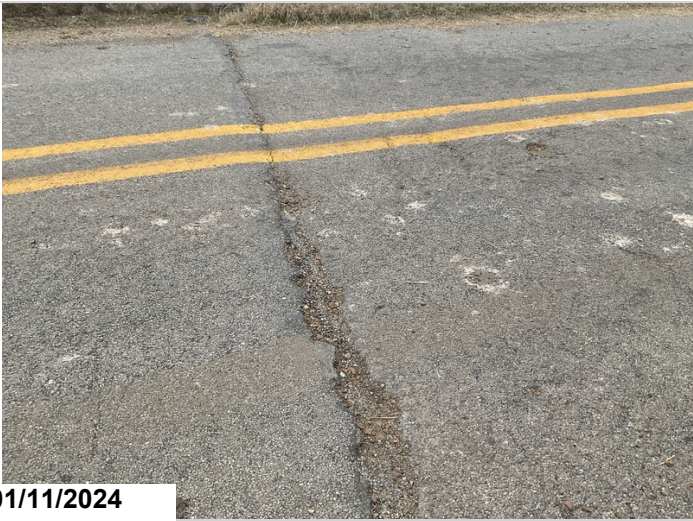
Abutment #2 approach roadway settlement

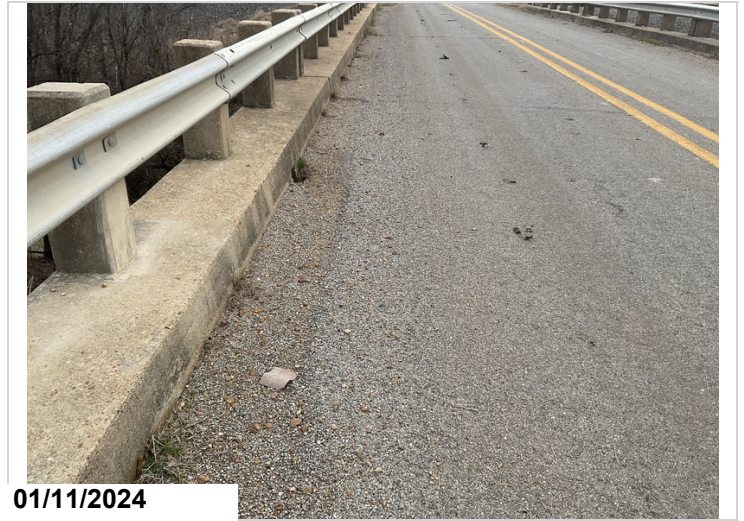
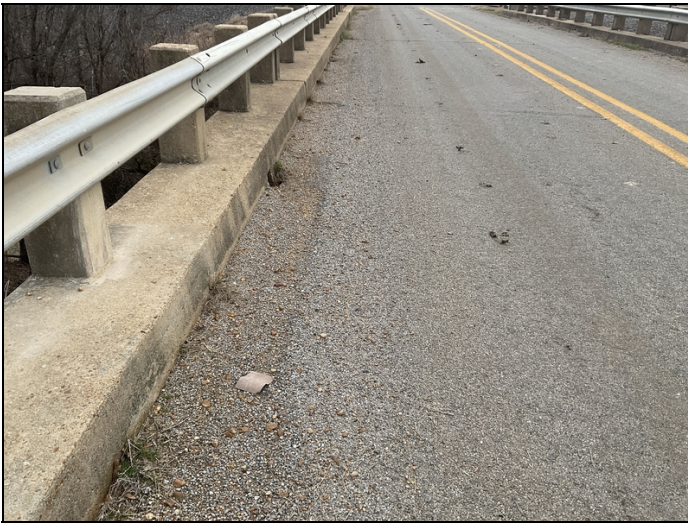
Gutters have dirt and vegetation growing in them.

Dirt and debris in gutters

A-55 - Deck Washing Needed (Y)

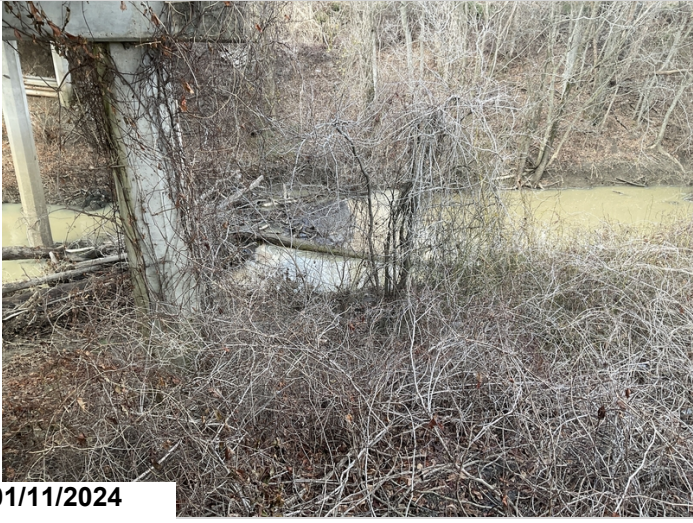
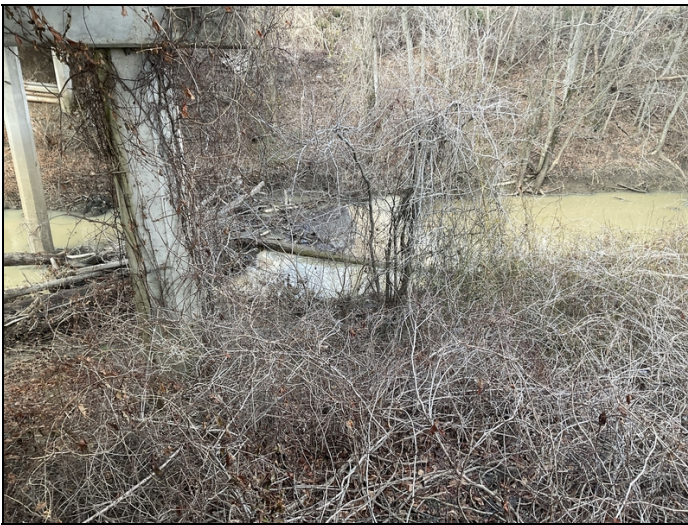
Trees and vegetation growing under and beside bridge.

Trees and vegetation growing beside and under bridge

A-64 - Vegetation Removal Requested (Y)

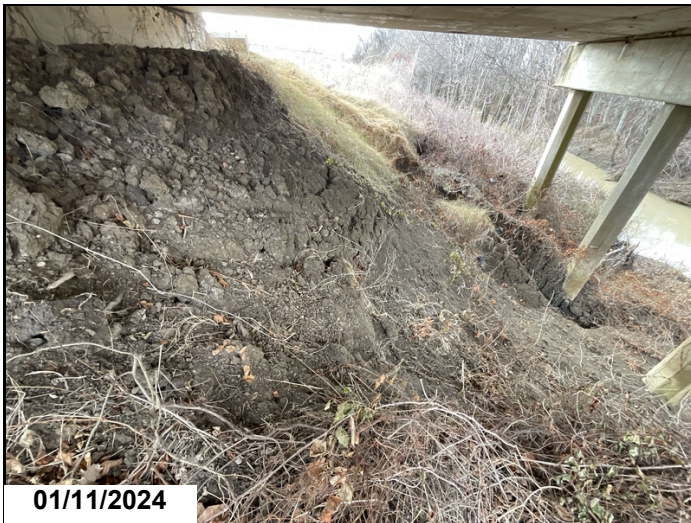
Slope at abutment #1 is eroding.

Abutment #1 slope erosion

Type of Work: Repair (General)

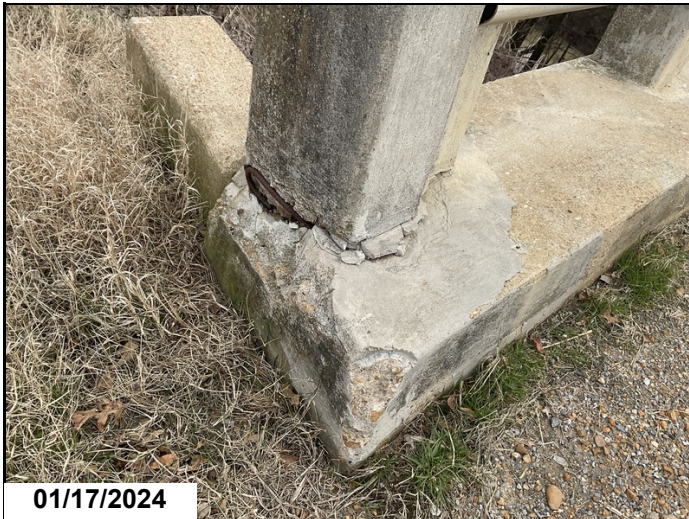
Abutment #2 right end posts have collision damage with exposed rebar with no section loss.
Span #4 left side 2nd post from bent #4 is broken at base.
Abutment #2 right end post is broken at bottom.

Abutment #2 right end post broken at bottom with exposed rebar and curb spalled

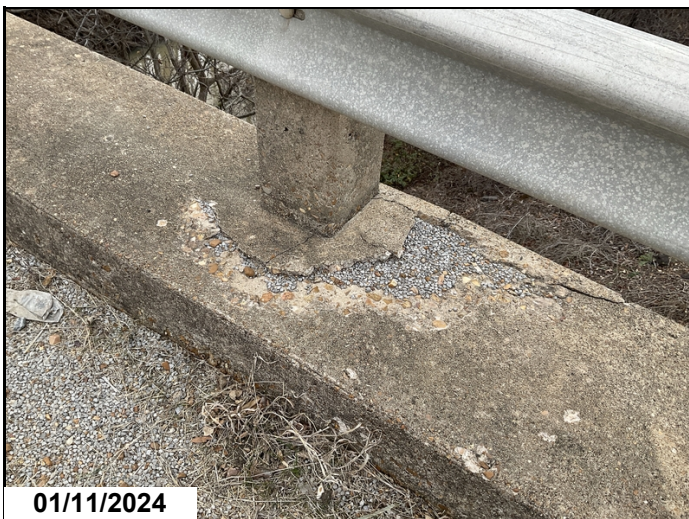
Span #4 left side 2nd post from bent #4 is broken at base.

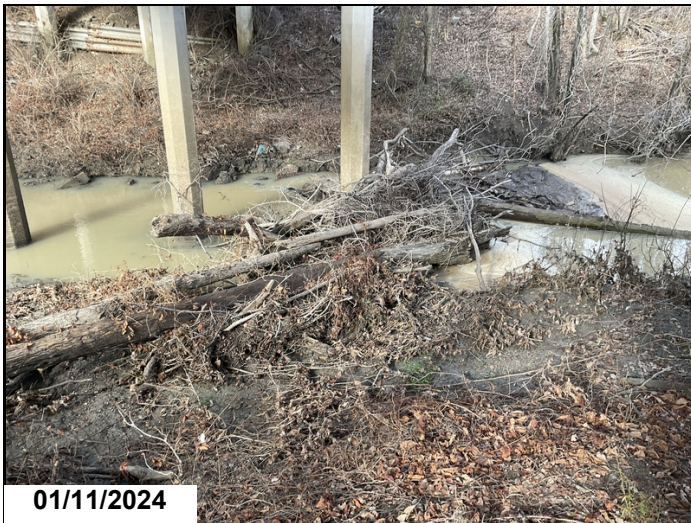
Moderate drift at bent #3 right side.

Moderate drift in channel bent #2 right side

Type of Work: Channel Work/Drift Removal
