Route:50 Section:01 Log:13.54

Arnold Road ID:68x50x1xA, Arnold Log mile:13.543

District 01, 123 - St. Francis County

INSPECTIONS *			
(90) Inspection Date	03/25/2024		
(91) Frequency	12		
(92) Critical Feature Inspection	Done	Freq. (Mon)	Date
A: Fracture Critical Detail	No		
B: Underwater Inspection	No		
C: Other Special Inspection	No		
* The inspection date and frequency information in this box contains the current NBI date and frequency information. Please refer to the report header for the date this inspection was conducted.

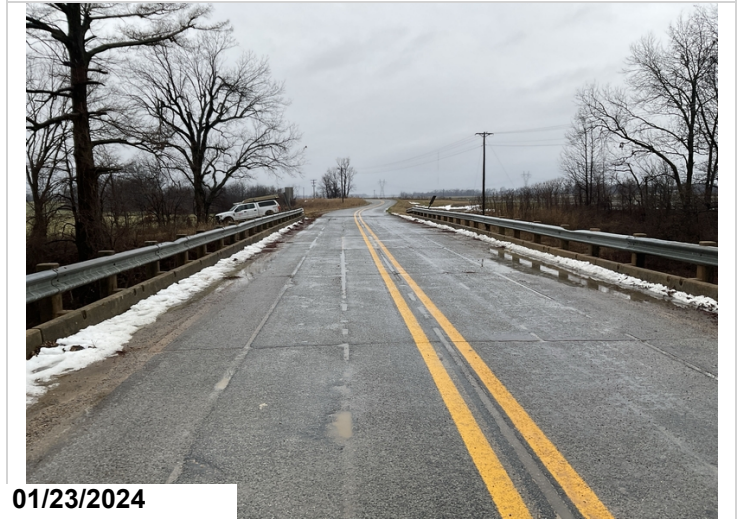
Minor damage to bridge rails

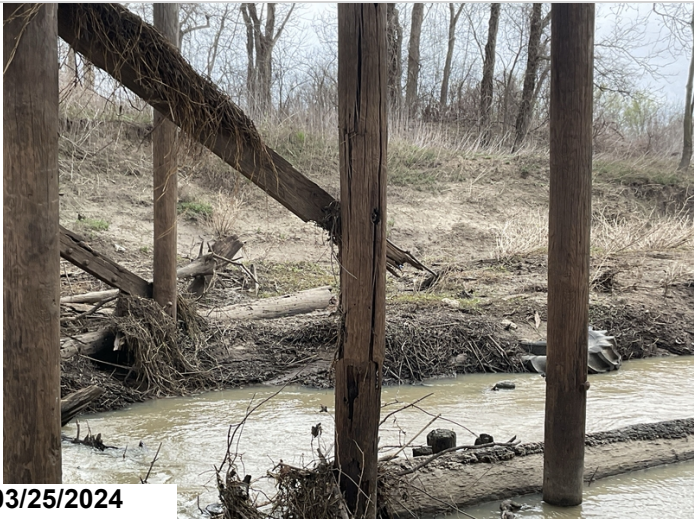
Bent #5 pile #4 is core decayed with large section loss and mushrooming.

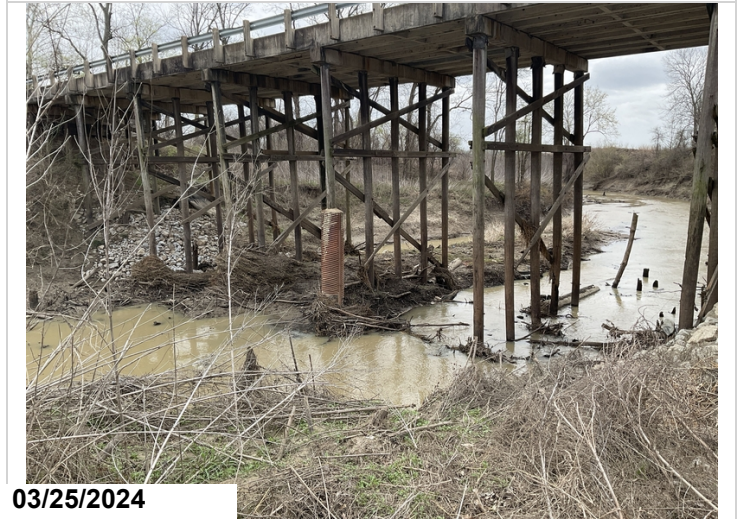
Silt and debris in channel

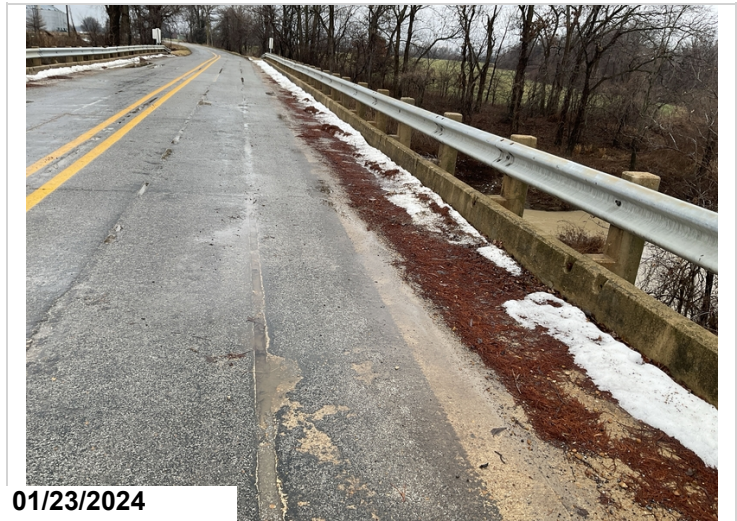
Dirt and debris in gutters

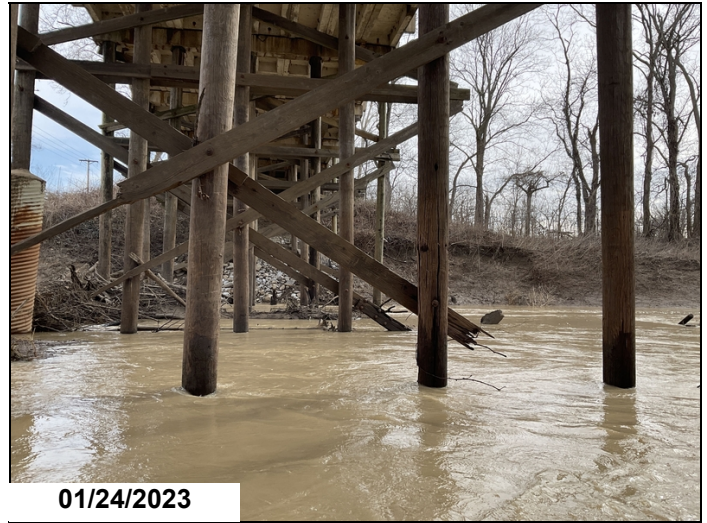
01/24/2023

Bent #5 pile #4 is core decayed with large section loss and mushrooming.

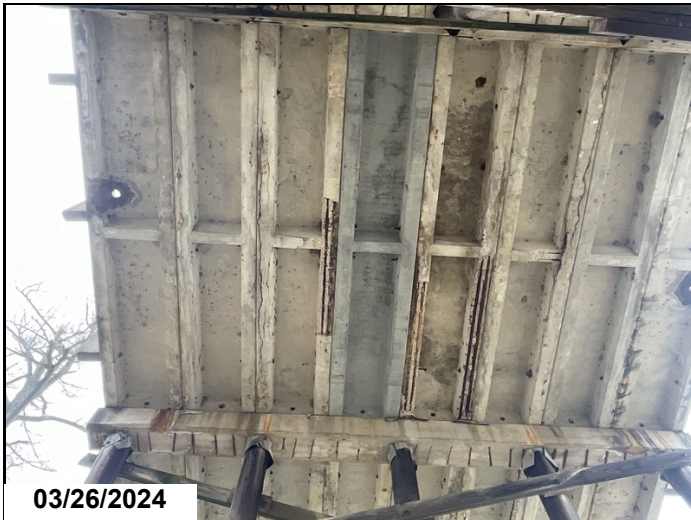
Span 5 soffit / under surface of deck.

Span 5, Unit 4, Left Leg, First ½ of Span: Spalled with exposed, unbonded reinforcing steel with moderate section loss. 9LF CS4

Type of Work: Superstructure Repair

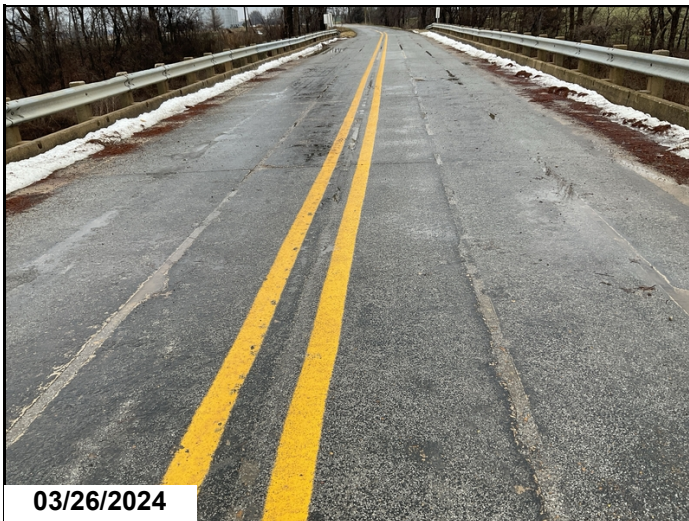
Typical deck

Deck spans #1,2,3,4,5,6,8 have areas of spalling no rebar exposed.
Deck grout joints are spalling out.

Deck each span has several units with light to moderate scaling.
Deck grout joints are spalling out.
Deck spans #1,3,6 have areas of spalling no rebar exposed.

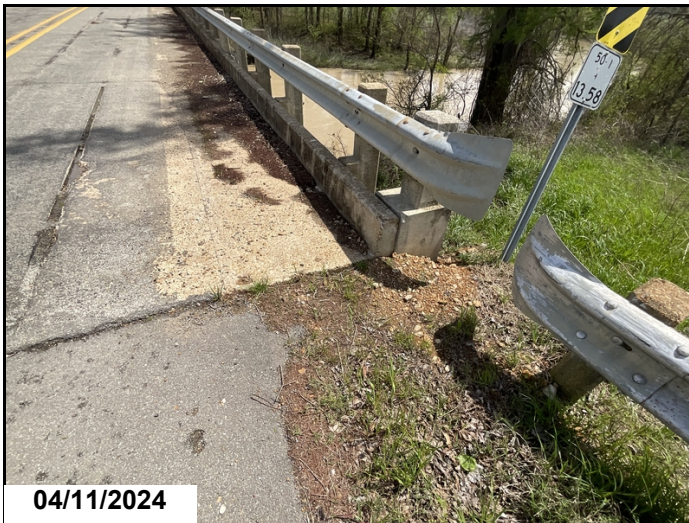
Erosion at abutment #1 right approach shoulder has been repaired at time of inspection.

4/11/2024-Erosion at abutment #1 right approach shoulder has been repaired at time of inspection.

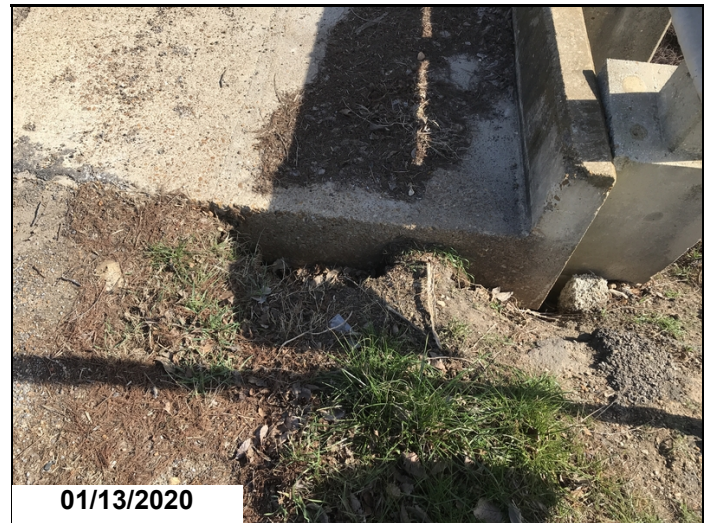
Abutment #1 right approach shoulder is eroded with two holes at bridge end.
