Asset #m3912(Routine)

Sh-75/Sec-00/L4.66 over Creek

Location: 4.0 Mi No Of Jct Sh 50

Team Lead: Myron Futrell Inspection Date: 08/22/2024

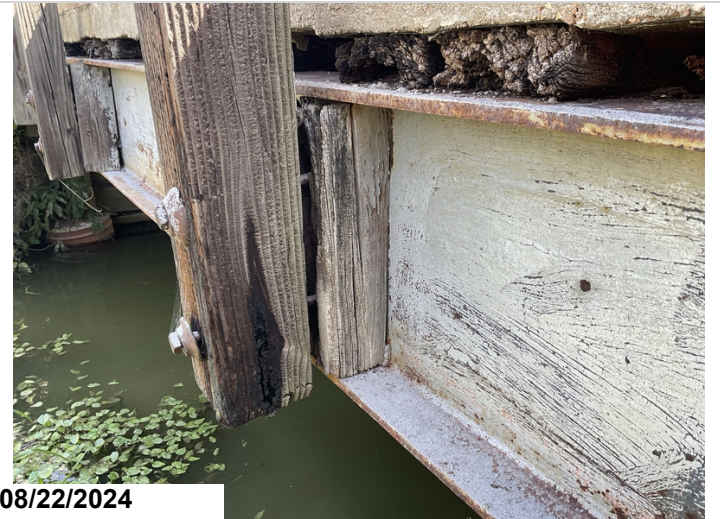
(330)	Bridge rails, full length: surface rust very limited paint left with little to no section loss.	Corrosion 46LF	CS3				
Bridge rail, left side:	not connected to last rail post.	Connection 1LF	CS4				
Left rail rocked back and rail post spacers and split and decayed.	Connection 5LF	CS3					
Steel protective coating, full length:	paint system failing.	Effectiveness 165SF	CS4

Typical, decayed rail post spacers, left side.

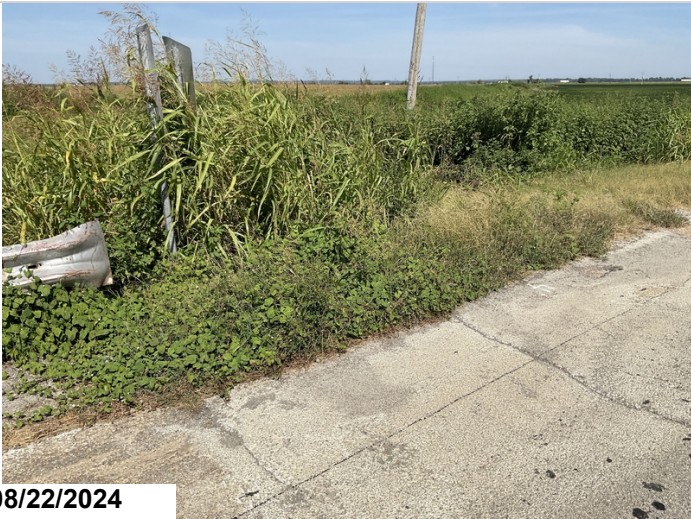
Abutment #2 left side has no approach rail.

Abutment 2, approach rail, left side: missing.

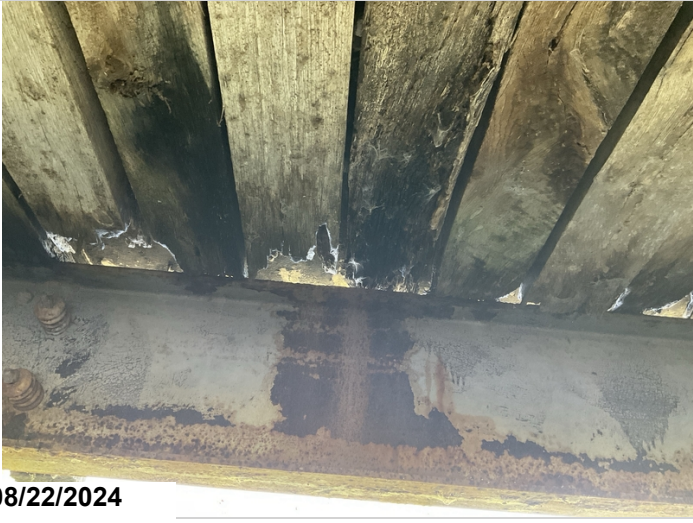
Deck appears to be in overall satisfactory condition, top of deck has achm overlay, underside of deck is mostly covered with timber and is only visible in areas where timber has completely decayed. Overlay has transverse and longitudinal cracking and curbs are heavily scaled and spalled on ends with some exposed rebar. Gutters have dirt, debris and vegetation in them. Timber sub deck / stay in place forms have areas over exterior girders and at bridge ends with 100% section loss due to decay.

Typical missing timber slab deck over exterior girders

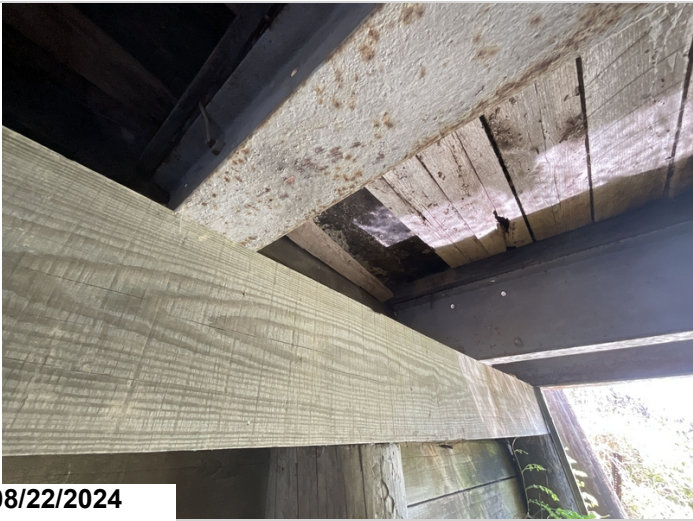
Typical missing timber sub deck at abutment 2

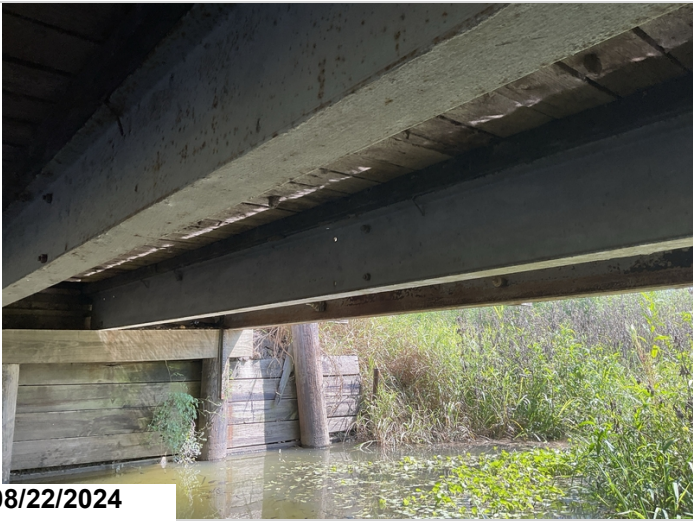
Superstructure is in overall satisfactory condition; exterior girders have areas of corrosion with laminations to top and bottom flanges with moderate section loss. Paint is chalky with areas of surface rust throughout.

Typical girder paint

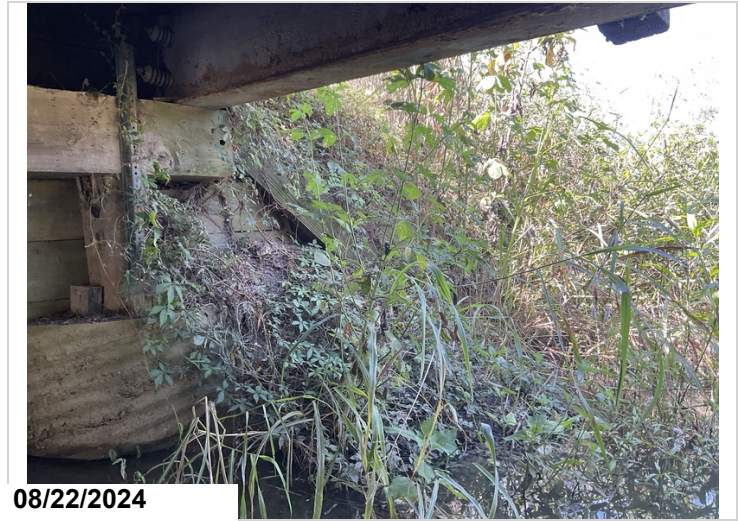
Abutment 1, timber back wall, left side decayed with broken and missing boards.

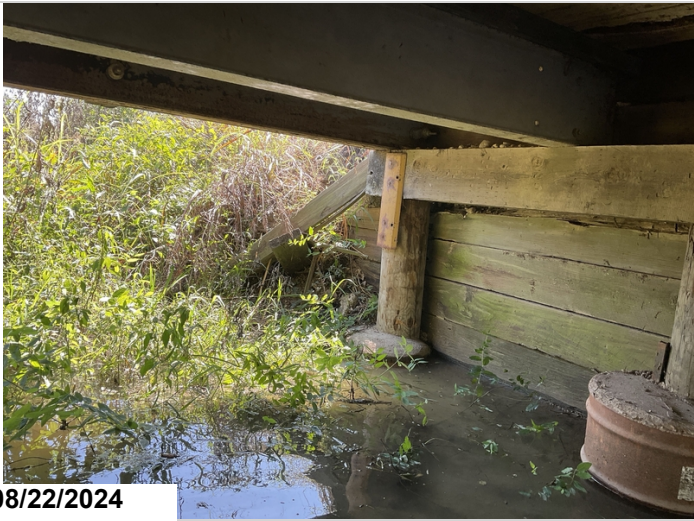
Abutment 1, timber back wall, right side decayed with broken and missing boards.

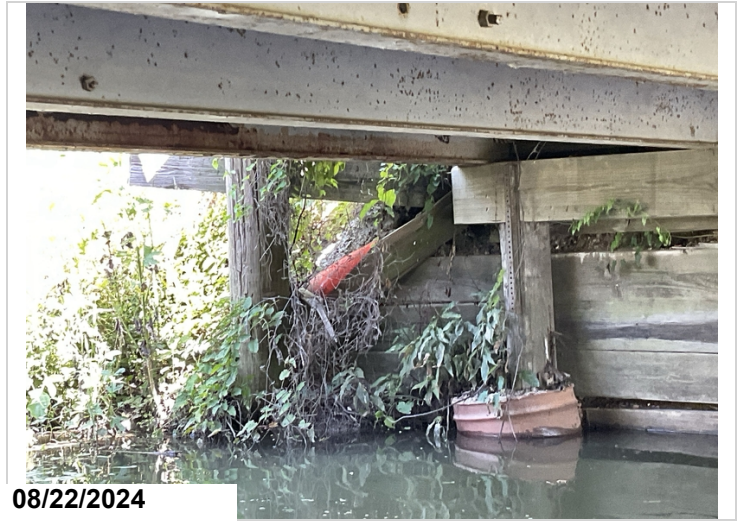
Abutment 2, timber back wall, left side: decayed with missing and broken boards , timber pile is leaning in.

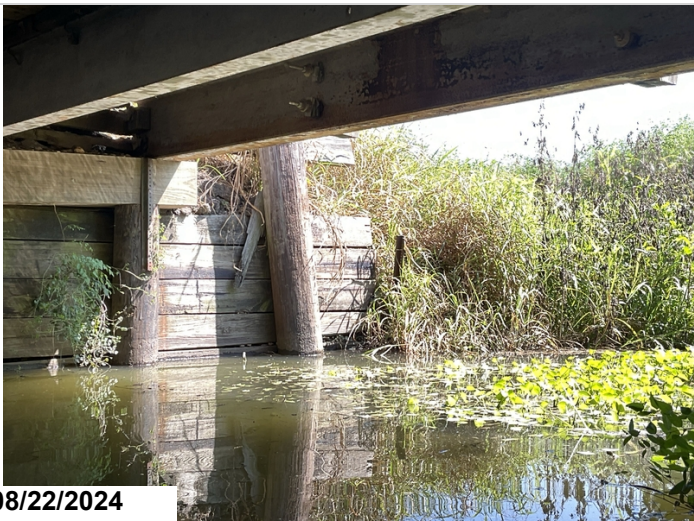
Abutment 2, timber back wall, right side: decayed with missing and broken boards.

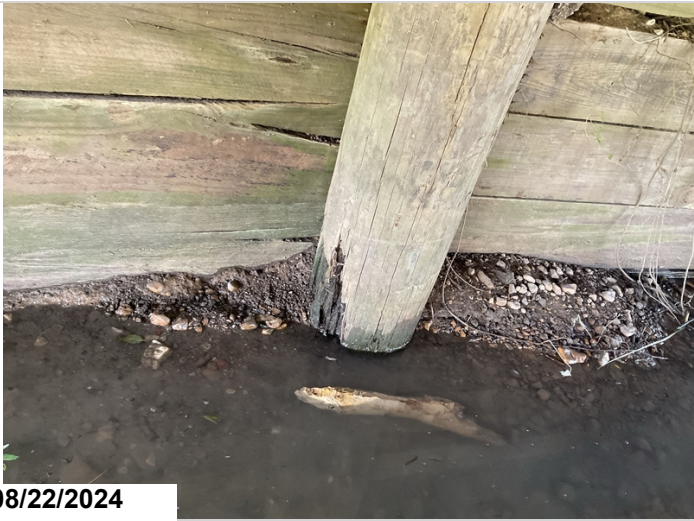
Abutment 1, pile 3: moderate decay at ground line. 1EA CS3

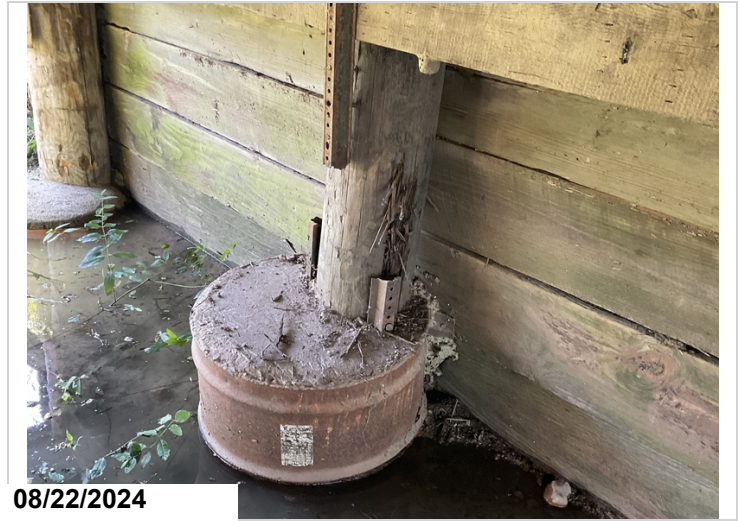
Abutment 1, pile 4: minor outer shell decay on upper section of spliced pile. 1EA CS3

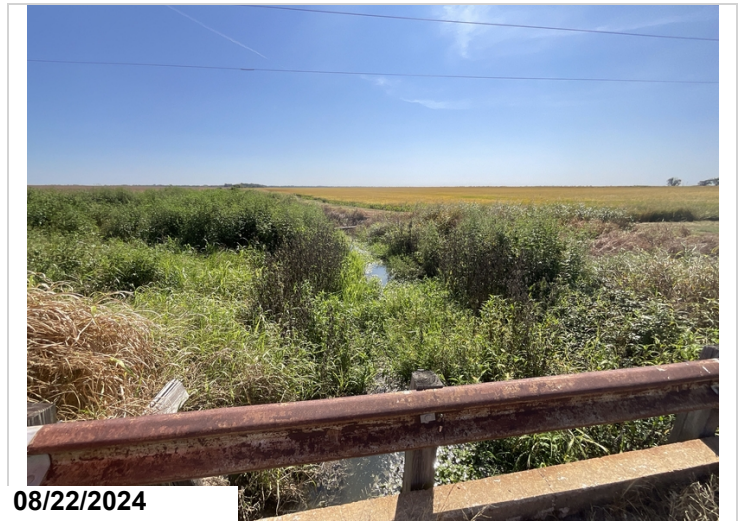
Channel, right side

Channel is in fair condition with vegetation growing in channel and a small beaver dam in channel left side of bridge. Channel alignment is good at structure.

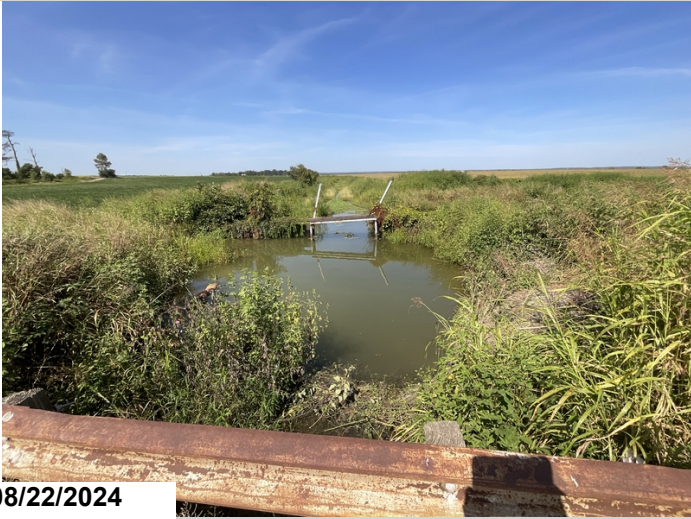
Channel, left side

7/11/2023-Lowered channel from 6 to 5 due to small beaver dam left side of bridge and vegetation growing in channel.

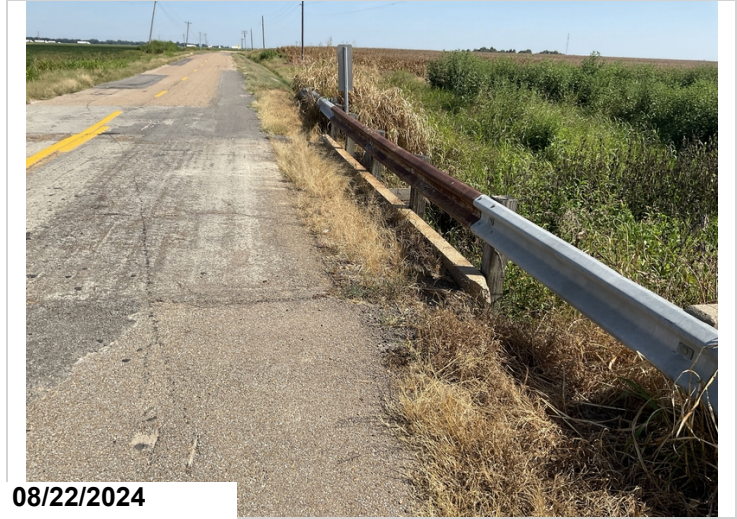
Dirt, debris and vegetation in gutters.

Dirt and vegetation in gutters

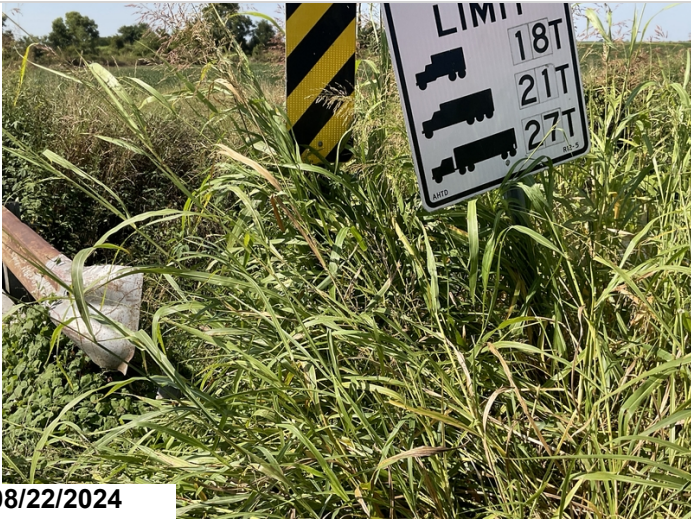
Missing log mile signs, should read 4.66.

Abutment 2, log mile sign missing

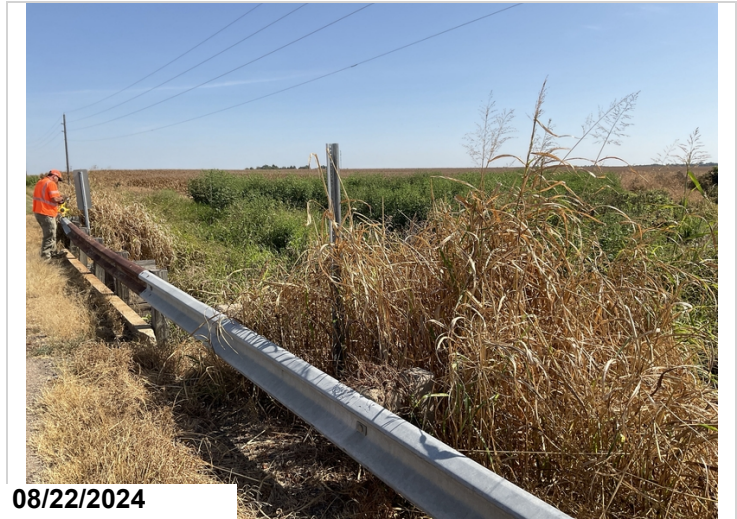
Abutment 1, right flair board and log mile sign missing

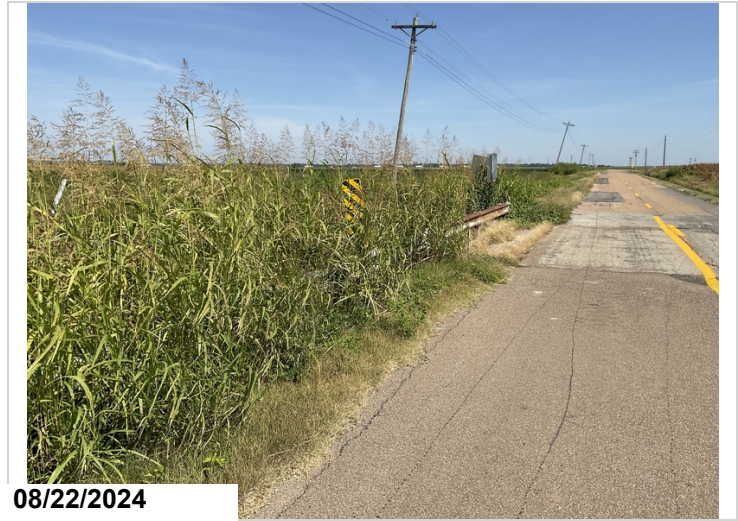
Vegetation growing onto bridge.

Vegetation growing beside, under and onto bridge

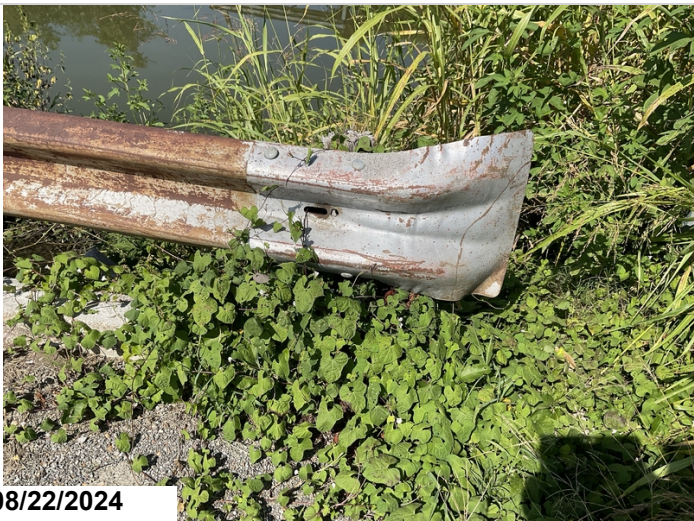
Bridge rail, left side: not connected to last rail post.
Connection 1LF CS3

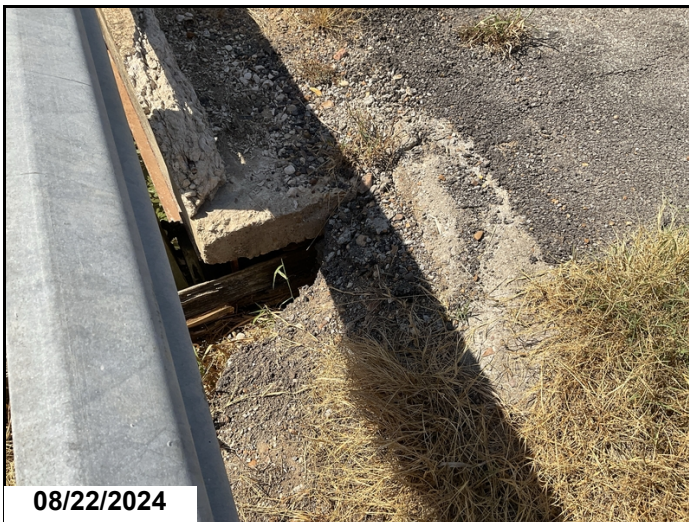
Abutment 2, right shoulder, at bridge end: eroded due to roadway run off.

Abutment 2, right shoulder: eroded at bridge end.

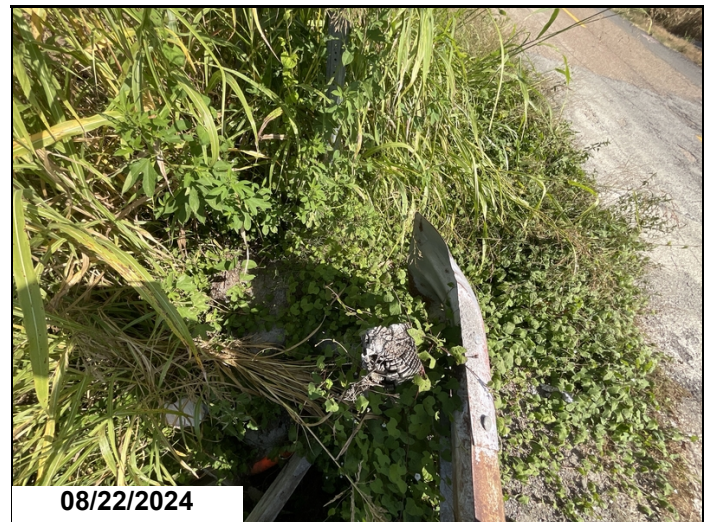
Abutment 2, left shoulder: erosion has been repaired at time of inspection.

8/22/2024-Abutment 2 left approach shoulder erosion has been repaired at time of inspection.

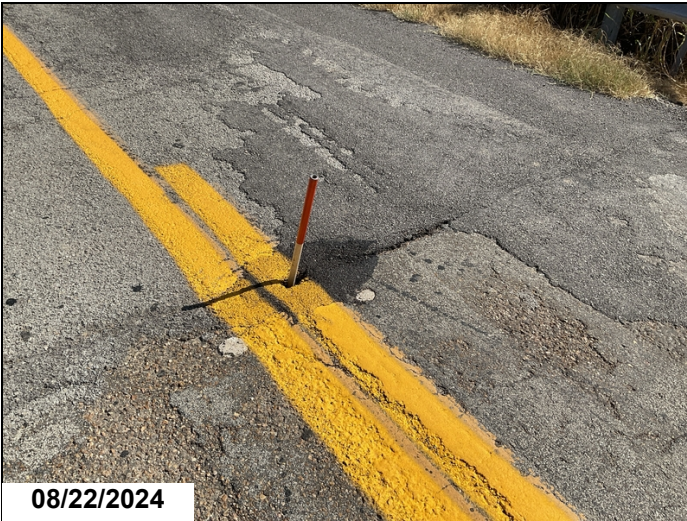
Abutment 2, approach roadway, at centerline: hole at bridge end with two-foot-deep void underneath, due to erosion caused by missing back wall above cap.

Small hole in abutment 2, approach roadway with 2' deep void underneath.

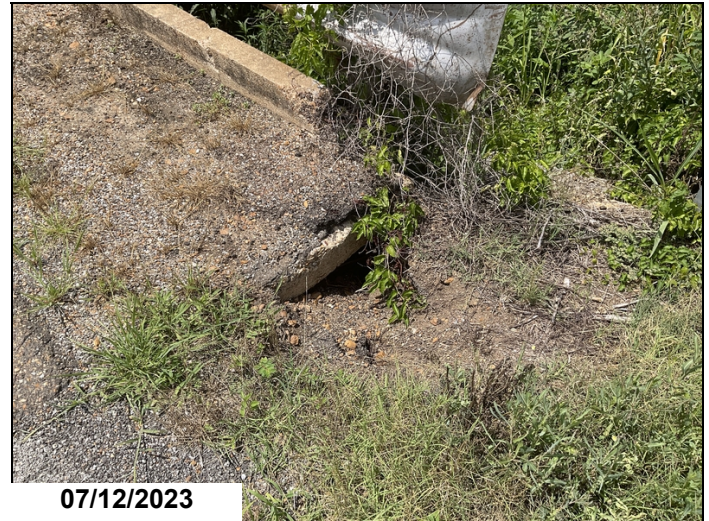
7/11/2023-Reopened maintenance need as an A priority, due to increased size of hole in shoulder in abutment #2 left approach roadway and added hole in roadway at centerline with void underneath.

Abutment #2 left approach shoulder has two foot by two foot by one foot deep hole at bridge end

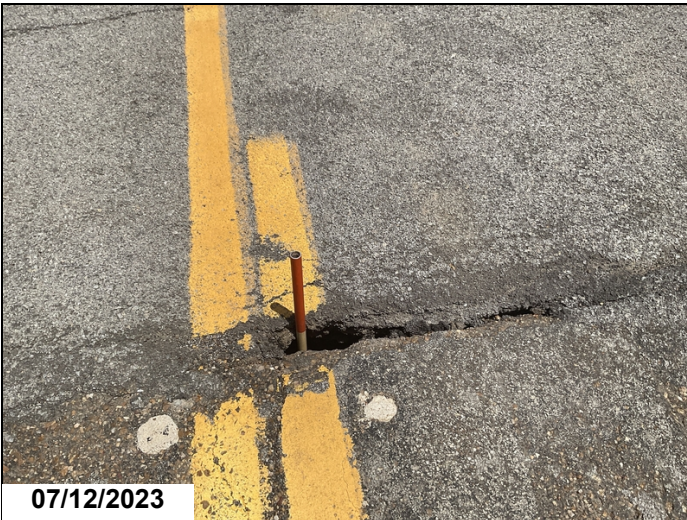
3' deep hole in abutment #2 approach roadway at centerline

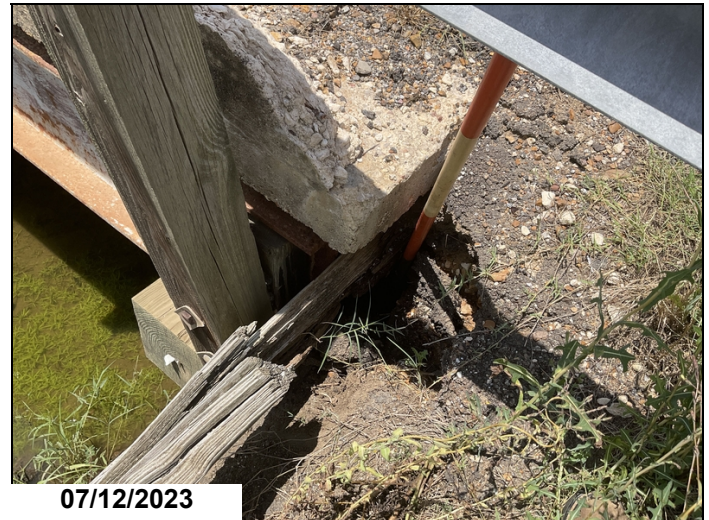
Abutment #2 right approach shoulder has two foot deep void

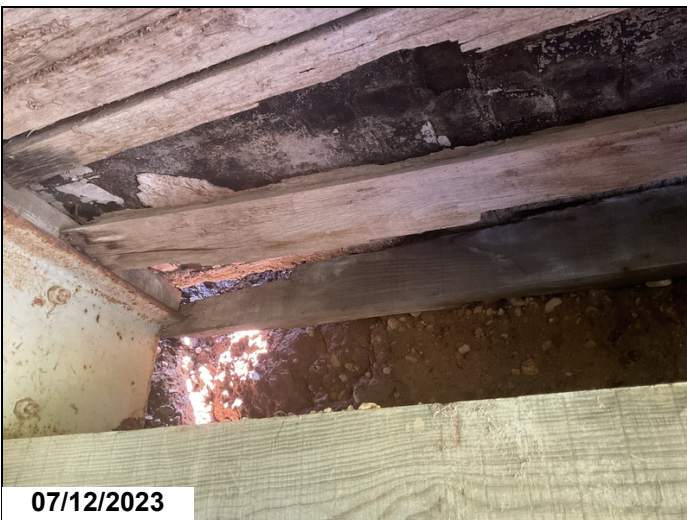
Void behind girder #4 at abutment #2

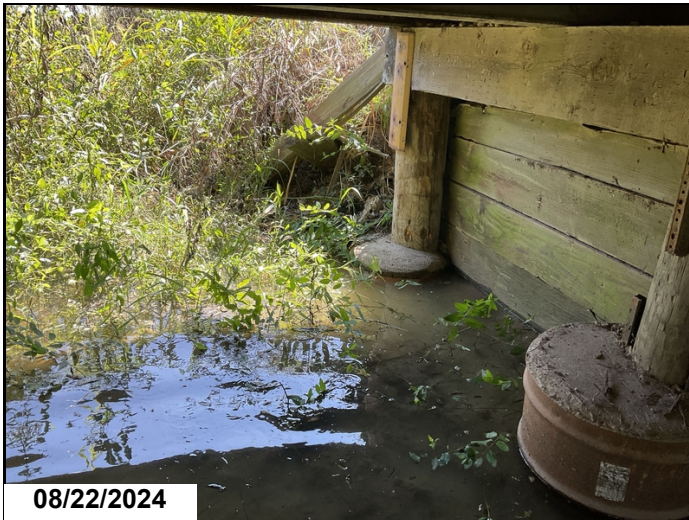
Bent 1, pile 5: spliced and encased in concrete.
Encasement is of unknown structural integrity. Decay
1EA CS3

9/18/2024-Raised substructure from 4 to 5 due to bent 1 pile 4 having been spliced and encased in concrete.

8/22/2024-Pile has been spliced and encased in concrete at time of inspection.

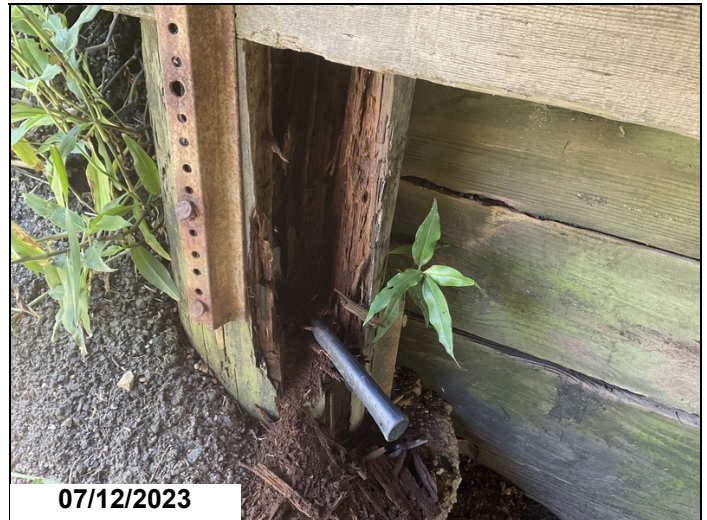
Bent 1, Pile 5, upper portion of spliced pile: severely decayed.

Bent #1 pile #5 upper portion of spliced pile decayed with
up to 70% section loss.

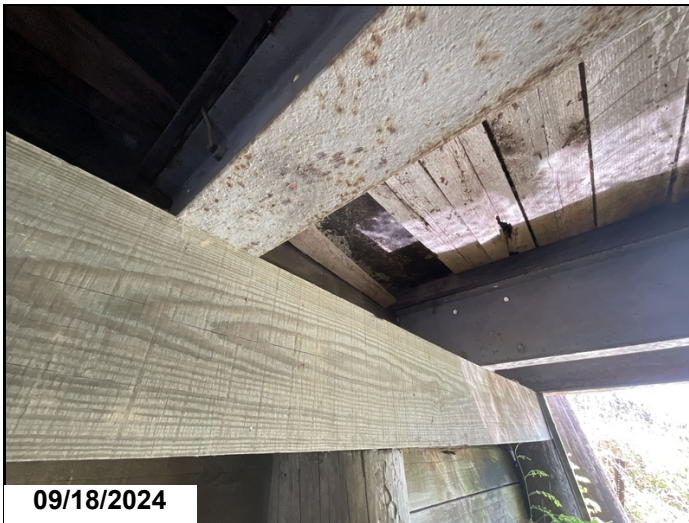
Timber sub deck at bridge ends and over exterior girders and at bridge ends are decayed with up to 100% section loss.

Typical missing timber sub deck at abutment 2

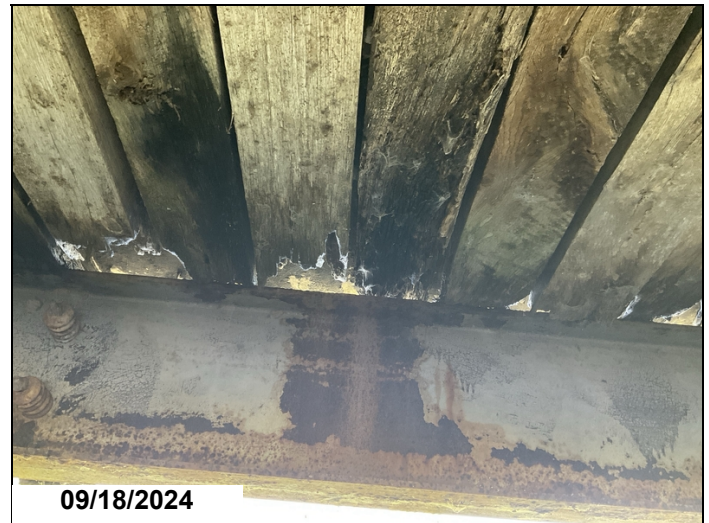
Typical missing timber slab deck over exterior girders

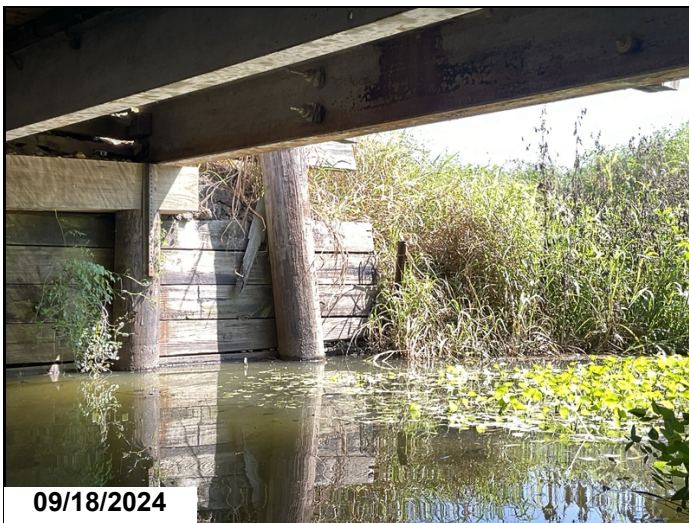
Both abutments, timber back walls: areas of decay with up to 100% section loss causing roadway to settle.

Abutment 2, timber back wall, right side: decayed with missing and broken boards

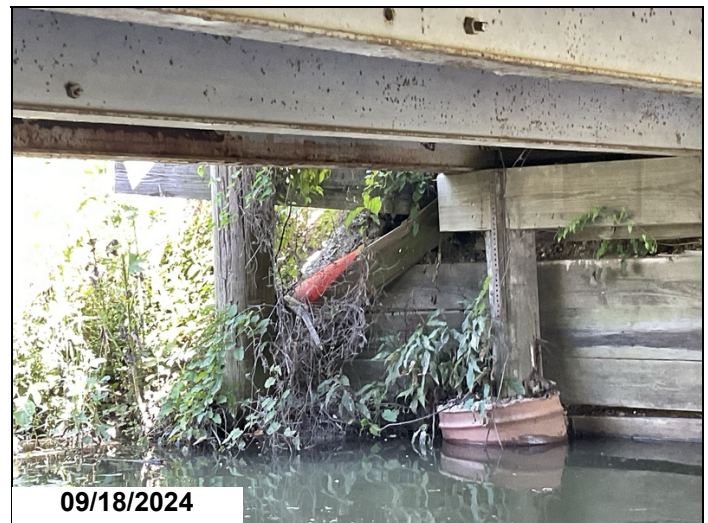
Abutment 2, timber back wall, left, side: decayed with missing and broken boards , timber pile is leaning in

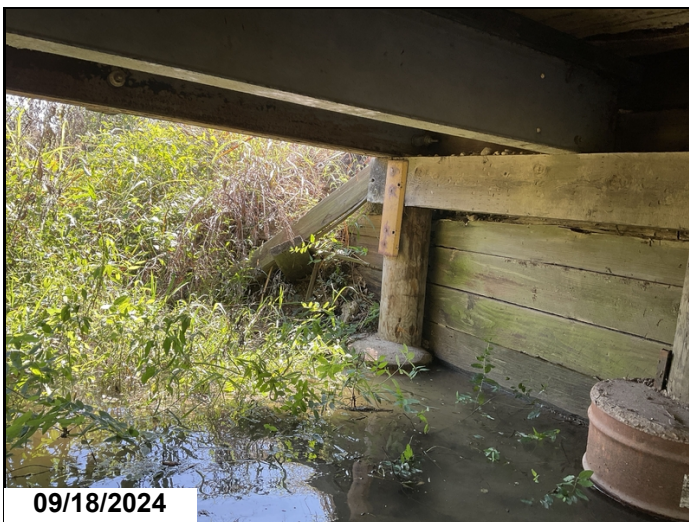
Abutment 1, timber back wall, right side decayed with broken and missing boards.

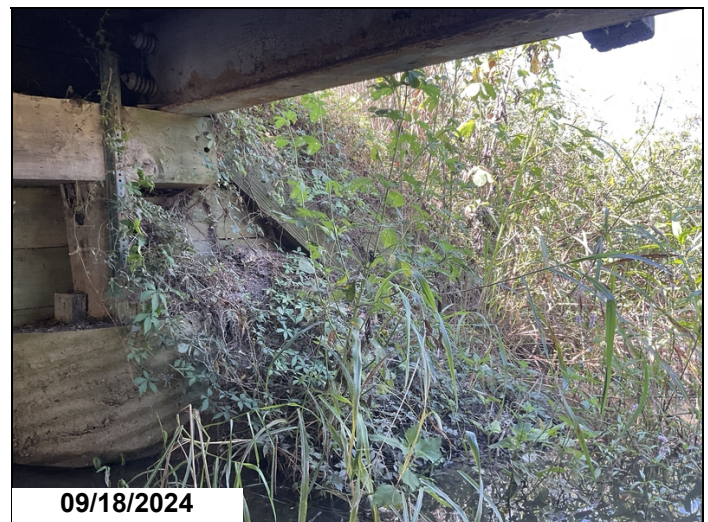
Abutment 1, timber back wall, left side decayed with broken and missing boards.

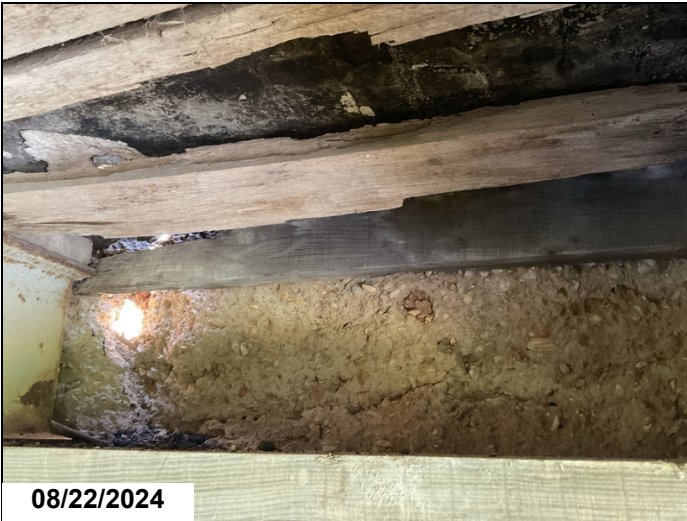
Abutment 2, void at centerline above cap where timber
back wall is missing

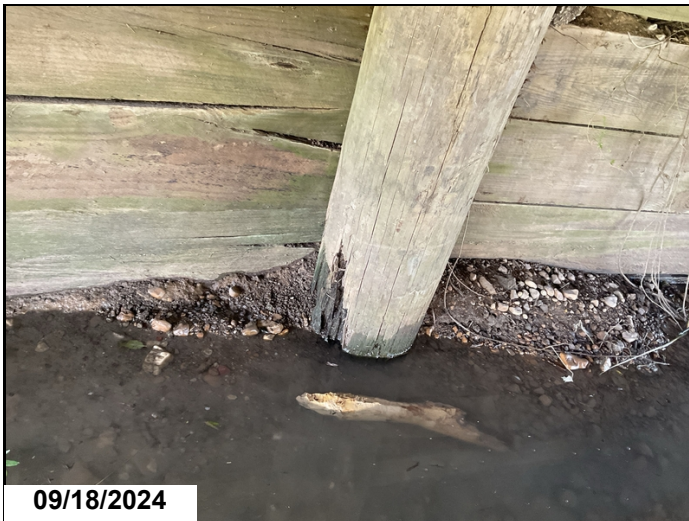
Bent 1, pile 3: outer shell decay with moderate section loss.

Abutment 1, pile 3: moderate decay at ground line. 1EA
CS3

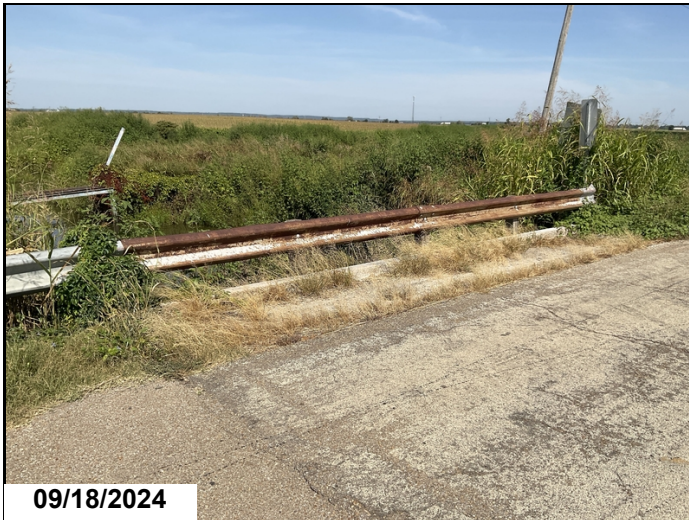
Bridge rail, left side

Left rail: not connected to last rail post.

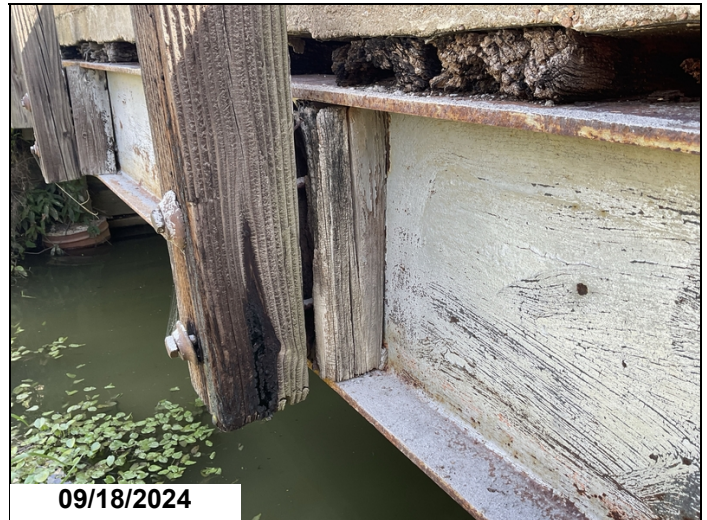
Left rail: rocked back and rail post spacers and split and decayed.

Typical, decayed rail post spacers, left side.

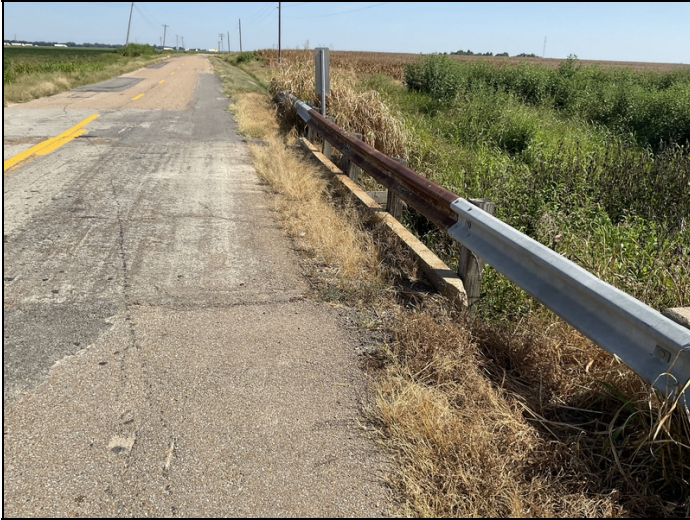
Dirt, debris and vegetation in gutters.

Dirt and vegetation in gutters

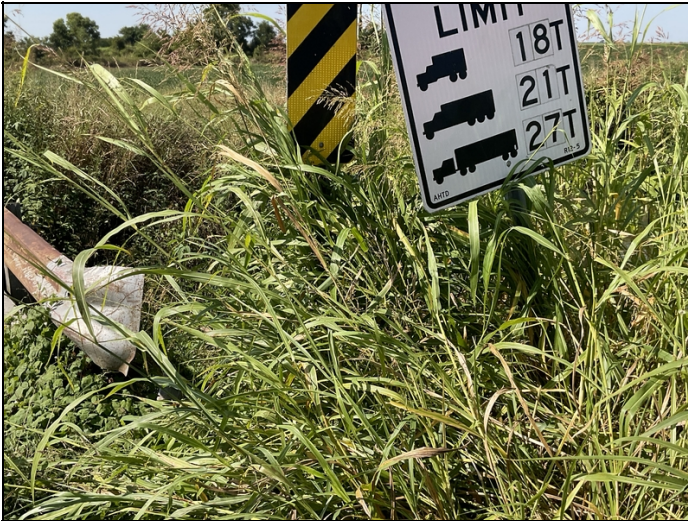
Missing log mile signs, should read 4.66.

Abutment 2, log mile sign missing

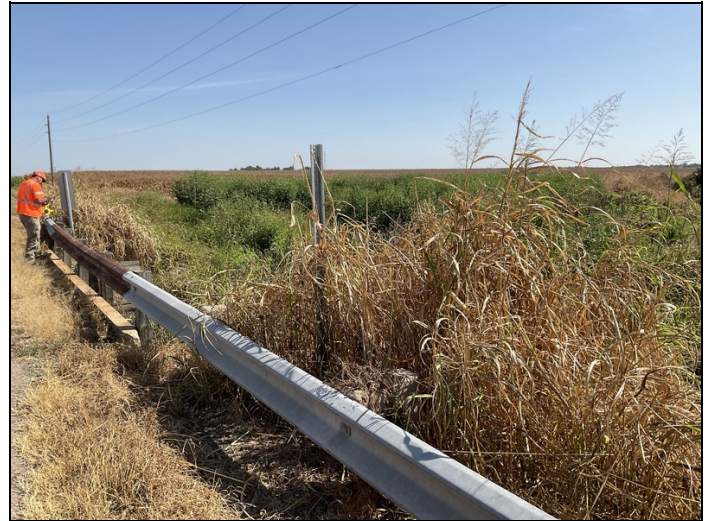
Abutment 1, right flair board and log mile sign missing

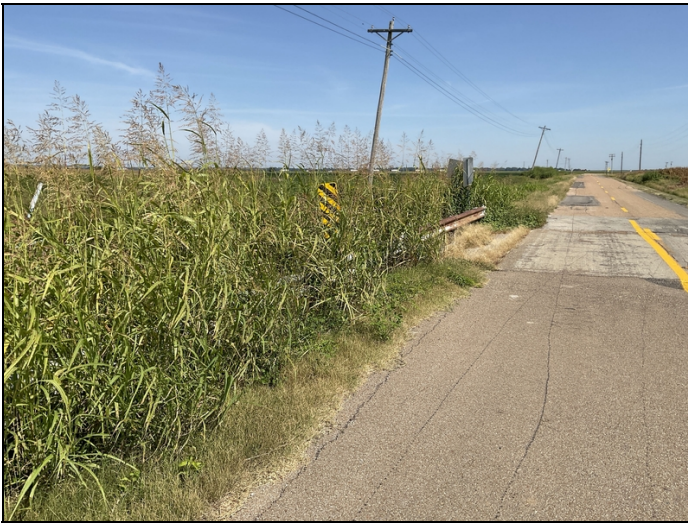
Vegetation growing onto bridge.

Vegetation growing beside, under and onto bridge
