**Bridge #01372(Routine, Underwater type 2)**

**Us70/Sec-19/L17.73 over Allen Bayou**

**Location: 2.00 Mi Sw Jct Of Sh 149**

**Team Lead: Myron Futrell Inspection Date: October 29, 2020**

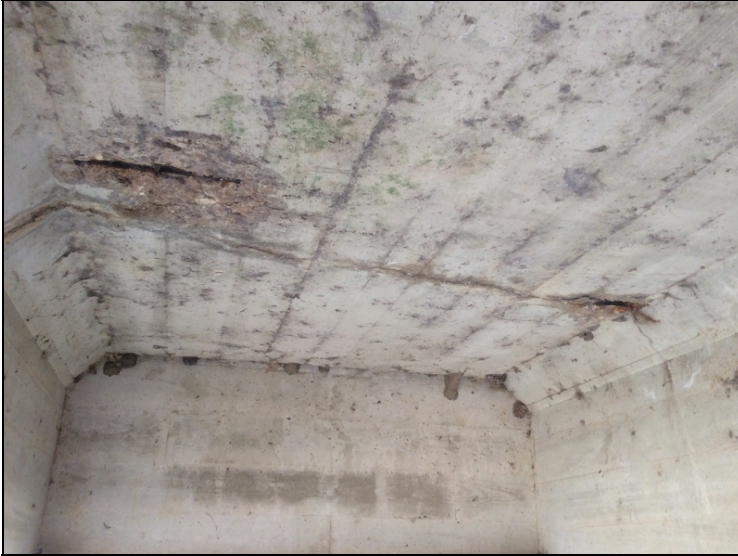
Soffit span #2 bay #4 has a one foot spall and a eight inch spall with exposed rebar with 5% section loss.

Span #2 bay #4 soffit.

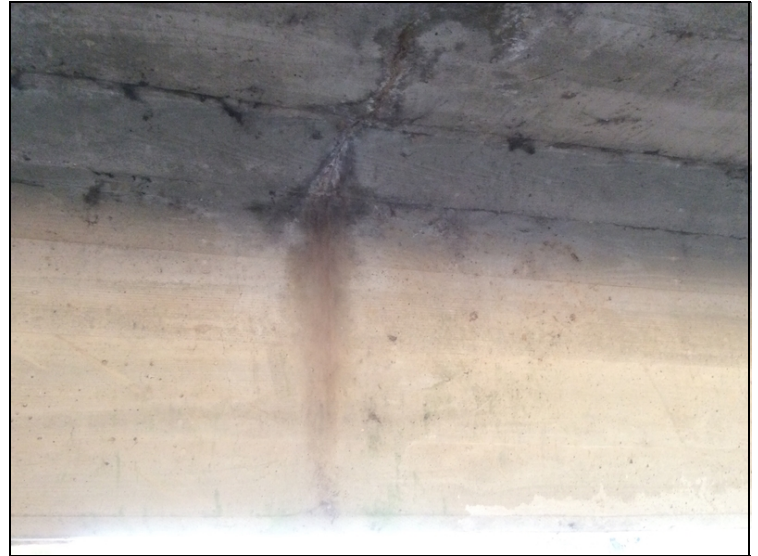
Soffit span #2 cracks extend into tee beams four inches.

Soffit crack with efflorescence extending into girder.

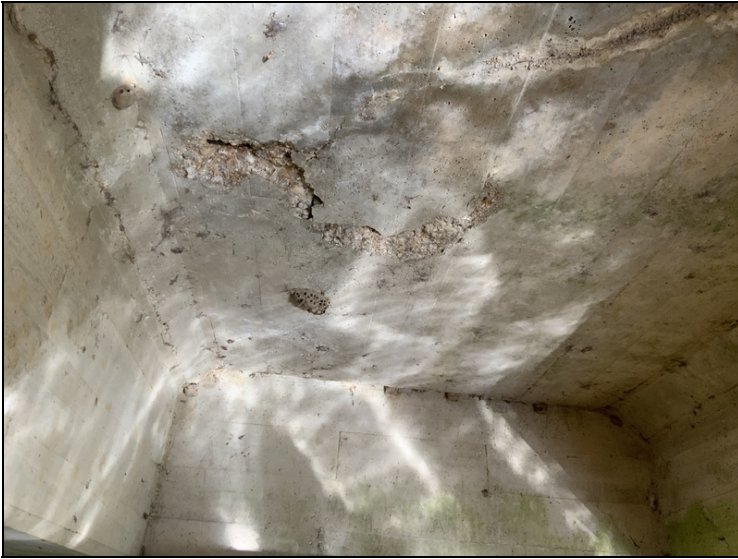
Soffit span #1 bay #4 at bent #2 has 1' delamination and 6' of exposed rebar.

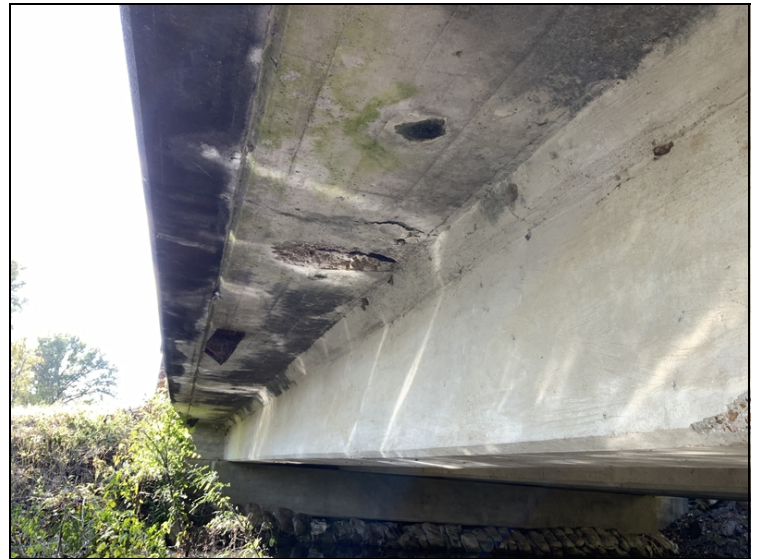
Soffit overhangs have several small spalls with exposed rebar and delamination's.

Typical soffit overhang spall with exposed rebar.

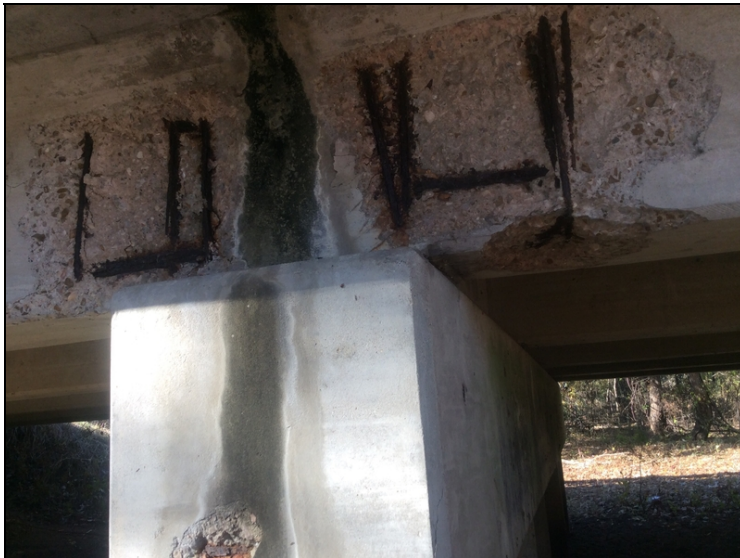
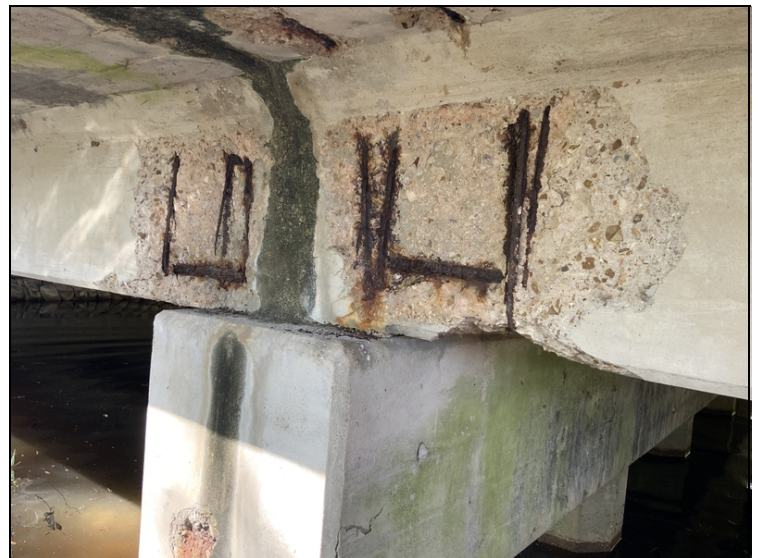
Girder #5 is spalled on outside face at bearing bent #2 with exposed rebar with 5% section loss in both spans.  
Girders have hairline vertical flexure cracks in sides.  
Span #1 girder #5 at bent #1 left side has several six inch spalls with exposed rebar.  
Span #1 girder #2 right side at bent #2 has three 6' spalls with exposed rebar and 3' of cracking.  
Span #1 girder #3 at bent #2 right side has a six inch delamination.  
Span #1 girder #3 at bent #2 left side has a six inch spall with exposed rebar.  
Span #2 girder #3 has 3 six inch delaminations on right side.  
Span #2 girder #2 has a 6' delamination on left side.  
Span #2 girder #3 at bent #2 left side has a six inch spall with exposed rebar.  
Span #2 girder #4 at bent #3 left side has a four inch spall with exposed rebar.  
Span #2 girder #5 at bent #3 left side has two six inch spalls with exposed rebar.

Girder #5 spans #1,2 at bent #2.

Spans #1 and 2 girder #5 spalled with exposed rebar at bent #2.

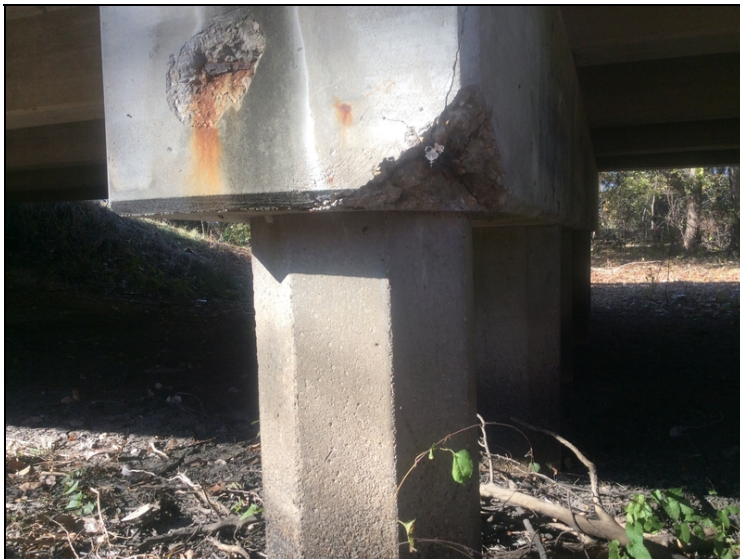
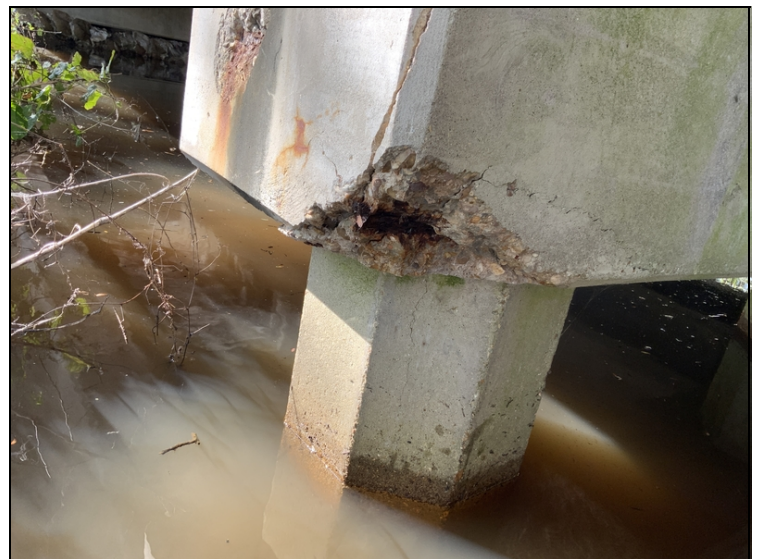
Bent #2 cap ahead face bottom right end has a one foot spall with exposed rebar with 5% section loss.

Bent #2 cap ahead face bottom right corner.

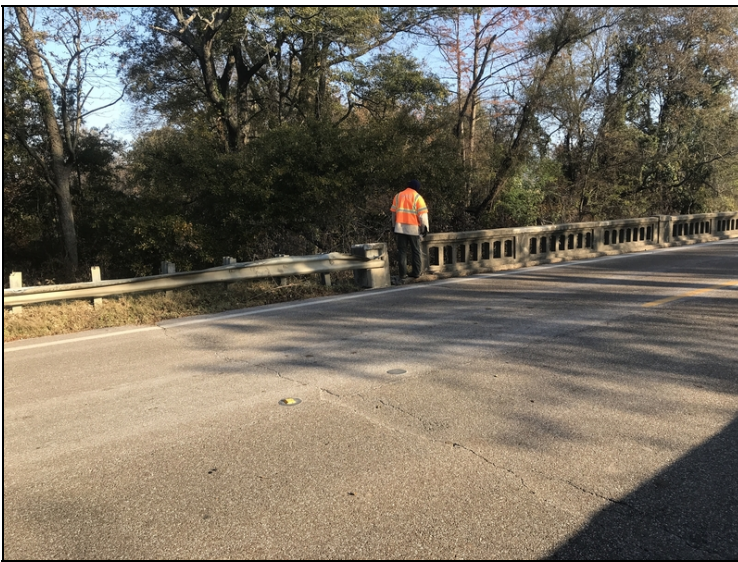
Abutment #1 left side monument post has been broken off with first fifteen feet of rail having collision damage, and approach rail has collision damage full length.

Abutment #1 left side monument post has been broken off and approach rail has collision damage.

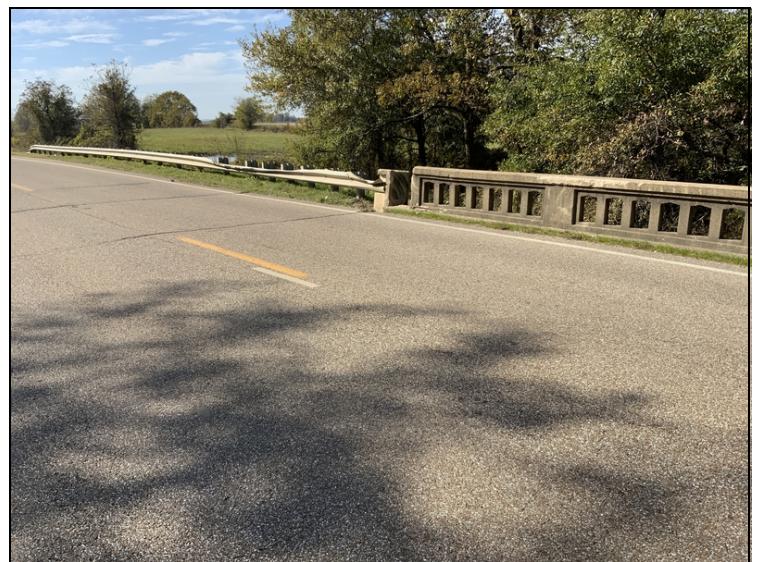
Abutment #1 left approach rail left side.

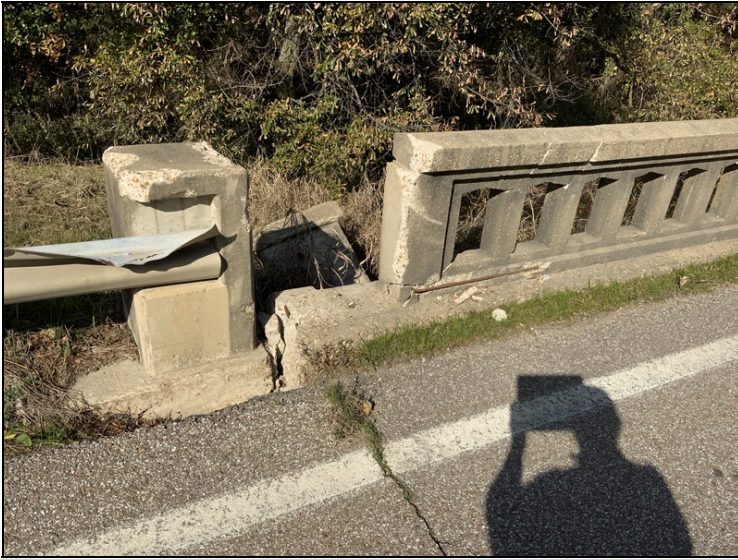
Abutment #1 left monument post broken off.

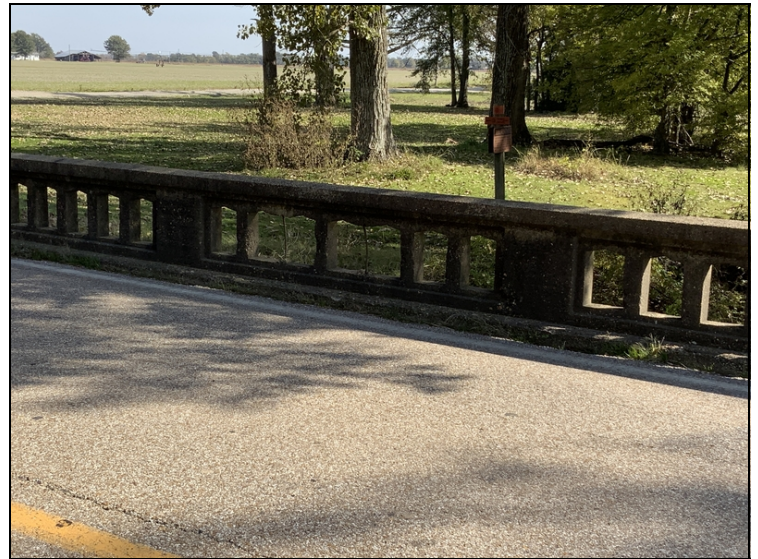
Span #2 right rail damage.

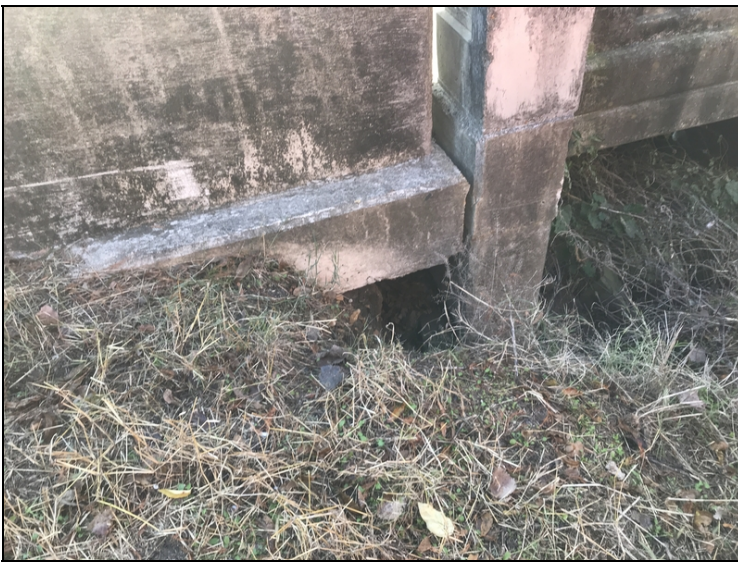
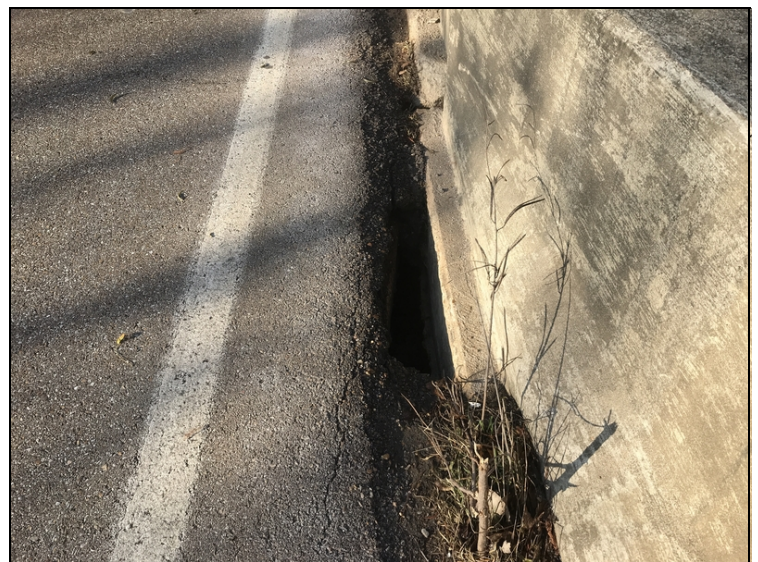
Abutment #2 left side has a void under approach slab extending into roadway with hole in approach roadway shoulder. Abutment #1 left approach gutter has small hole due to end rail post being pushed over.

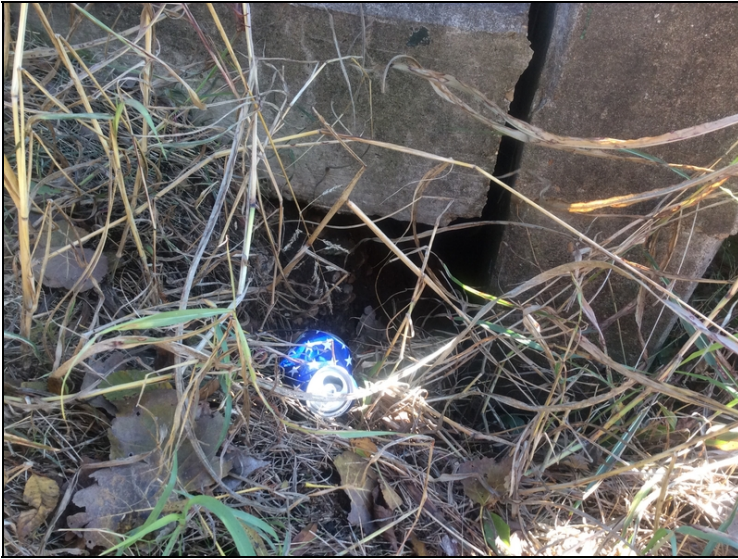
Erosion under abutment #2 left approach gutter.

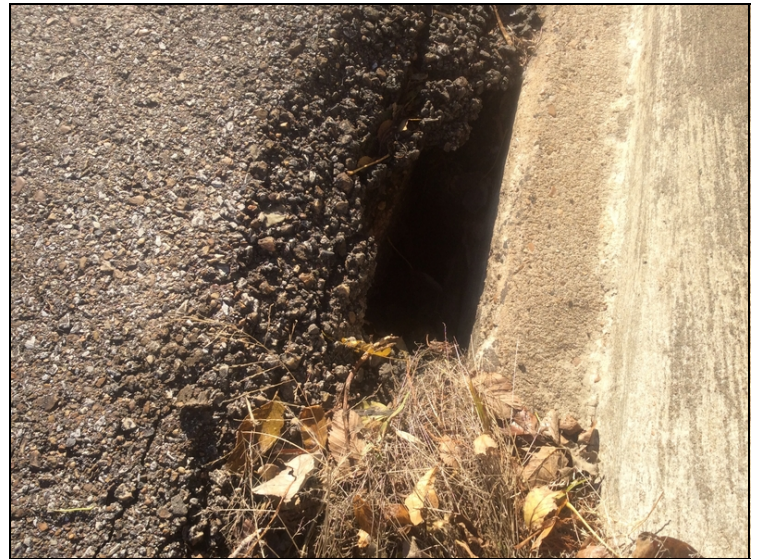
Hole at abutment #2 left approach shoulder.

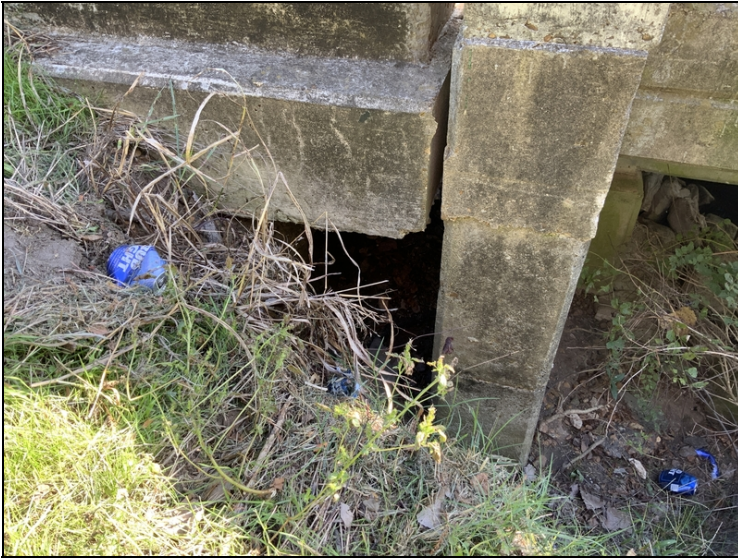
Void under abutment #2 approach slab left side.

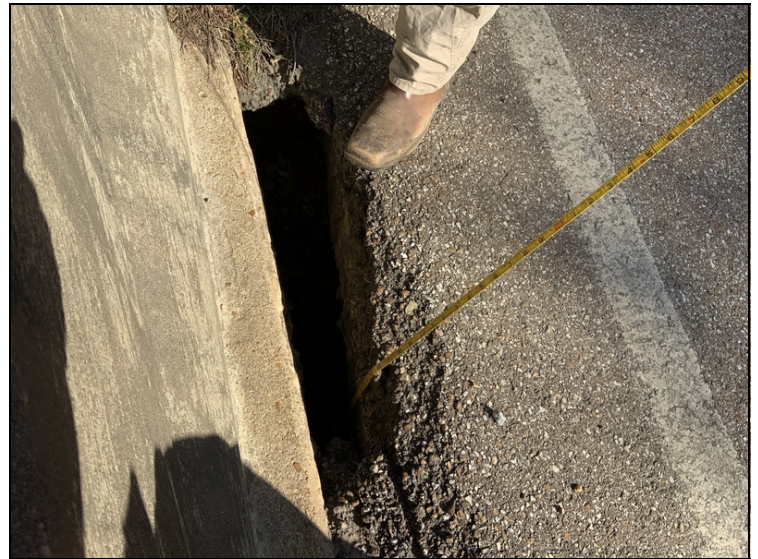
3' long by 2 1/2' deep hole in abutment #2 left approach gutter.

Abutment #2 left approach gutter has 3' long by 2 1/2' deep hole due to void under approach slab.

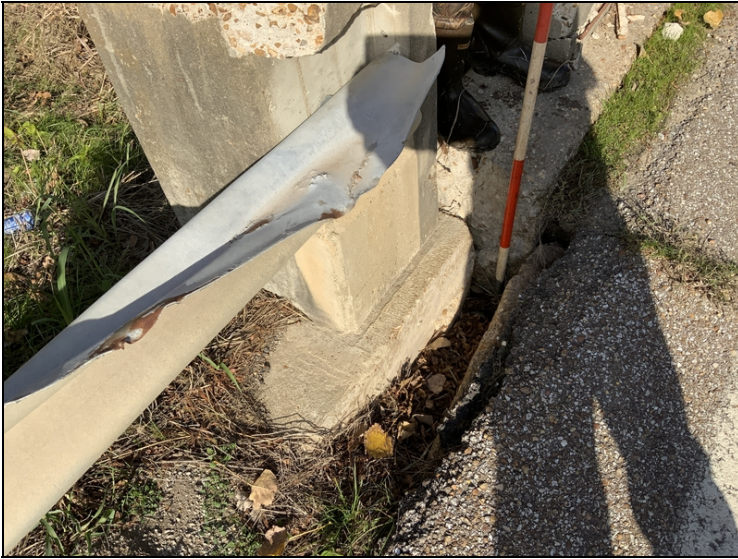
Hole in abutment #1 left approach gutter.

Abutment #1 left approach gutter has small hole due to end rail post being pushed over.
