Bridge #01373(Routine, Underwater type 2)

Us70/Sec-19/L18.42 over Cypress Bayou

Team Lead: Myron Futrell Inspection Date: January 19, 2021

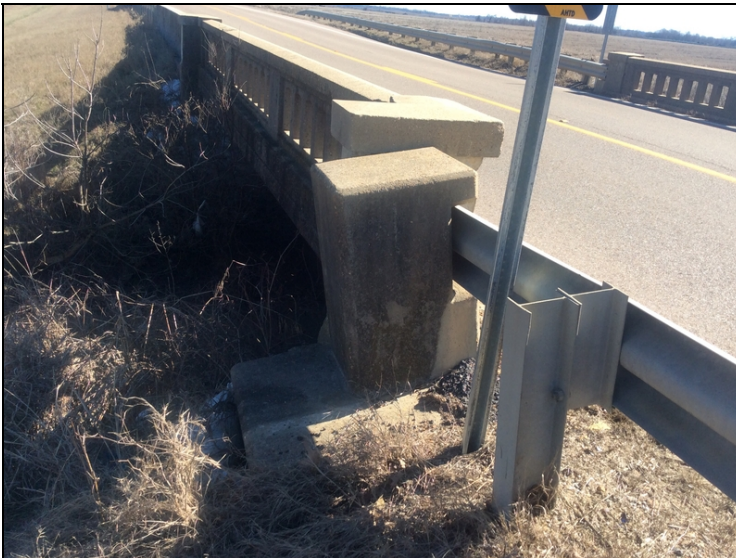
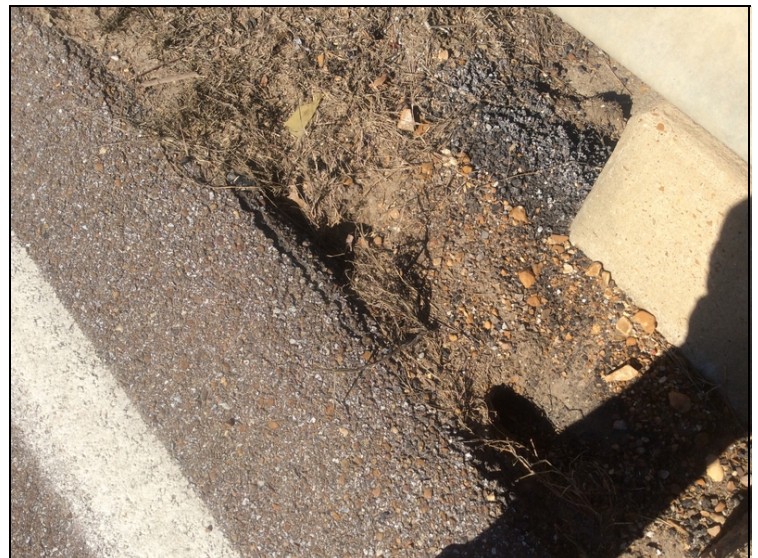
Terminal end post at abutment #1 left side, and abutment #2 right side roadway run off has undermined these posts allowing them to settle.

Placed sandbags around posts.

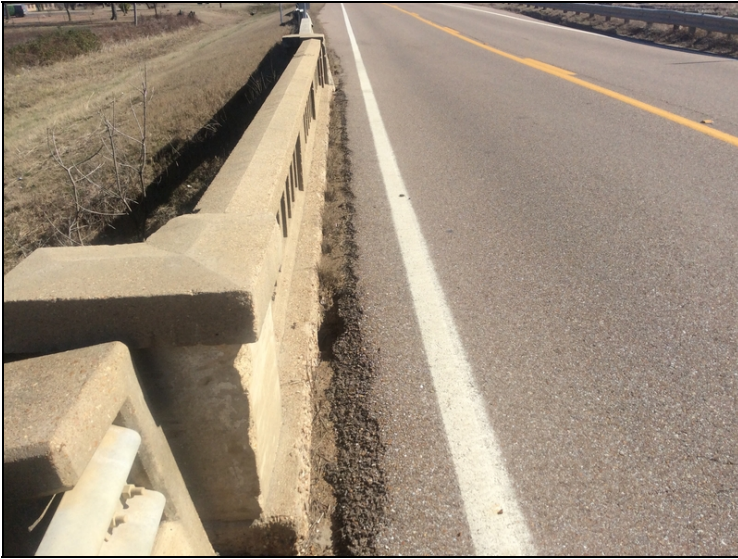
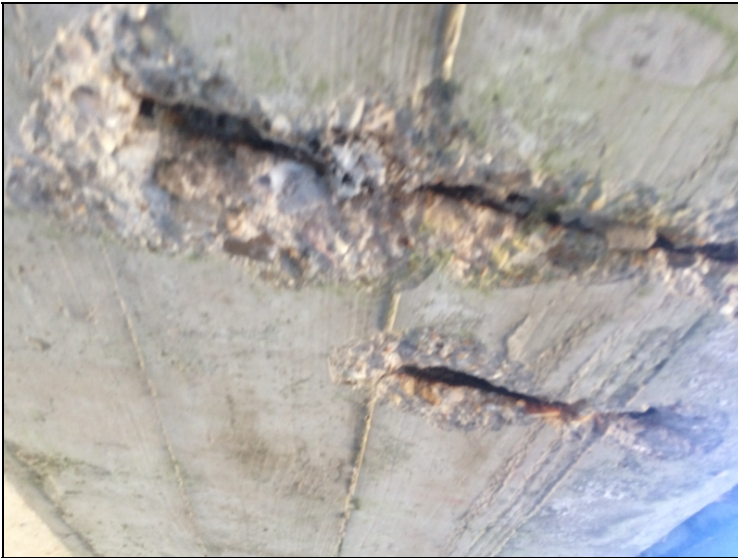
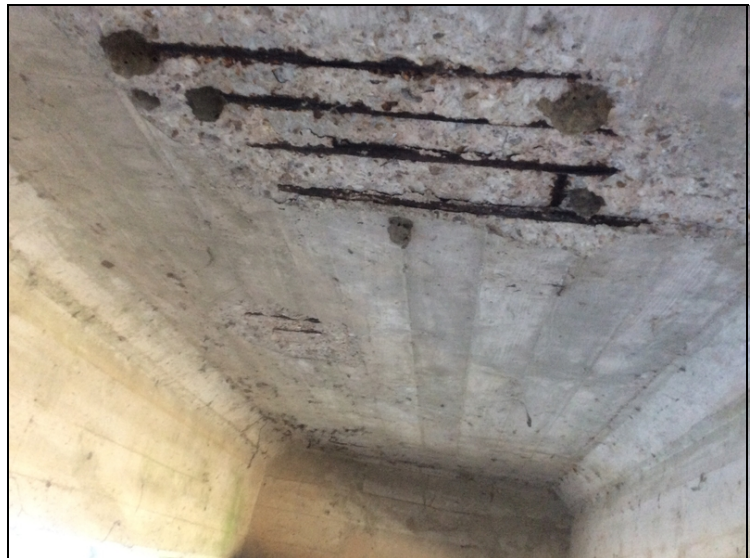
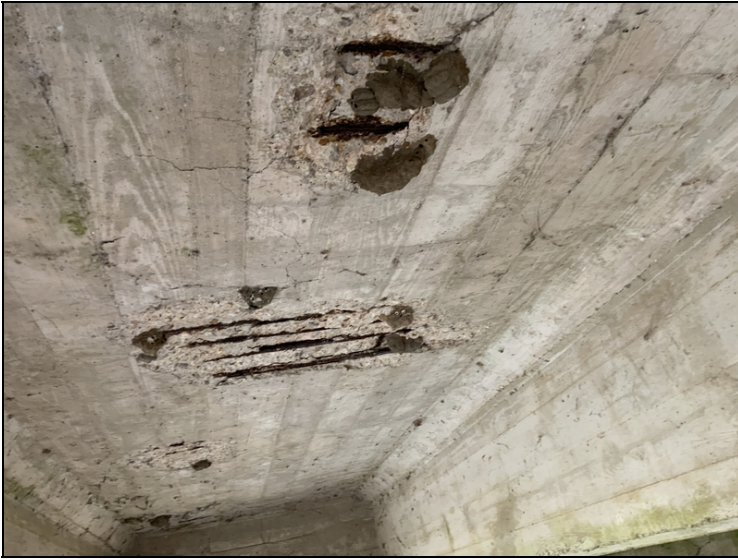
Bay #1 2'X3' spall between girders #1,2 at 3/4 span with exposed rebar with 10% section loss.

Soffit right overhang has one spall and one delamination near bent #1 with exposed rebar.

Bay #3 has a delamination area and a 1' spall with exposed rebar at bent #2.

Bay #1 soffit spalls.

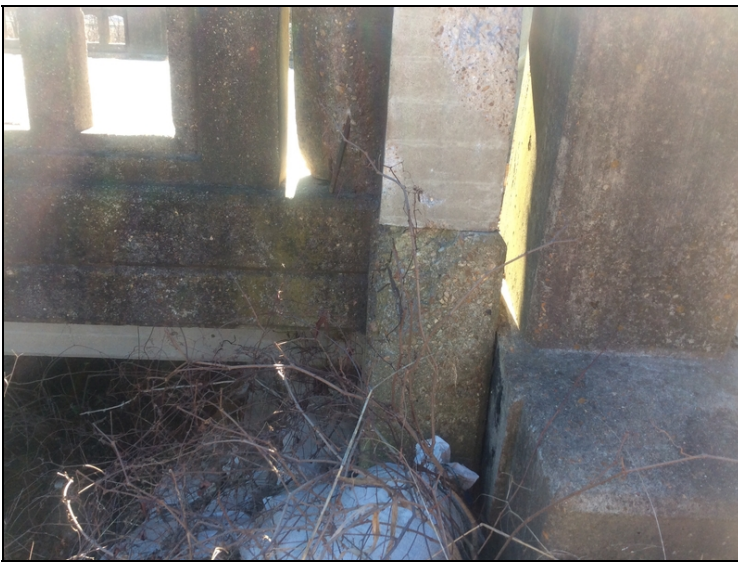
Abutment #1 left side end post back wall has spalled area with exposed rebar where end post sits on back wall.

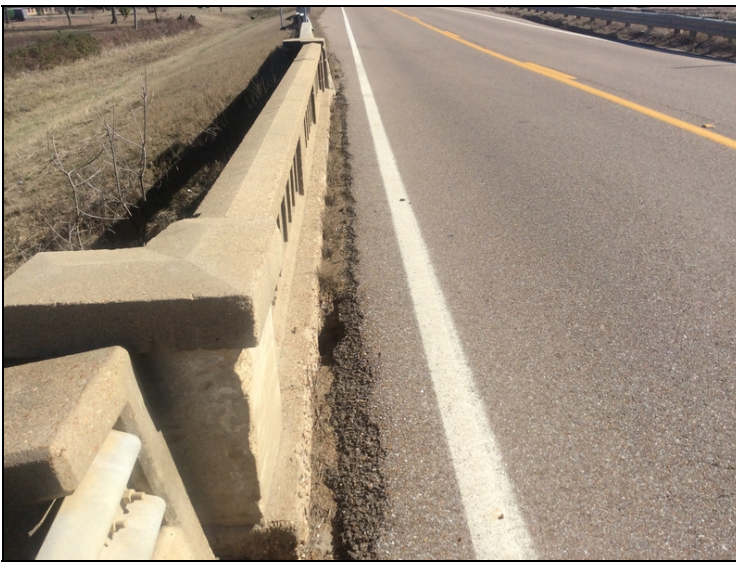
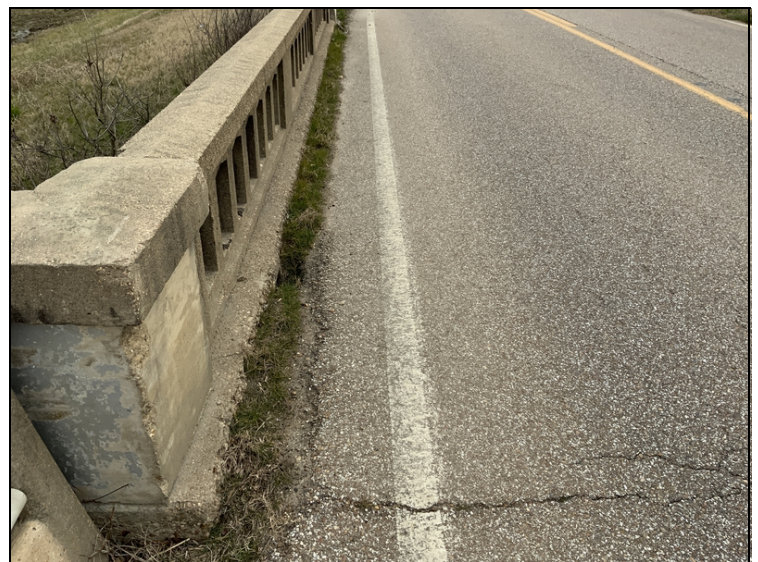
Gutters both sides have dirt and debris in them with vegetation growing in them.

Dirt, debris and vegetation in gutters.

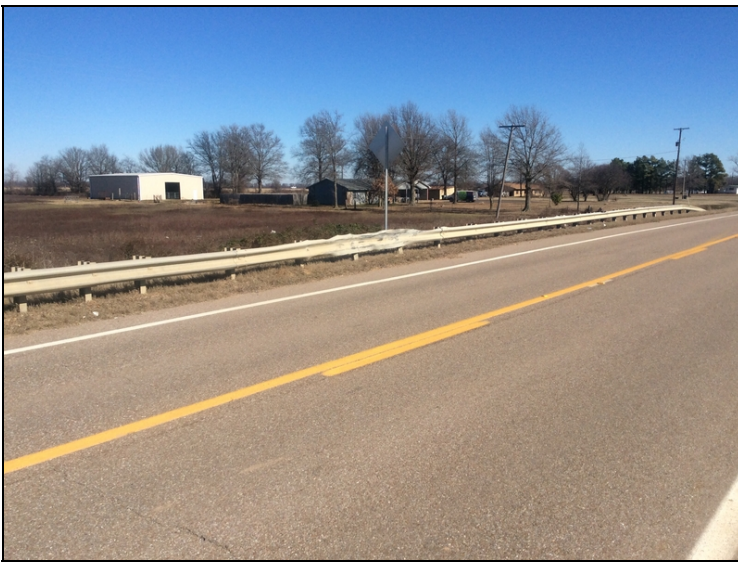
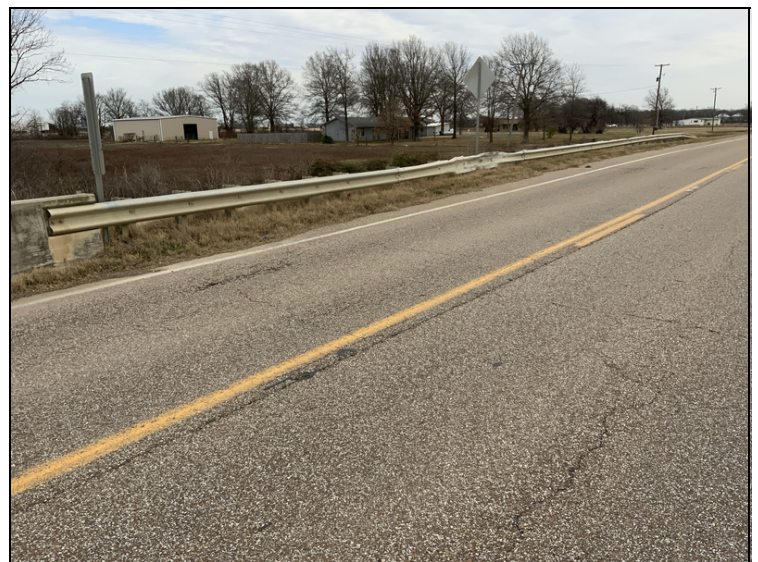
Approach rail abutment #2 left approach rail has collision damage.

Collision damage to abutment #2 left approach rail.

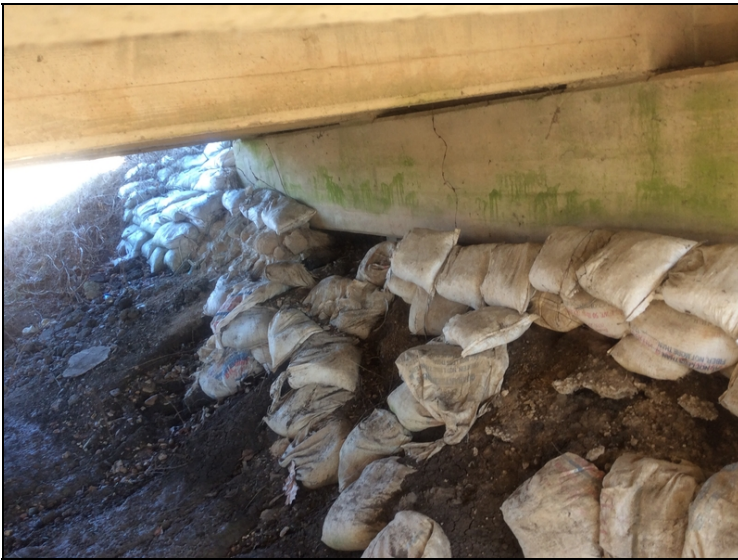
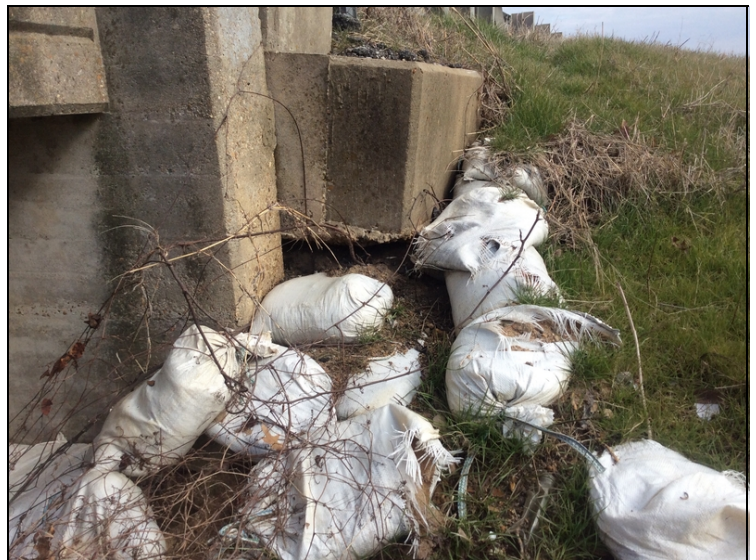
Abutment #2 right monument post

Abutment #2 sacked sand and cement bags have slid down slope in several locations.

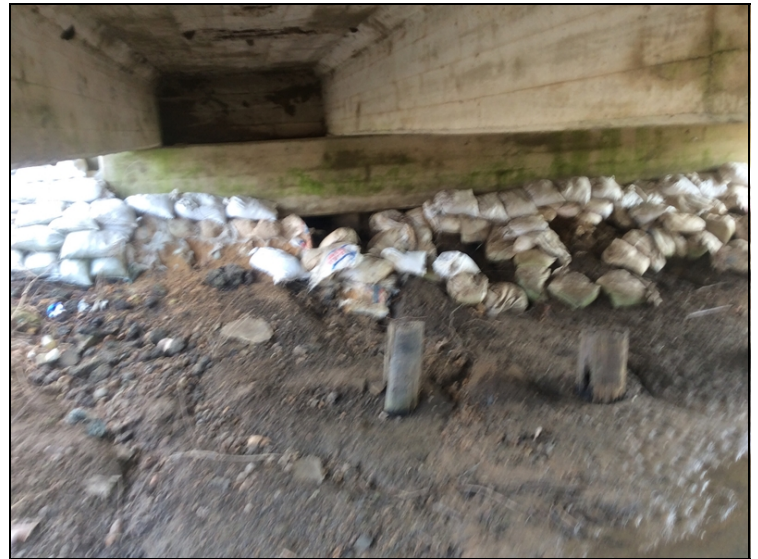
Abutment #2 bags falling down

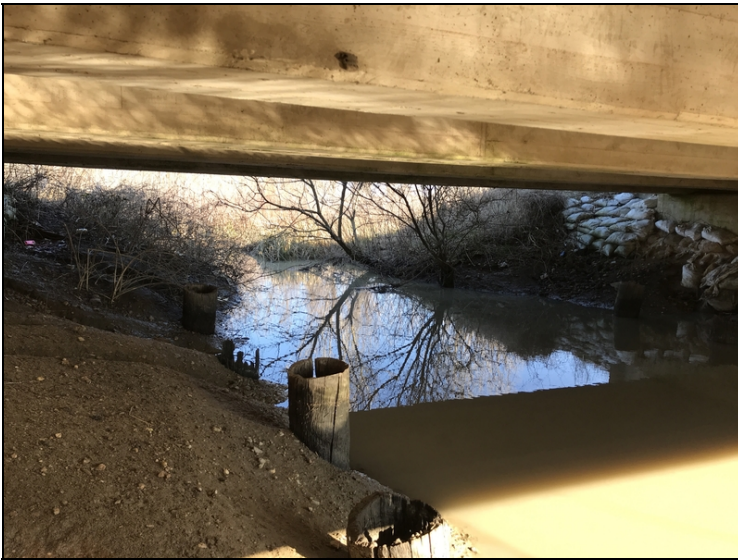
Trees and vegetation are growing beside and under bridge.

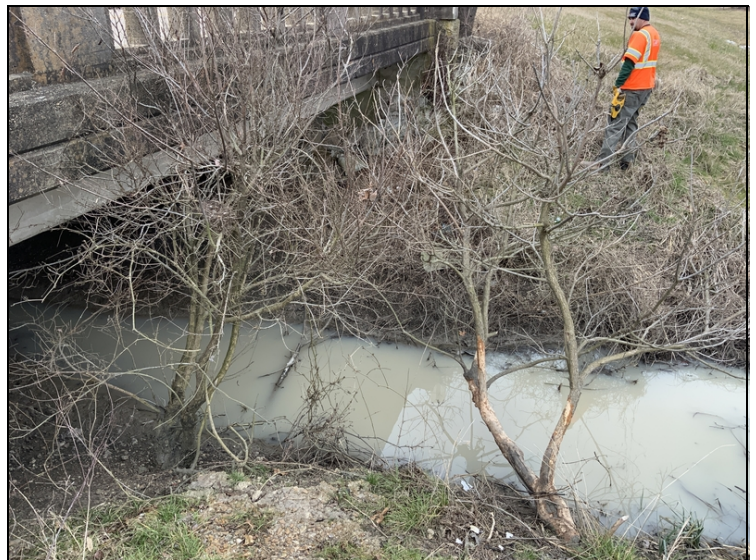
Trees and vegetation growing beside and under bridge.

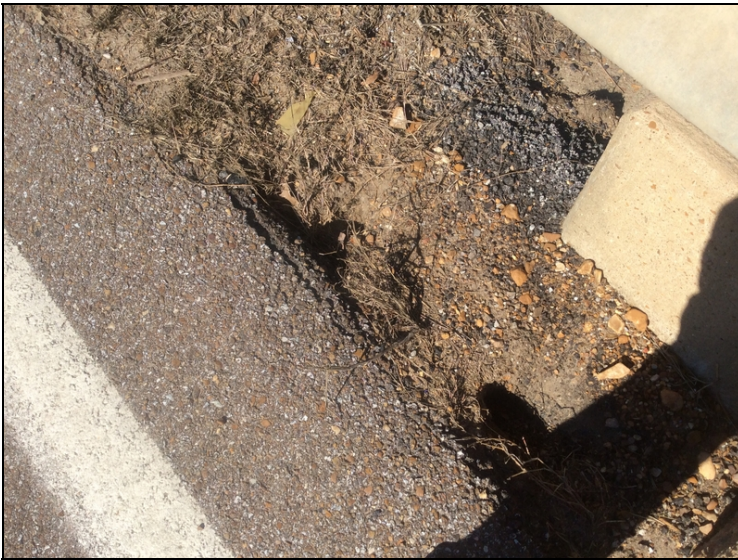
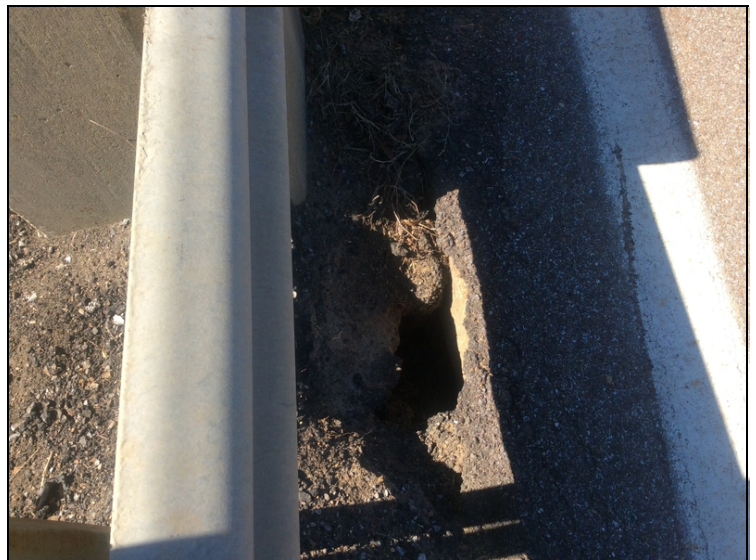
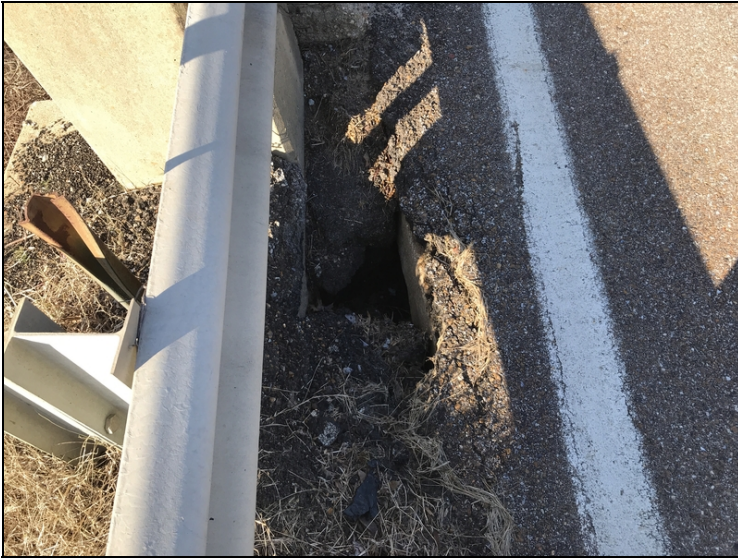
Abutment #1 left side and Abutment #2 right side have holes in edge of shoulder at terminal end posts due to erosion.

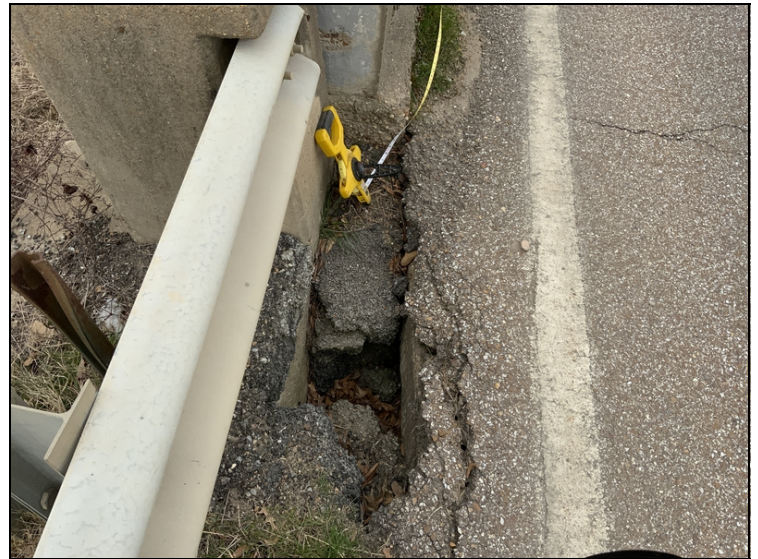
Abutment #2 right side hole in approach shoulder
and void underneath slab.

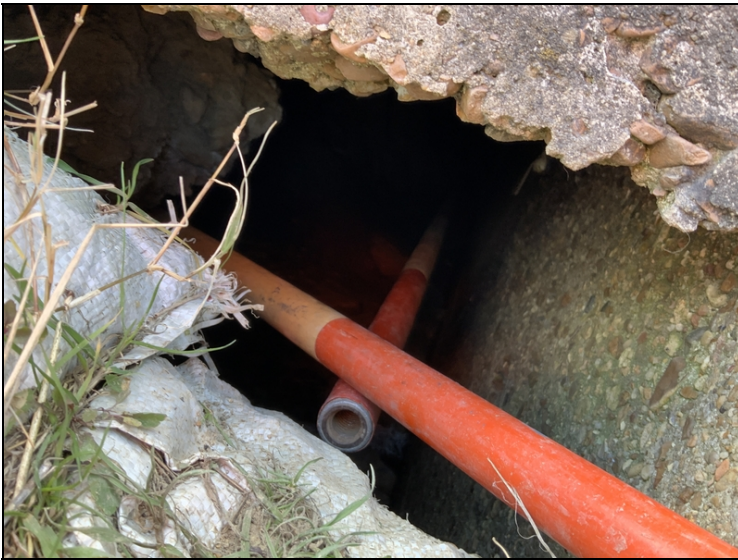
Abutment #2 has large void up to 3' wide by 2' tall, full length behind cap, under approach slab.

Void behind abutment #2 .

1/19/2021-Lowered substructure from 7 5o 5 due to erosion behind abutment #2 cap.

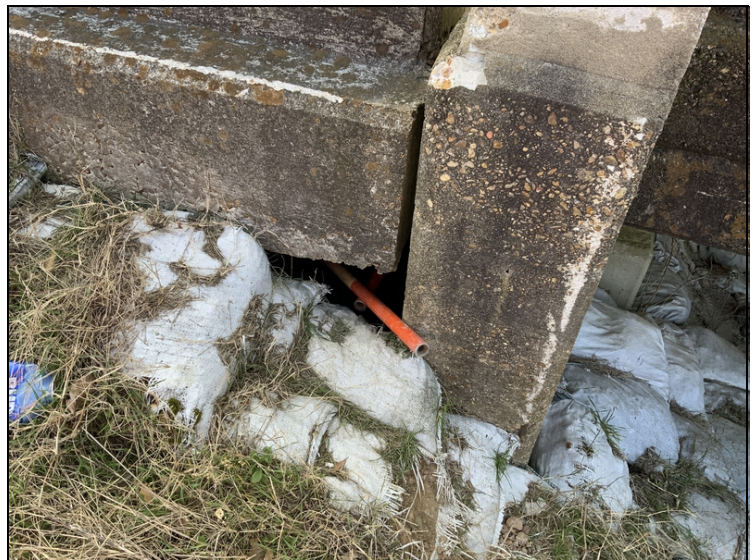
Void behind abutment #2 .

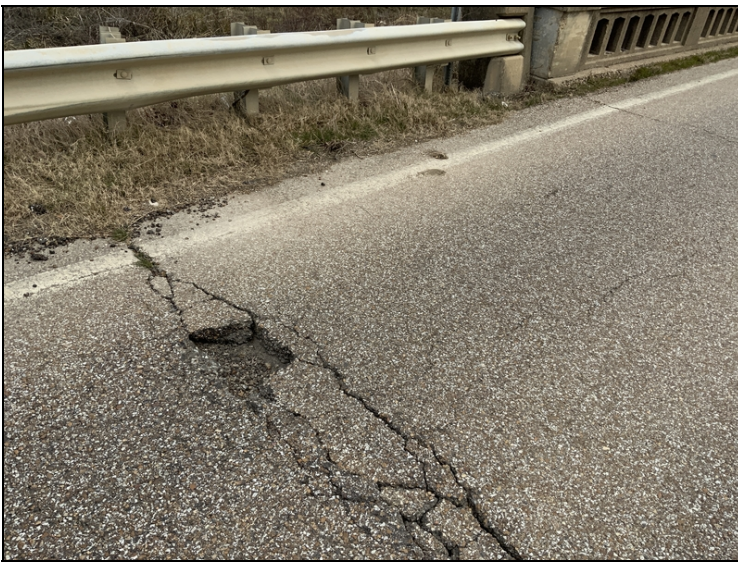
Abutment #1 left lane approach roadway overlay
has 1' spall.
