**Bridge #01374(Routine, Underwater type 2)**

**Us-70/Sec-19/L18.9 over Drainage Canal**

**Location: 1.00 Mi Sw Jct Of Sh 149**

**Team Lead: Myron Futrell Inspection Date: January 13, 2020**

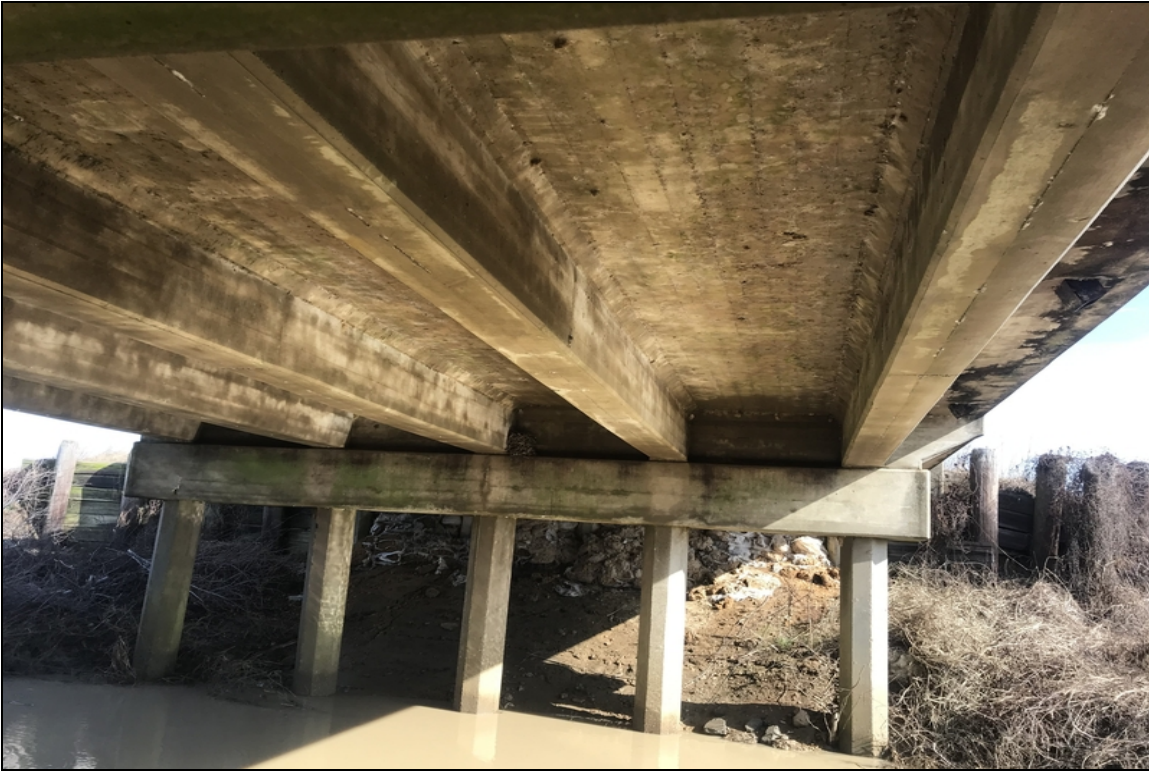
Typical soffit.

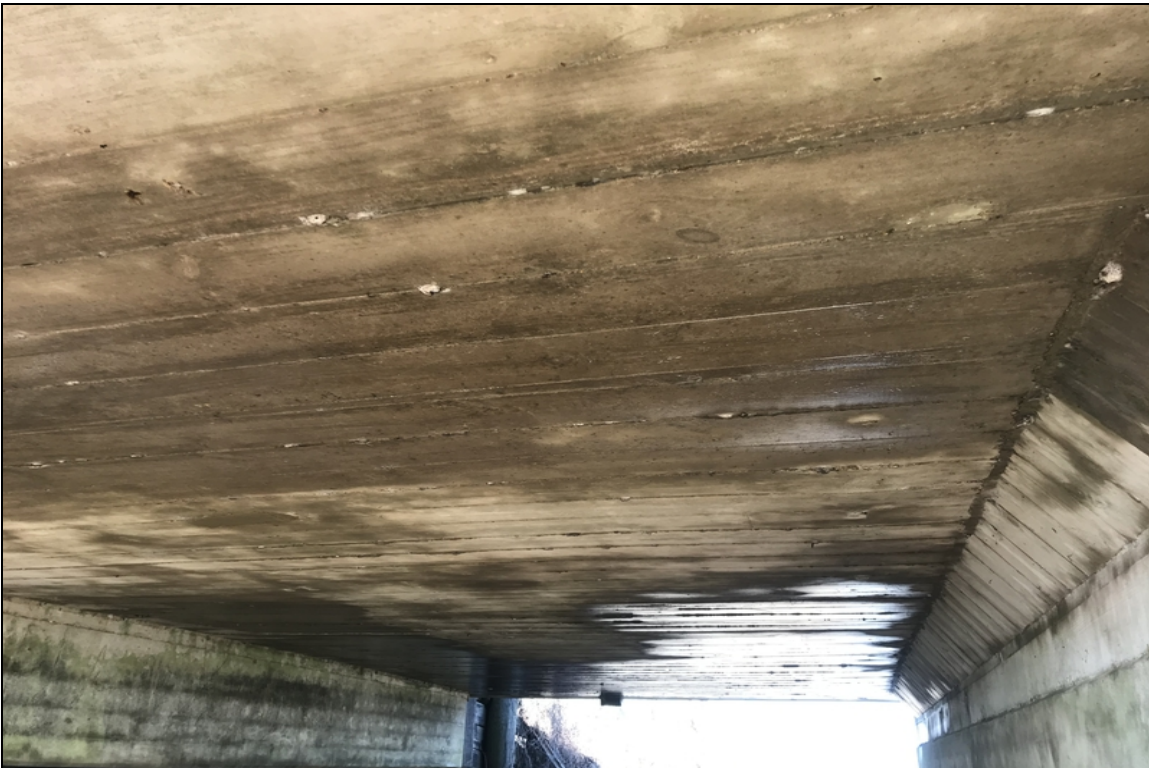
Typical soffit.

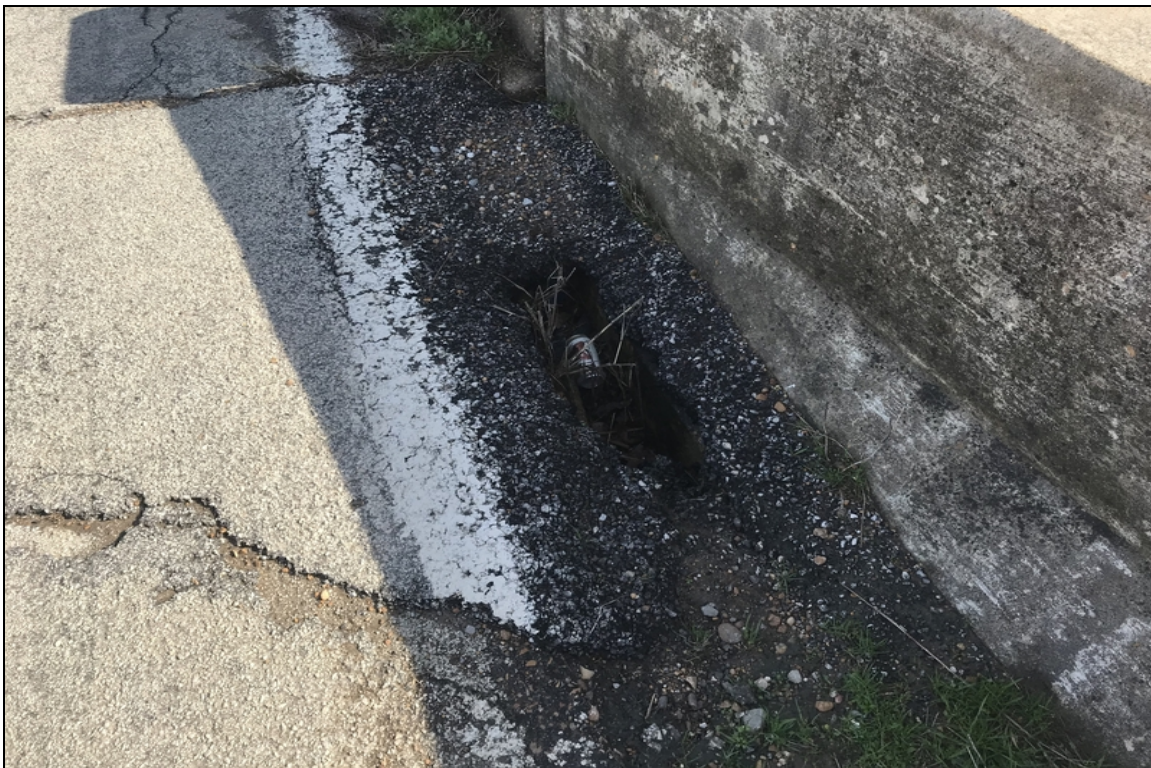
Hole in abutment 1 right approach shoulder.

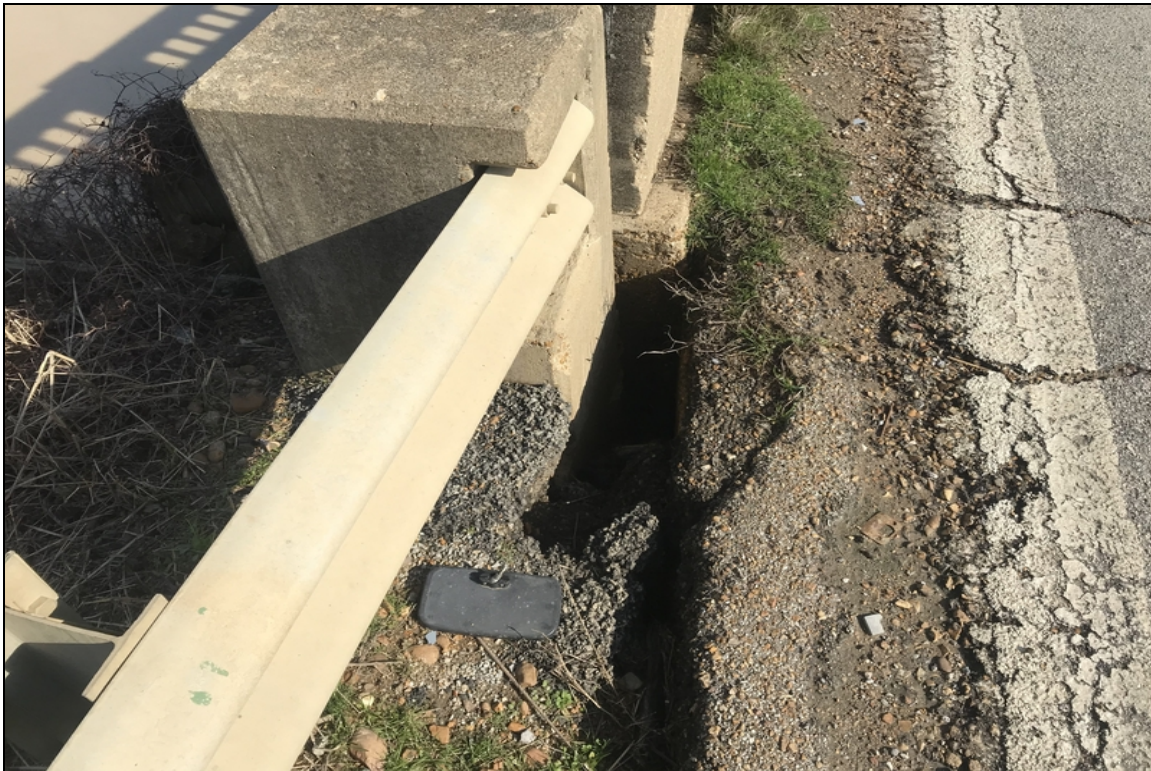
Hole in abutment 1 left approach shoulder.

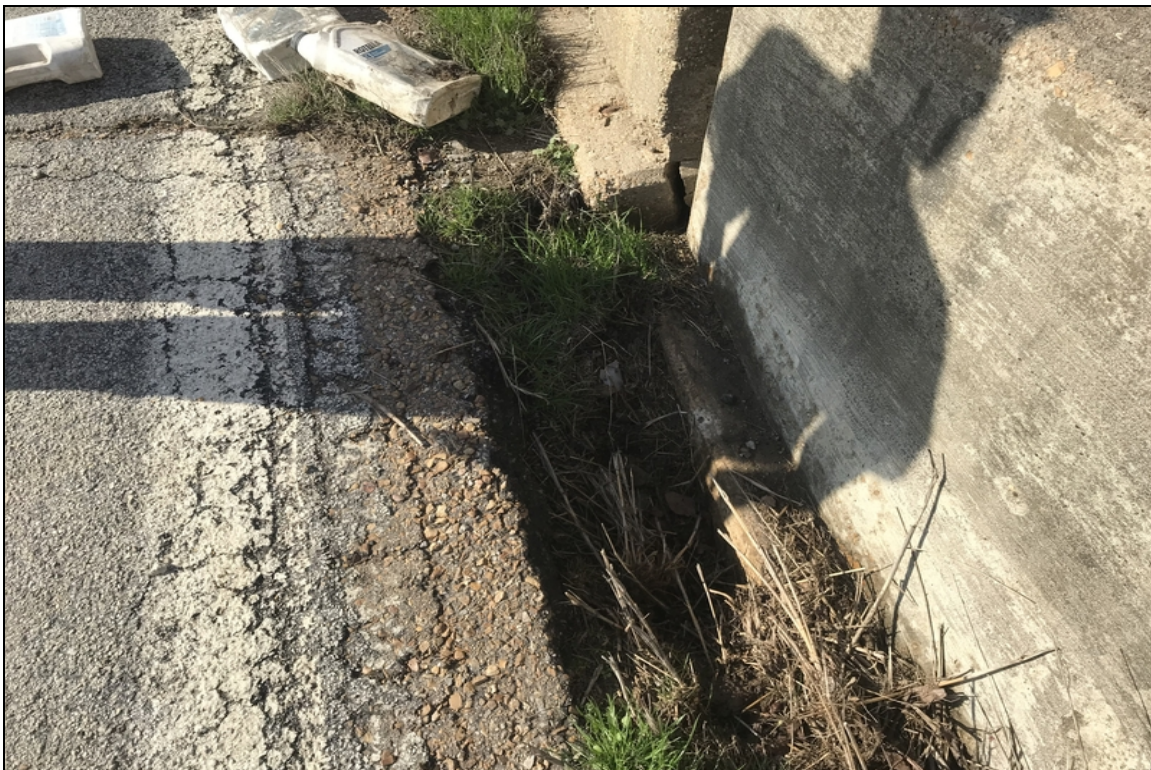
Hole in abutment 2 approach gutter left side.

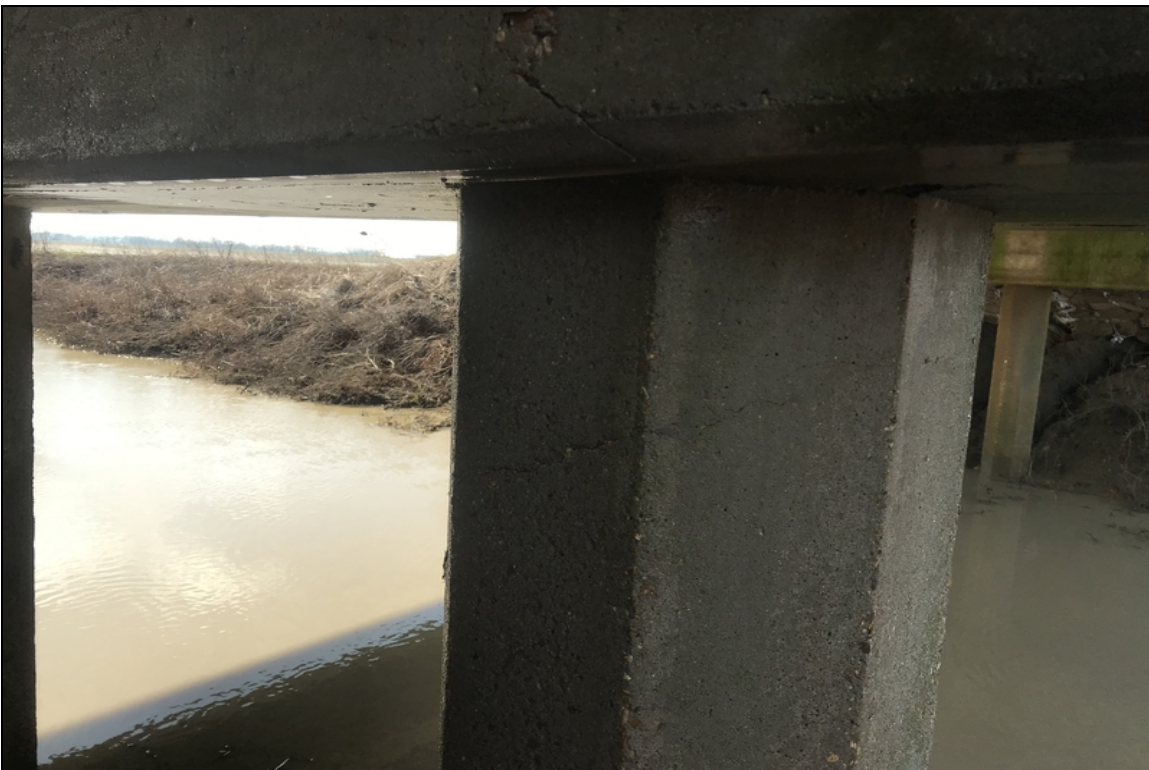
Bent 3 pile 1.

(215)	Abutment 2 left headwall/wing cracked,						
227	Reinforced Concrete Pile	EA	20	20	0	0	0
(227)	Bent 3 pile 1 cracked near cap.						
234	Reinforced Concrete Pier Cap	LF	54	26	4	24	0
1080	Delamination/Spall/Patched Area	LF	20	0	0	20	0

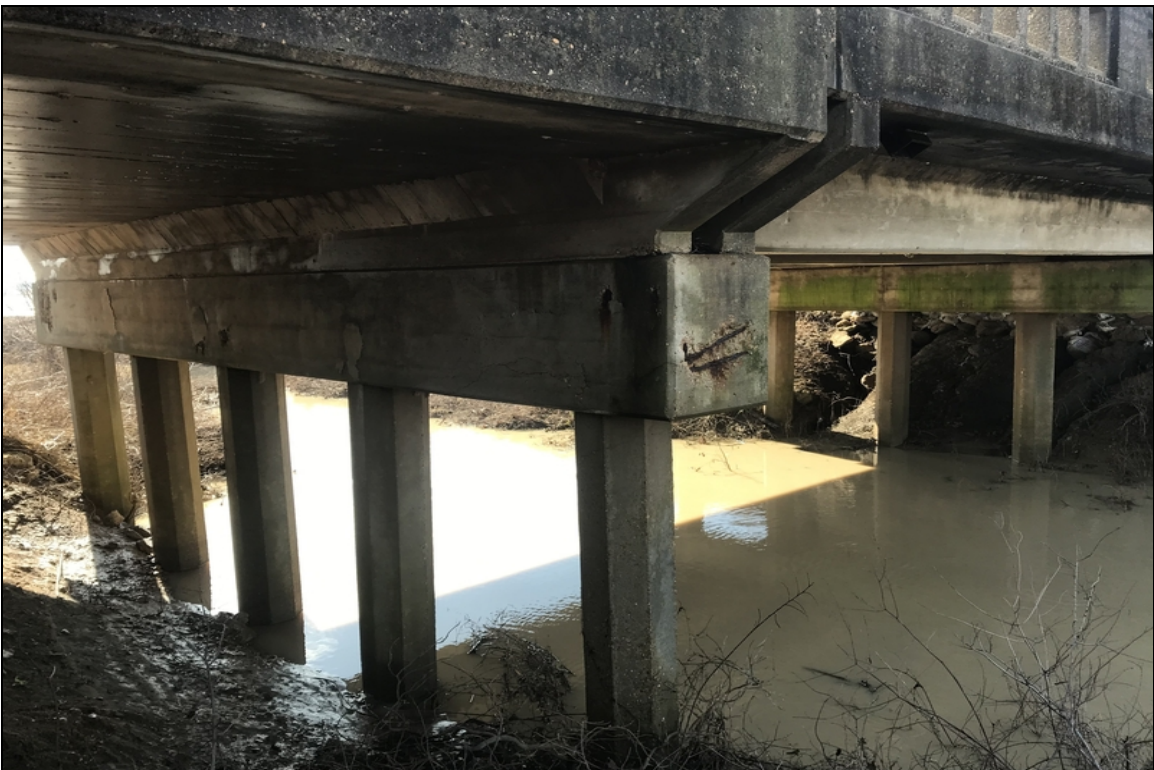
Bent 3 cap left end.

Bent #3 cap has areas of delamination's on both faces, ahead face has two foot spall with exposed rebar towards right end with 5% section loss, and four feet of cracking towards left. Left end has 2' spall with exposed rebar with 5% section loss.

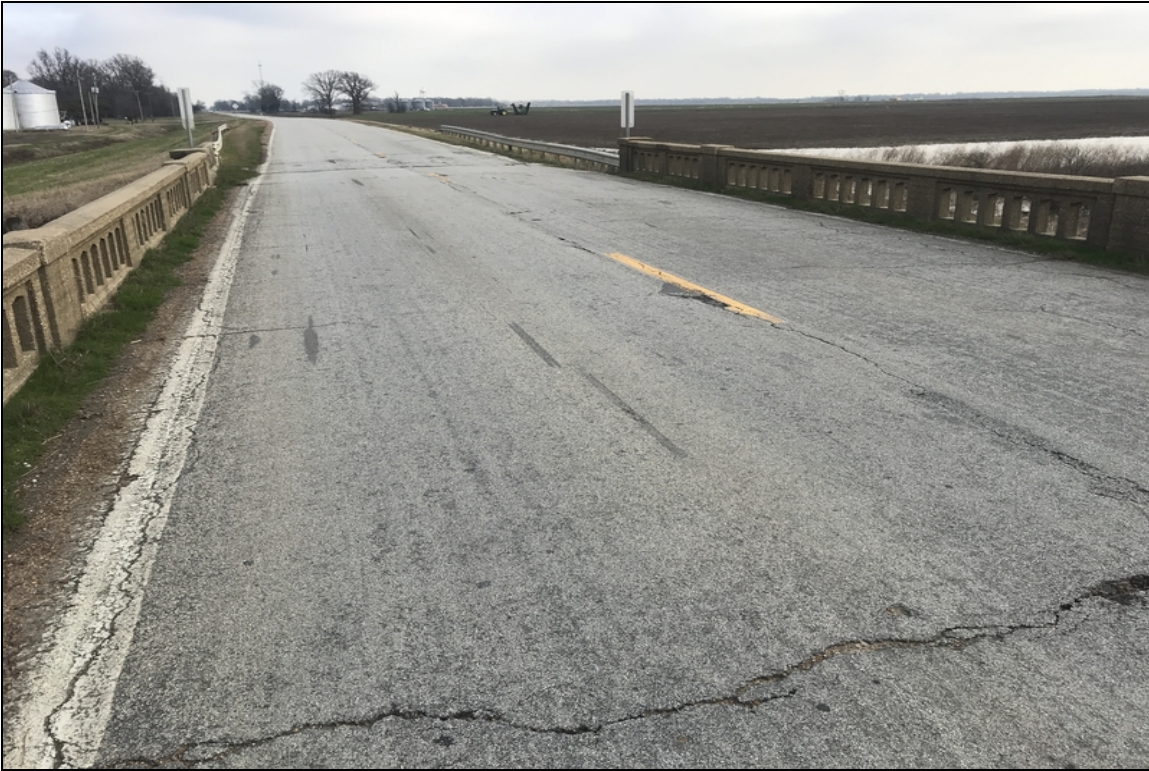
Typical deck.

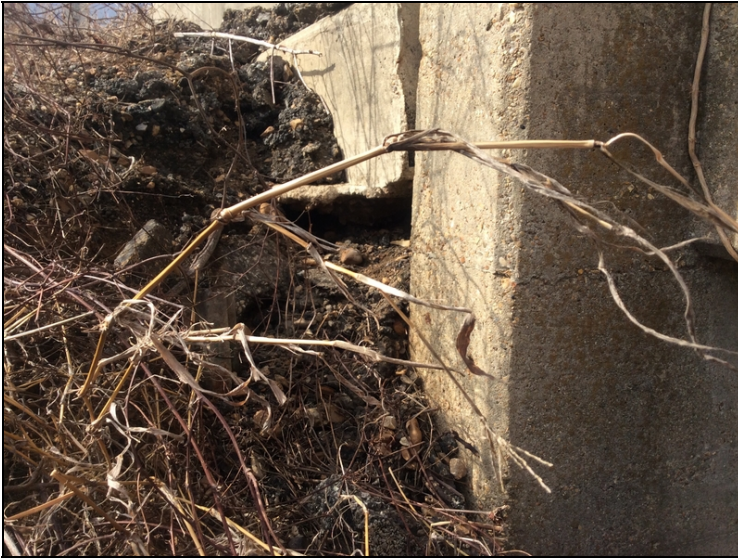
Wing wall abutment #1 right side wall broken and falling down and slope under wing wall eroded.

Abutment #1 right approach gutter undermined  
with hole in roadway

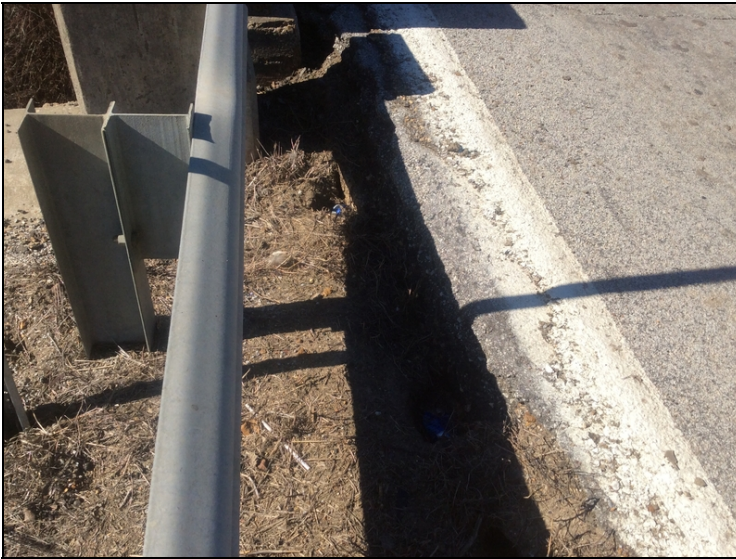
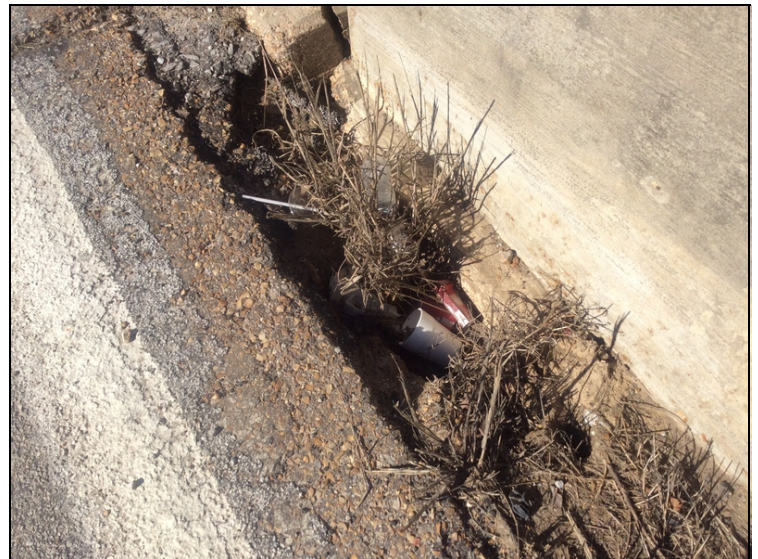
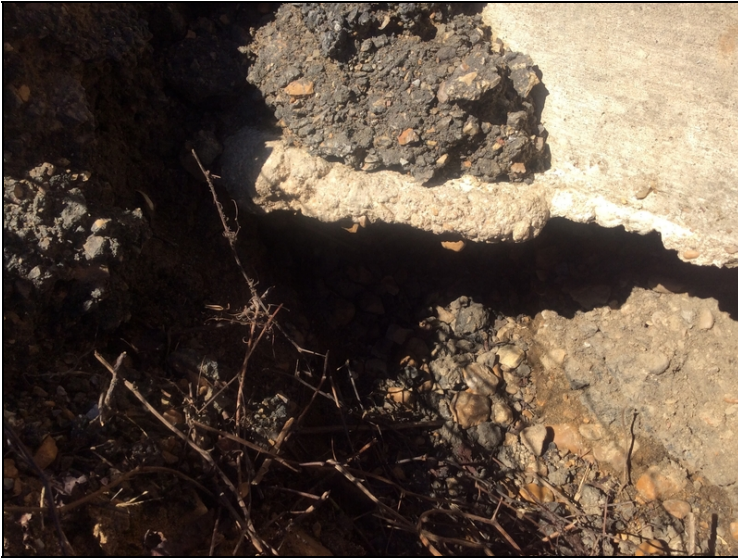
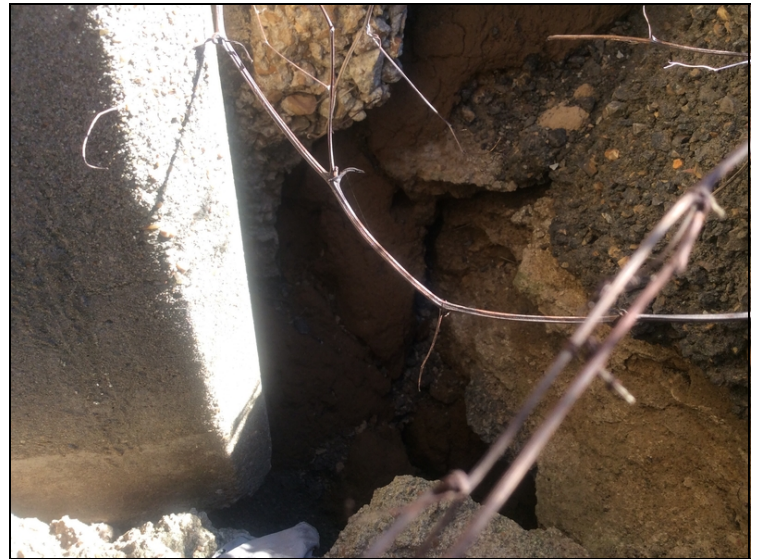
Edge of roadway all four corners are eroding causing holes to form at bridge ends and causing approach slabs to have voids under them.

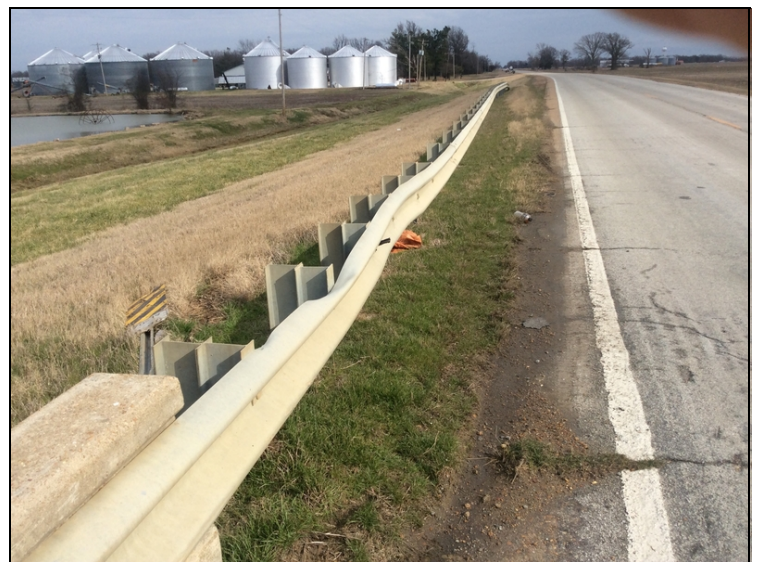
Approach rails abutment #1 right side and abutment #2 both sides have minor collision damage.

Abutment #2 left approach rail minor damage

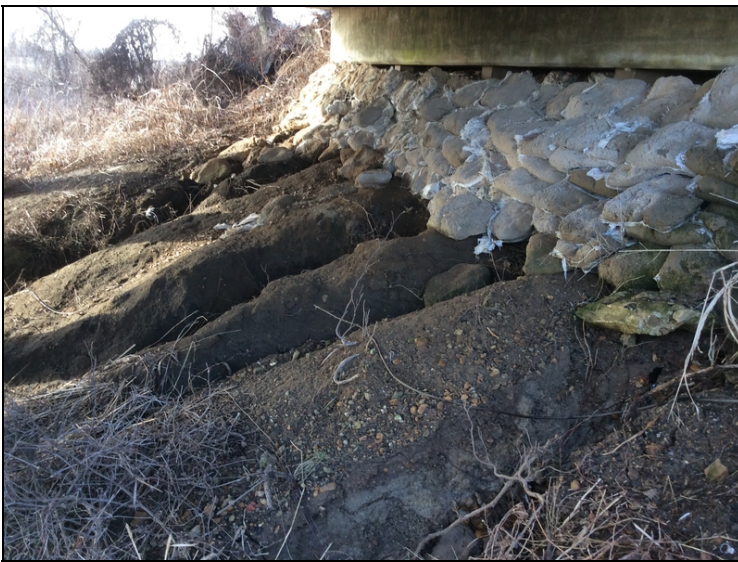
Abutment #1 slope has erosion gulleys up to 2' deep.

Abutment #1 slope has erosion veins up to 2' deep.

01/22/2018 lowered substructure from 7 to 6 to erosion at abutments.

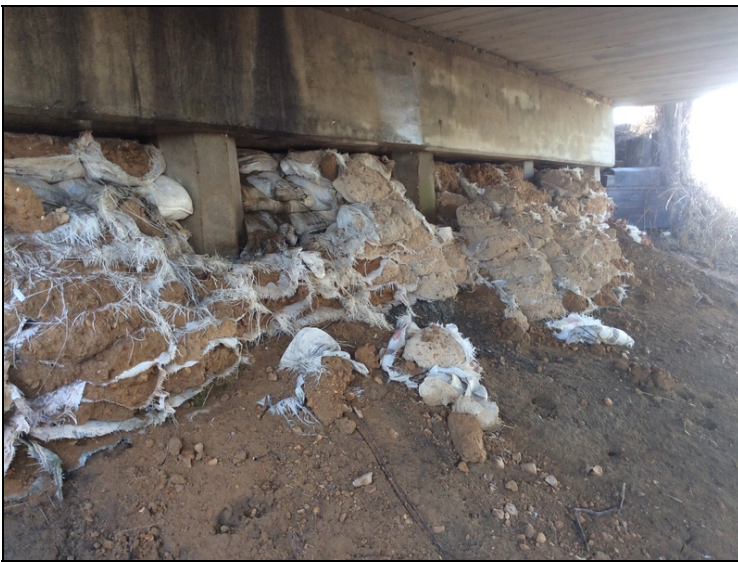
Abutment #2

Both abutments erosion control is starting to fail.

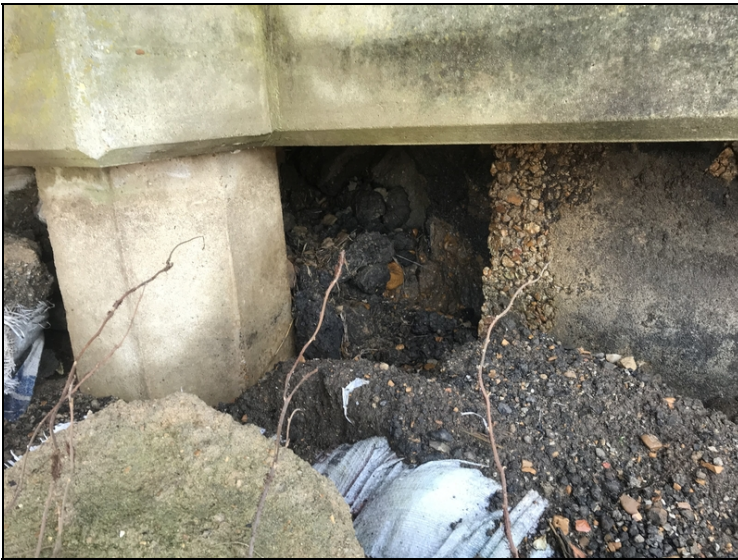
Abutment 1 left side behind pile 1 has a 2' void behind cap.

Void behind abutment 1 cap left side.
