Bridge #01375(Routine)

Us70/Sec-19/L19.83 over Shell Lake

Location: .20 Mi Ne Jct Of Sh 149

Team Lead: Drew Melton Inspection Date: April 26, 2021

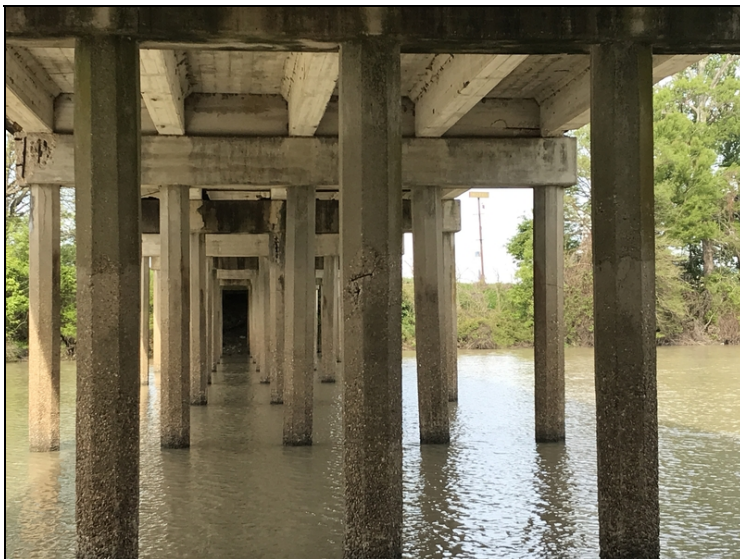
Bent #3 piles #1,2,5 all have vertical crack from top down for 3'  
Bent #5 pile #1 back face has 1' spall at top with exposed rebar with 10% section loss.  
Bent #5 pile #5 has vertical cracks from top down 6' long.  
Bent #7 pile #1 has 2' delamination at top.  
Bent #7 pile #2 has 4' delamination at top.  
Bent #7 pile #4 has 5' long crack from top down.  
Bent #8 pile #1 has 1' crack at top.  
Bent #8 pile #5 cracked at top 2'.  
Bent #9 pile #2 has 1' spall with exposed rebar with no section loss.  
Bent #9 pile #3 has a 1' spall with exposed rebar with 5% section loss.

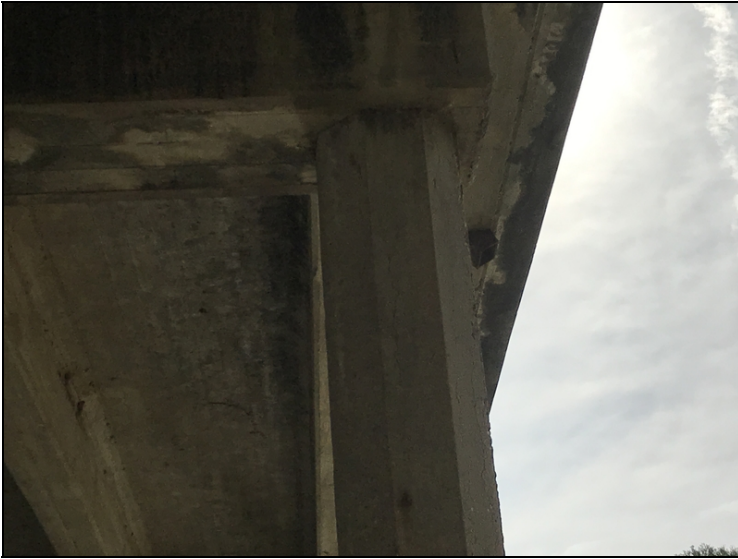
Typical cracks in piles.

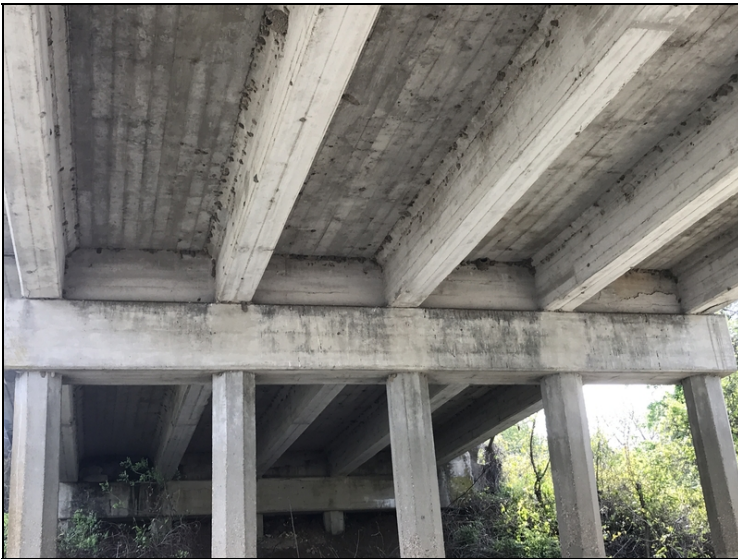
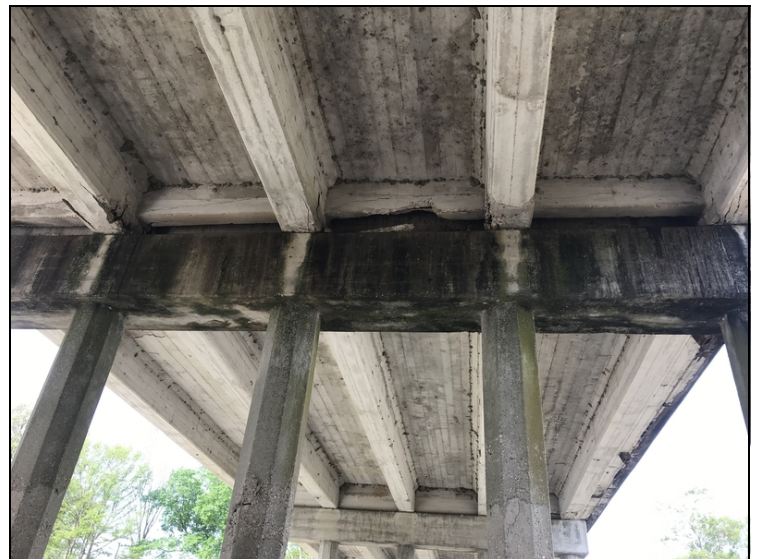
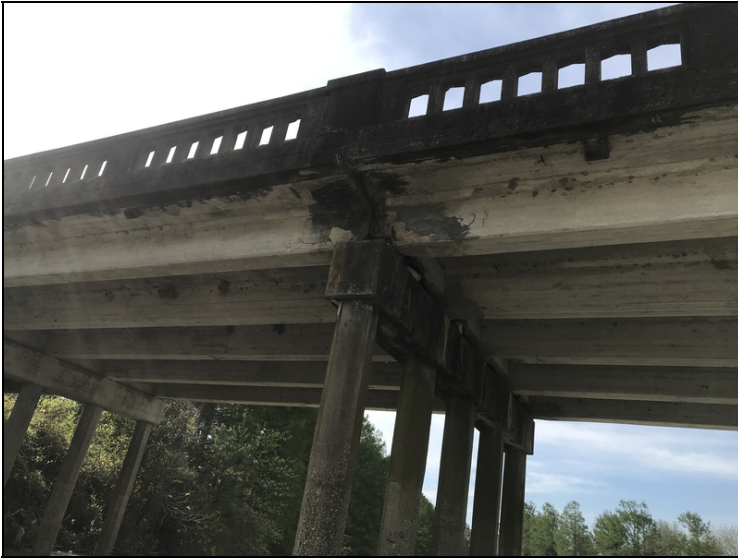
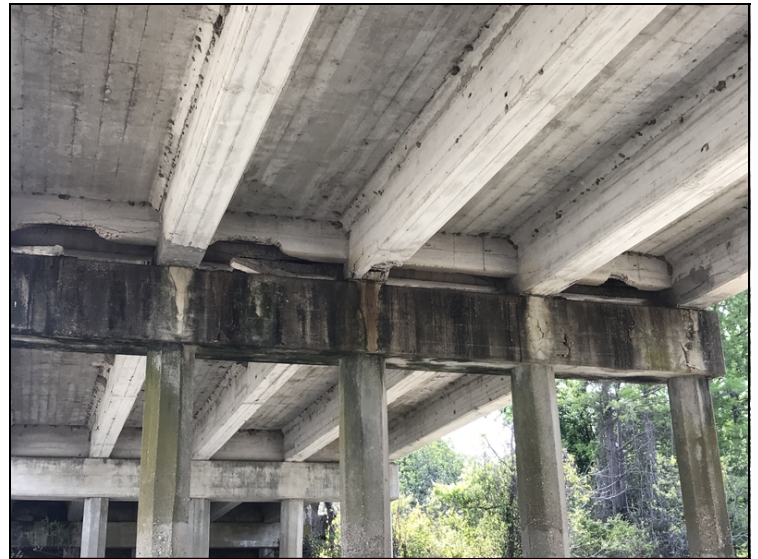
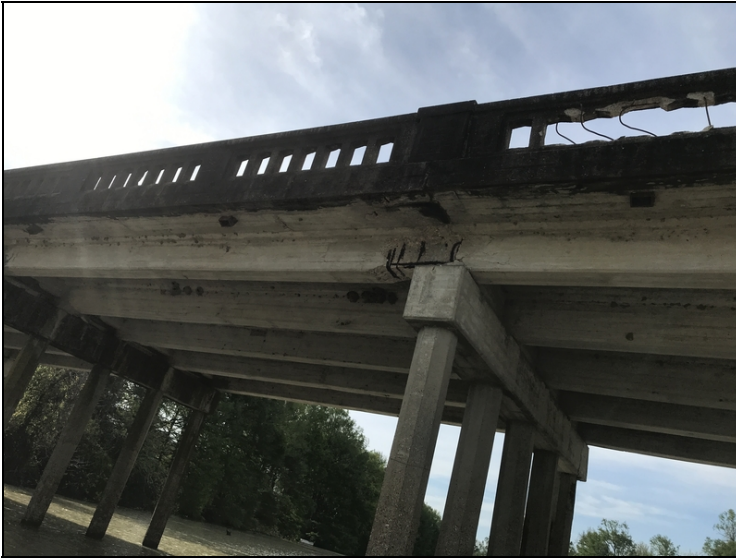
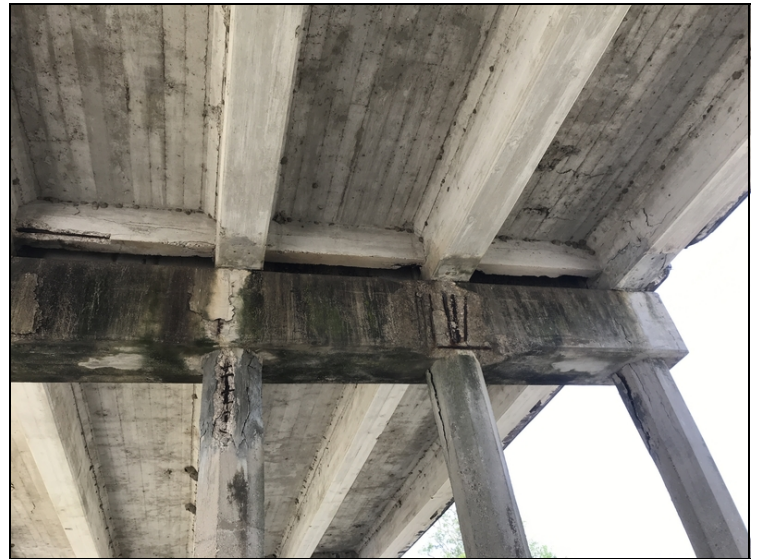
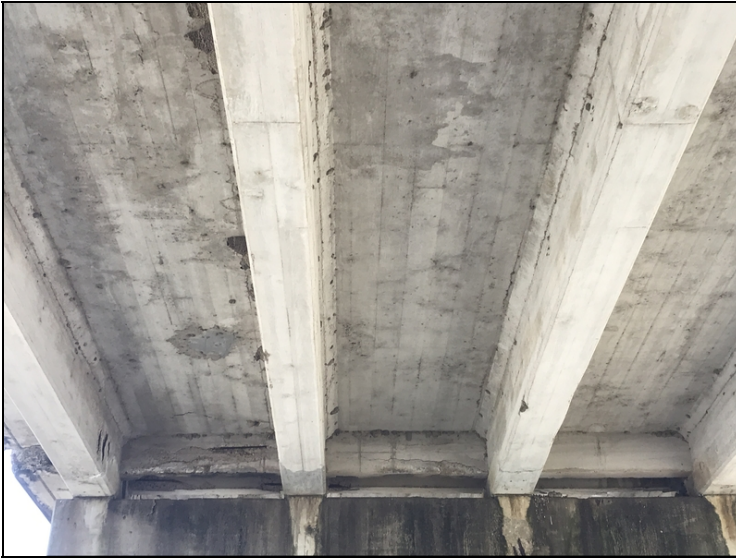
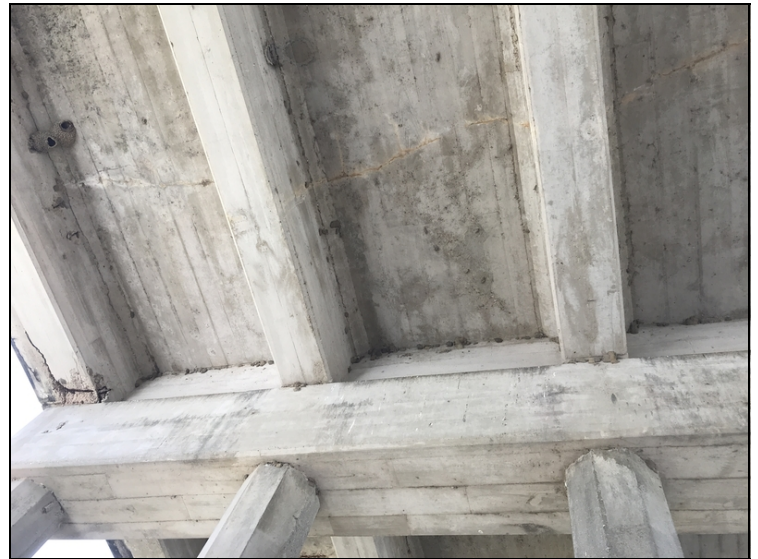
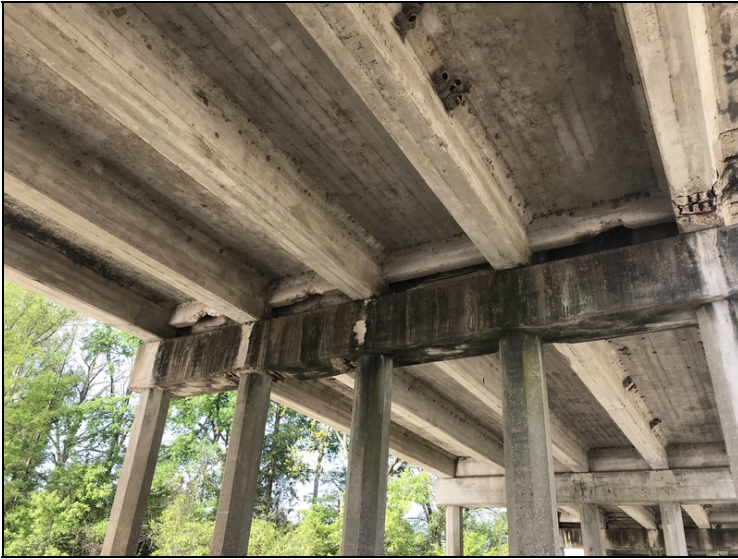
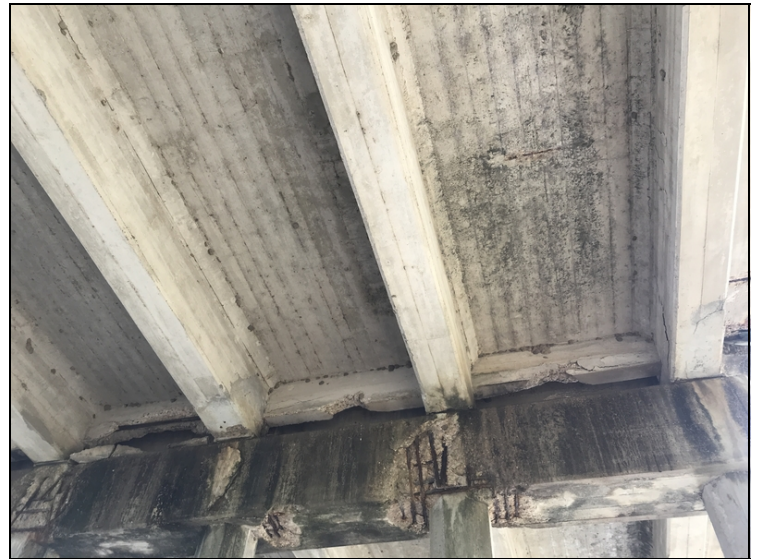
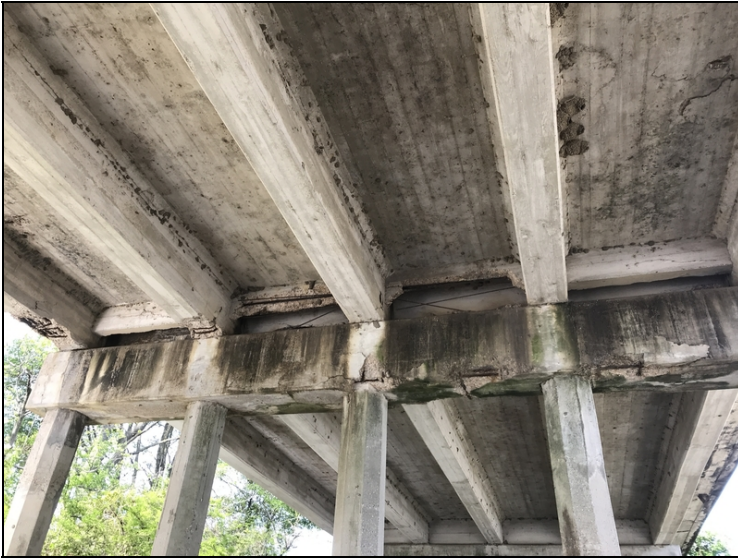
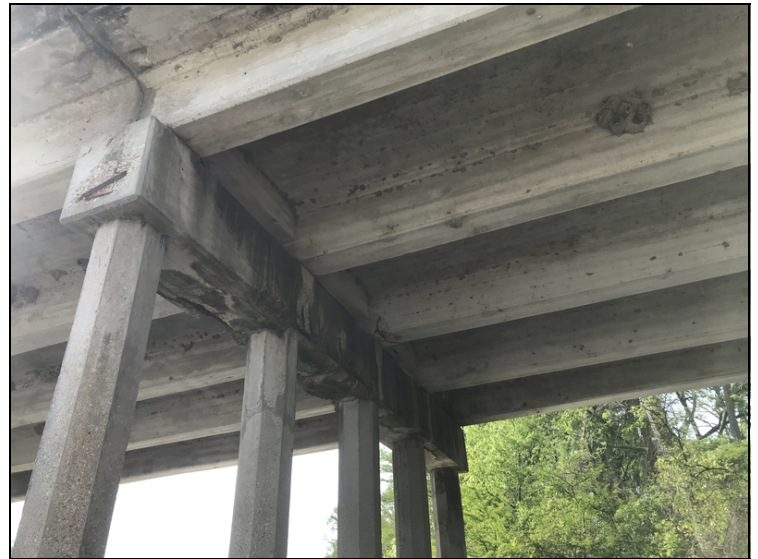
Span #1 girder #1 center span left side has 6' long crack with delamination at bottom.  
Span #1 girder #1 left side at bent #2 has 2' spall with exposed rebar with 5% section loss.  
Span #1 girder #5 bottom at bent #1 has 4' long crack with heavy efflorescence.  
Span #1 girder #5 bottom at bent #2 has 1' long crack.  
Span #2 girder #1 at bent #2 left side has 2' spall with exposed rebar with 5% section loss.  
Span #2 girder #2 at bent #3 left side has 1' delamination.  
Span #2 girder #3 at bent #3 bottom and sides have 1' spall with exposed rebar with 5% section loss.  
Span #2 girder #5 left side has 3' of delamination's near bent #3.  
Span #2 girder #5 bottom at bent #3 has 4' crack with light efflorescence.  
Span #3 girder #1 at bent #3 has 2' delamination on left side.  
Span #3 girder #1 at bent #4 has 1' delamination on left side.  
Span #3 girder #2 left side at bent #3 has 1' delamination.

Span #3 girder #3 at bent #3 left side has 1' delamination.  
Span #3 girder #4 at bent #3 bottom has 1' delamination and 1' spall with exposed rebar with no section loss.  
Span #3 girder #5 bottom at bent #3 has 2' spall with exposed rebar with 10% section loss.  
Span #3 girder #5 right side and bottom at bent #4 has 2' delamination.  
Span #4 girder #1 left side at bent #4 has 2' spall with exposed rebar with 5% section loss.  
Span #4 girder #1 left side at bent #5 has 1' delamination and cracks.  
Span #4 girder #2 left side at bent #5 has 1' delamination.  
Span #4 girder #3 bottom at bent #5 has 1' spall with no rebar exposed.  
Span #4 girder #5 left side at bent #5 has 2' delamination.  
Span #4 girder #5 right side has 2' delamination with 1' spall with exposed rebar with no section loss at bent #5.  
Span #5 girder #1 left outside at bent #5 has 2' delamination with 1' spall with exposed rebar with 10% section loss.

Span #5 girder #1 left outside at bent #6 has 3' delamination.  
Span #5 girder #1 right side at bent #6 has 2' delamination.  
Span #5 girder #5 at bent #5 has 2' spall with exposed rebar with 5% section loss.  
Span #5 girder #5 at bent #6 bottom and right side has 2' spall with exposed rebar with 5% section loss.  
Span #6 girder #1 left side at bent #6 has 3' crack on bottom and sides.  
Span #6 girder #1 right side at bent #7 has 1' delamination and 1' spall with exposed rebar with no section loss.  
Span #6 girder #5 near bent #5 has 2' delamination on bottom stating up sides with 1' spall with exposed rebar with 10% section loss.  
Span #6 girder #5 at bent #7 right side has 2' spall with exposed rebar with 10% section loss.  
Span #7 girder #1 left side at bent #7 has 3' delamination with 1' spall with exposed rebar with 10% section loss.  
Span #7 girder #1 left side at bent #8 has 2' of cracks and delamination.

Span #7 girder #1 right side at bent #7 has 2' delamination.  
Span #7 girder #2 left side at bent #8 has 1' delamination.  
Span #7 girder #5 left side and bottom at bent #7 has 3' delamination, right side spalled with exposed rebar with 10 % section loss.  
Span #7 girder #5 right side at bent #8 has 2' spall with exposed rebar with 5% section loss.  
Span #8 girder #1 left side at bent #8 has 3' spall with exposed rebar with 10% section loss.  
Span #8 girder #1 left side at bent #9 has 2' delamination and a 2' spall with exposed rebar with 5% section loss.  
Span #8 girder #1 right side at bent #9 has 1' spall with exposed rebar with 10% section loss.  
Span #8 girder #2 has two 6' long cracks in bottom one at each bent.  
Span #8 girder #2 at bent #9 right side has 1' spall with exposed rebar with 5% section loss.  
Span #8 girder #3 at bent #9 last 2' on bottom and both sides cracked with 1' spall with exposed rebar with 5% section loss on bottom.

Span #8 girder #4 at bent #9 last 2' bottom and left side is cracked.  
Span #8 girder #5 at bent #9 is cracked and delaminated last 3' on bottom and spalled on outside with exposed rebar with 5% section loss.  
Span #9 girder #1 left side and bottom at bent #9 has 3' of cracks and delamination's.  
Span #9 girder #1 left side at bent #10 has 2' delamination.

Span #9 girder #2 at bent #9 left side and bottom has 2' spall with exposed rebar with 5% section loss.  
Span #9 girder #3 at bent #9 has 1' delamination on left and right sides.  
Span #9 girder #4 at bent #9 left side has 1' spall with exposed rebar with 5% section loss.  
Span #9 girder #4 at bent #9 right side has 2' delamination.  
Span #9 girder #5 at bent #9 right side has 2' spall with exposed rebar with 10% section loss with cracking on bottom.  
Span #9 girder #5 right side has 2' delamination and spall with exposed rebar with 10% section loss.  
Span #10 girder #1 left outside at bent #10 has 2' delamination.  
Span #10 girder #1 left outside at bent #11 is cracked for 1' and has 6" of rebar exposed with no section loss.  
Span #10 girder #2 right side at bent #11 has 1' spall with exposed rebar with 10% section loss.  
Span #10 girder #2 right side has 3' of small delamination's from mid-span on.

Span #10 girder #3 right side at bent #11 has 1' delamination.  
Span #10 girder #4 left side at bent #11 has 1' delamination and 1' spall with exposed rebar with no section loss.  
Span #10 girder #5 left side at bent #11 has 1' spall with exposed rebar with 10% exposed rebar.  
Span #10 girder #5 at bent #10 has 1' spall with exposed rebar with 10% section loss.

Span #9 bent #9 girder.

Span #9 bent #9 girders.

Bent #9 left side girders.

Span #8 bent #9 girders

Bent #8 left side girder

Span #7 bent #7 ahead face girders

Span #6 bent #7 girders.

Span #6 bent #6 girders

Span #5 girders at bent #5

Girders span #4 bent #5

Girders span #3 bent #3

Girders span #2 bent #3

04/24/2017 Lowered superstructure from 6 to 5 due to large number of cracks, delamination's, and spalls at shear zones at end of girders.

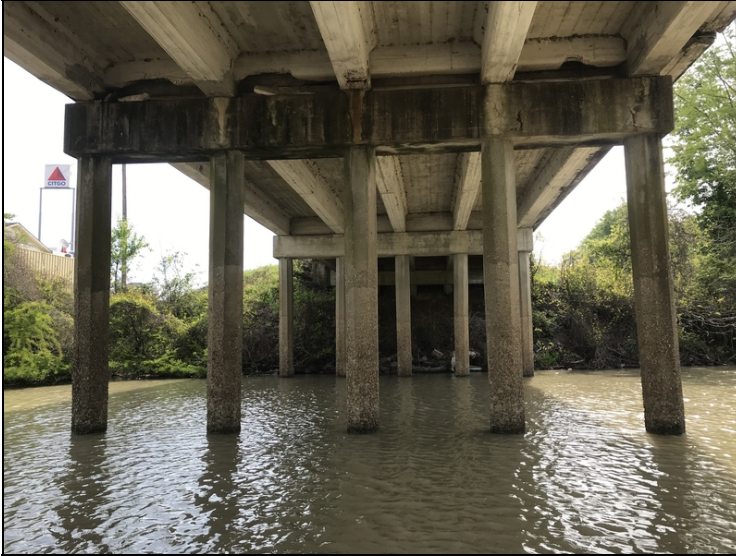
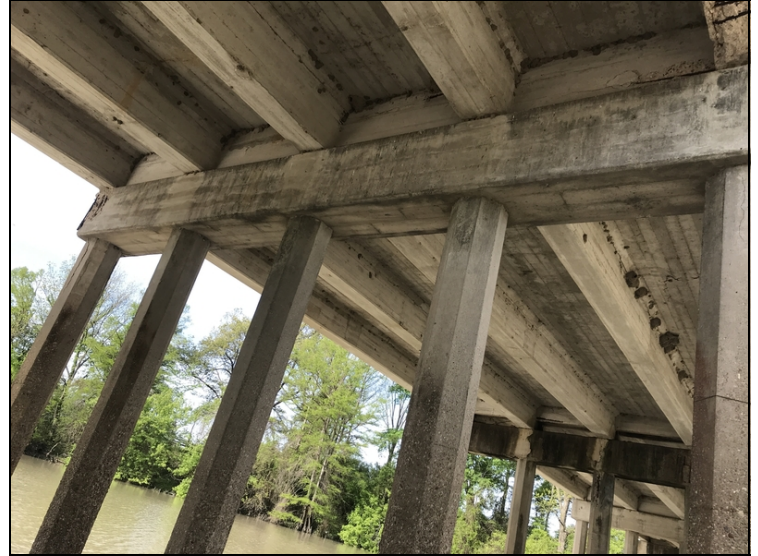
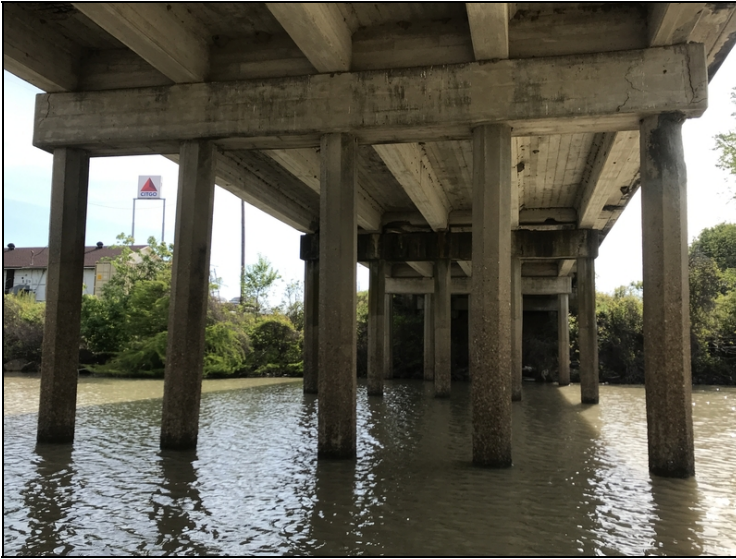
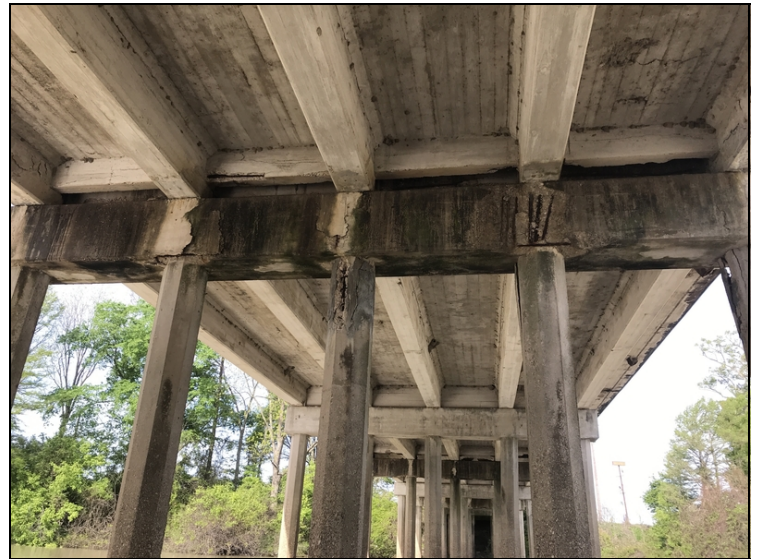
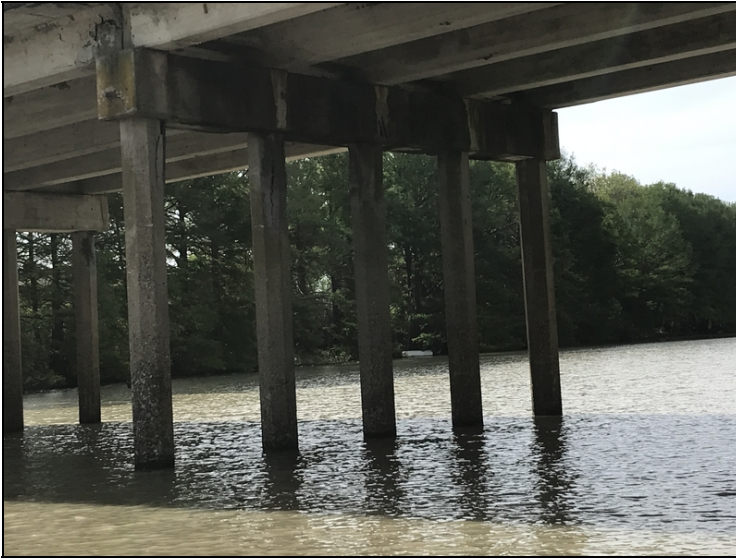
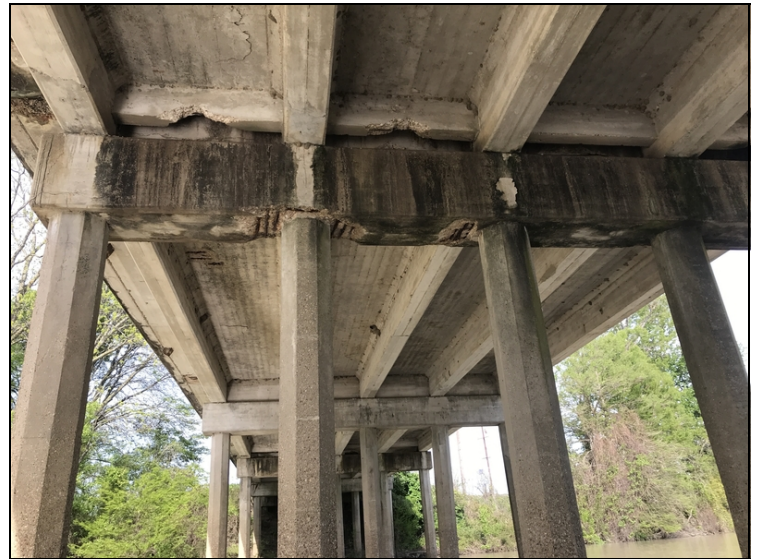
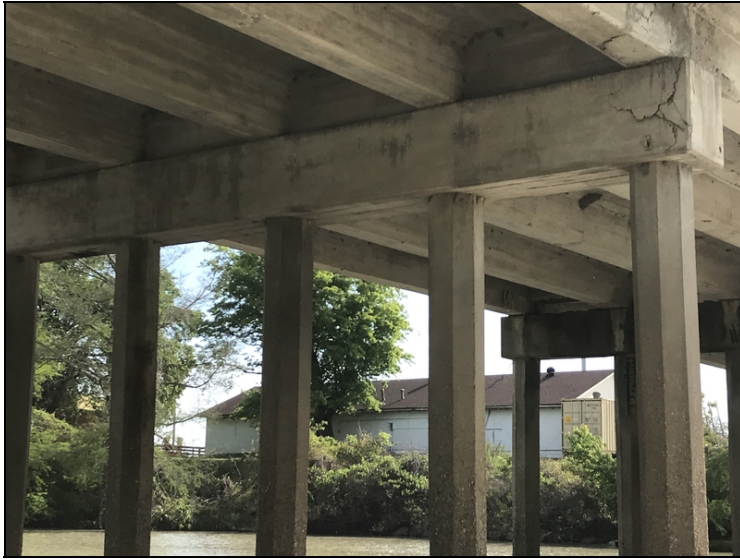
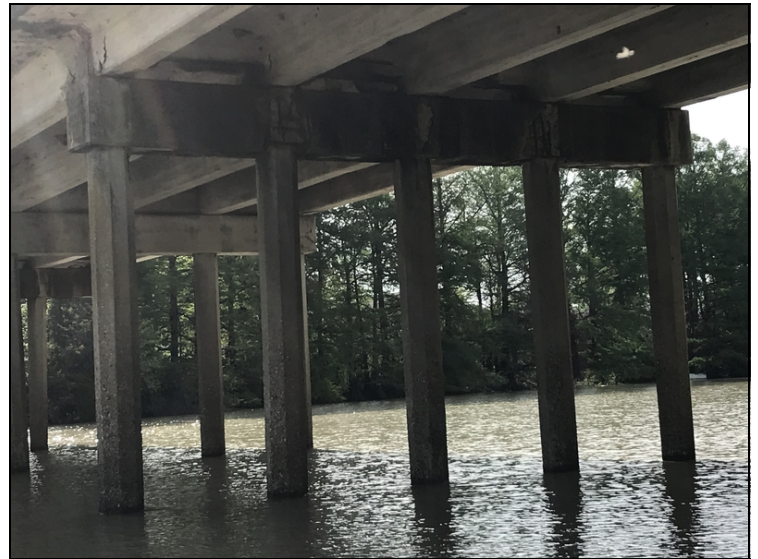
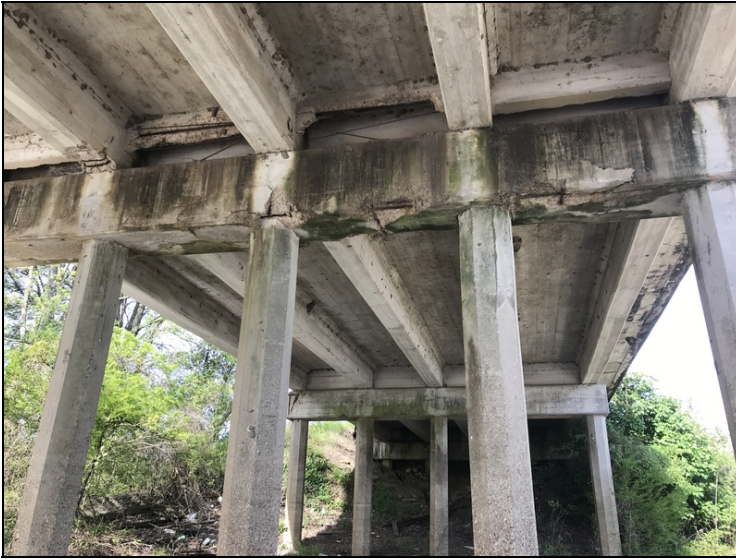
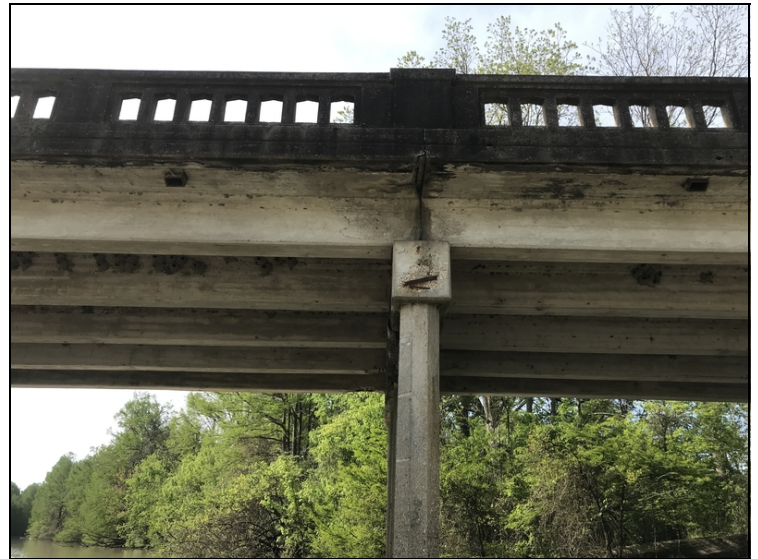
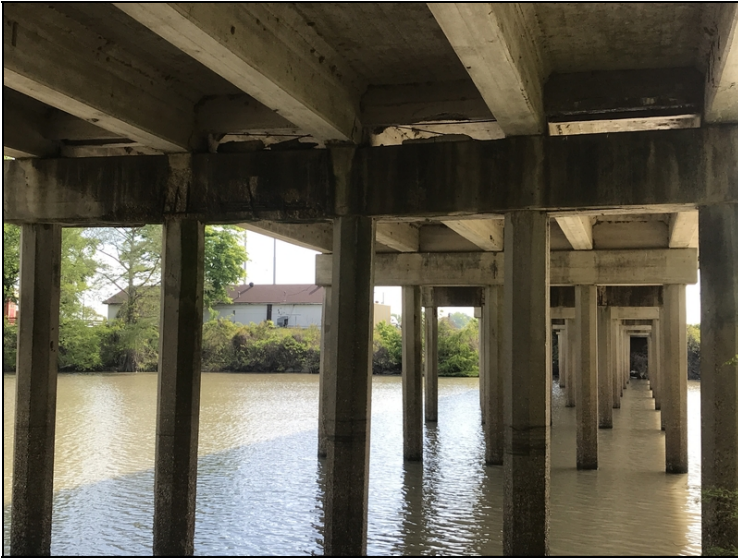
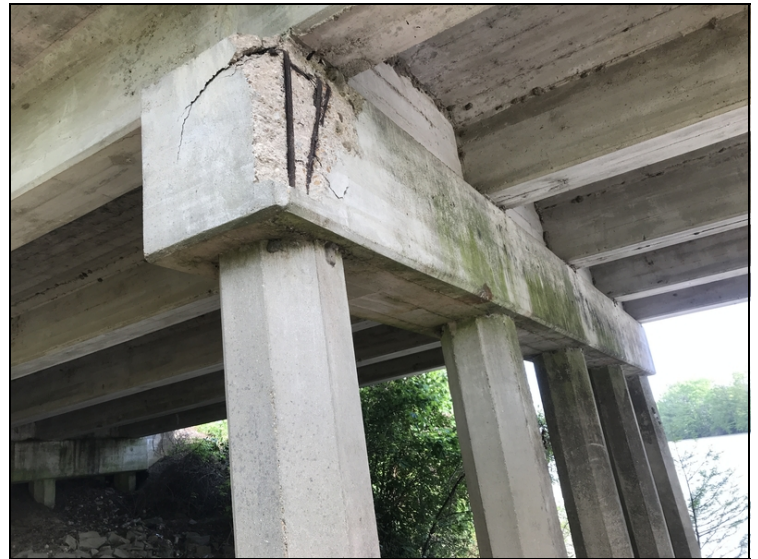
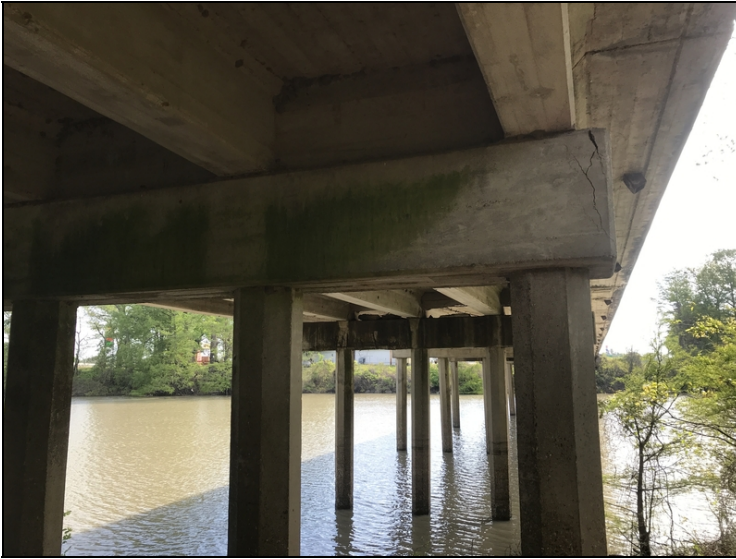
Bent #2 cap right end back face is cracked and delaminated for 2'.  
Bent #2 cap right end ahead face has 2' spall with exposed rebar with 5% section loss.  
Bent #2 cap left end has 1' spall with exposed rebar no section loss.  
Bent #3 cap left end has 2' spall with exposed rebar with no section loss.  
Bent #3 cap back face has 6' spall between piles #1,3 with exposed rebar with 10% section loss.  
Bent #3 cap bottom has 2' spall with exposed rebar between piles #1,2 with 10% section loss.  
Bent #3 cap has 2' spall between piles #2,3 with exposed rebar with 10% section loss.  
Bent #3 cap ahead face between piles #1,2 has 3' spall with exposed rebar with 5% section loss.  
Bent #3 cap ahead face between piles #2,3 has a 2' spall with exposed rebar with no section loss.  
Bent #3 cap ahead face above pile #3 has 2' delamination.  
Bent #3 cap ahead face right end has vertical crack.  
Bent #5 cap back face has 2' spall above pile #2 with exposed rebar with 10% section loss.

Bent #5 cap back face has 1' spall above pile #3 with exposed rebar with 5% section loss.  
Bent #5 cap bottom by pile #3 has 1' spall with exposed rebar with 5% section loss and a 1' delamination.  
Bent #5 cap back face has 2' delamination with 1' spall with exposed rebar with 10% section loss.  
Bent #5 cap bottom has two 1' spalls with exposed rebar with 10% section loss one on each side of pile #4.  
Bent #5 cap ahead face has 1' delamination above pile #3.  
Bent #6 cap right back face end has 2' delamination.  
Bent #6 cap left back face has 2' delamination.  
Bent #7 cap back face has 6" spall with rebar exposed with 5% section loss above pile #2.  
Bent #7 cap back face has 1' spall exposed rebar with 10% section loss above pile #3.  
Bent #7 cap left end has 1' spall with exposed rebar with no section loss.  
Bent #7 cap ahead face above pile#2 has a 3' spall with exposed rebar with 10% section loss.

Bent #7 cap ahead face above pile #3 has 2' delamination with 1' spall with exposed rebar with no section loss.  
Bent #7 cap ahead face above pile #4 has 2' delamination with 1' spall on bottom with exposed rebar with 5% section loss.  
Bent #8 cap right end ahead face spalled 2' with exposed rebar with 5% section loss.  
Bent #8 cap right end back face last 2' is cracked and delaminated.  
Bent #8 cap left end back face last 1' is cracked.  
Bent #9 cap right back face has 2' crack with delamination.  
Bent #9 cap above pile #4 back face has 2' delamination, 1' spall with exposed rebar with 5% section loss.  
Bent #10 cap right end has 1' spall with exposed rebar with 5% section loss.

Bent #9 cap back face

Bent #8 cap ahead face

Bent #8 cap back face

Span #7 cap ahead face

Bent #7 back face

Bent #5 cap ahead face

Bent #6 cap back face

Bent #5 cap back face

Bent #3 cap ahead face

Bent #3 cap left end

Bent #3 cap back face

Bent #2 cap ahead face

Bent #2 right end

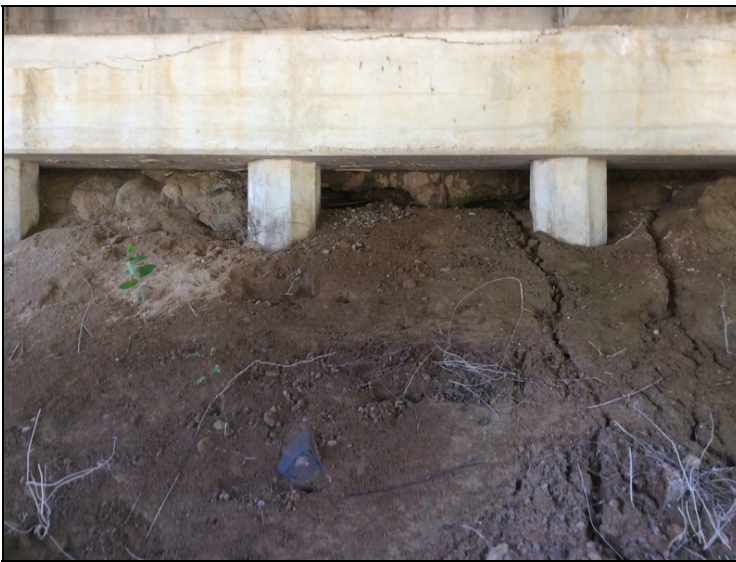
Abutment #2 is undermined 2'.

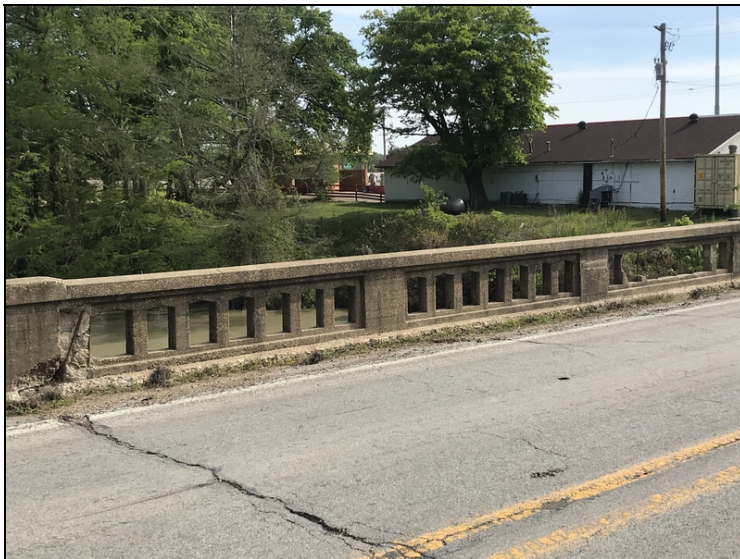
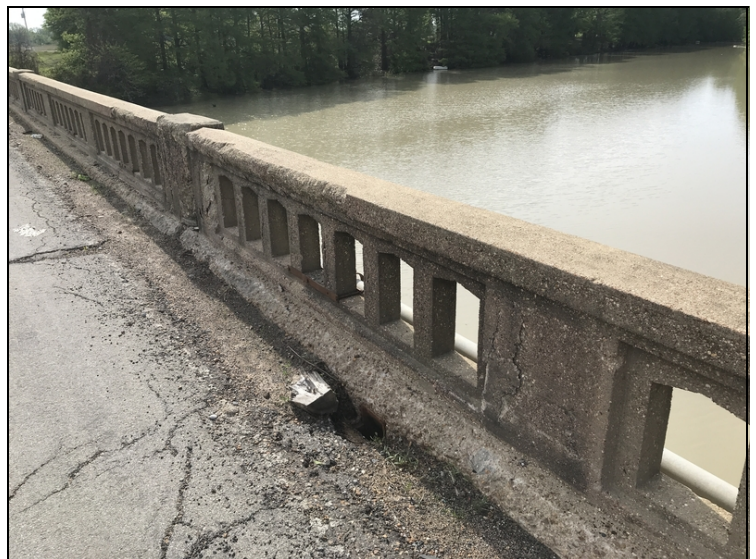
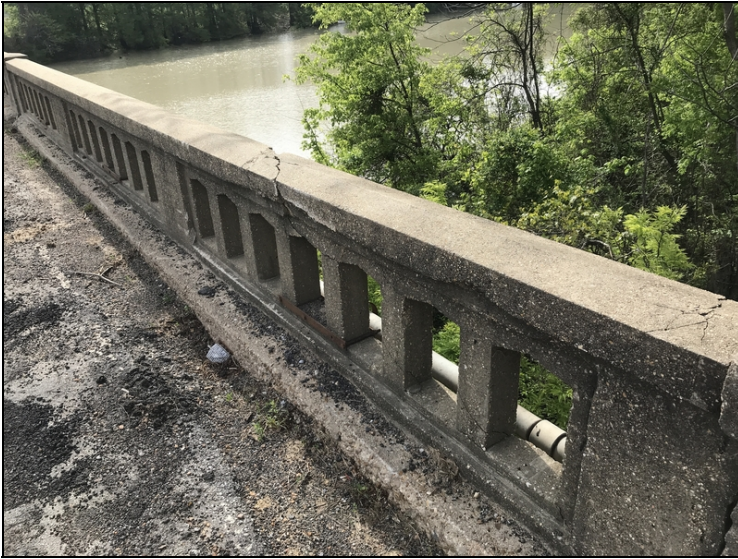
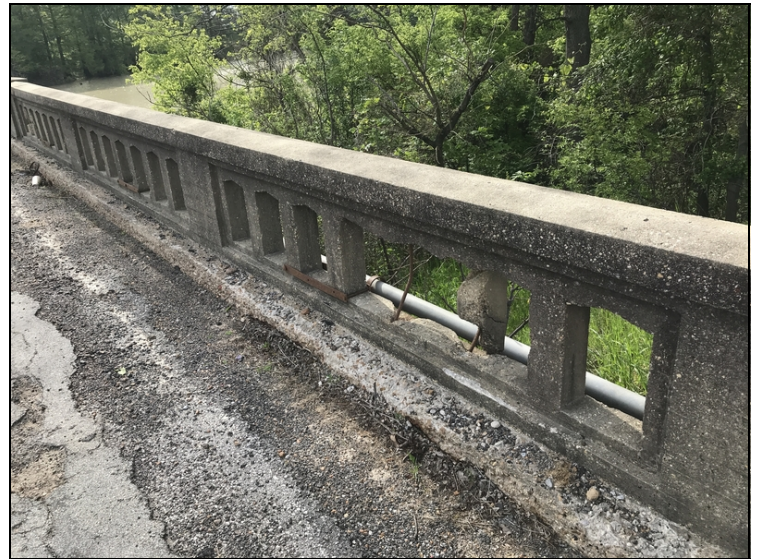
Right bridge rail at first joint broken each direction 6'.

The following locations of bridge rail have collision damage with cracking, spalling, and broken rail posts. Span #1 bent #1 right side, Span #2 right side, Bent #6 right side, Span #7 right and left side.

Two rail posts are broken on right side at abutment #2.

Span #7 left bridge rail

Span #4,5 right bridge rail

Span #2 right bridge rail

Span #1 right side bridge rail

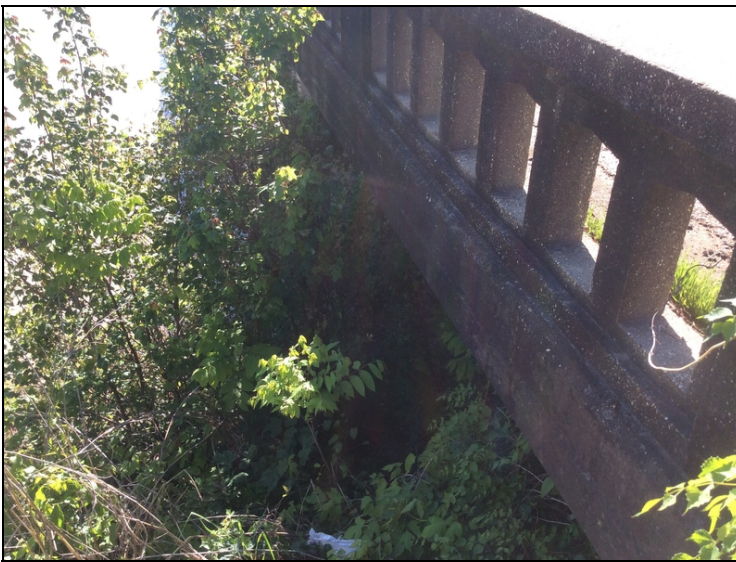
Trees and vegetation are growing beside and under bridge.

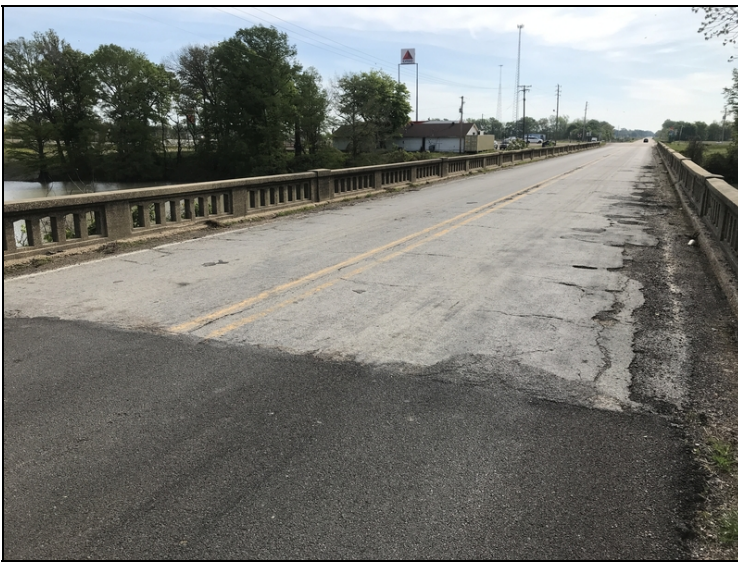
Debris in gutters

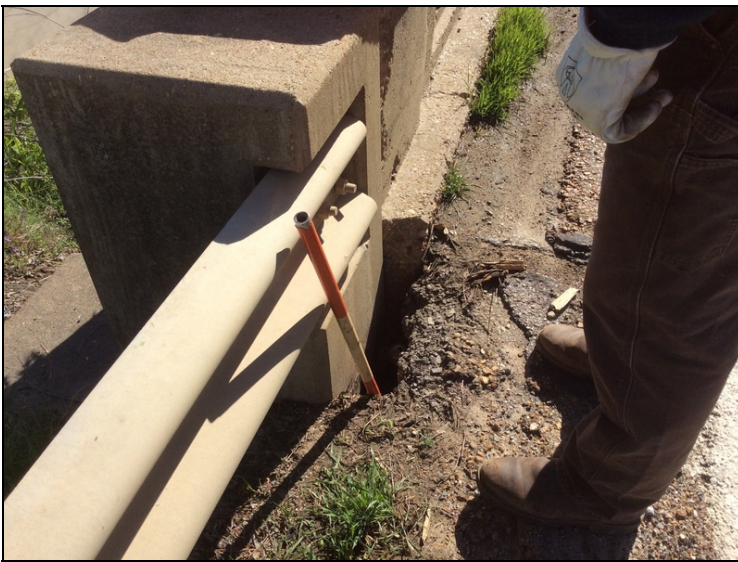
Abutment #1 left, right approach roadway has hole in it 3' deep with large void under roadway.

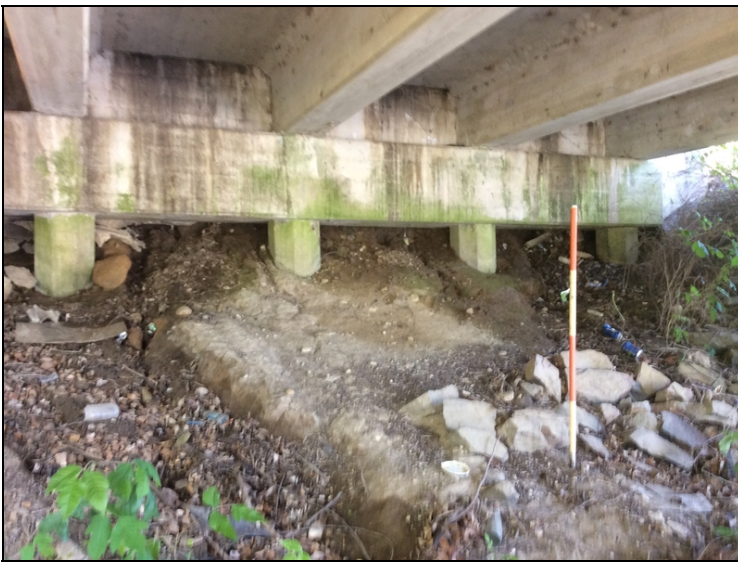
Abutment #1 cap is undermined 2' with voids  
behind cap.

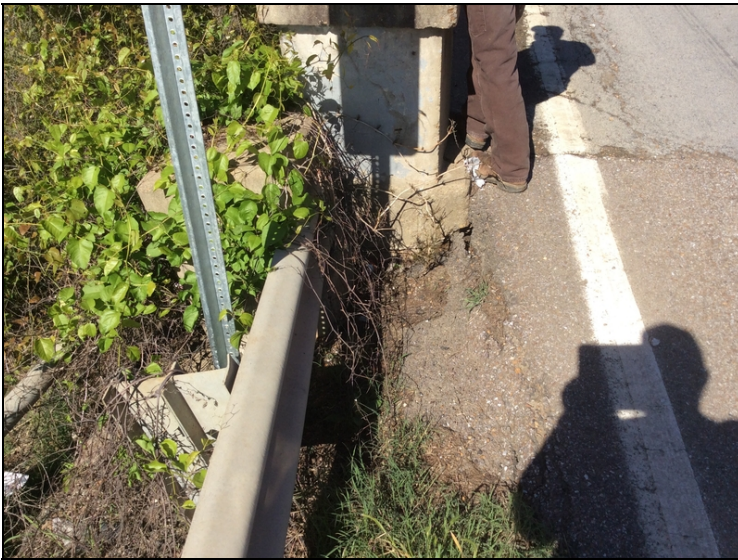
Abutment #2 right side erosion has caused monument post on approach rail to slide down 2'.

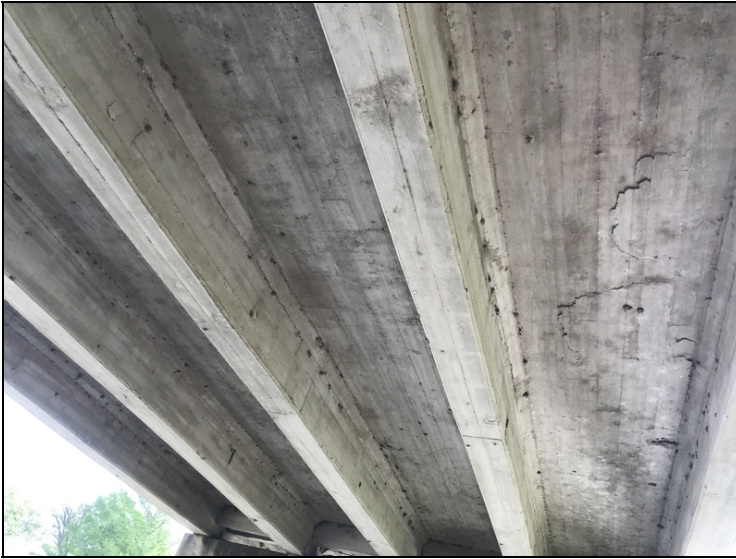
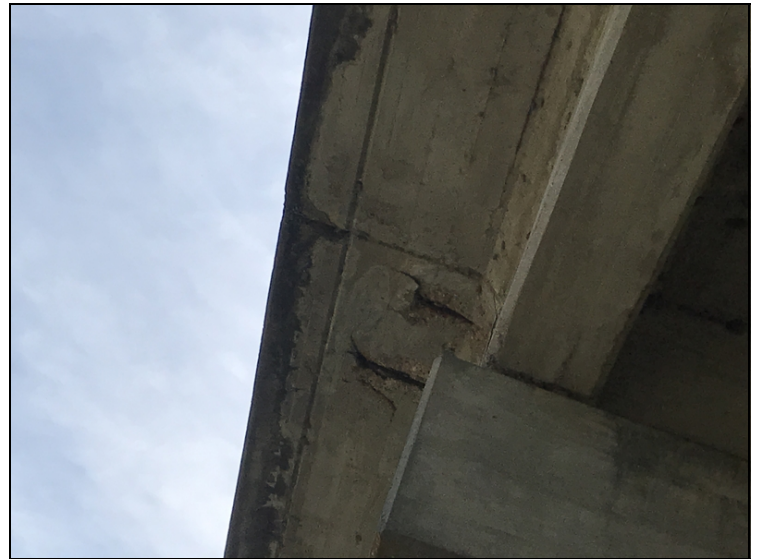
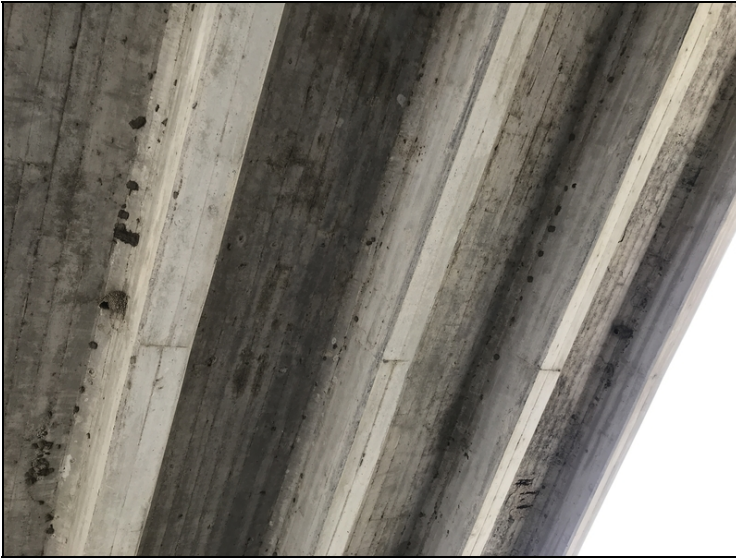
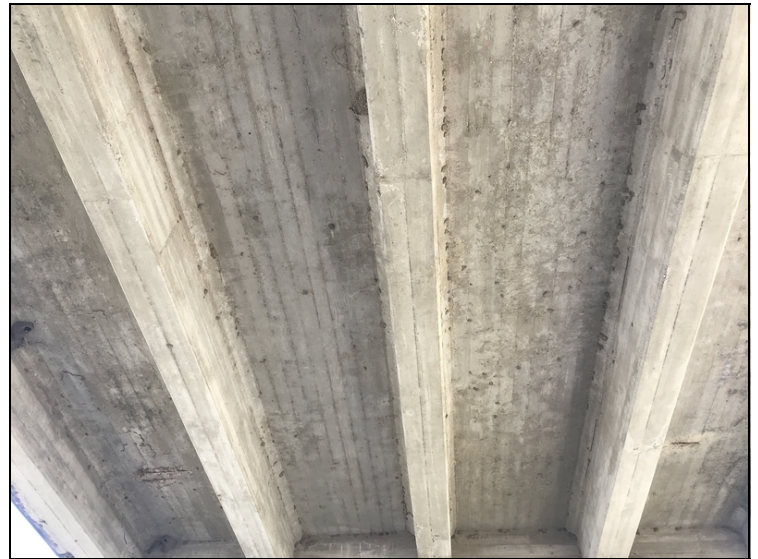
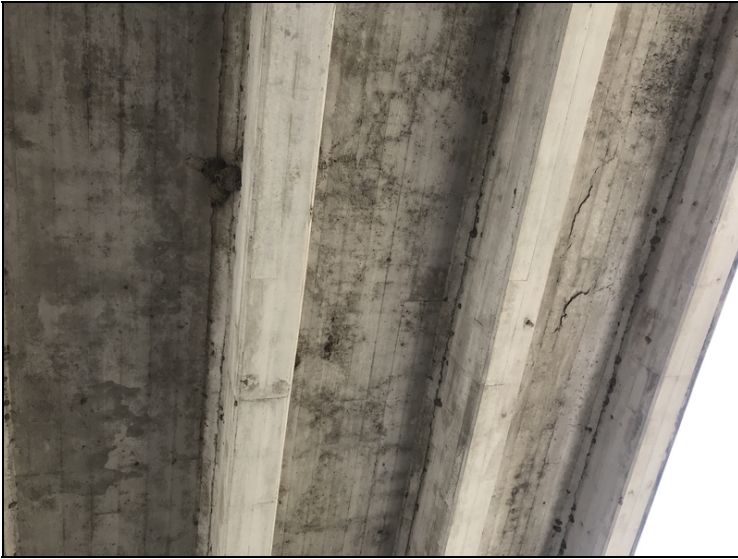
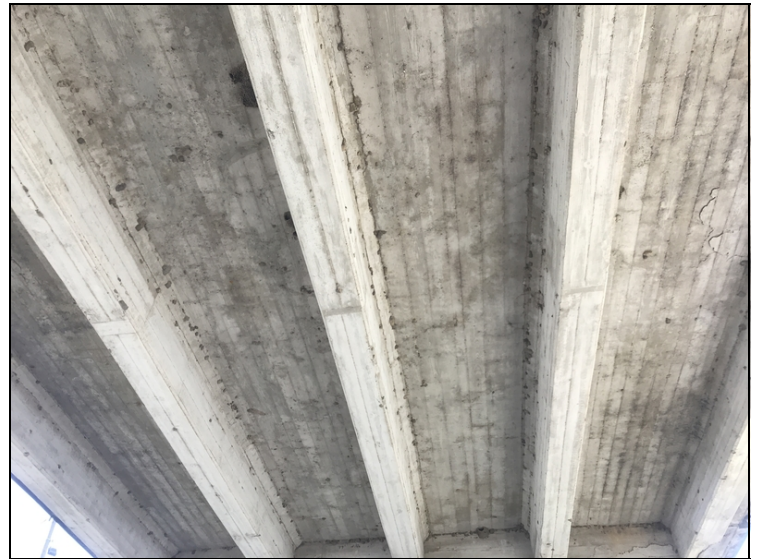
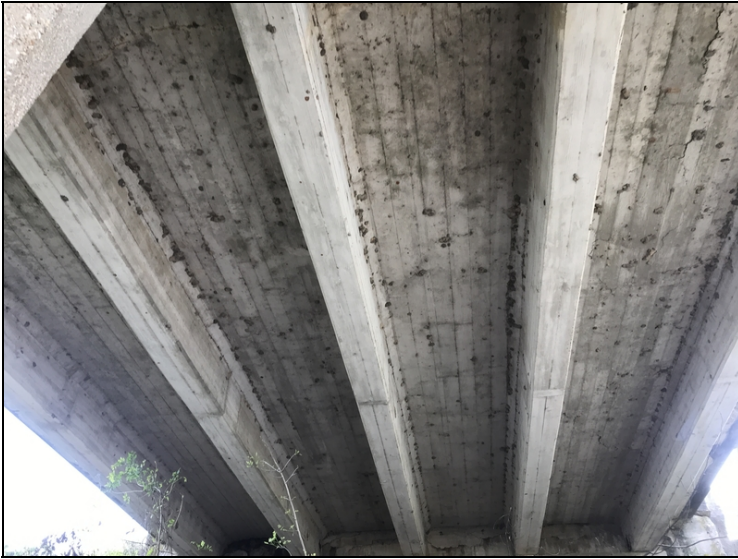
Span #1 soffit-under surface left overhang has 1' delamination near bent #2.  
Span #1 soffit-under surface right overhang has 1' spall with exposed rebar with 5% section loss.  
Span #2 soffit-under surface right overhang has 3' of cracks with moderate efflorescence.  
Span #2 soffit-under surface between girders #4,5 has a 1' spall in center with exposed rebar with no section loss.  
Span #2 soffit-under surface between girders # 4,5 has two 4' delamination's from 1/4 span to mid-span.  
Span #2 soffit-under surface left overhang has three 1' spalls with exposed rebar with no section loss.  
Span #3 soffit -under surface left overhang has two 1' spalls with exposed rebar with 5% section loss.  
Span #3 soffit-under surface left overhang has a 2' delamination near second drain.  
Span #3 soffit-under surface between girders #1,2 has a 1' spall with exposed rebar with 5% section loss in center.

Span #3 soffit-under surface between girders #1,2 has 10' of delamination's.  
Span #3 soffit-under surface between girders #4,5 has a 2' spall near bent #3 with exposed rebar with no section loss.  
Span #4 soffit-under surface right overhang has 3' spall with 2' exposed rebar with 10% section loss near bent #4.  
Span #4 soffit-under surface right overhang has 1' spall with exposed rebar with no section loss near bent #5.  
Span #4 soffit-under surface left overhang has four 1' spalls with exposed rebar with 5% section loss two at each bent.  
Span #4 soffit-under surface between girders #4,5 has 5' of delamination's, and a 1' spall with exposed rebar with no section loss.  
Span #5 soffit-under surface left overhang has 9' total of spalls with exposed rebar with 5% section loss.  
Span #5 soffit-under surface left overhang has 4' total of delamination's.  
Span #5 soffit-under surface between girders #1,2 has 2' spall with exposed rebar with 10% section loss near bent #6.

Span #5 soffit-under surface between girders #1,2 has 4' total areas of delamination's.  
Span #5 soffit-under surface between girders #4,5 has a 1' spall with exposed rebar with no section loss near bent #6.  
Span #6 soffit-under surface right overhang has 3' of spalls with exposed rebar with 10% section loss.  
Span #6 soffit-under surface left overhang has a 2' spall with exposed rebar with 5% section loss near second drain.  
Span #6 soffit-under surface left overhang has 3' of delamination's.  
Span #6 soffit-under surface between girders #1,2 has 1' spall with exposed rebar with no section loss near bent #5.  
Span #6 soffit-under surface has transverse crack with rust stain near bent #6 full width of bridge.  
Span #6 soffit-under surface between girders #4,5 has 2' delamination at mid-span.  
Span #7 soffit-under surface right overhang has 3' spall from span to span thru to deck.  
Span #7 soffit-under surface left overhang at bent #7 has 3' spall thru to deck with exposed rebar with no section loss.

Span #7 soffit-under surface between girders #1,2 has three 3' delaminations and 4' spall with exposed rebar, rebar has 5% section loss.  
Span #7 soffit-under surface between girders #4,5 has 2' delamination at mid-span.  
Span #7 soffit-under surface right overhang has 4' spalls with exposed rebar with 5% section loss.  
Span #8 soffit-under surface left overhang has two 1' spalls with exposed rebar with 5% section loss.  
Span #8 soffit-under surface between girders #4,5 has 4' of delamination's.  
Span #8 soffit-under surface right overhang has 6' of spalls with exposed rebar with 10% section loss.  
Span #8 soffit-under surface has transverse crack with rust stains near bent 8.  
Span #9 soffit-under surface right overhang has 3' of spalls with exposed rebar with 5% section loss.  
Span #9 soffit-under surface right overhang has 3' of delamination's.  
Span #9 soffit-under surface left overhang has 2' of spalls with exposed rebar with 5% section loss.

Span #9 soffit-under surface between girders #4,5 has 3' delamination at mid-span.  
Span #10 soffit-under surface left overhang has 1' delamination at abutment #2.  
Span #10 soffit -under surface right overhang has 6' of spalls from mid-point to end of bridge with exposed rebar with 5% section loss.  
Span #10 soffit-under surface between girders 4 and 5 has 20' delaminations.  
Span #10 soffit-under surface has transverse crack with rust stains near bent #10

Span #2 soffit-under surface

Typical spalls on soffit-under surface overhang.

Span #4 soffit-Under surface

Span #5 soffit-under surface

Span #6 soffit-under surface

Span #9 soffit-under surface

Span #10 soffit-under surface
