Bridge #01375(Routine)

Us70/Sec-19/L19.83 over Shell Lake

Location: .20 Mi Ne Jct Of Sh 149

Team Lead: Drew Melton Inspection Date: April 26, 2021

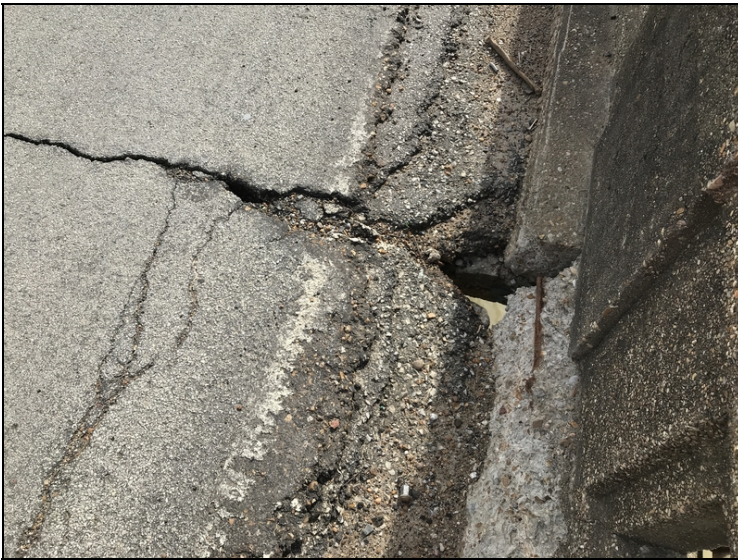
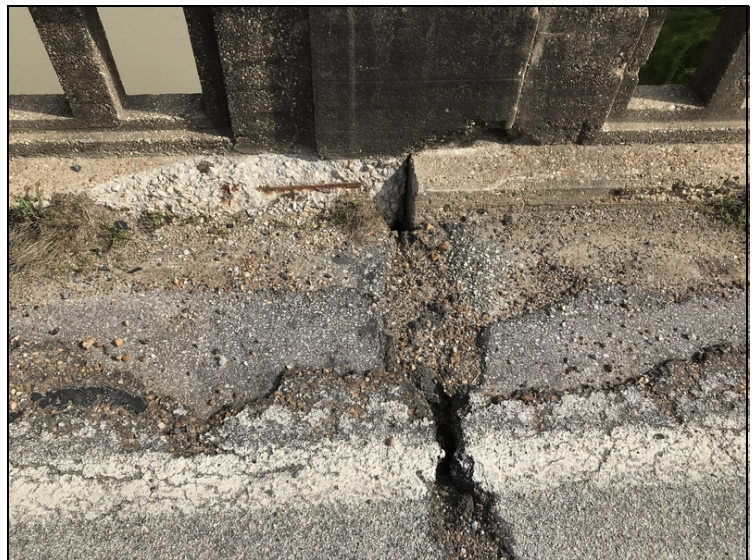
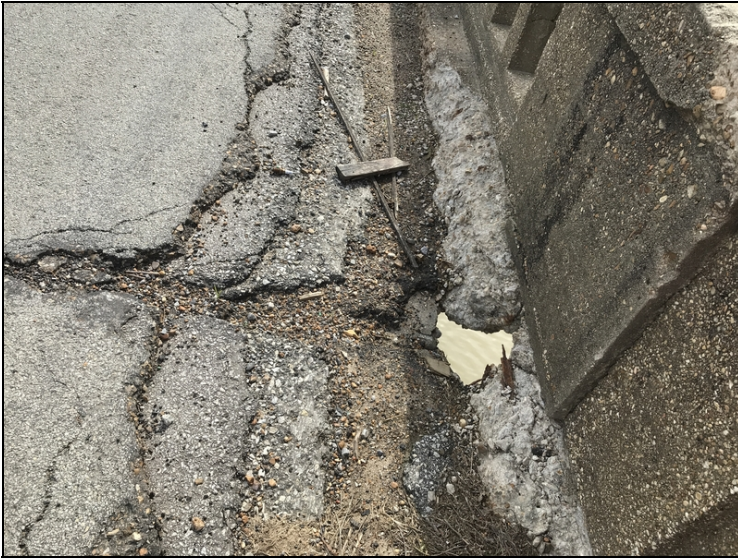
Deck at bent #7 right side and deck at bent #9 both sides in gutter each location has a hole through the deck.

Bent #9 deck right side

Bent #9 deck left side

Bent #7deck right side

04/24/2017 Lowered deck from 6 to 5 due to full depth failures at some joints.

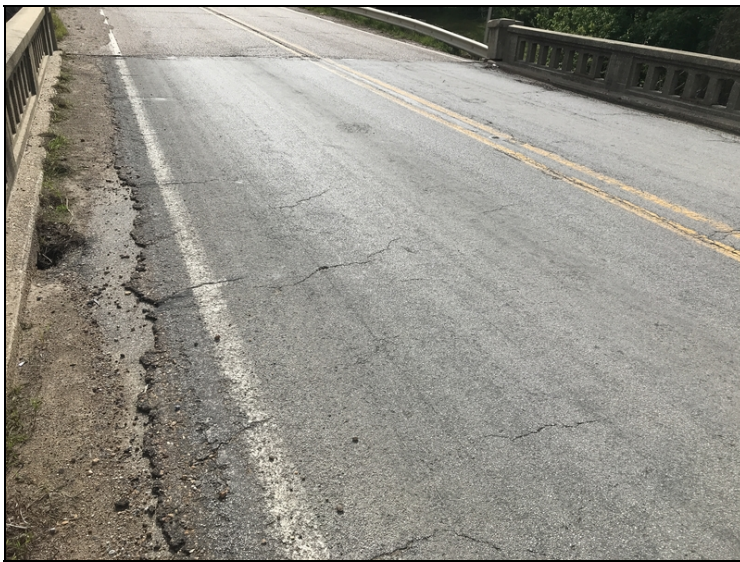
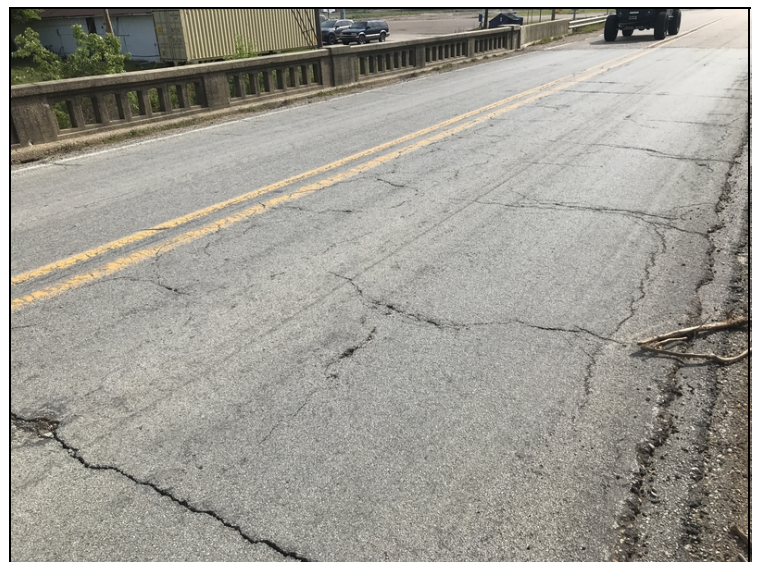
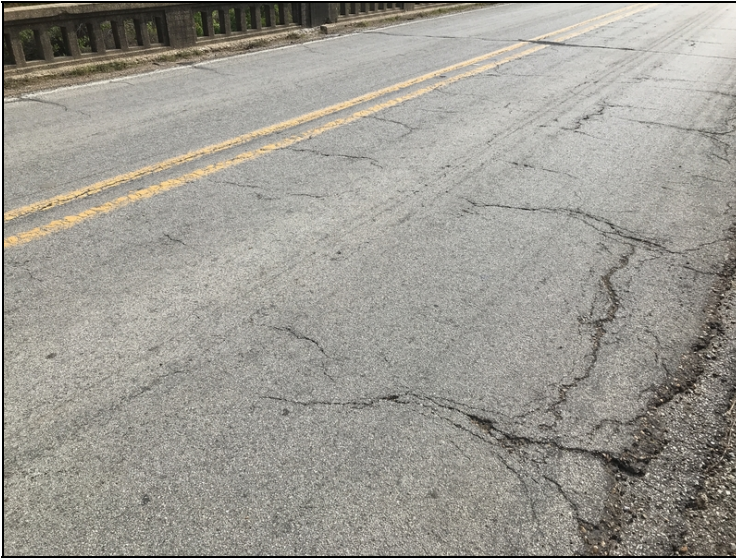
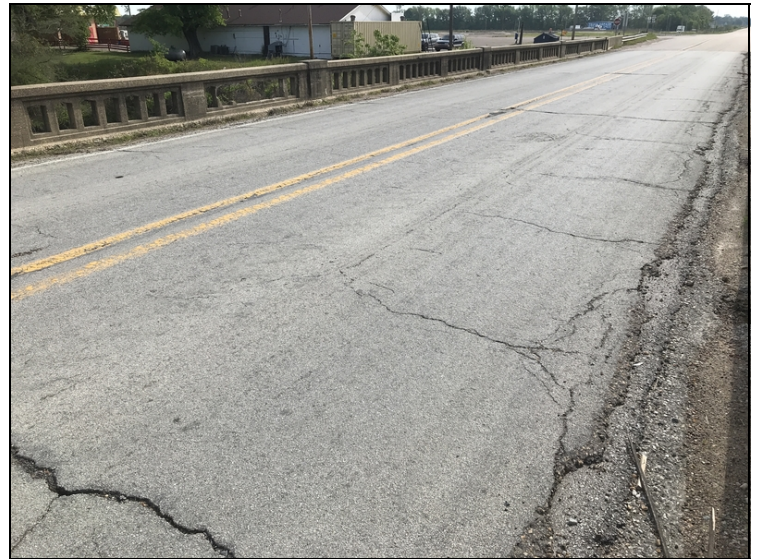
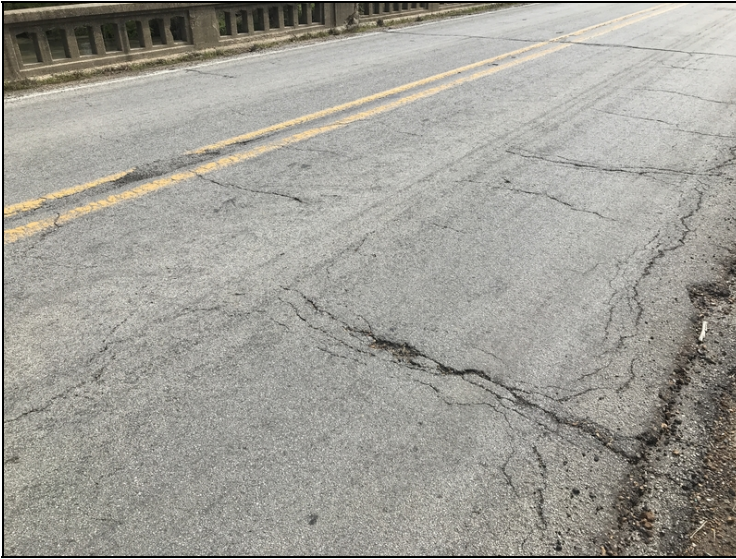
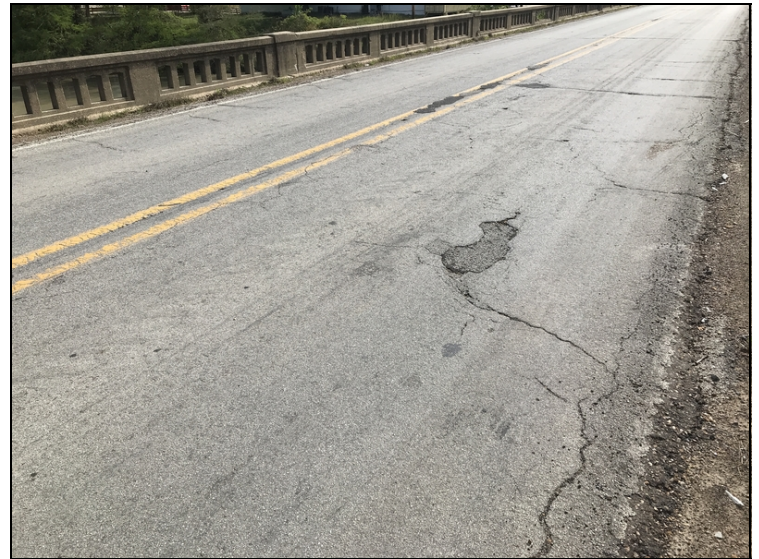
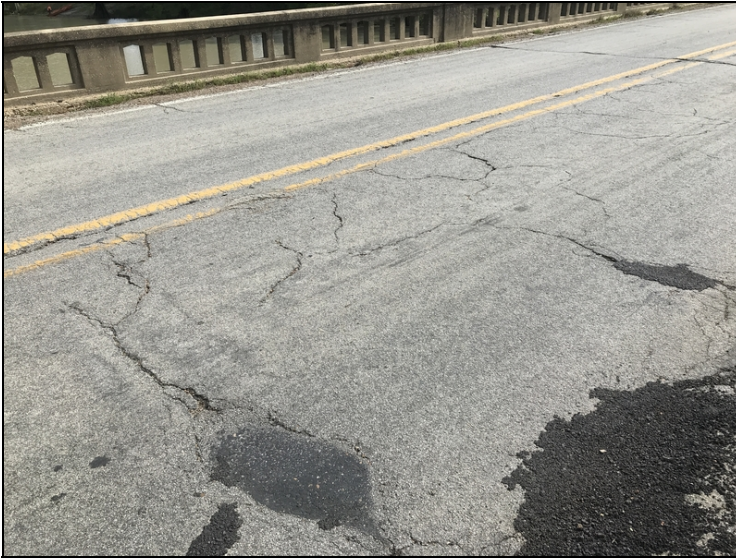
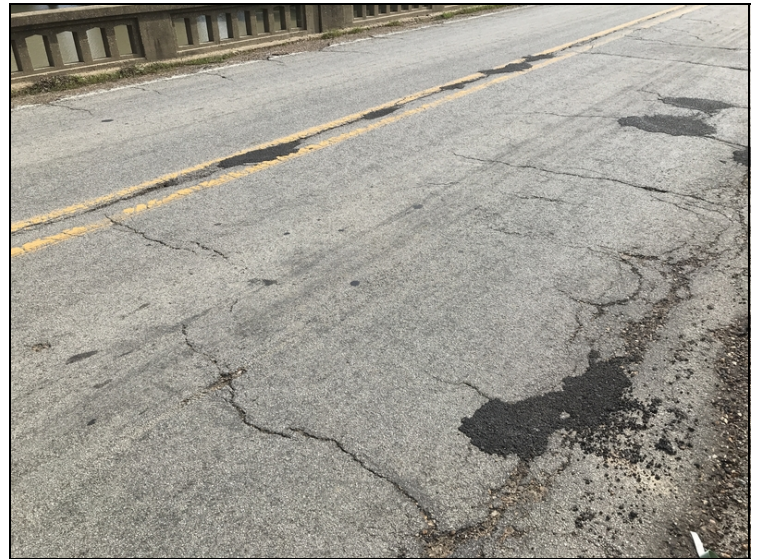
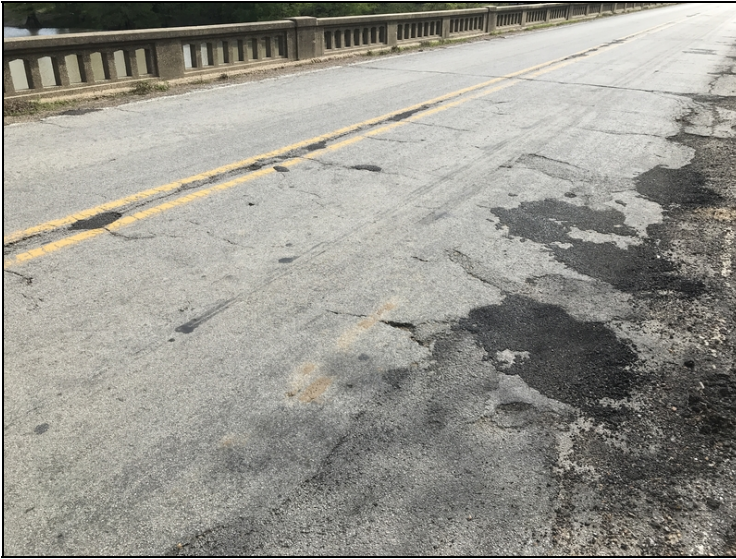
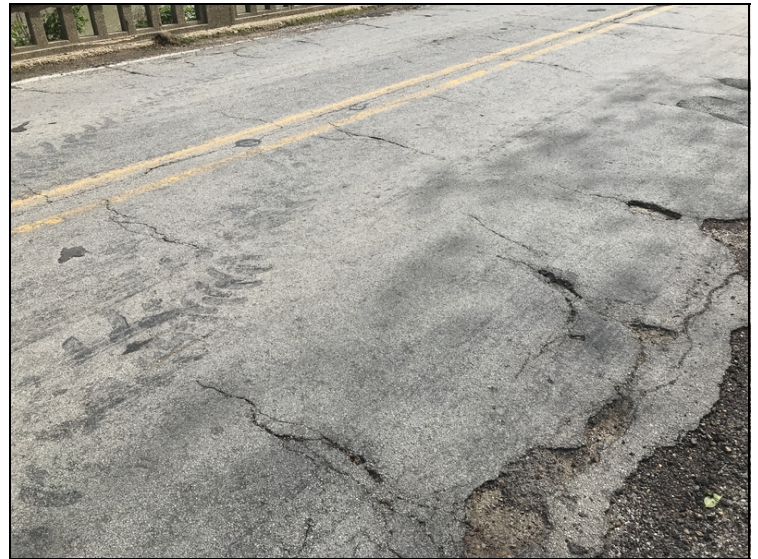
Wearing surface is cracked transverse and longitudinal with all different size cracks all of surface has cracks and multiple areas of achm patches.

Span #10 deck

Span #9 deck

Span #8 deck

Span #7 deck

Span #6 deck

Span #5 deck

Span #4 deck

Span #3 deck

Span #2 deck

Span #1 deck
