Bridge #01376(Underwater type 2, Routine)

Us-70/Sec-19/L20.2 over Drainage Canal

Team Lead: Myron Futrell Inspection Date: February 11, 2020

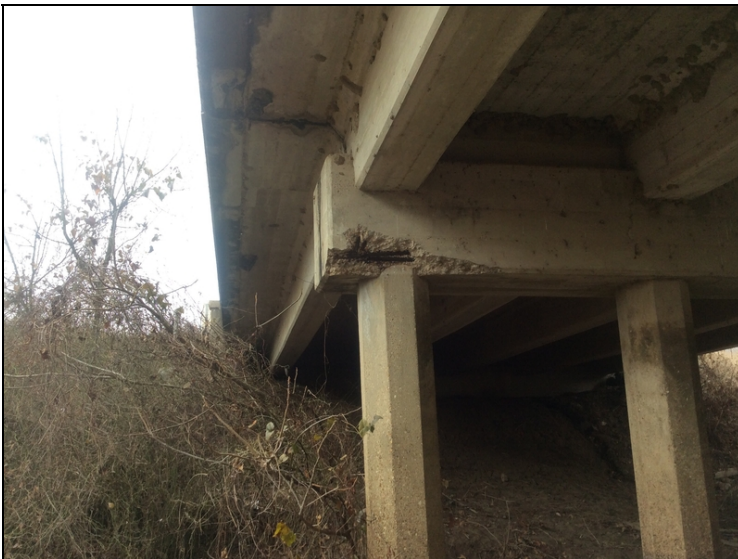
Bent #2 right end front face has two foot spall with exposed rebar with 10% section loss.

Bent #2 cap right end front face

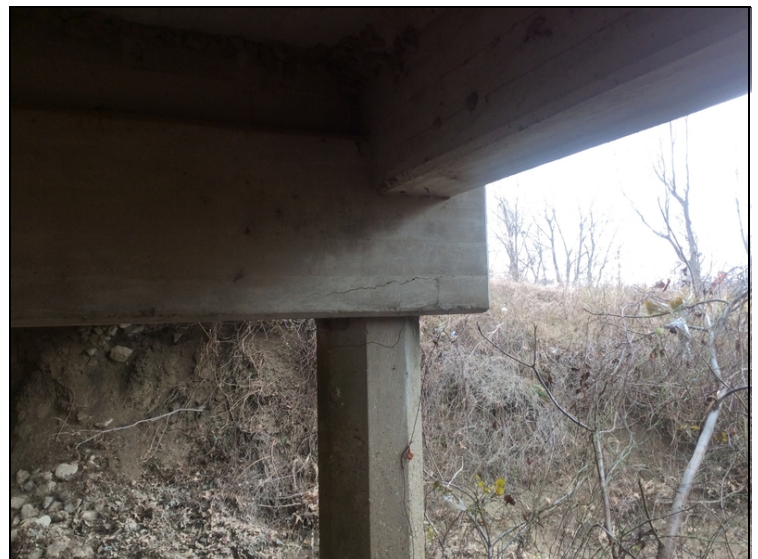
(234) Bent #2 right end back face has three foot delamination.

Bent #2 right end back face has two foot delamination.

Bent #2 cap right end back face

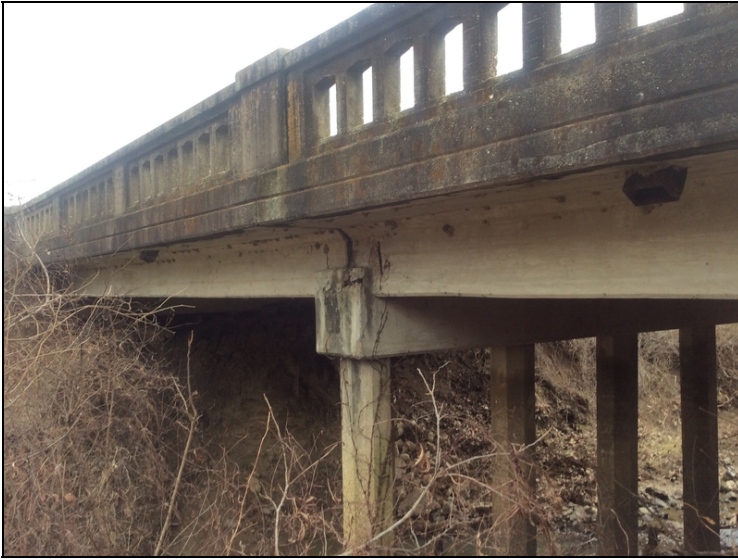
Bent #2 left end is cracked and delaminated with one foot spall with exposed rebar with 10% section loss.

Left end cap at bent #2 and side of concrete t
beam span #1 bent #2

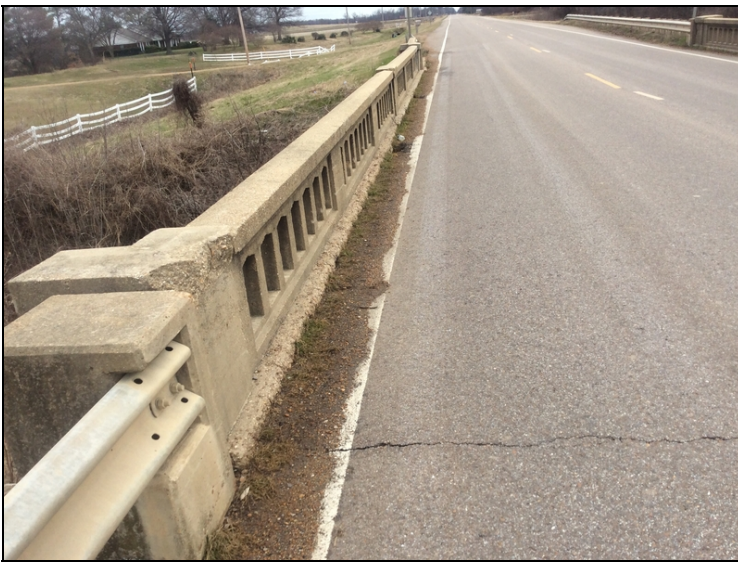
Gutters have dirt and debris in them with vegetation.

Gutters full of dirt and vegetation

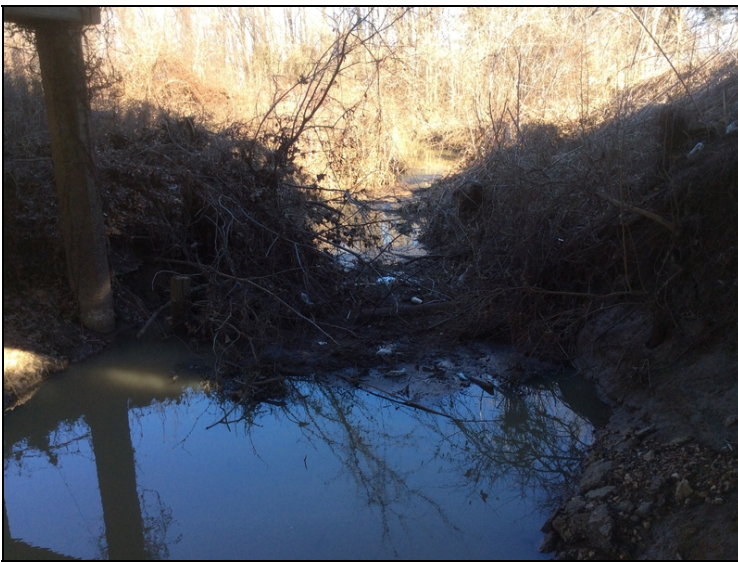
Left side channel is blocked with debris.

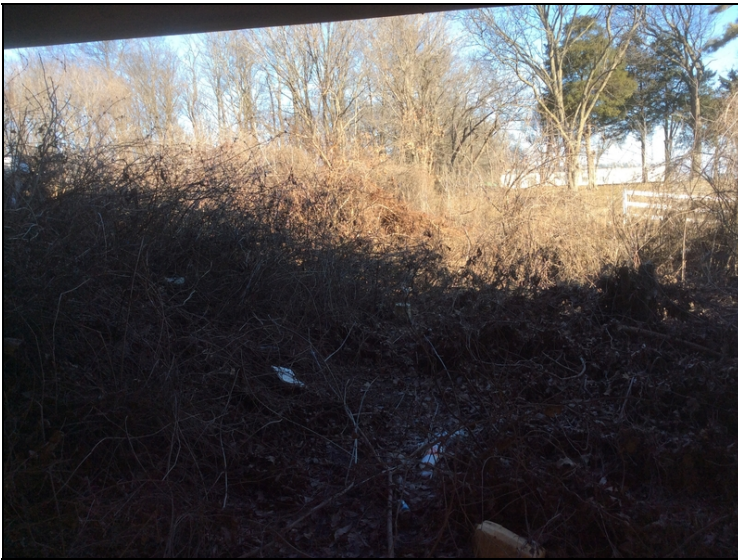
Brush and small trees are growing beside and under bridge.

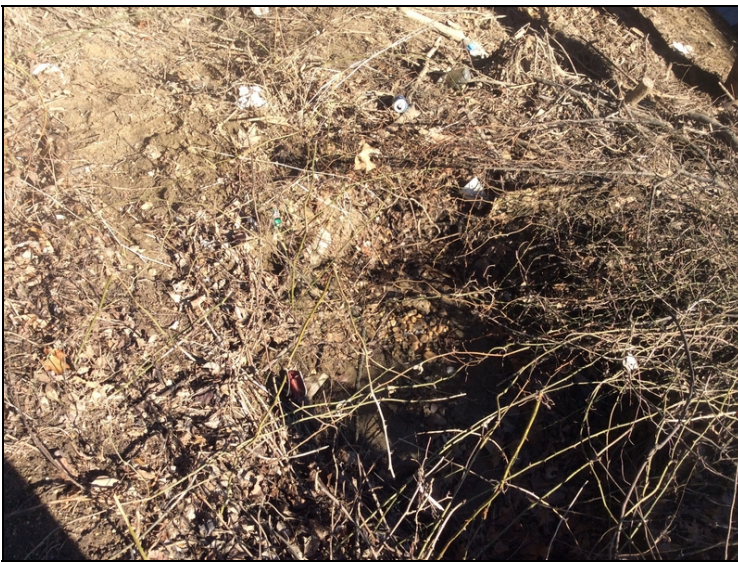
Abutment #1 right side at drain has four foot hole in slope due to drain erosion.

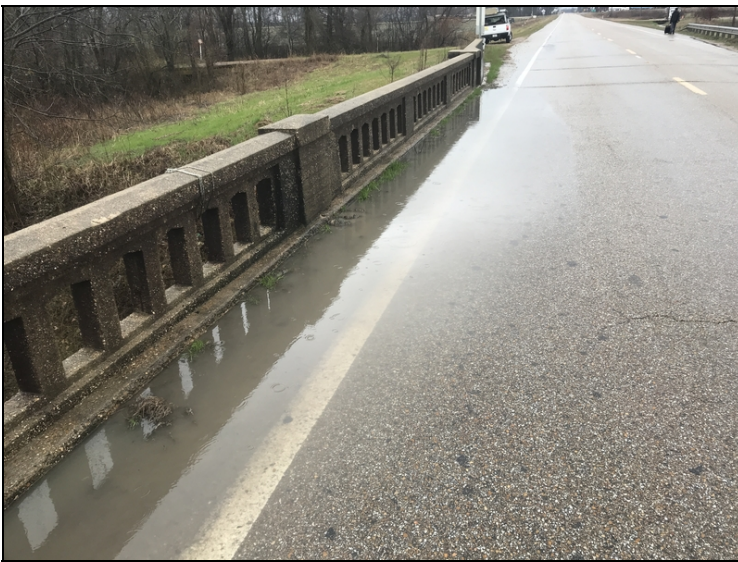
Deck drains plugged causing water to pool on deck.

Right deck drain plugged causing water to pool on deck.

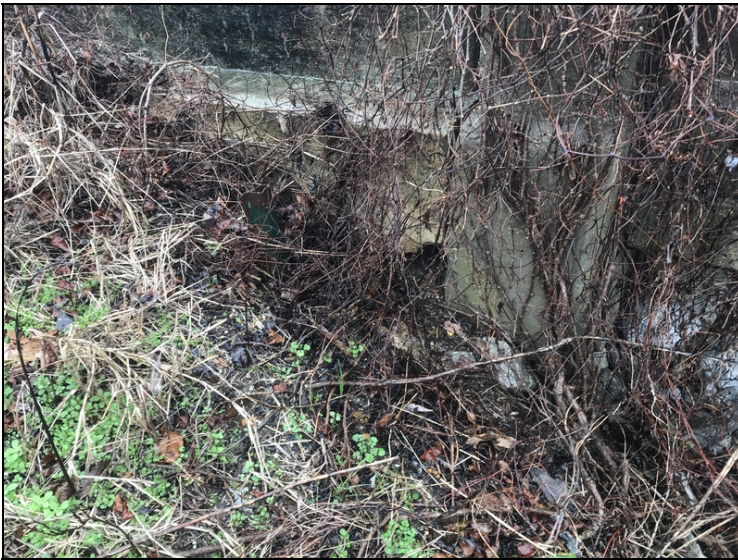
Abutment 2 left approach gutter has small void underneath.

Small void under abutment 2 left approach gutter.
