Bridge #01377(Routine, Underwater type 2)

Us-70/Sec-19/L21.6 over Blackfish Lake

Team Lead: Myron Futrell Inspection Date: March 25, 2020

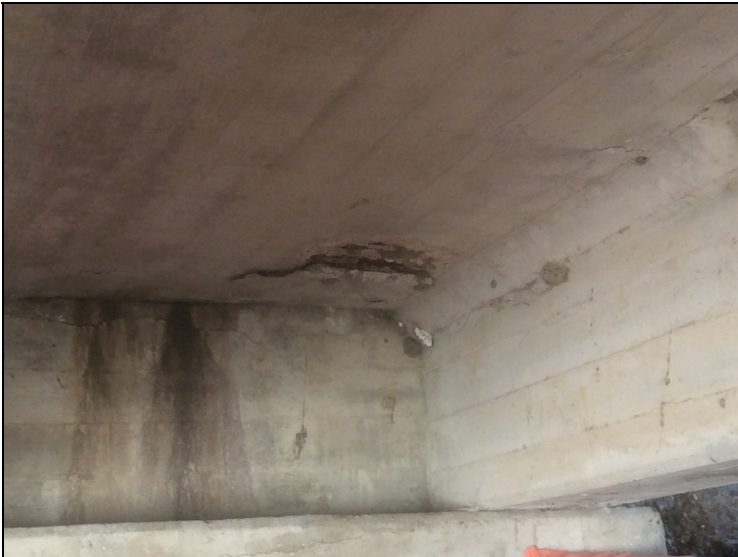
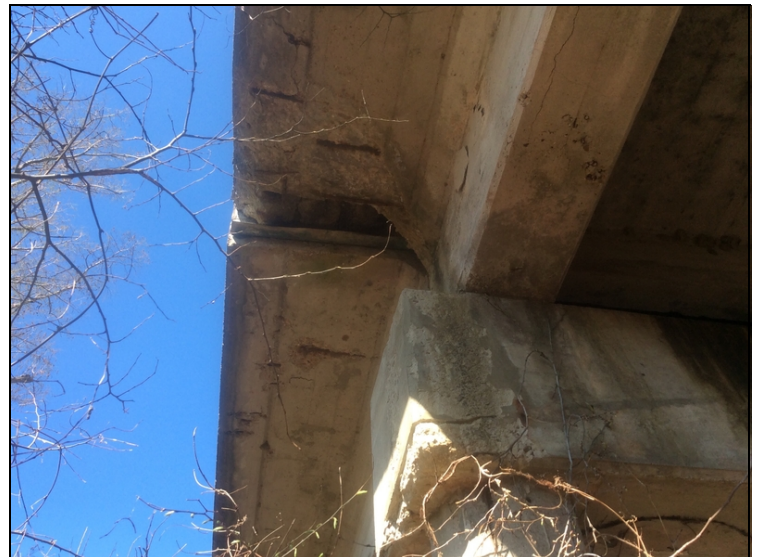
SOFFIT

SPAN#1 BAY #1

SPAN#8 BAY #4

SPAN #9 BAY ALL BAYS

SPAN#10 ALL BAYS

GUTTER AT JOINTS

BAYS HAVE AREAS OF DELAMINATIONS AND SPALLS WITH EXPOSED REBAR

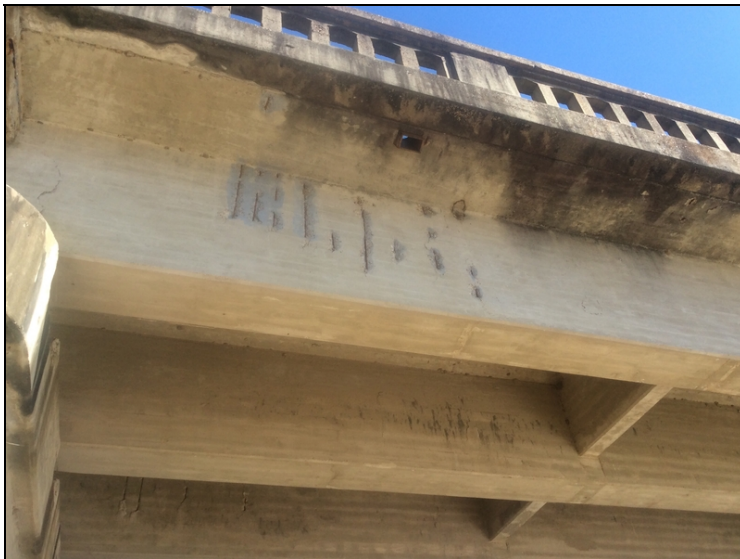
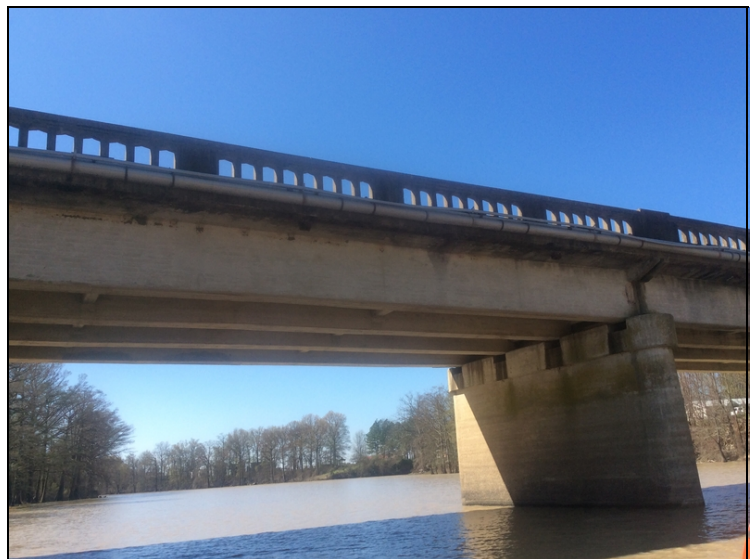
GIRDERS

SPANS # 2,3,4,5,6,7,8

SEVERAL GIRDERS HAVE SMALL SPALLS (EXPOSED CAGE REBAR)

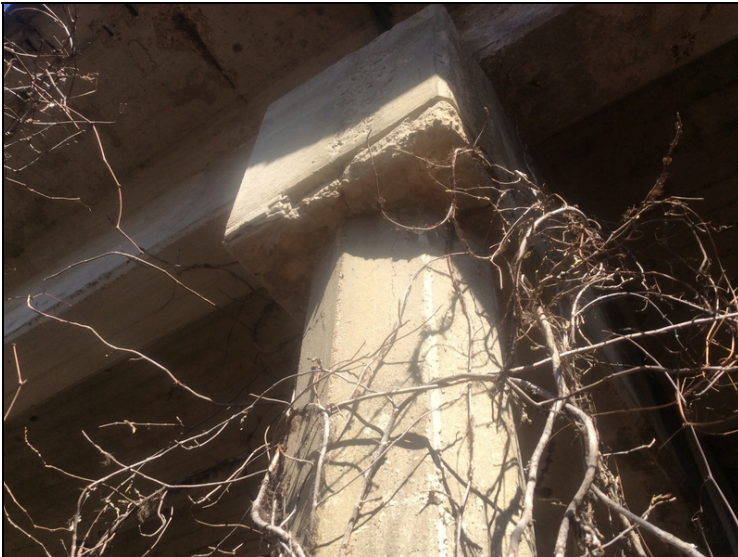
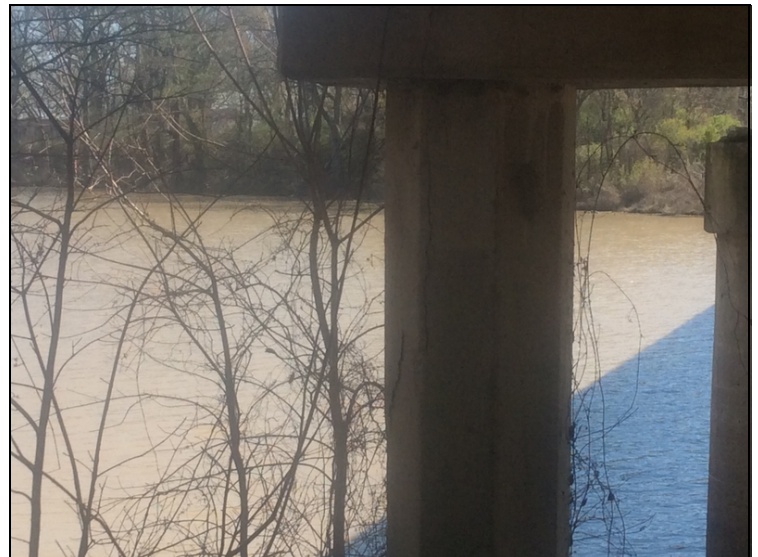
PILE

BENT # 2 PILE #1,4,5

BENT #9 PILE #5

PILES ARE CRACKED NEAR TOP 3'+- DOWN FROM CAP

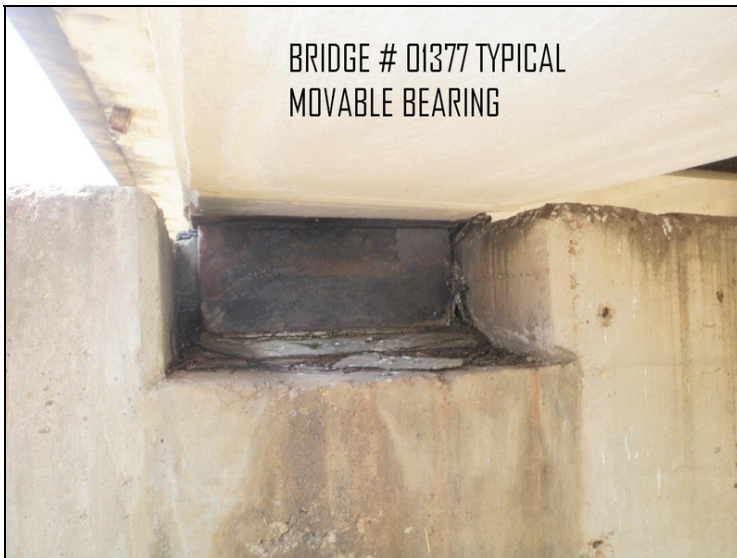
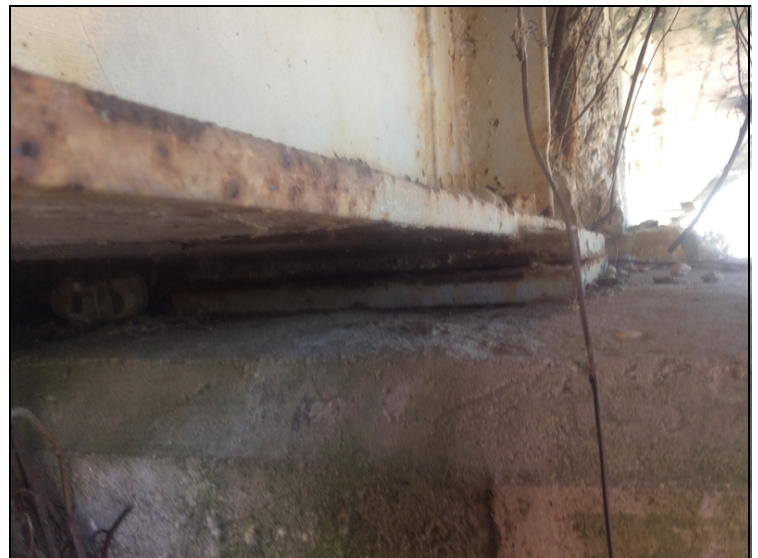
(311)							
Heavily rusted with laminations, section loss, and loss of movement.							
313	Fixed Bearing	EA	40	20	0	20	0
1000	Corrosion	EA	20	0	0	20	0
515	Steel Protective Coating	SF	120	120	0	0	0

MOVABLE BEARINGS

ALL

CORODED WITH LAMINATIONS SOME SECTION LOSS NON- MOVING

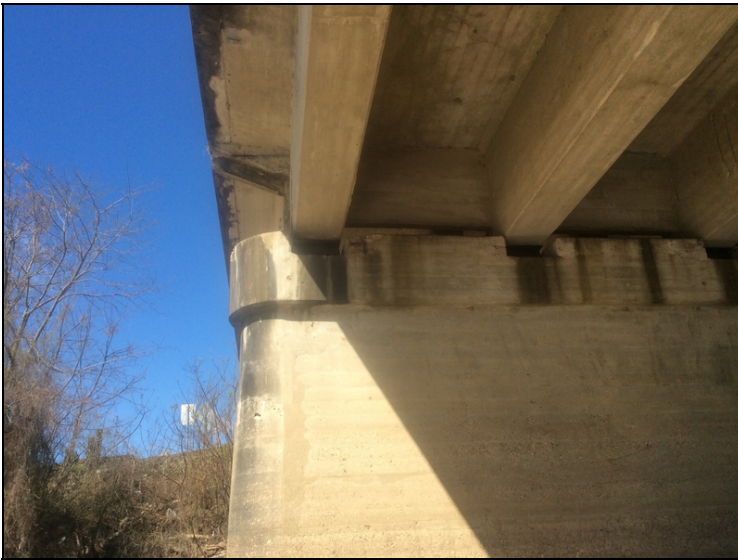
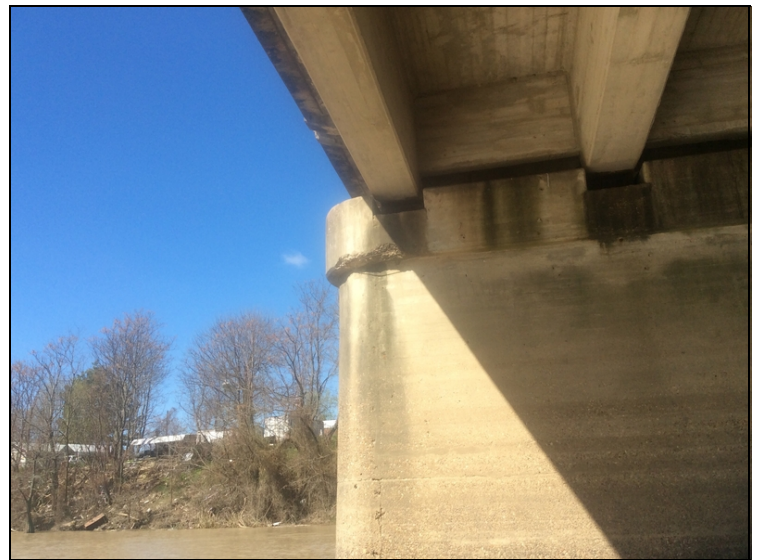
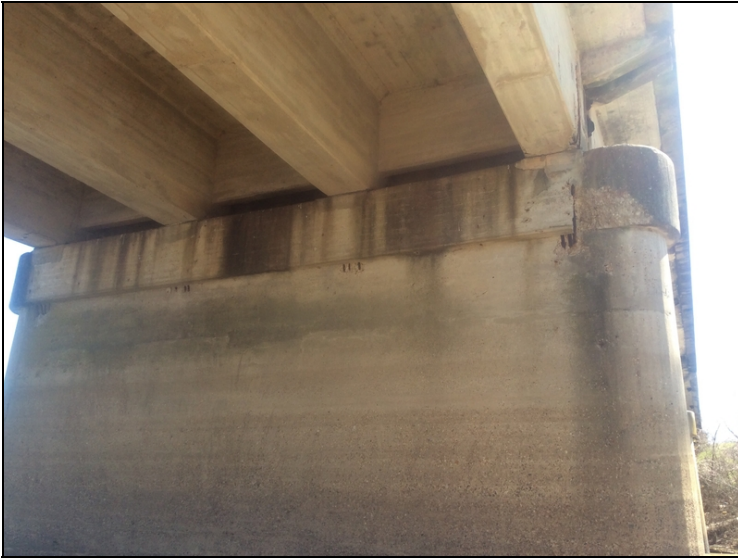
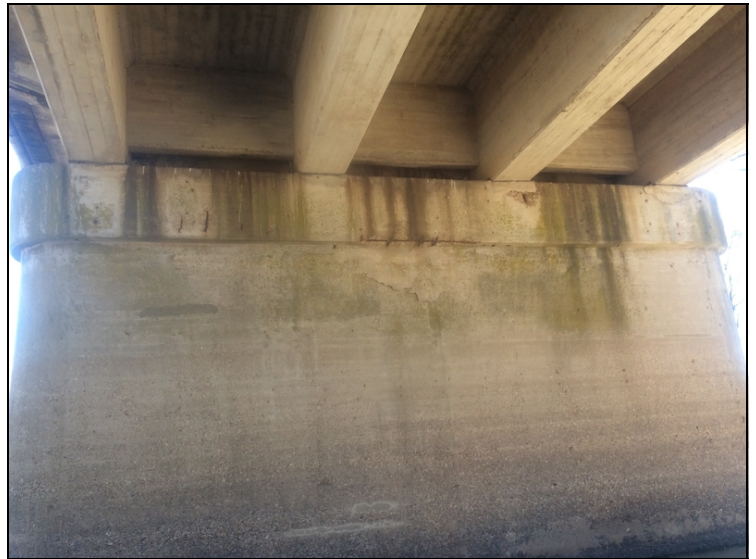
CAP

BENT # 4 RIGHT END
BENT #6 AHEAD FACE
BENT #7 BOTH FACES
BENT #10 AHEAD FACE

SPALLED WITH EXPOSED REBAR

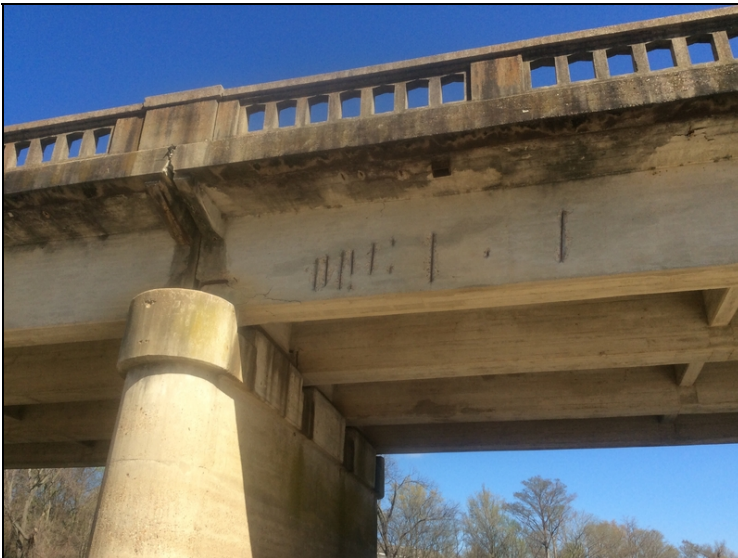
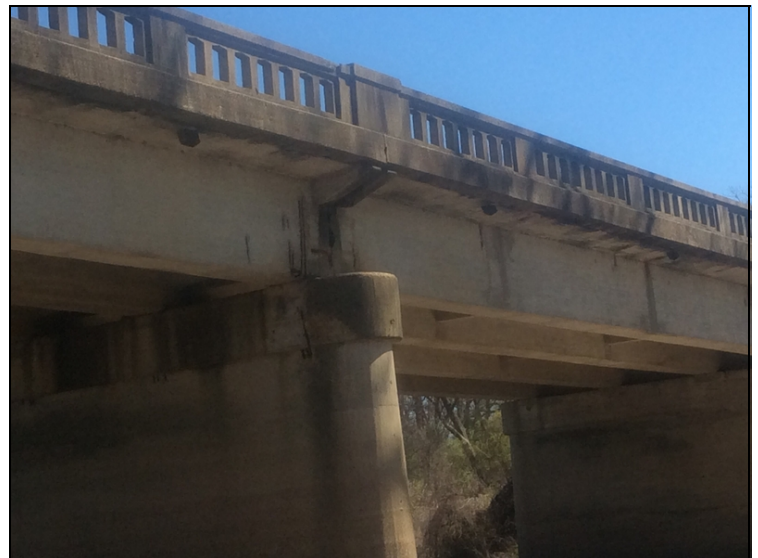
GIRDERS

BENT #5 GIRDER #4

BENT #6 GIRDER #4

BENT #7 GIRDER #4

SPALLED ON GIRDER ENDS WITH PRIMARY REBAR EXPOSED.

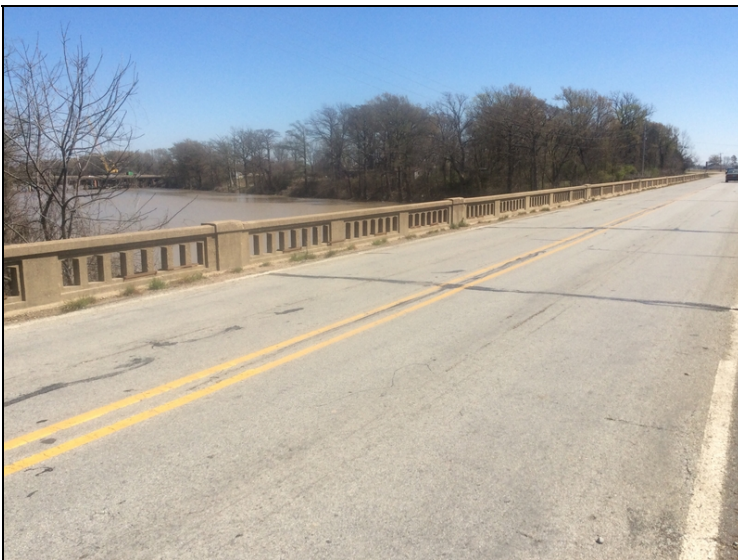
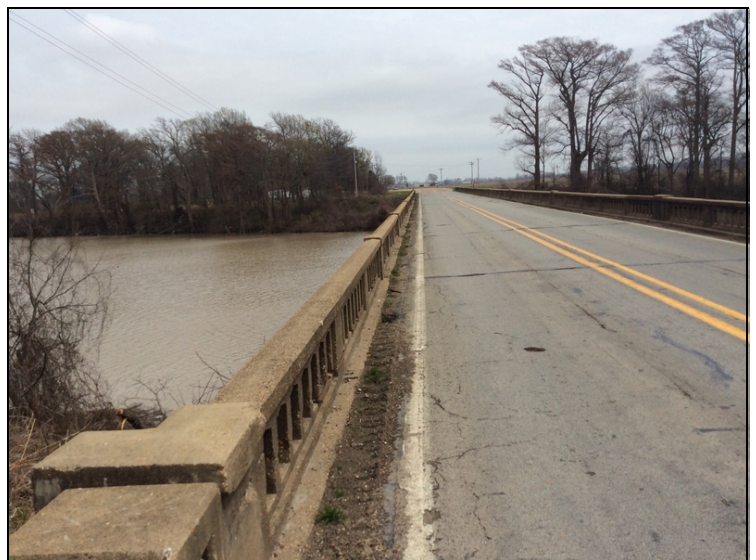
GUTTERS FULL OF DIRT AND VEGETATION.

Gutters full of dirt and debris

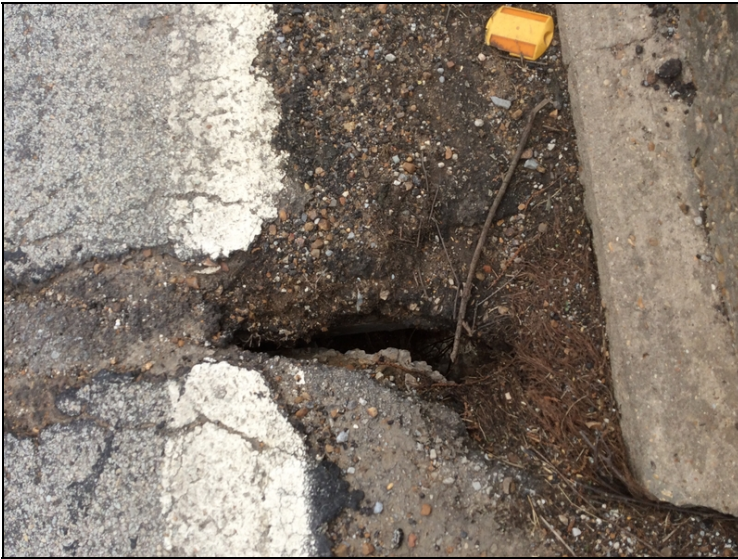
Bent 9 right gutter between spans 8 and 9 has 8" hole through deck.
Bent #10 right shoulder has hole in deck

Bent#10 right shoulder hole in deck

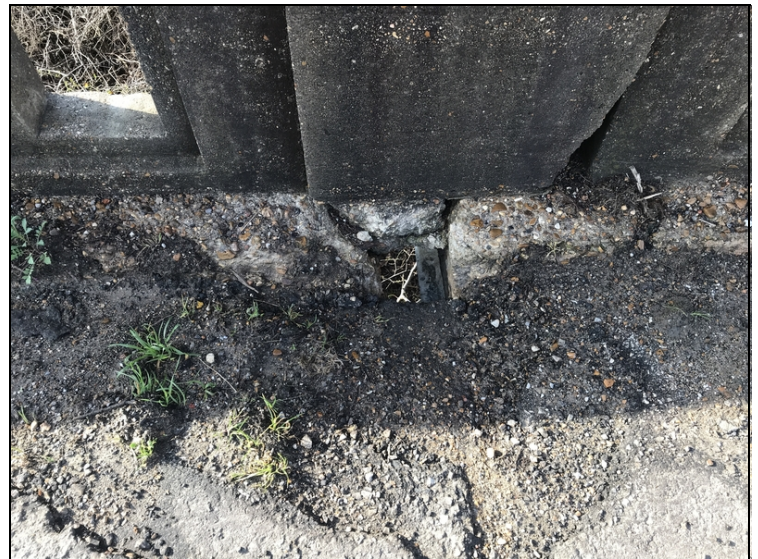
Hole in right gutter of bent 9.

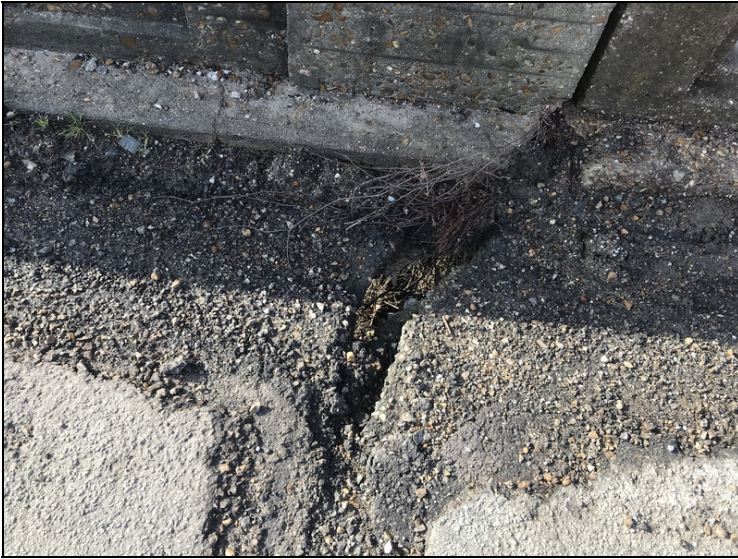
Hole in right gutter at bent 10.

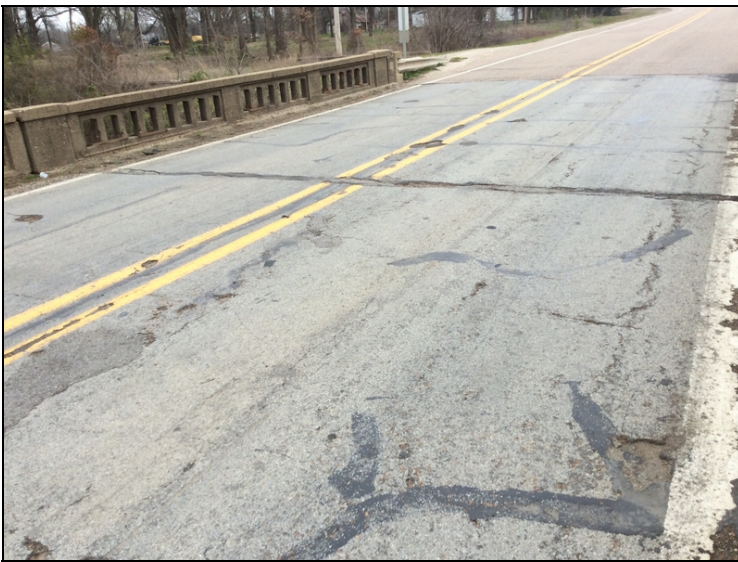
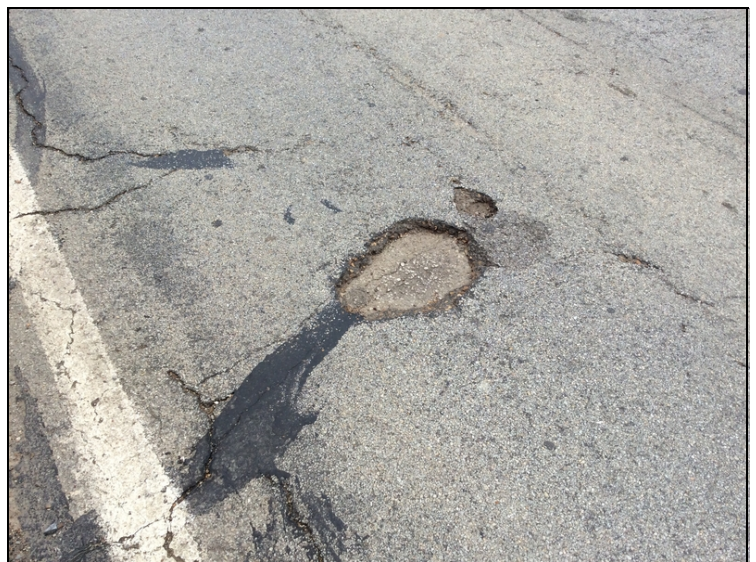
All spans have spalls in asphalt overlay both lanes. Spans # 5,6,7,8,9 are the worst.

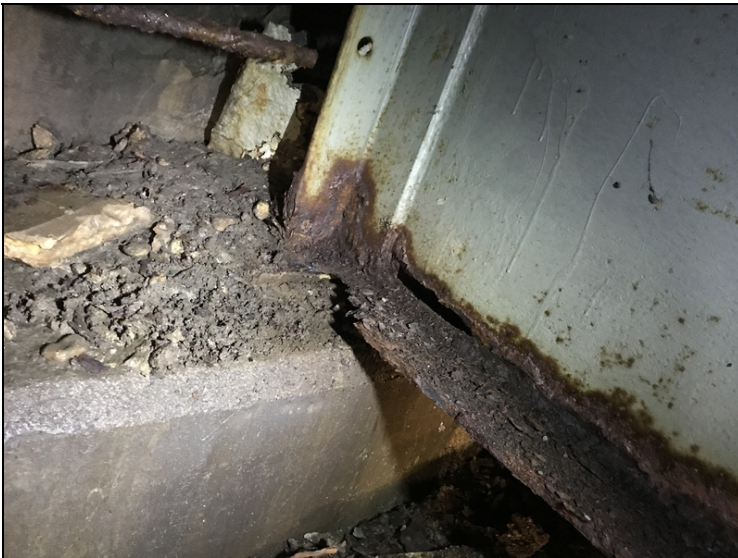
Girder #2 last 10" has 1" tall area of 100% section loss in web near bottom flange at girder end. Bottom flange has up to 80% section loss last 3'.
Girder #3 has 6" x 1" long hole in web near bottom flange, bottom flange has 100% section loss both sides at abutment #2.
Girder #4 has 1" hole in bottom flange with up to 85% section loss last 1', web has up to 50% section loss last 3' near bottom flange at abutment #2.

Span 10 girder 3 left side.

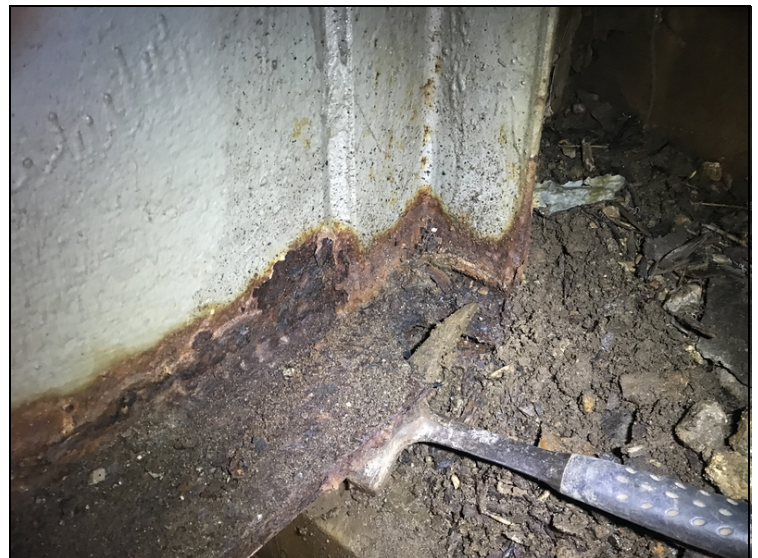
Span 10 girder 4 right side at abutment 3

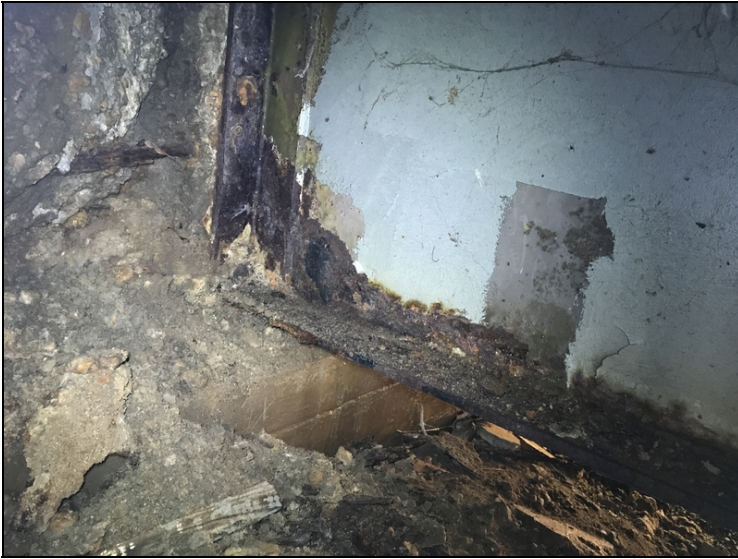
Span 10 girder 4 at abutment 2

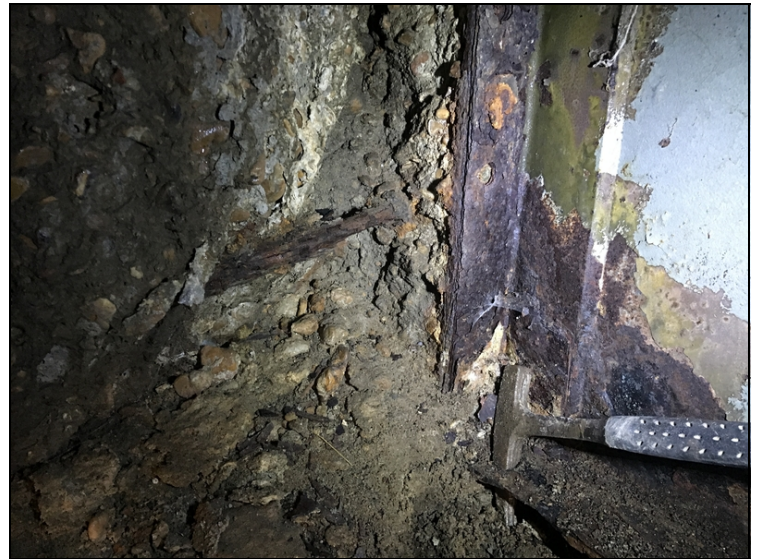
Span 10 girder 4 left side at abutment 2.

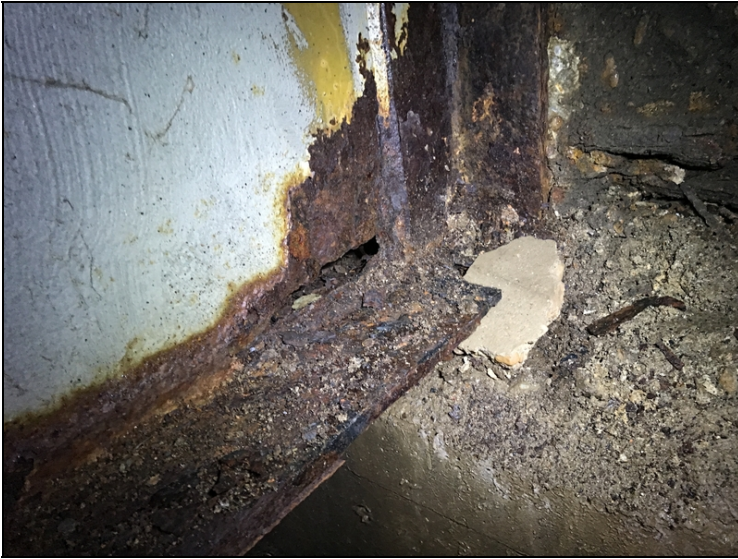
Span 10 girder 3 right side at abutment 2.

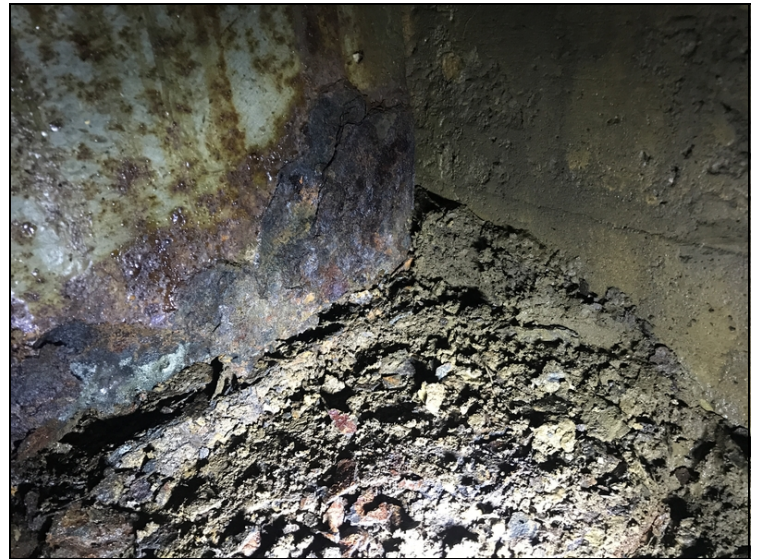
Girder #2 last 10" has 1" tall area of 100% section loss in web near bottom flange at girder end. Bottom flange has up to 80% section loss last 3'.

03/26/2020-lowered superstructure from 5 to 4 due to girder condition in span #10 at abutment #2.

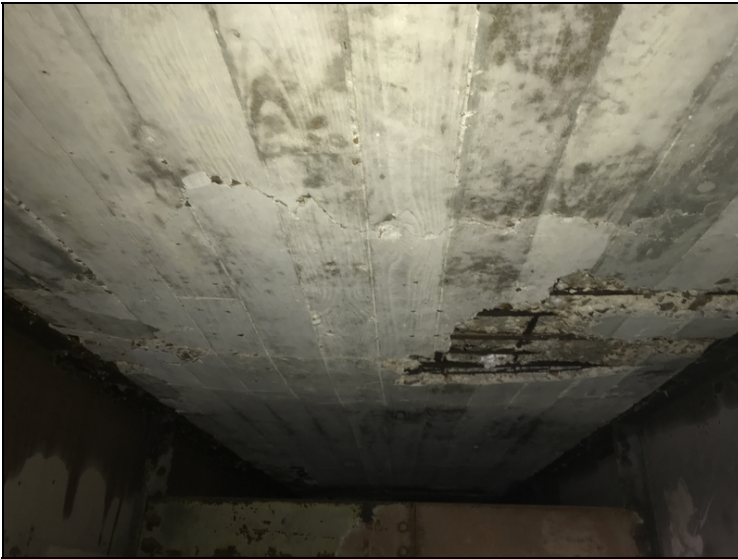
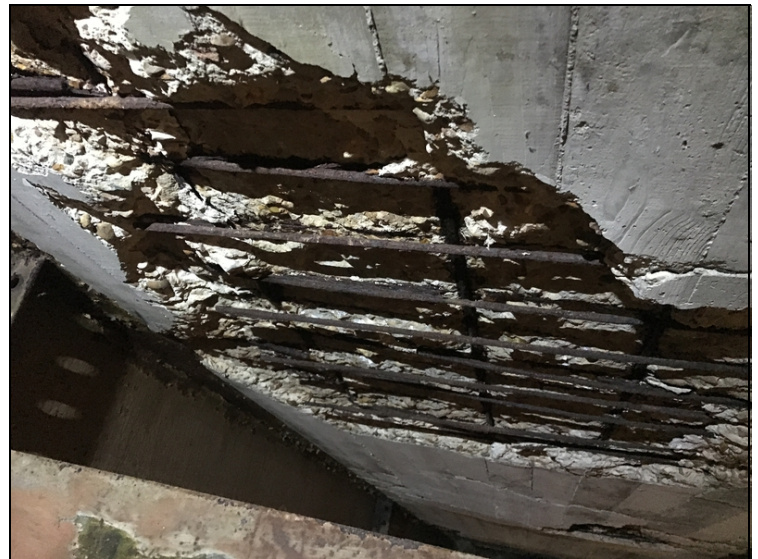
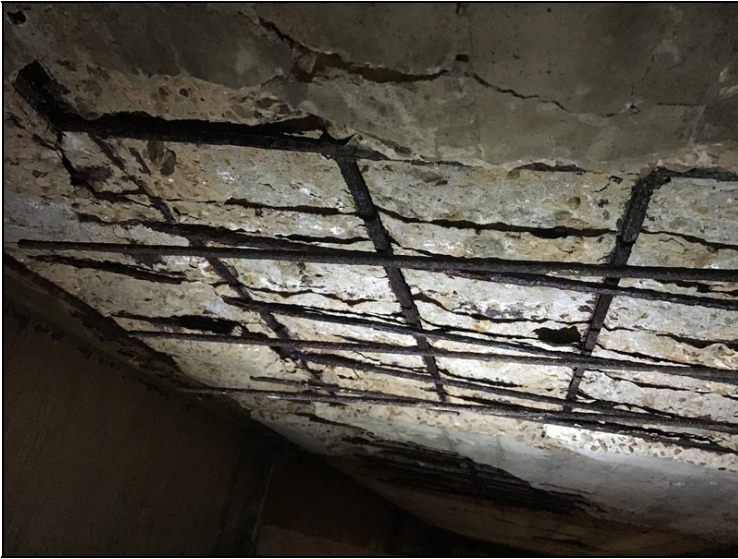
Span 10 soffit between girders 3 and 4 has approximately 60 square feet of spalling up to 3" deep with exposed rebar with up to 40% section loss and approximately 80 square feet of delamination.

Span 10 soffit between girders 3 and 4.

03/26/2020-lowered deck from 6 to 4 due to spalling with exposed rebar and delaminations in span #10 soffit.

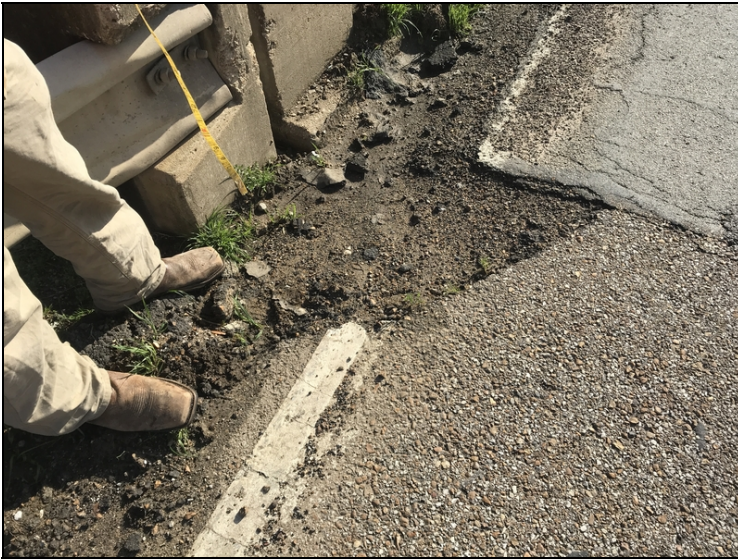
Abutment #1 left approach shoulder overlay spalled 2' x 3' x 3" deep.
Abutment 2 right shoulder overlay spalled 3' x 4' x 4" deep.

Abutment 1 left shoulder overlay spalled.

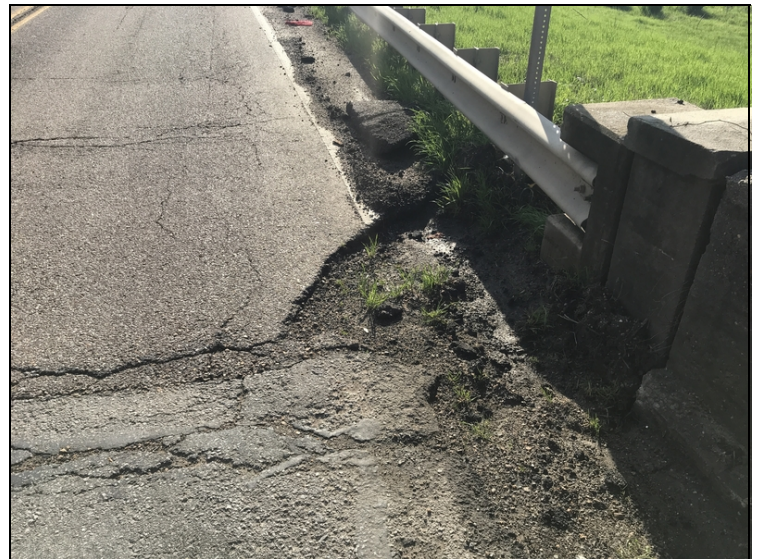
Abutment 2 right shoulder overlay spalled 3' x 4' x 4" deep.
